## Profile/Photo Observation Report

Date:	<b>04/10/2018</b>	Weather:		Coding:	<b>PACP 6.0</b>
Pipe Length (ft):	<b>298.9</b>	Owner:	<b>NA</b>	Pre Clean:	<b>No Pre-Cleaning</b>
P.O.#:		Surveyor:	<b>Mark Ruby</b>	PSR:	<b>P-606-015-014</b>
Customer:		Clean Date:	<b>01/01/1900</b>	Shape:	<b>C</b>

Street:	<b>FOXCROFT STREET</b>	Flow Control:	<b>Not Controlled</b>
City:	<b>Hobart, IN</b>	Year Renewed:	
Location:	<b>Yard</b>	Tape/Media #:	
Purpose:	<b>Routine Assessment</b>	Dia/Height:	<b>8"</b>
Use:	<b>Sanitary</b>	Material:	<b>VCP</b>
Drain Area:	<b>NA</b>	Lining:	
Category:	<b>NA</b>		
Comment:

Location Details:		Direction of Survey:	<b>Upstream</b>
US MH:	<b>M-606-014</b>	DS MH:	<b>M-606-015</b>
		Total Length Surveyed (ft):	<b>290.1</b>

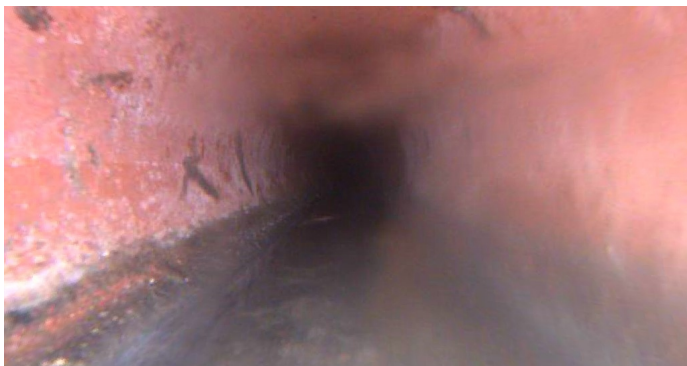
Code: **AMH**  
 Description: **Manhole**

Distance (ft): **.0**  
 Structural Grade: **0**  
 O&M Grade: **0**  
 Clock Start/From:  
 Clock To:  
 1st Value:  
 2nd Value:  
 Value Percent:  
 Continuous Index:  
 Within 8" of Joint: **NO**  
 Remarks: **M-606-015**

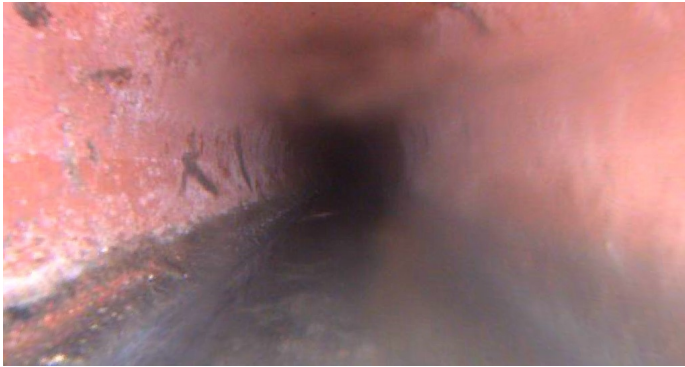
Code:	<b>MWL</b>
Description:	<b>Water Level</b>

Distance (ft):	<b>.0</b>
Structural Grade:	<b>0</b>
O&M Grade:	<b>0</b>
Clock Start/From:	
Clock To:	
1st Value:	
2nd Value:	
Value Percent:	<b>10.000</b>
Continuous Index:	
Within 8" of Joint:	<b>NO</b>
Remarks:

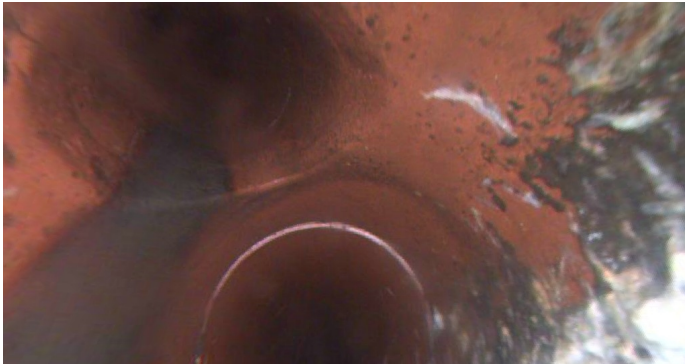
Code:	<b>TF</b>
Description:	<b>Tap Factory</b>

Distance (ft):	<b>26.6</b>
Structural Grade:	<b>0</b>
O&M Grade:	<b>0</b>
Clock Start/From:	<b>2</b>
Clock To:	
1st Value:	<b>4.000</b>
2nd Value:	
Value Percent:	
Continuous Index:	
Within 8" of Joint:	
Remarks:	<b>Photo taken from rear camera.</b>

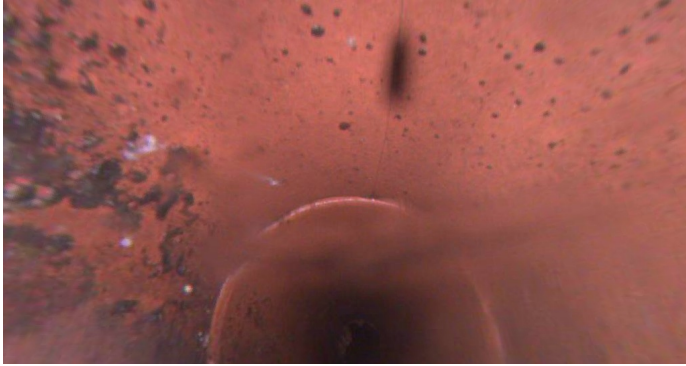
Code: **CL**  
Description: **Crack Longitudinal**

Distance (ft): **26.6**  
Structural Grade: **2**  
O&M Grade: **0**  
Clock Start/From: **1**  
Clock To:  
1st Value:  
2nd Value:  
Value Percent:  
Continuous Index:  
Within 8" of Joint:  
Remarks:

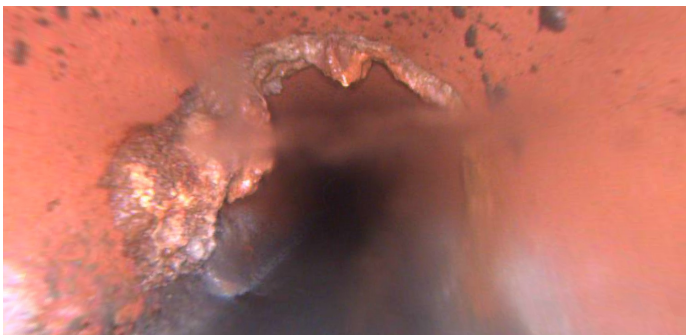
Code: **ID**  
Description: **Infil Dripper**

Distance (ft): **31.7**  
Structural Grade: **0**  
O&M Grade: **3**  
Clock Start/From: **12**  
Clock To:  
1st Value:  
2nd Value:  
Value Percent:  
Continuous Index:  
Within 8" of Joint: **YES**  
Remarks:

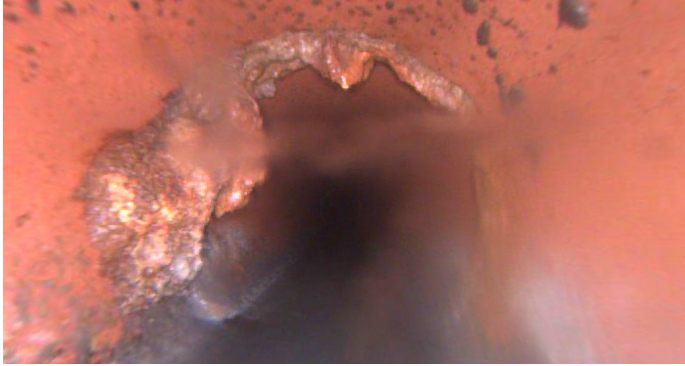
Code: **DAZ**  
Description: **Deposits Attached Other**

Distance (ft): **31.7**  
Structural Grade: **0**  
O&M Grade: **2**  
Clock Start/From: **7**  
Clock To: **5**  
1st Value:  
2nd Value:  
Value Percent: **5.000**  
Continuous Index:  
Within 8" of Joint: **YES**  
Remarks:

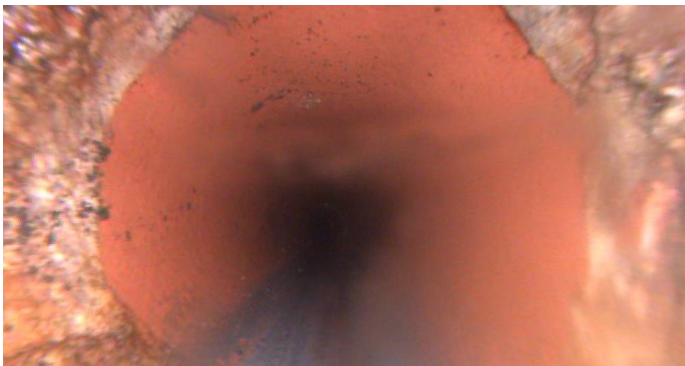
Code: **DAZ**  
Description: **Deposits Attached Other**

Distance (ft): **42.0**  
Structural Grade: **0**  
O&M Grade: **2**  
Clock Start/From: **7**  
Clock To: **5**  
1st Value:  
2nd Value:  
Value Percent: **5.000**  
Continuous Index: **S01**  
Within 8" of Joint: **YES**  
Remarks:

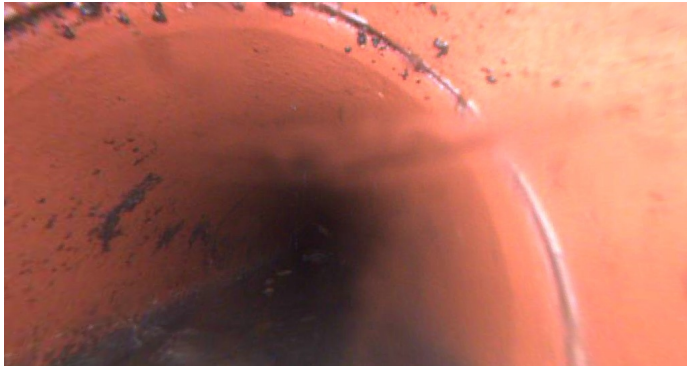
Code:	<b>DAZ</b>
Description:	<b>Deposits Attached Other</b>
Distance (ft):	<b>61.7</b>
Structural Grade:	<b>0</b>
O&M Grade:	<b>2</b>
Clock Start/From:	<b>7</b>
Clock To:	<b>5</b>
1st Value:	
2nd Value:	
Value Percent:	<b>5.000</b>
Continuous Index:	<b>F01</b>
Within 8" of Joint:	<b>YES</b>
Remarks:

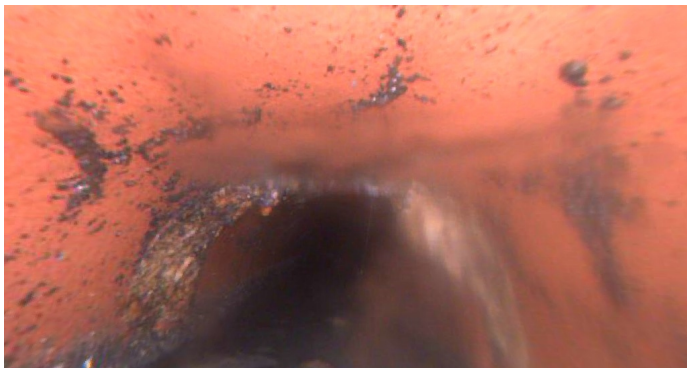
Code:	<b>DAZ</b>
Description:	<b>Deposits Attached Other</b>
Distance (ft):	<b>66.3</b>
Structural Grade:	<b>0</b>
O&M Grade:	<b>2</b>
Clock Start/From:	<b>7</b>
Clock To:	<b>5</b>
1st Value:	
2nd Value:	
Value Percent:	<b>5.000</b>
Continuous Index:	
Within 8" of Joint:	<b>YES</b>
Remarks:

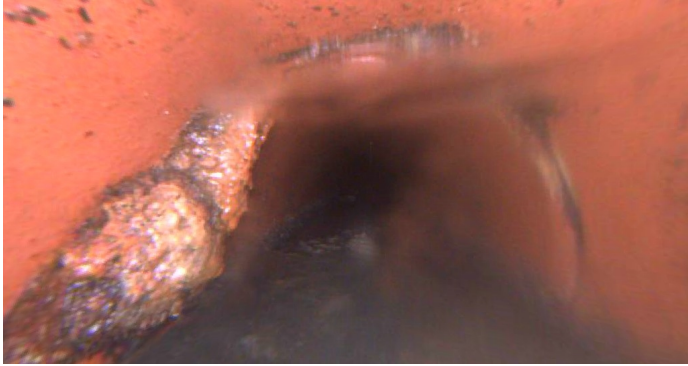
Code: **DAZ**  
Description: **Deposits Attached Other**

Distance (ft): **76.4**  
Structural Grade: **0**  
O&M Grade: **2**  
Clock Start/From: **7**  
Clock To: **10**  
1st Value:  
2nd Value:  
Value Percent: **5.000**  
Continuous Index:  
Within 8" of Joint: **YES**  
Remarks:

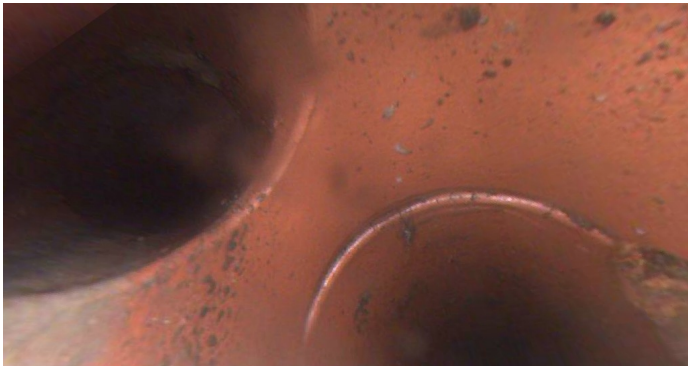
Code: **TF**  
Description: **Tap Factory**

Distance (ft): **87.6**  
Structural Grade: **0**  
O&M Grade: **0**  
Clock Start/From: **10**  
Clock To:  
1st Value: **4.000**  
2nd Value:  
Value Percent:  
Continuous Index:  
Within 8" of Joint:  
Remarks: **Photo taken from rear camera.**

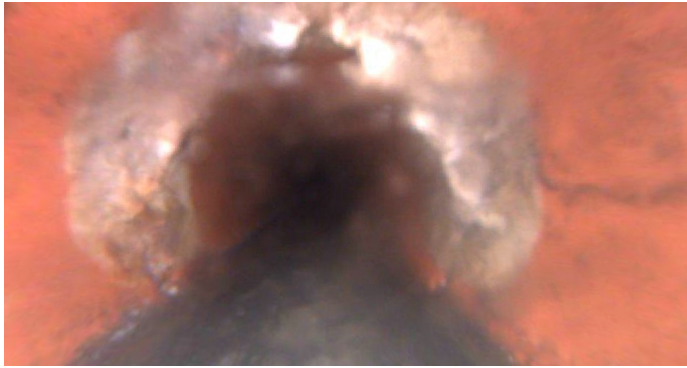
Code:	<b>DAZ</b>
Description:	<b>Deposits Attached Other</b>
Distance (ft):	<b>103.0</b>
Structural Grade:	<b>0</b>
O&M Grade:	<b>2</b>
Clock Start/From:	<b>7</b>
Clock To:	<b>5</b>
1st Value:	
2nd Value:	
Value Percent:	<b>5.000</b>
Continuous Index:	
Within 8" of Joint:	<b>NO</b>
Remarks:

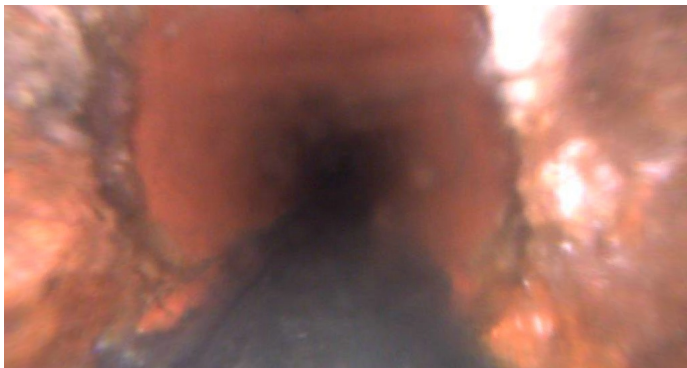
Code:	<b>DAZ</b>
Description:	<b>Deposits Attached Other</b>
Distance (ft):	<b>118.2</b>
Structural Grade:	<b>0</b>
O&M Grade:	<b>2</b>
Clock Start/From:	<b>7</b>
Clock To:	<b>5</b>
1st Value:	
2nd Value:	
Value Percent:	<b>5.000</b>
Continuous Index:	
Within 8" of Joint:	<b>YES</b>
Remarks:

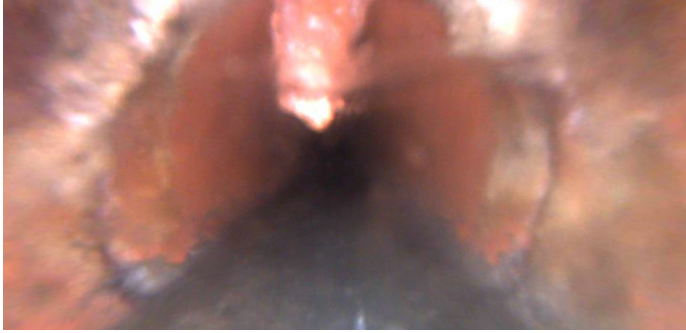
Code: ID  
Description: Infil Dripper

Distance (ft): 128.0  
Structural Grade: 0  
O&M Grade: 3  
Clock Start/From: 12  
Clock To:  
1st Value:  
2nd Value:  
Value Percent:  
Continuous Index:  
Within 8" of Joint: YES  
Remarks:

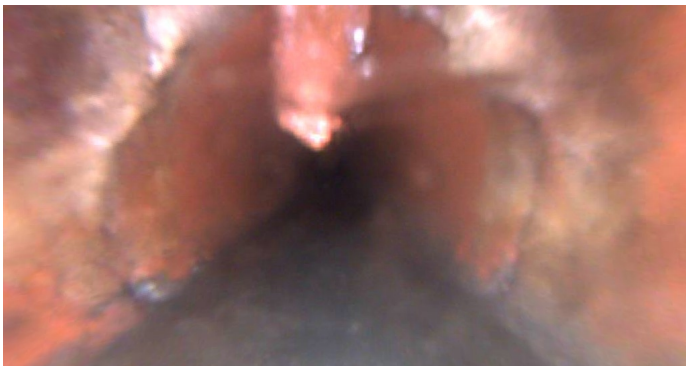
Code: DAZ  
Description: Deposits Attached Other

Distance (ft): 128.0  
Structural Grade: 0  
O&M Grade: 2  
Clock Start/From: 7  
Clock To: 5  
1st Value:  
2nd Value:  
Value Percent: 5.000  
Continuous Index: S02  
Within 8" of Joint: YES  
Remarks:

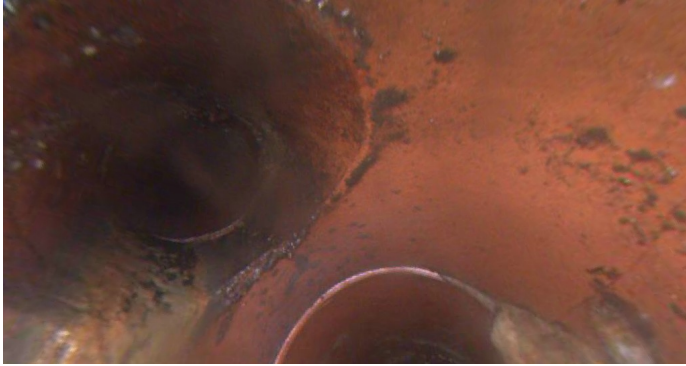
Code: **TF**  
Description: **Tap Factory**

Distance (ft): **144.3**  
Structural Grade: **0**  
O&M Grade: **0**  
Clock Start/From: **2**  
Clock To:  
1st Value: **4.000**  
2nd Value:  
Value Percent:  
Continuous Index:  
Within 8" of Joint:  
Remarks: **Photo taken from rear camera.**

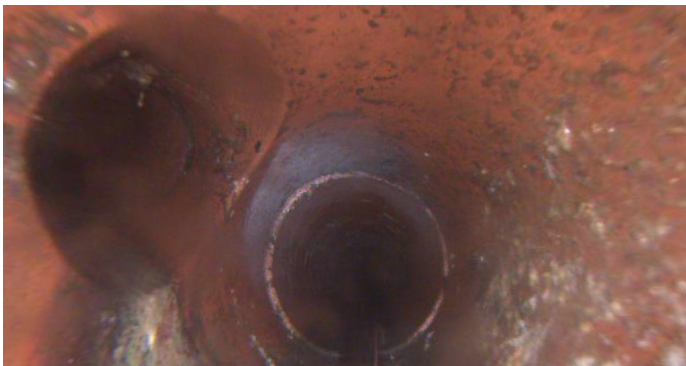
Code: **TF**  
Description: **Tap Factory**

Distance (ft): **201.2**  
Structural Grade: **0**  
O&M Grade: **0**  
Clock Start/From: **3**  
Clock To:  
1st Value: **4.000**  
2nd Value:  
Value Percent:  
Continuous Index:  
Within 8" of Joint:  
Remarks: **Photo taken from rear camera.**

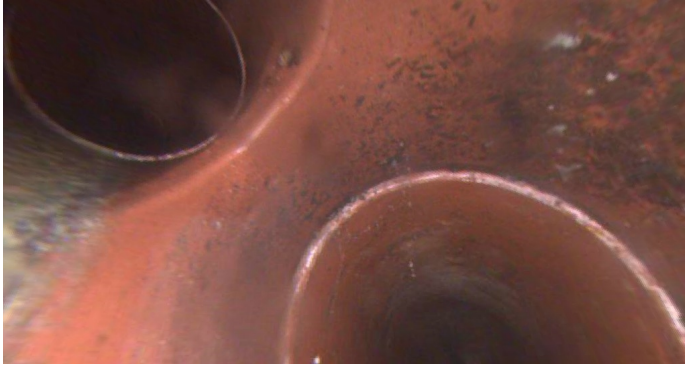
Code: **TF**  
Description: **Tap Factory**

Distance (ft): **267.2**  
Structural Grade: **0**  
O&M Grade: **0**  
Clock Start/From: **2**  
Clock To:  
1st Value: **4.000**  
2nd Value:  
Value Percent:  
Continuous Index:  
Within 8" of Joint:  
Remarks: **Photo taken from rear camera.**

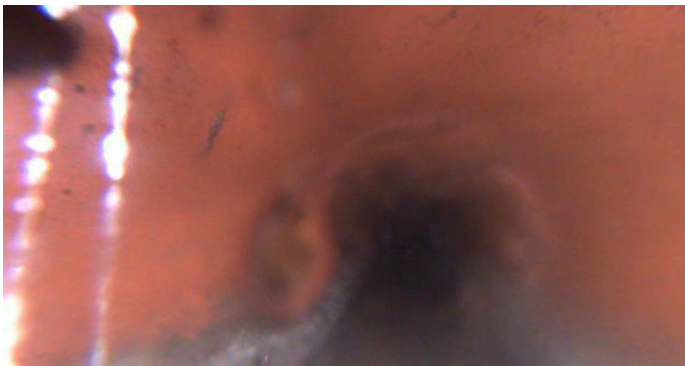
Code: **DAZ**  
Description: **Deposits Attached Other**

Distance (ft): **282.4**  
Structural Grade: **0**  
O&M Grade: **2**  
Clock Start/From: **7**  
Clock To: **5**  
1st Value:  
2nd Value:  
Value Percent: **5.000**  
Continuous Index: **F02**  
Within 8" of Joint: **YES**  
Remarks:

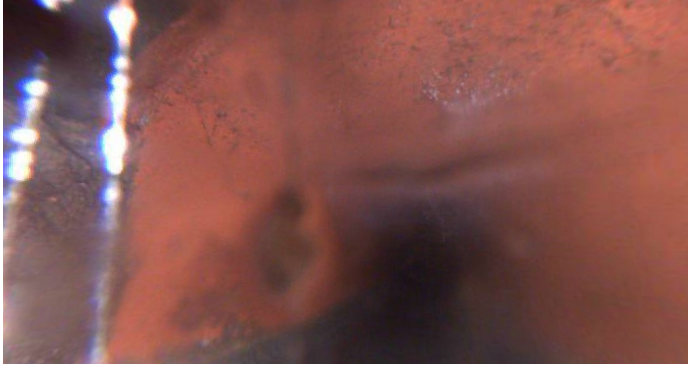
Code:	<b>AMH</b>
Description:	<b>Manhole</b>
Distance (ft):	<b>290.1</b>
Structural Grade:	<b>0</b>
O&M Grade:	<b>0</b>
Clock Start/From:	
Clock To:	
1st Value:	
2nd Value:	
Value Percent:	
Continuous Index:	
Within 8" of Joint:	<b>NO</b>
Remarks:	<b>M-606-014</b>
