## Profile/Photo Observation Report

Date:	<b>04/10/2018</b>	Weather:		Coding:	<b>PACP 6.0</b>
Pipe Length (ft):	<b>172.0</b>	Owner:	<b>NA</b>	Pre Clean:	<b>No Pre-Cleaning</b>
P.O.#:		Surveyor:	<b>Mark Ruby</b>	PSR:	<b>P-606-017-014</b>
Customer:		Clean Date:	<b>01/01/1900</b>	Shape:	<b>C</b>

Street:	<b>W 8TH PL</b>	Flow Control:	<b>Not Controlled</b>
City:	<b>Hobart, IN</b>	Year Renewed:	
Location:	<b>Yard</b>	Tape/Media #:	
Purpose:	<b>Routine Assessment</b>	Dia/Height:	<b>10"</b>
Use:	<b>Sanitary</b>	Material:	<b>VCP</b>
Drain Area:	<b>NA</b>	Lining:	
Category:	<b>NA</b>		
Comment:			
Location Details:		Direction of Survey:	<b>Downstream</b>
US MH:	<b>M-606-014</b>	DS MH:	<b>M-606-017</b>
		Total Length Surveyed (ft):	<b>152.9</b>

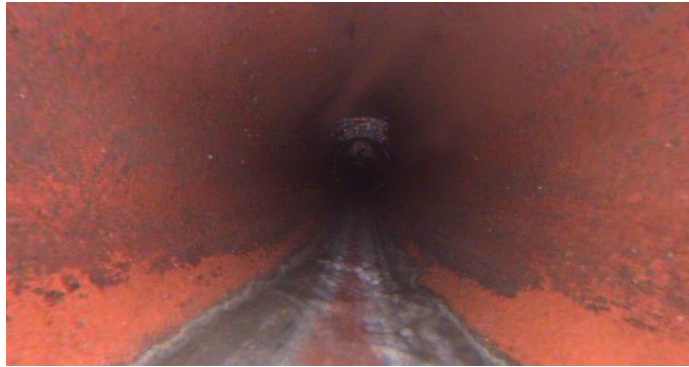
Code: **MWL**  
Description: **Water Level**

Distance (ft): **.0**  
Structural Grade: **0**  
O&M Grade: **0**  
Clock Start/From:  
Clock To:  
1st Value:  
2nd Value:  
Value Percent: **10.000**  
Continuous Index:  
Within 8" of Joint: **NO**  
Remarks:

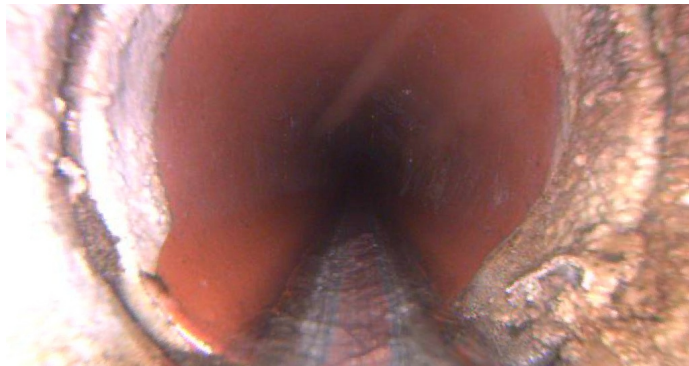
Code: **DAZ**  
Description: **Deposits Attached Other**

Distance (ft): **35.1**  
Structural Grade: **0**  
O&M Grade: **2**  
Clock Start/From: **7**  
Clock To: **5**  
1st Value:  
2nd Value:  
Value Percent: **5.000**  
Continuous Index:  
Within 8" of Joint: **YES**  
Remarks:

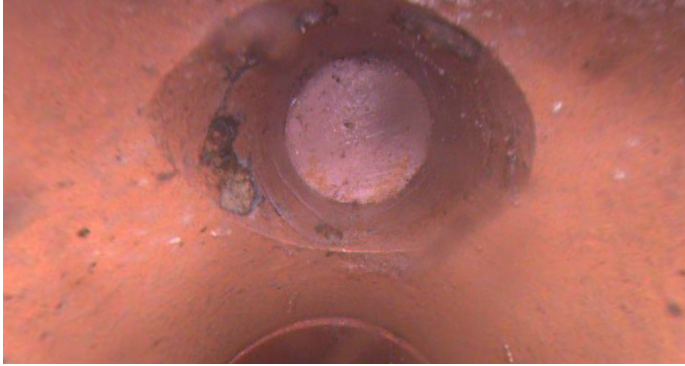
Code: **TFC**  
Description: **Tap Factory Capped**

Distance (ft): **66.5**  
Structural Grade: **0**  
O&M Grade: **0**  
Clock Start/From: **1**  
Clock To:  
1st Value: **4.000**  
2nd Value:  
Value Percent:  
Continuous Index:  
Within 8" of Joint:  
Remarks:

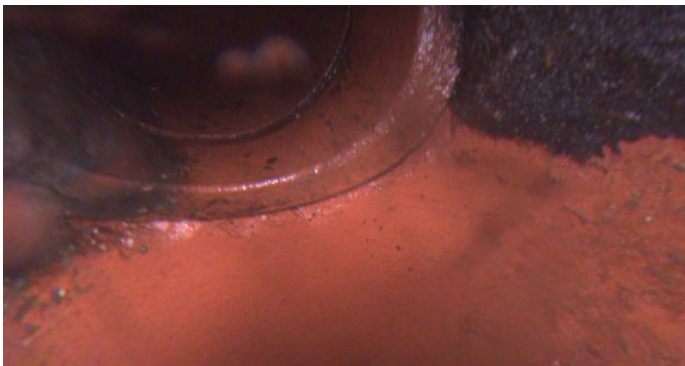
Code: **TB**  
Description: **Tap Break-in**

Distance (ft): **80.9**  
Structural Grade: **0**  
O&M Grade: **0**  
Clock Start/From: **10**  
Clock To:  
1st Value: **4.000**  
2nd Value:  
Value Percent:  
Continuous Index:  
Within 8" of Joint:  
Remarks:

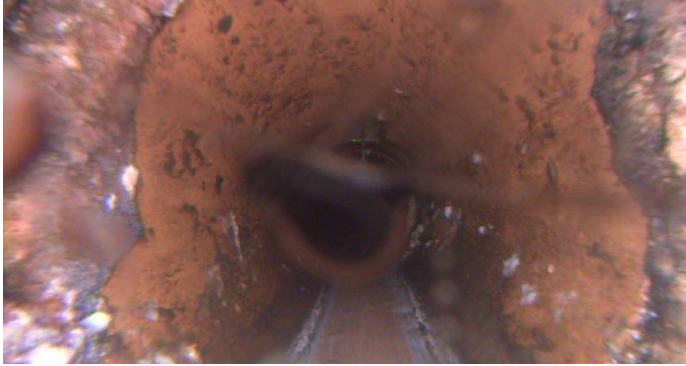
Code: **DAZ**  
Description: **Deposits Attached Other**

Distance (ft): **112.3**  
Structural Grade: **0**  
O&M Grade: **2**  
Clock Start/From: **7**  
Clock To: **5**  
1st Value:  
2nd Value:  
Value Percent: **5.000**  
Continuous Index:  
Within 8" of Joint: **YES**  
Remarks:

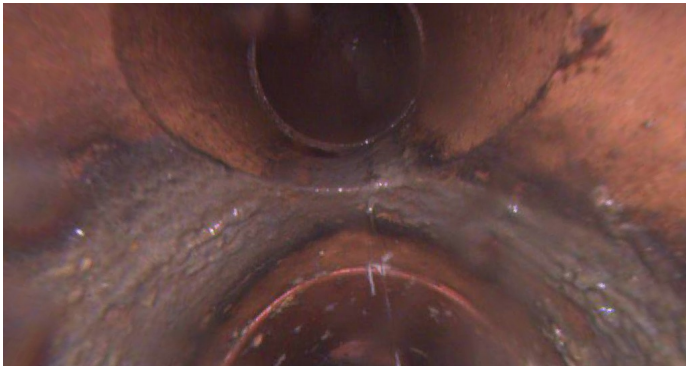
Code: **TF**  
Description: **Tap Factory**

Distance (ft): **113.8**  
Structural Grade: **0**  
O&M Grade: **0**  
Clock Start/From: **12**  
Clock To:  
1st Value: **4.000**  
2nd Value:  
Value Percent:  
Continuous Index:  
Within 8" of Joint:  
Remarks:

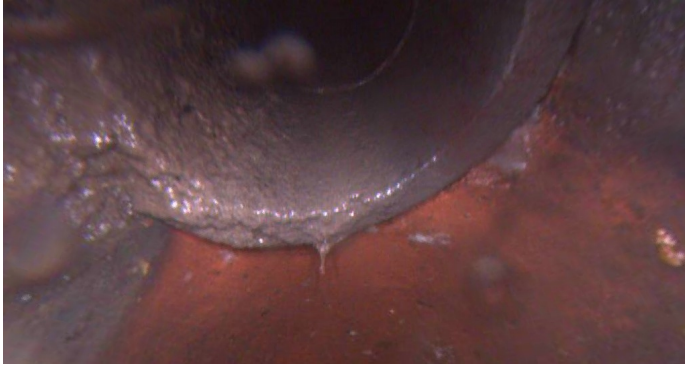
Code: **TB**  
Description: **Tap Break-in**

Distance (ft): **115.7**  
Structural Grade: **0**  
O&M Grade: **0**  
Clock Start/From: **11**  
Clock To:  
1st Value: **4.000**  
2nd Value:  
Value Percent:  
Continuous Index:  
Within 8" of Joint:  
Remarks:

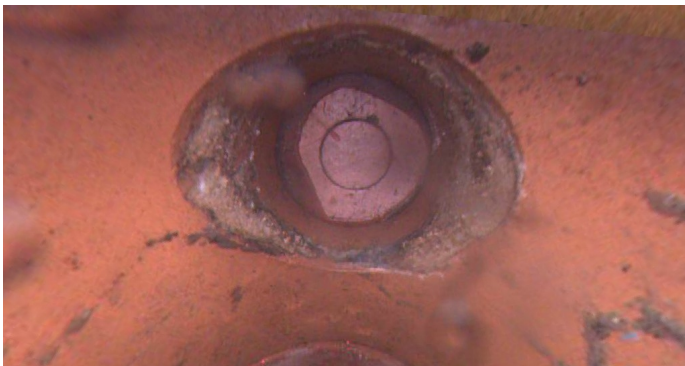
Code: **TFC**  
Description: **Tap Factory Capped**

Distance (ft): **125.8**  
Structural Grade: **0**  
O&M Grade: **0**  
Clock Start/From: **1**  
Clock To:  
1st Value: **4.000**  
2nd Value:  
Value Percent:  
Continuous Index:  
Within 8" of Joint:  
Remarks:

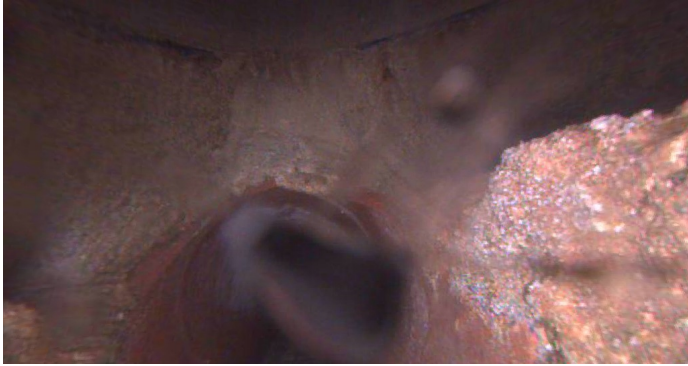
Code:	AMH
Description:	Manhole
Distance (ft):	152.9
Structural Grade:	0
O&M Grade:	0
Clock Start/From:	
Clock To:	
1st Value:	
2nd Value:	
Value Percent:	
Continuous Index:	
Within 8" of Joint:	NO
Remarks:	M-606-017
