Profile/Photo Observation Report

Street:	W 8TH PL	Flow Control:	Not Controlled
City:	Hobart, IN	Year Renewed:	
Location:	Yard	Tape/Media #:	
Purpose:	Routine Assessment	Dia/Height:	10"
Use:	Sanitary	Material:	VCP
Drain Area:	NA	Lining:	
Category:	NA		
Comment:

Location Details:		Direction of Survey:	Downstream
US MH:	M-606-015	DS MH:	M-606-019
		Total Length Surveyed (ft):	35.7

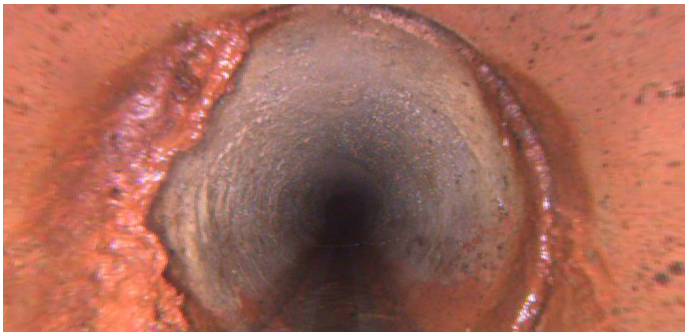
Code:	DAE
Description:	Deposits Attached Encrustation

Distance (ft):	3.3
Structural Grade:	0
O&M Grade:	2
Clock Start/From:	7
Clock To:	11
1st Value:	
2nd Value:	
Value Percent:	5.000
Continuous Index:	
Within 8" of Joint:	YES
Remarks:

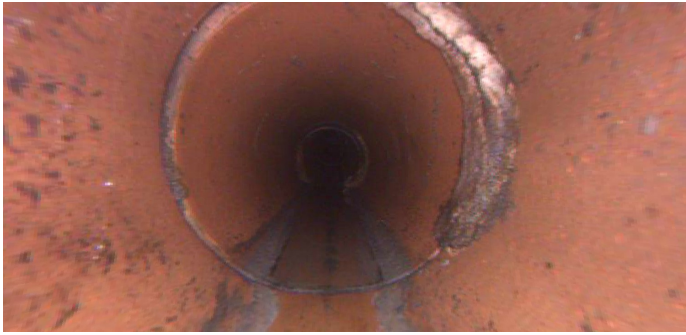
Code: **DAE**
Description: **Deposits Attached Encrustation**

Distance (ft): **10.0**
Structural Grade: **0**
O&M Grade: **2**
Clock Start/From: **12**
Clock To: **5**
1st Value:
2nd Value:
Value Percent: **5.000**
Continuous Index:
Within 8" of Joint: **YES**
Remarks:

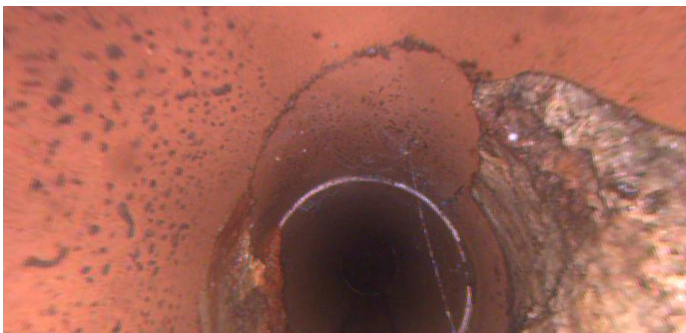
Code: **CS**
Description: **Crack Spiral**

Distance (ft): **12.4**
Structural Grade: **2**
O&M Grade: **0**
Clock Start/From: **9**
Clock To: **1**
1st Value:
2nd Value:
Value Percent:
Continuous Index:
Within 8" of Joint: **YES**
Remarks:

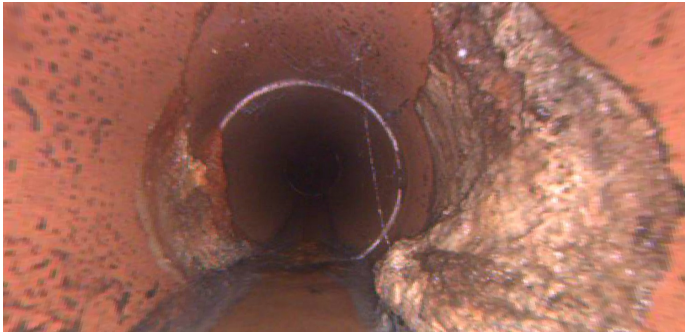
Code: **DAE**
Description: **Deposits Attached Encrustation**

Distance (ft): **12.4**
Structural Grade: **0**
O&M Grade: **2**
Clock Start/From: **7**
Clock To: **5**
1st Value:
2nd Value:
Value Percent: **5.000**
Continuous Index:
Within 8" of Joint: **YES**
Remarks:

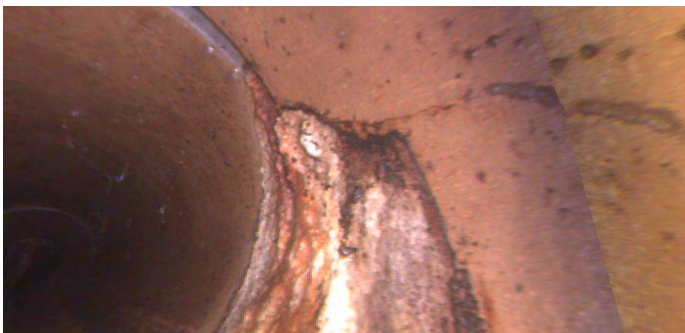
Code: **CL**
Description: **Crack Longitudinal**

Distance (ft): **16.1**
Structural Grade: **2**
O&M Grade: **0**
Clock Start/From: **2**
Clock To:
1st Value:
2nd Value:
Value Percent:
Continuous Index:
Within 8" of Joint: **YES**
Remarks:

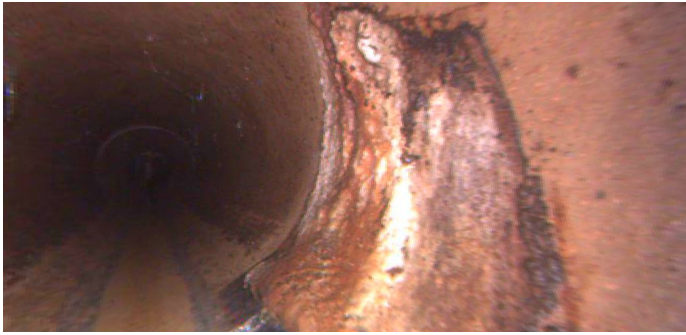
Code: **DAE**
Description: **Deposits Attached Encrustation**

Distance (ft): **16.1**
Structural Grade: **0**
O&M Grade: **2**
Clock Start/From: **2**
Clock To: **5**
1st Value:
2nd Value:
Value Percent: **5.000**
Continuous Index:
Within 8" of Joint: **NO**
Remarks:

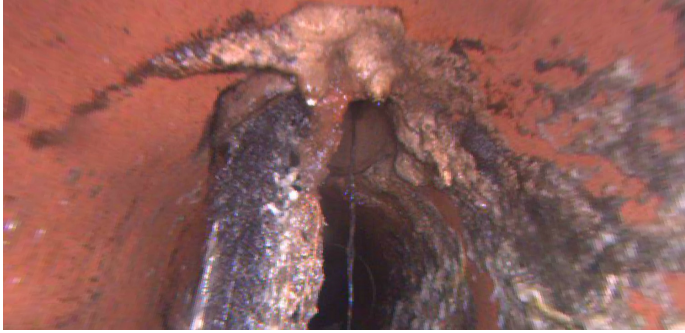
Code: **RFL**
Description: **Roots Fine Lateral**

Distance (ft): **22.8**
Structural Grade: **0**
O&M Grade: **1**
Clock Start/From: **5**
Clock To:
1st Value:
2nd Value:
Value Percent:
Continuous Index:
Within 8" of Joint: **NO**
Remarks:

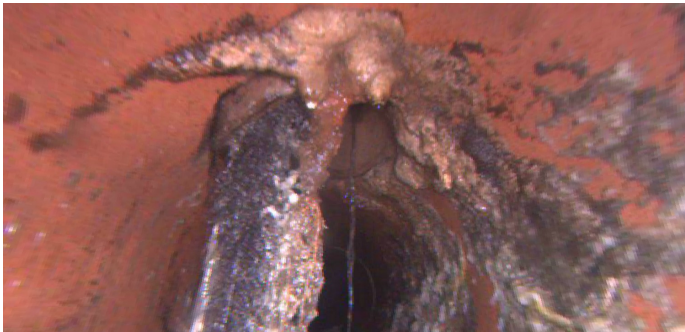
Code: **DAE**
Description: **Deposits Attached Encrustation**

Distance (ft): **22.8**
Structural Grade: **0**
O&M Grade: **2**
Clock Start/From: **11**
Clock To: **1**
1st Value:
2nd Value:
Value Percent: **5.000**
Continuous Index:
Within 8" of Joint: **NO**
Remarks:

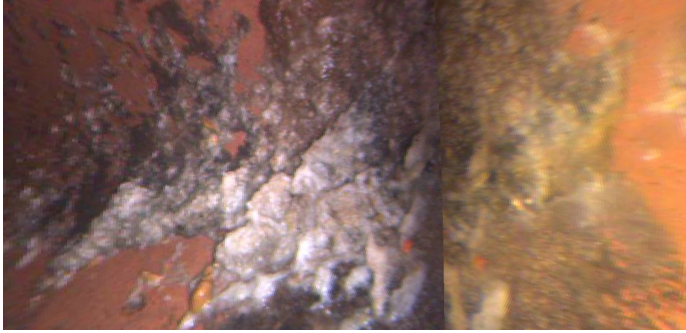
Code: **DAGS**
Description: **Deposits Attached Grease**

Distance (ft): **23.8**
Structural Grade: **0**
O&M Grade: **2**
Clock Start/From: **2**
Clock To: **5**
1st Value:
2nd Value:
Value Percent: **5.000**
Continuous Index:
Within 8" of Joint: **NO**
Remarks:

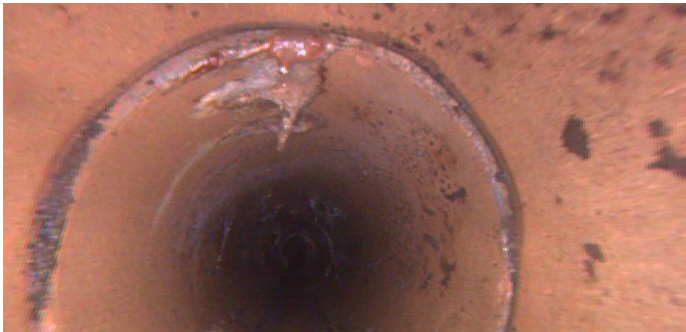
Code: **ID**
Description: **Infil Dripper**

Distance (ft): **28.1**
Structural Grade: **0**
O&M Grade: **3**
Clock Start/From: **12**
Clock To:
1st Value:
2nd Value:
Value Percent:
Continuous Index:
Within 8" of Joint: **YES**
Remarks:

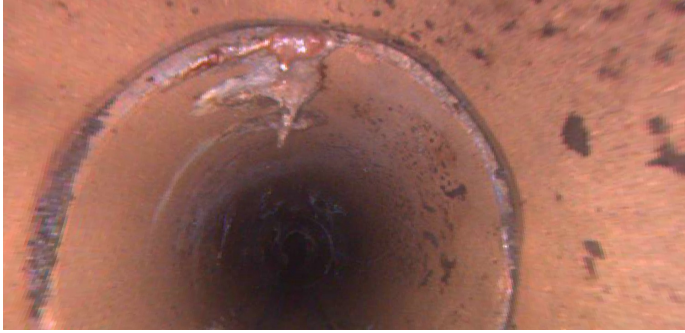
Code: **DAE**
Description: **Deposits Attached Encrustation**

Distance (ft): **28.1**
Structural Grade: **0**
O&M Grade: **2**
Clock Start/From: **12**
Clock To:
1st Value:
2nd Value:
Value Percent: **5.000**
Continuous Index:
Within 8" of Joint: **YES**
Remarks:

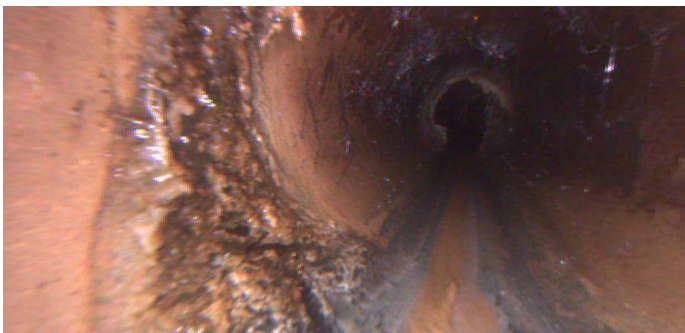
Code: **DAE**
Description: **Deposits Attached Encrustation**

Distance (ft): **31.2**
Structural Grade: **0**
O&M Grade: **2**
Clock Start/From: **7**
Clock To: **11**
1st Value:
2nd Value:
Value Percent: **5.000**
Continuous Index:
Within 8" of Joint: **YES**
Remarks:

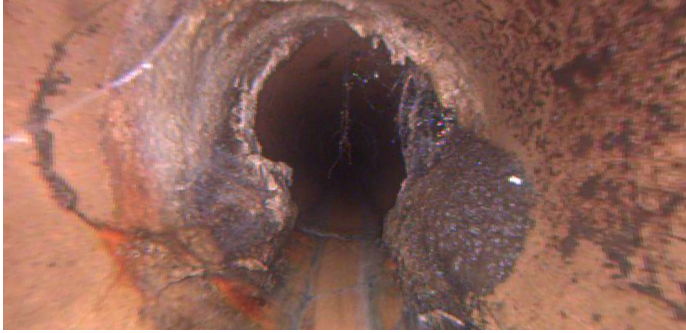
Code: **DAZ**
Description: **Deposits Attached Other**

Distance (ft): **33.5**
Structural Grade: **0**
O&M Grade: **4**
Clock Start/From: **7**
Clock To: **5**
1st Value:
2nd Value:
Value Percent: **25.000**
Continuous Index:
Within 8" of Joint: **YES**
Remarks: **dae/roots**

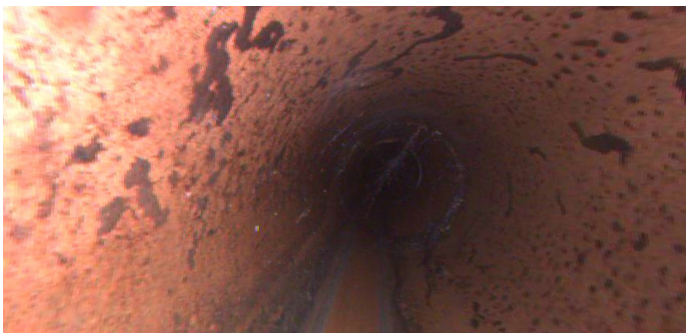
Code: **MSA**
Description: **Abandoned Survey**

Distance (ft): **35.7**
Structural Grade: **0**
O&M Grade: **0**
Clock Start/From:
Clock To:
1st Value:
2nd Value:
Value Percent:
Continuous Index:
Within 8" of Joint: **NO**
Remarks: **daz**
