Profile/Photo Observation Report

Date:	04/10/2018	Weather:		Coding:	PACP 6.0
Pipe Length (ft):	158.9	Owner:	NA	Pre Clean:	No Pre-Cleaning
P.O.#:		Surveyor:	Byrd Fitzgerald	PSR:	P-606-019-015
Customer:		Clean Date:	01/01/1900	Shape:	C

Street:	FOXCROFT STREET	Flow Control:	Not Controlled
City:	Hobart, IN	Year Renewed:	
Location:	Yard	Tape/Media #:	
Purpose:	Routine Assessment	Dia/Height:	10"
Use:	Sanitary	Material:	VCP
Drain Area:	NA	Lining:	
Category:	NA		
Comment:			
Location Details:		Direction of Survey:	Downstream
US MH:	M-606-015	DS MH:	M-606-019
		Total Length Surveyed (ft):	35.7

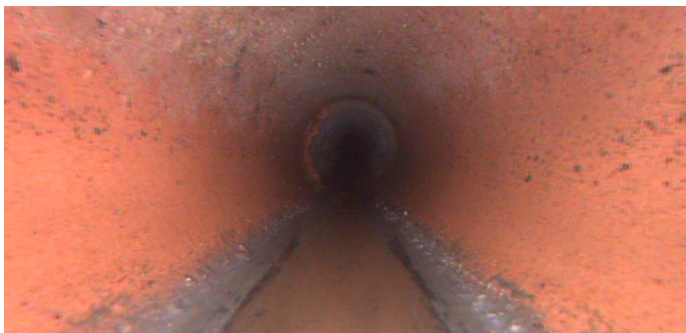
Code: **MWL**
Description: **Water Level**

Distance (ft): **.0**
Structural Grade: **0**
O&M Grade: **0**
Clock Start/From:
Clock To:
1st Value:
2nd Value:
Value Percent: **5.000**
Continuous Index:
Within 8" of Joint: **NO**
Remarks:

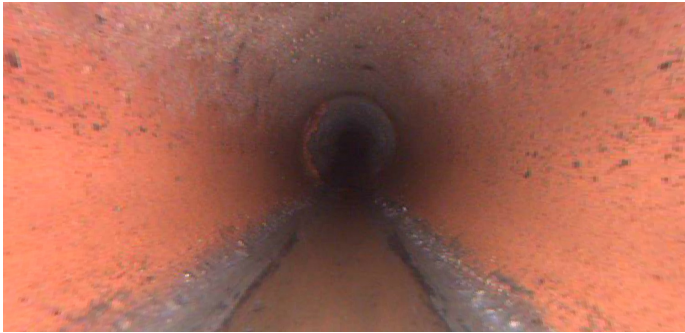
Code:	AMH
Description:	Manhole

Distance (ft):	.0
Structural Grade:	0
O&M Grade:	0
Clock Start/From:	
Clock To:	
1st Value:	
2nd Value:	
Value Percent:	
Continuous Index:	
Within 8" of Joint:	NO
Remarks:	M-606-015

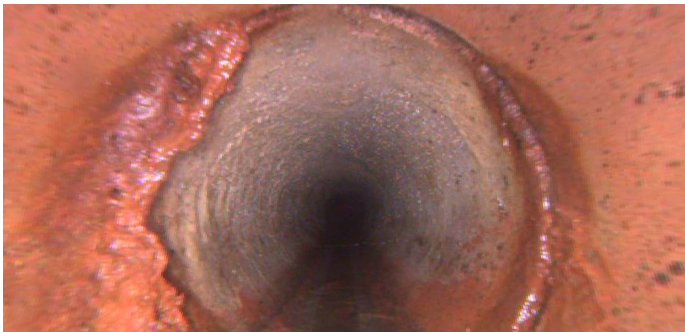
Code:	DAE
Description:	Deposits Attached Encrustation

Distance (ft):	3.3
Structural Grade:	0
O&M Grade:	2
Clock Start/From:	7
Clock To:	11
1st Value:	
2nd Value:	
Value Percent:	5.000
Continuous Index:	
Within 8" of Joint:	YES
Remarks:

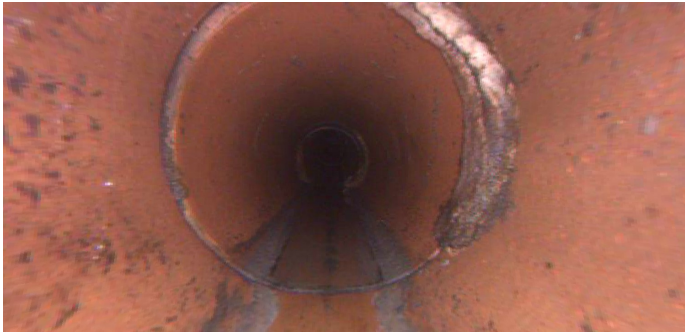
Code: **DAE**
Description: **Deposits Attached Encrustation**

Distance (ft): **10.0**
Structural Grade: **0**
O&M Grade: **2**
Clock Start/From: **12**
Clock To: **5**
1st Value:
2nd Value:
Value Percent: **5.000**
Continuous Index:
Within 8" of Joint: **YES**
Remarks:

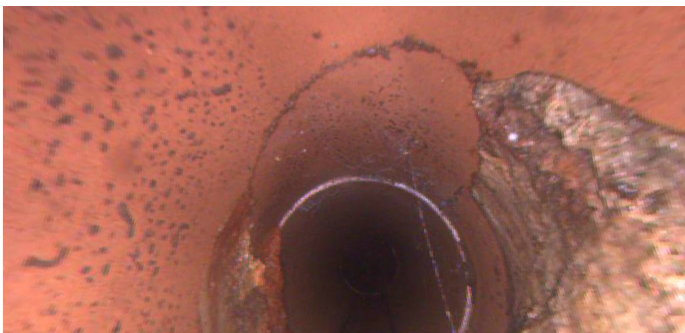
Code: **CS**
Description: **Crack Spiral**

Distance (ft): **12.4**
Structural Grade: **2**
O&M Grade: **0**
Clock Start/From: **9**
Clock To: **1**
1st Value:
2nd Value:
Value Percent:
Continuous Index:
Within 8" of Joint: **YES**
Remarks:

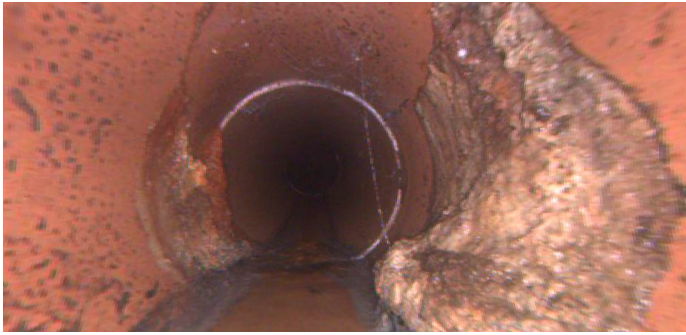
Code: **DAE**
Description: **Deposits Attached Encrustation**

Distance (ft): **12.4**
Structural Grade: **0**
O&M Grade: **2**
Clock Start/From: **7**
Clock To: **5**
1st Value:
2nd Value:
Value Percent: **5.000**
Continuous Index:
Within 8" of Joint: **YES**
Remarks:

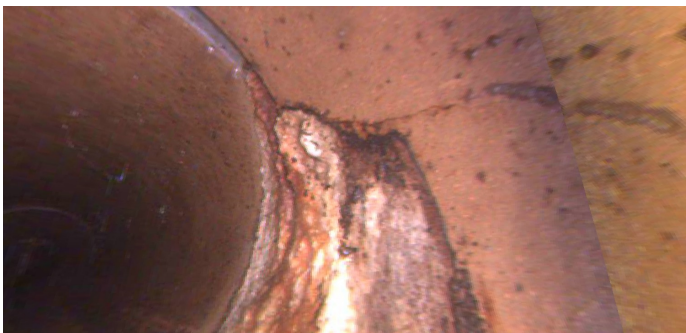
Code: **CL**
Description: **Crack Longitudinal**

Distance (ft): **16.1**
Structural Grade: **2**
O&M Grade: **0**
Clock Start/From: **2**
Clock To:
1st Value:
2nd Value:
Value Percent:
Continuous Index:
Within 8" of Joint: **YES**
Remarks:

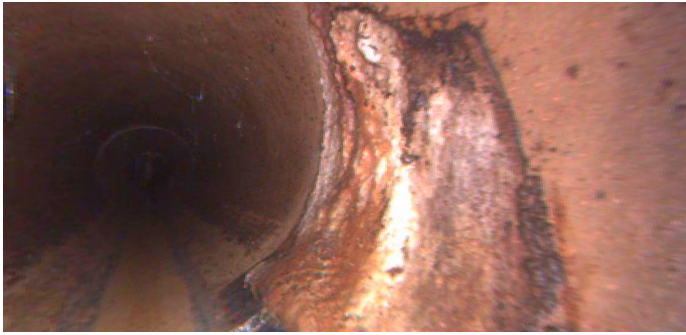
Code: **DAE**
Description: **Deposits Attached Encrustation**

Distance (ft): **16.1**
Structural Grade: **0**
O&M Grade: **2**
Clock Start/From: **2**
Clock To: **5**
1st Value:
2nd Value:
Value Percent: **5.000**
Continuous Index:
Within 8" of Joint: **NO**
Remarks:

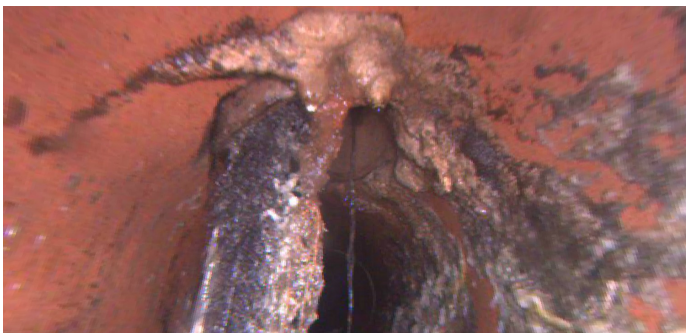
Code: **TF**
Description: **Tap Factory**

Distance (ft): **22.8**
Structural Grade: **0**
O&M Grade: **0**
Clock Start/From: **12**
Clock To:
1st Value: **4.000**
2nd Value:
Value Percent:
Continuous Index:
Within 8" of Joint:
Remarks:

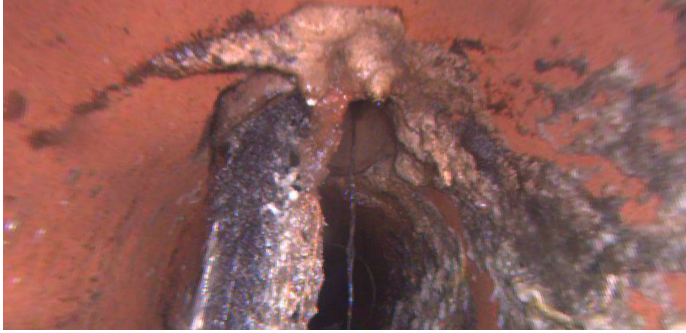
Code: **RFL**
Description: **Roots Fine Lateral**

Distance (ft): **22.8**
Structural Grade: **0**
O&M Grade: **1**
Clock Start/From: **5**
Clock To:
1st Value:
2nd Value:
Value Percent:
Continuous Index:
Within 8" of Joint: **NO**
Remarks:

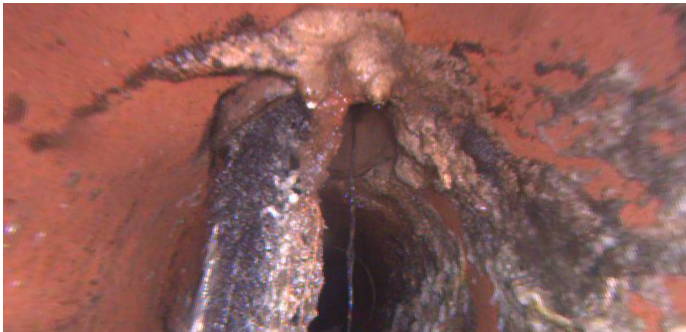
Code: **DAE**
Description: **Deposits Attached Encrustation**

Distance (ft): **22.8**
Structural Grade: **0**
O&M Grade: **2**
Clock Start/From: **11**
Clock To: **1**
1st Value:
2nd Value:
Value Percent: **5.000**
Continuous Index:
Within 8" of Joint: **NO**
Remarks:

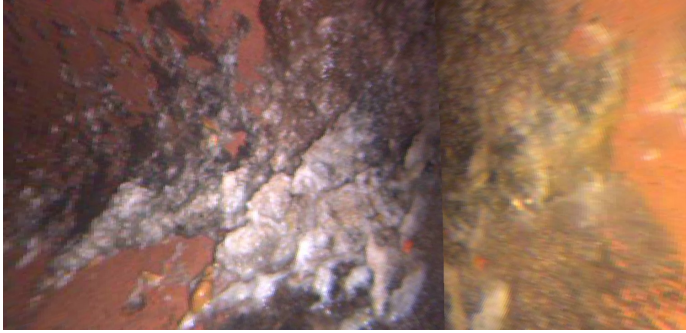
Code: **DAGS**
Description: **Deposits Attached Grease**

Distance (ft): **23.8**
Structural Grade: **0**
O&M Grade: **2**
Clock Start/From: **2**
Clock To: **5**
1st Value:
2nd Value:
Value Percent: **5.000**
Continuous Index:
Within 8" of Joint: **NO**
Remarks:

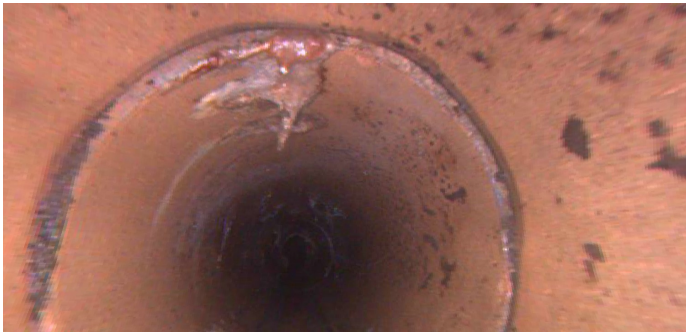
Code: **ID**
Description: **Infil Dripper**

Distance (ft): **28.1**
Structural Grade: **0**
O&M Grade: **3**
Clock Start/From: **12**
Clock To:
1st Value:
2nd Value:
Value Percent:
Continuous Index:
Within 8" of Joint: **YES**
Remarks:

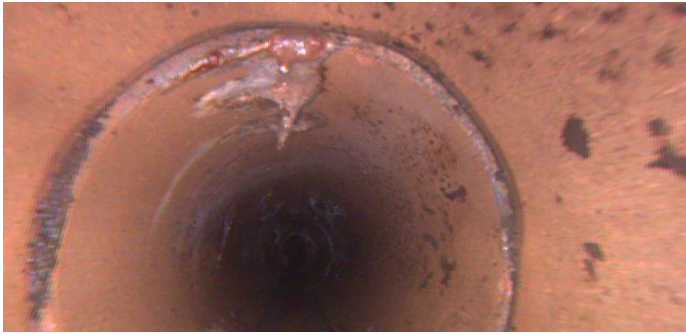
Code: **DAE**
Description: **Deposits Attached Encrustation**

Distance (ft): **28.1**
Structural Grade: **0**
O&M Grade: **2**
Clock Start/From: **12**
Clock To:
1st Value:
2nd Value:
Value Percent: **5.000**
Continuous Index:
Within 8" of Joint: **YES**
Remarks:

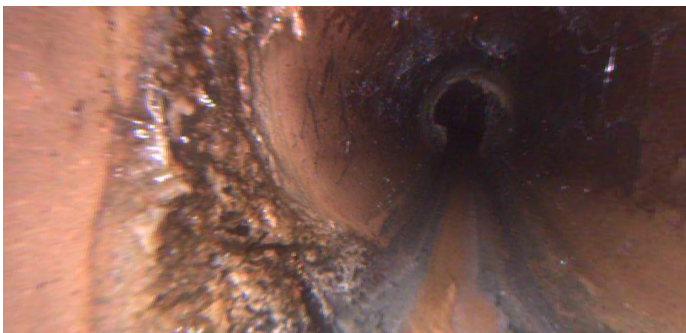
Code: **DAE**
Description: **Deposits Attached Encrustation**

Distance (ft): **31.2**
Structural Grade: **0**
O&M Grade: **2**
Clock Start/From: **7**
Clock To: **11**
1st Value:
2nd Value:
Value Percent: **5.000**
Continuous Index:
Within 8" of Joint: **YES**
Remarks:

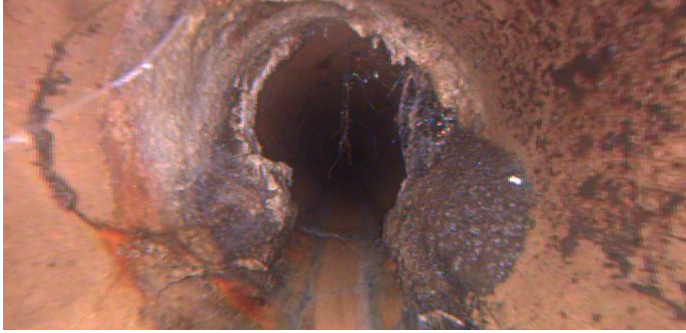
Code: **DAZ**
Description: **Deposits Attached Other**

Distance (ft): **33.5**
Structural Grade: **0**
O&M Grade: **4**
Clock Start/From: **7**
Clock To: **5**
1st Value:
2nd Value:
Value Percent: **25.000**
Continuous Index:
Within 8" of Joint: **YES**
Remarks: **dae/roots**

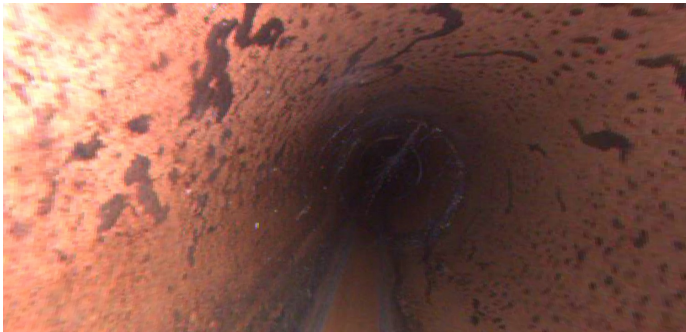
Code: **MSA**
Description: **Abandoned Survey**

Distance (ft): **35.7**
Structural Grade: **0**
O&M Grade: **0**
Clock Start/From:
Clock To:
1st Value:
2nd Value:
Value Percent:
Continuous Index:
Within 8" of Joint: **NO**
Remarks: **daz**
