Profile/Photo Observation Report

Date:	05/08/2018	Weather:		Coding:	PACP 6.0
Pipe Length (ft):		Owner:	City of Hobart	Pre Clean:	Not Known
P.O.#:	301	Surveyor:	B. Helbling	PSR:	P-606-022-021
Customer:	City of Hobart	Clean Date:		Shape:	C

Street:	West 8th Street	Flow Control:	Not Controlled
City:	Hobart, IN	Year Renewed:	
Location:	Light Highway	Tape/Media #:	DEP301
Purpose:	Routine Assessment	Dia/Height:	18"
Use:	Sanitary	Material:	VCP
Drain Area:		Lining:	
Category:	NA		
Comment:	5-21-2018		
Location Details:		Direction of Survey:	Upstream
US MH:	M-606-021	DS MH:	M-606-022
		Total Length Surveyed (ft):	190.9

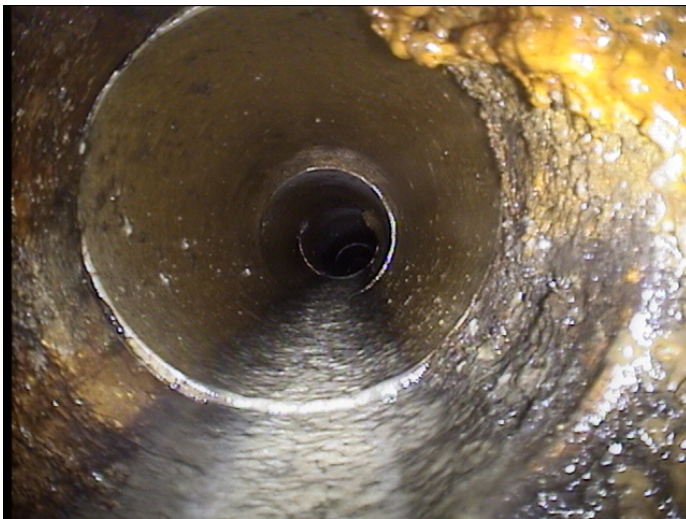
Code: **TFD**
Description: **Tap Factory Defective**

Distance (ft): **17.7**
Structural Grade: **0**
O&M Grade: **2**
Clock Start/From: **11**
Clock To:
1st Value: **6.000**
2nd Value:
Value Percent:
Continuous Index:
Within 8" of Joint: **NO**
Remarks: **Defective**

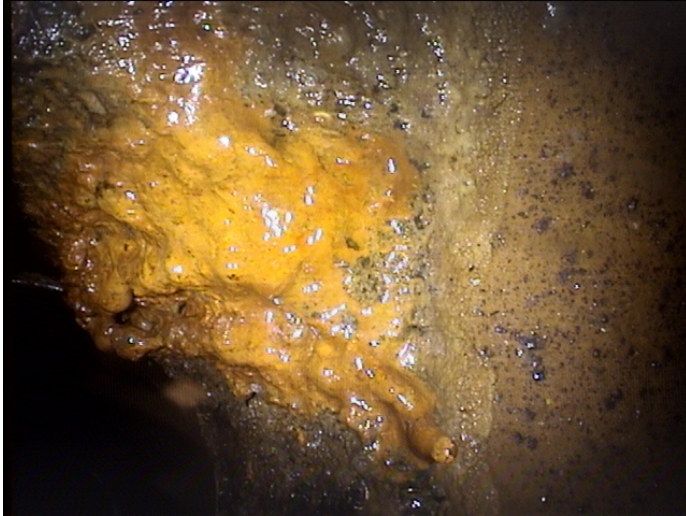
Code:	ID
Description:	Infil Dripper
Distance (ft):	17.7
Structural Grade:	0
O&M Grade:	3
Clock Start/From:	11
Clock To:	
1st Value:	
2nd Value:	
Value Percent:	
Continuous Index:	
Within 8" of Joint:	NO
Remarks:

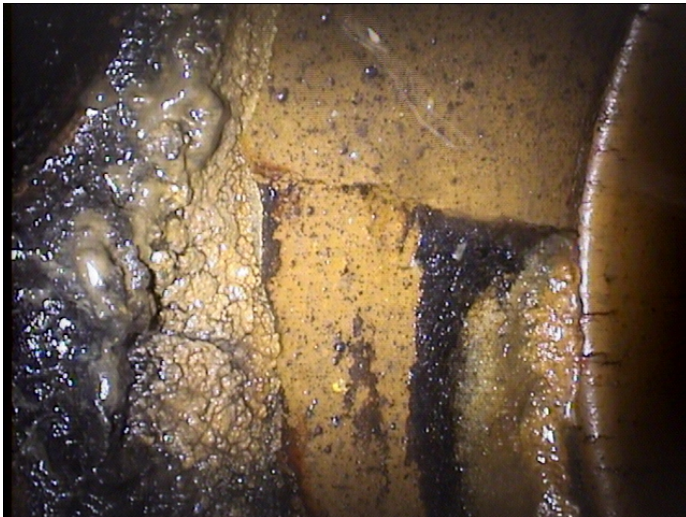
Code:	CL
Description:	Crack Longitudinal
Distance (ft):	17.7
Structural Grade:	2
O&M Grade:	0
Clock Start/From:	9
Clock To:	
1st Value:	
2nd Value:	
Value Percent:	
Continuous Index:	
Within 8" of Joint:	NO
Remarks:

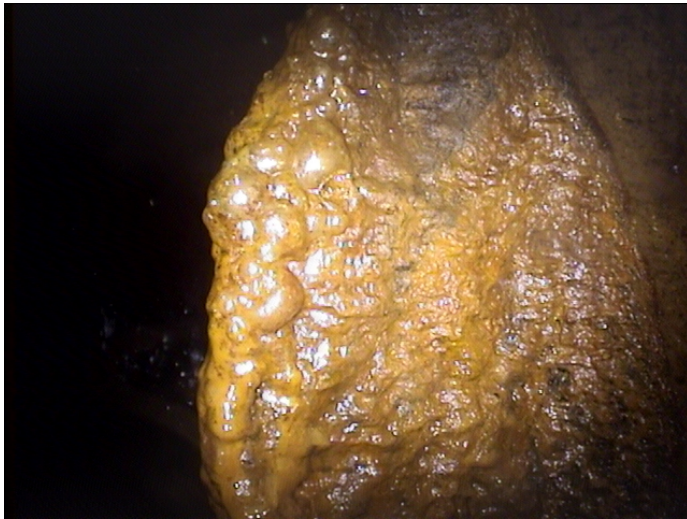
Code:	DAE
Description:	Deposits Attached Encrustation
Distance (ft):	78.9
Structural Grade:	0
O&M Grade:	2
Clock Start/From:	2
Clock To:	5
1st Value:	
2nd Value:	
Value Percent:	5.000
Continuous Index:	
Within 8" of Joint:	YES
Remarks:

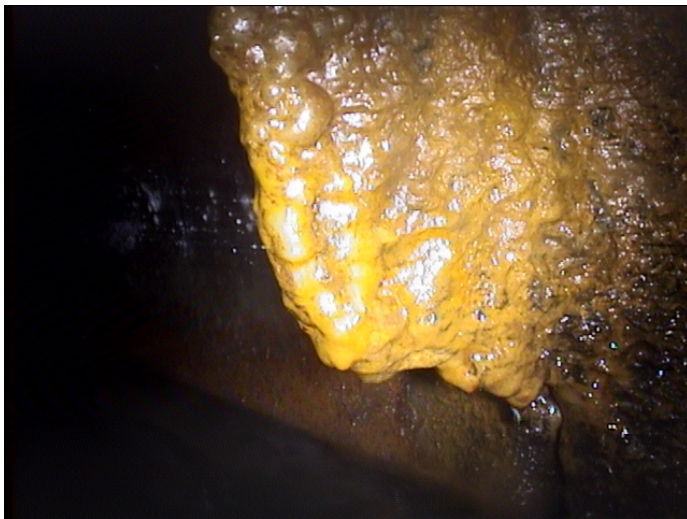
Code:	ID
Description:	Infil Dripper
Distance (ft):	78.9
Structural Grade:	0
O&M Grade:	3
Clock Start/From:	3
Clock To:	
1st Value:	
2nd Value:	
Value Percent:	
Continuous Index:	
Within 8" of Joint:	YES
Remarks:

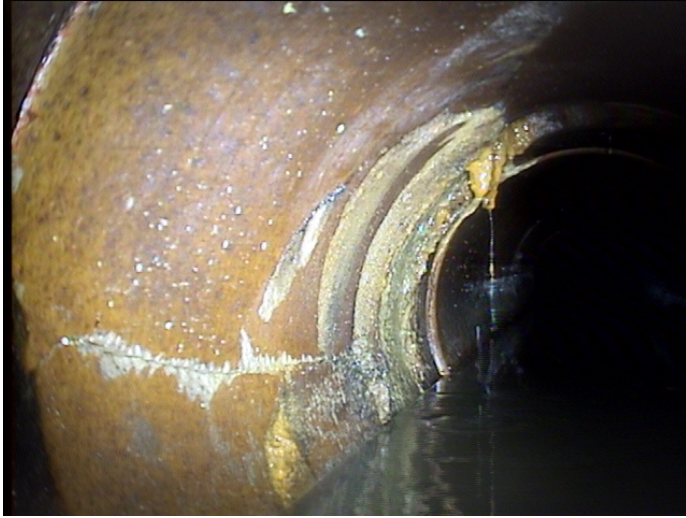
Code: **CH3**
Description: **Crack Longitudinal Hinge, 3**

Distance (ft): **83.6**
Structural Grade: **5**
O&M Grade: **0**
Clock Start/From: **6**
Clock To: **12**
1st Value:
2nd Value:
Value Percent:
Continuous Index:
Within 8" of Joint: **NO**
Remarks:

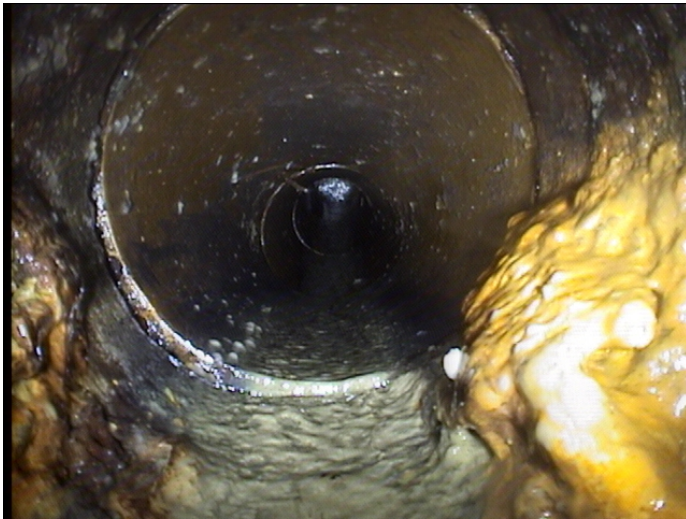
Code: **TFD**
Description: **Tap Factory Defective**

Distance (ft): **86.8**
Structural Grade: **0**
O&M Grade: **2**
Clock Start/From: **11**
Clock To:
1st Value: **6.000**
2nd Value:
Value Percent:
Continuous Index:
Within 8" of Joint: **NO**
Remarks: **Defective**

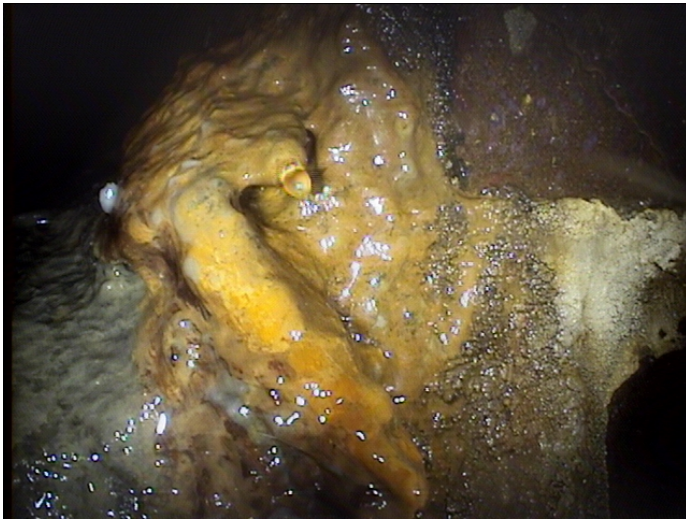
Code: **IR**
Description: **Infil Runner**

Distance (ft): **86.8**
Structural Grade: **0**
O&M Grade: **4**
Clock Start/From: **11**
Clock To:
1st Value:
2nd Value:
Value Percent:
Continuous Index:
Within 8" of Joint: **NO**
Remarks:

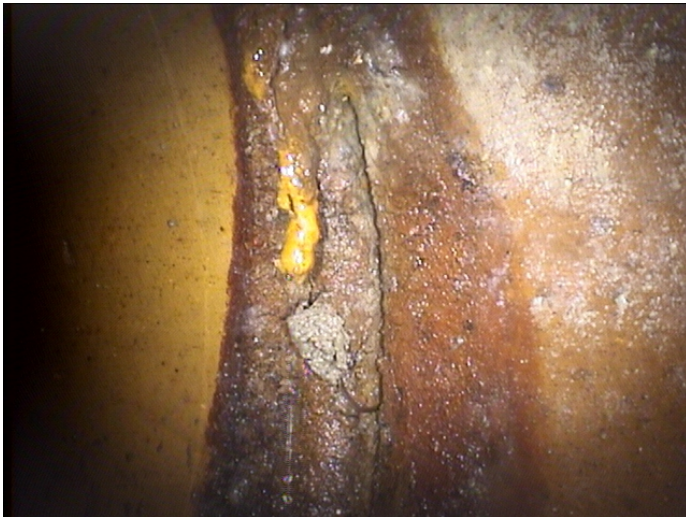
Code: **ID**
Description: **Infil Dripper**

Distance (ft): **121.9**
Structural Grade: **0**
O&M Grade: **3**
Clock Start/From: **3**
Clock To:
1st Value:
2nd Value:
Value Percent:
Continuous Index:
Within 8" of Joint: **NO**
Remarks:

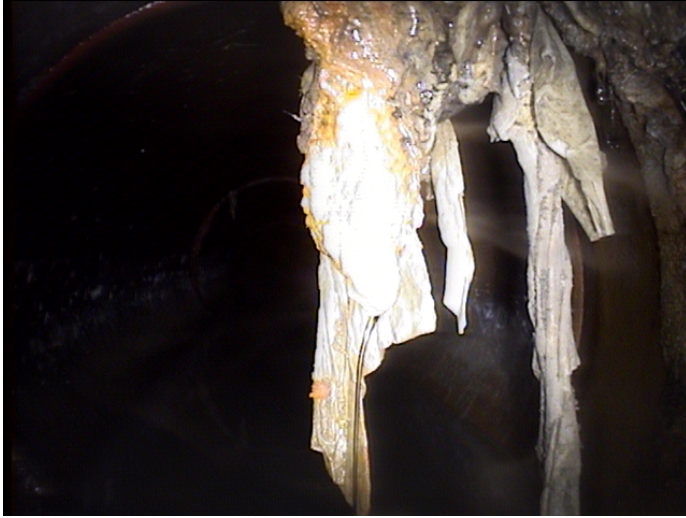
Code:	DAE
Description:	Deposits Attached Encrustation
Distance (ft):	128.3
Structural Grade:	0
O&M Grade:	2
Clock Start/From:	9
Clock To:	4
1st Value:	
2nd Value:	
Value Percent:	5.000
Continuous Index:	
Within 8" of Joint:	YES
Remarks:

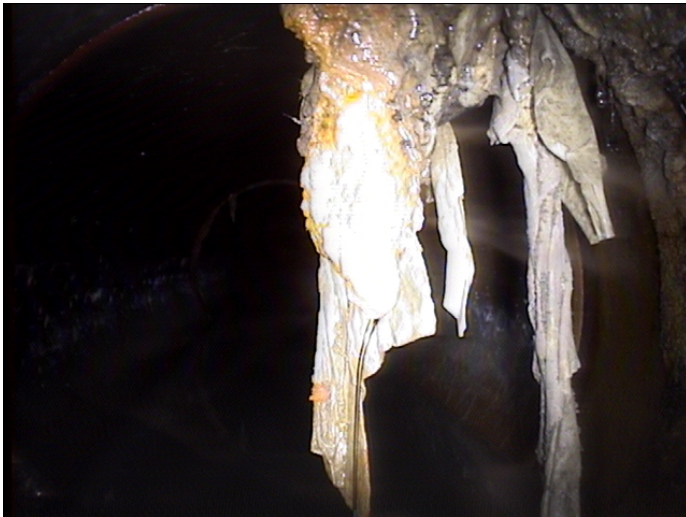
Code:	IR
Description:	Infil Runner
Distance (ft):	128.3
Structural Grade:	0
O&M Grade:	4
Clock Start/From:	12
Clock To:	
1st Value:	
2nd Value:	
Value Percent:	
Continuous Index:	
Within 8" of Joint:	YES
Remarks:

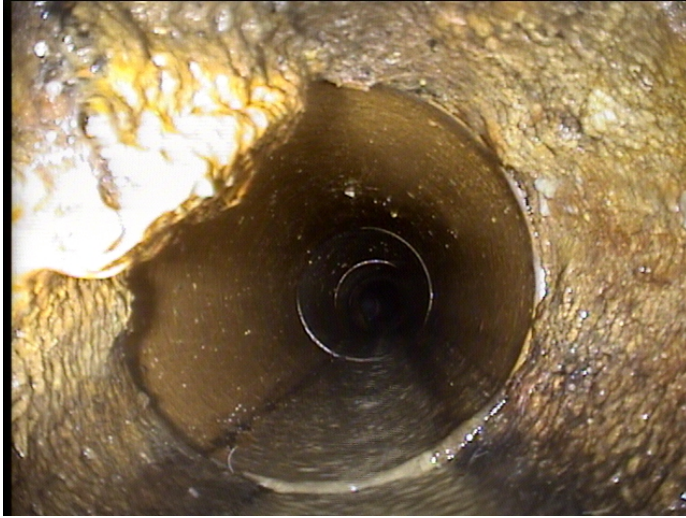
Code:	TFD
Description:	Tap Factory Defective
Distance (ft):	142.0
Structural Grade:	0
O&M Grade:	2
Clock Start/From:	11
Clock To:	
1st Value:	6.000
2nd Value:	
Value Percent:	
Continuous Index:	
Within 8" of Joint:	NO
Remarks:	Defective

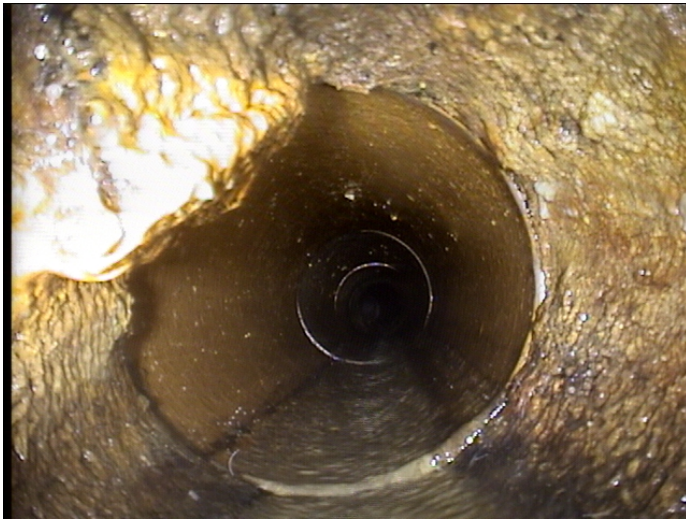
Code:	ID
Description:	Infil Dripper
Distance (ft):	142.0
Structural Grade:	0
O&M Grade:	3
Clock Start/From:	11
Clock To:	
1st Value:	
2nd Value:	
Value Percent:	
Continuous Index:	
Within 8" of Joint:	NO
Remarks:

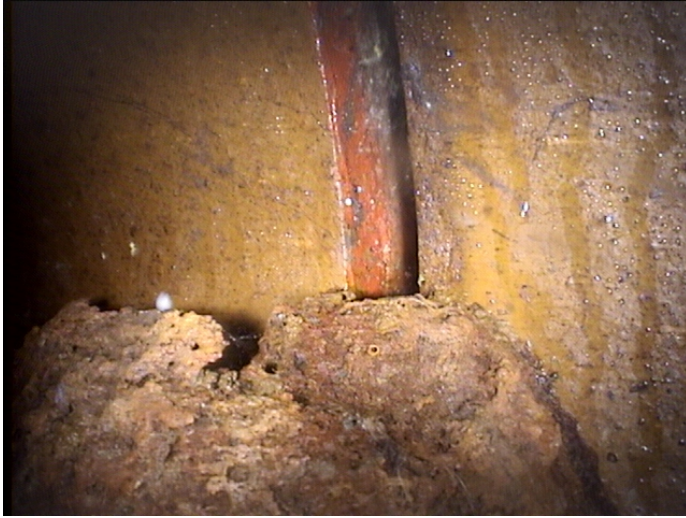
Code: **DAE**
Description: **Deposits Attached Encrustation**

Distance (ft): **162.5**
Structural Grade: **0**
O&M Grade: **2**
Clock Start/From: **3**
Clock To: **5**
1st Value:
2nd Value:
Value Percent: **5.000**
Continuous Index:
Within 8" of Joint: **NO**
Remarks:

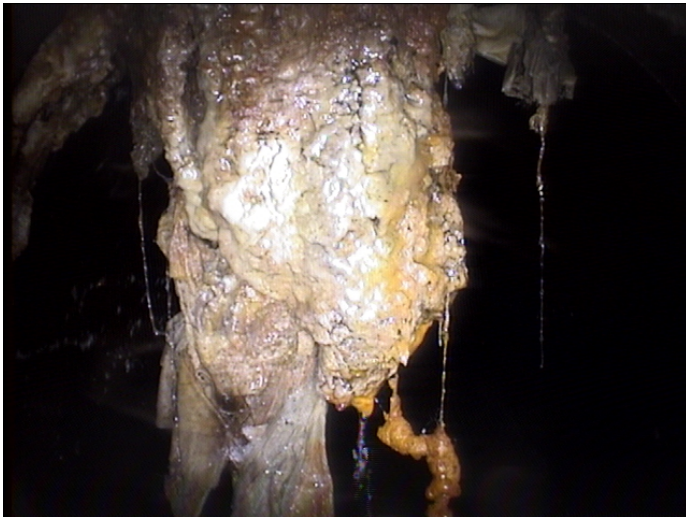
Code: **DAE**
Description: **Deposits Attached Encrustation**

Distance (ft): **166.4**
Structural Grade: **0**
O&M Grade: **3**
Clock Start/From: **9**
Clock To: **3**
1st Value:
2nd Value:
Value Percent: **15.000**
Continuous Index:
Within 8" of Joint: **YES**
Remarks:

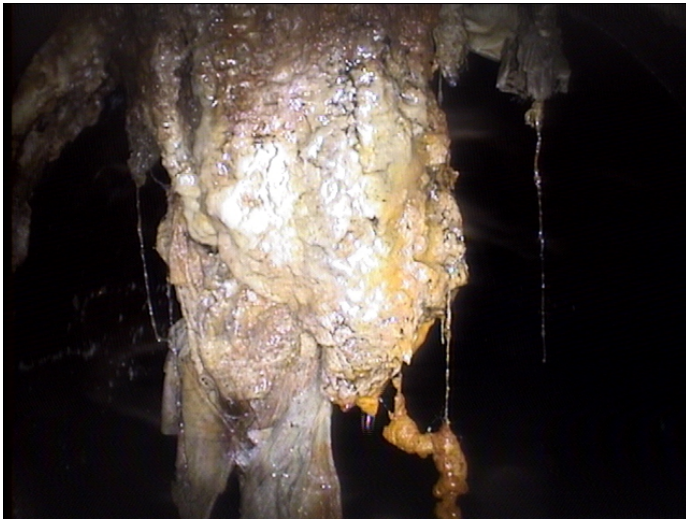
Code: **IR**
Description: **Infil Runner**

Distance (ft): **166.4**
Structural Grade: **0**
O&M Grade: **4**
Clock Start/From: **12**
Clock To:
1st Value:
2nd Value:
Value Percent:
Continuous Index:
Within 8" of Joint: **YES**
Remarks:

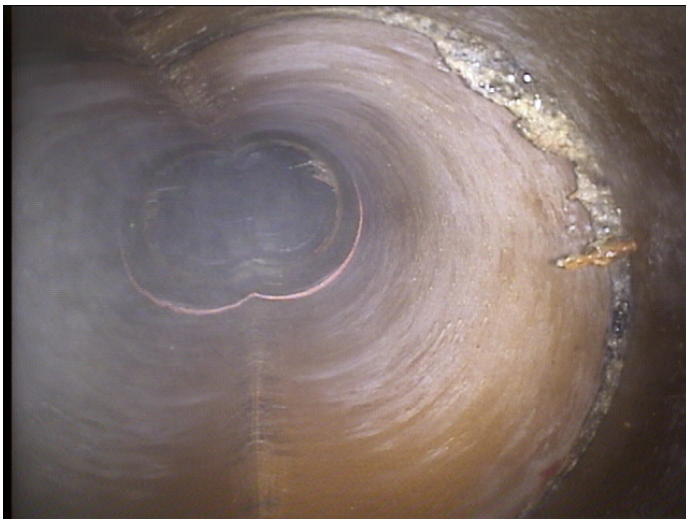
Code: **MSA**
Description: **Abandoned Survey**

Distance (ft): **190.9**
Structural Grade: **0**
O&M Grade: **0**
Clock Start/From:
Clock To:
1st Value:
2nd Value:
Value Percent:
Continuous Index:
Within 8" of Joint: **NO**
Remarks: **Rolled on debris**
