Profile/Photo Observation Report

Street:	South Lake Park Avenue	Flow Control:	
City:	Hobart, IN	Year Renewed:	
Location:	Light Highway	Tape/Media #:	963
Purpose:	Routine Assessment	Dia/Height:	24"
Use:	Sanitary	Material:	CP
Drain Area:		Lining:	
Category:	NA

US MH: **M-606-27** DS MH: **M-606-26** Total Length Surveyed (ft): **16.6**

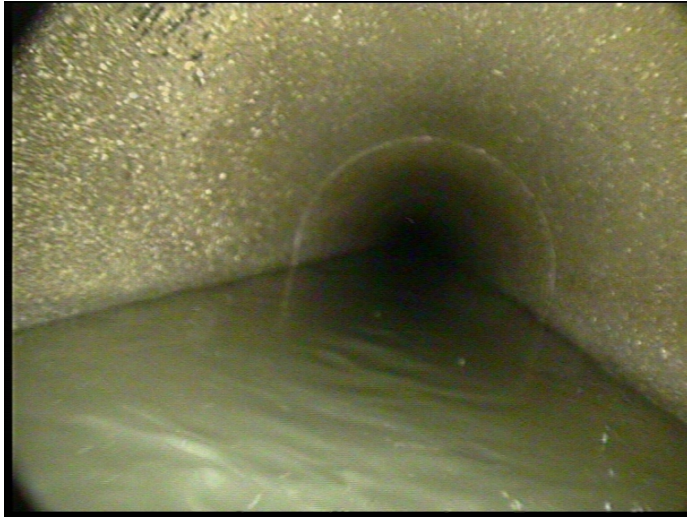
Code: **MWL**
Description: **Water Level**

Distance (ft): **.0**
Structural Grade: **0**
O&M Grade: **0**
Clock Start/From:
Clock To:
1st Value:
2nd Value:
Value Percent: **20.000**
Continuous Index:
Within 8" of Joint: **NO**
Remarks:

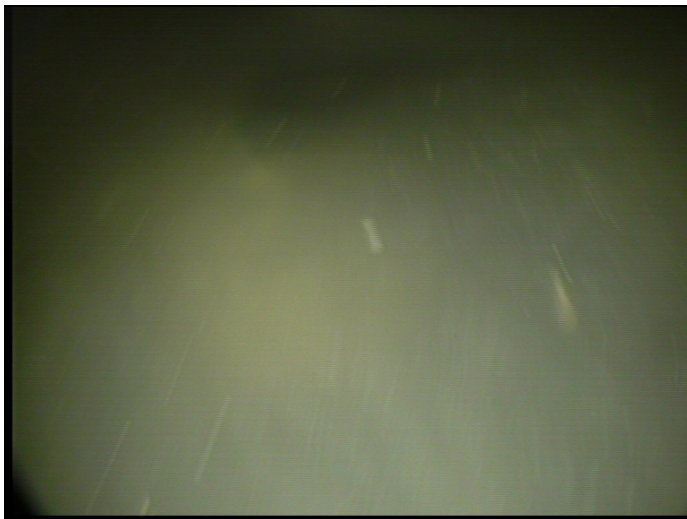
Code: **OBZ**
Description: **Obstacle Other**

Distance (ft): **15.9**
Structural Grade: **0**
O&M Grade: **2**
Clock Start/From: **6**
Clock To:
1st Value:
2nd Value:
Value Percent: **10.000**
Continuous Index:
Within 8" of Joint: **NO**
Remarks: **under water debris**

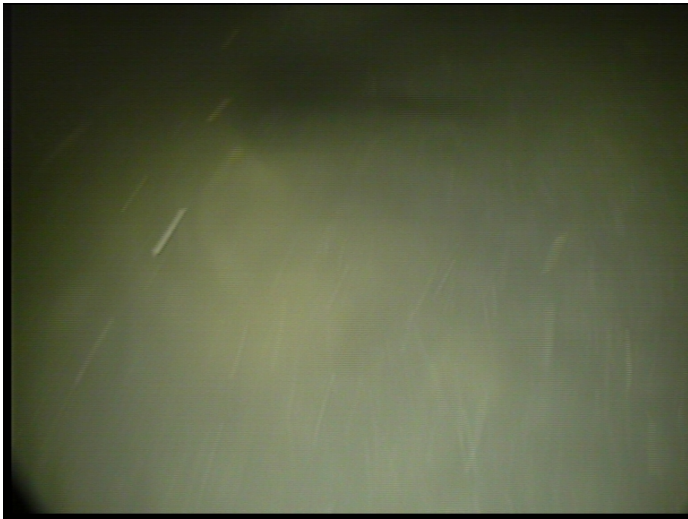
Code:	MSA
Description:	Abandoned Survey
Distance (ft):	15.9
Structural Grade:	0
O&M Grade:	0
Clock Start/From:	
Clock To:	
1st Value:	
2nd Value:	
Value Percent:	
Continuous Index:	
Within 8" of Joint:	NO
Remarks:	can not pass through under water debris
