Profile/Photo Observation Report

Date:	04/11/2018	Weather:		Coding:	PACP 6.0
Pipe Length (ft):	17.2	Owner:	NA	Pre Clean:	No Pre-Cleaning
P.O.#:		Surveyor:	Jen Costello	PSR:	P-706-063-028
Customer:		Clean Date:	01/01/1900	Shape:	C

Street:	S LAKE PARK AVE	Flow Control:	Not Controlled
City:	Hobart, IN	Year Renewed:	
Location:	Yard	Tape/Media #:	
Purpose:	Routine Assessment	Dia/Height:	8"
Use:	Sanitary	Material:	PVC
Drain Area:	NA	Lining:	
Category:	NA		
Comment:	Flow direction is marked wrong.		
Location Details:		Direction of Survey:	Upstream
US MH:	M-606-028	DS MH:	M-706-063
		Total Length Surveyed (ft):	13.0

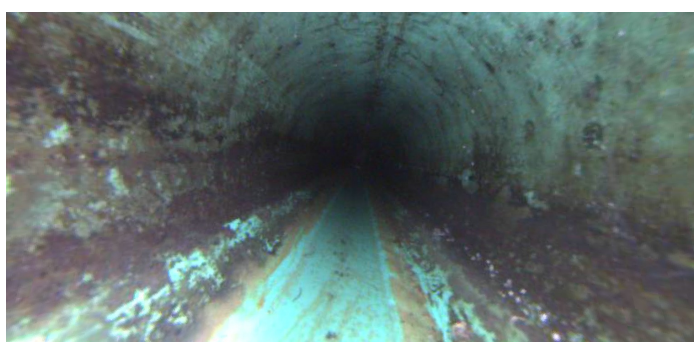
Code: **AMH**
Description: **Manhole**

Distance (ft): **.0**
Structural Grade: **0**
O&M Grade: **0**
Clock Start/From:
Clock To:
1st Value:
2nd Value:
Value Percent:
Continuous Index:
Within 8" of Joint: **NO**
Remarks: **M-706-063**

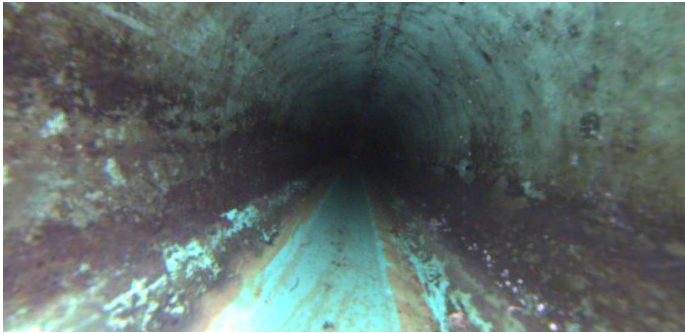
Code:	MWL
Description:	Water Level

Distance (ft):	.0
Structural Grade:	0
O&M Grade:	0
Clock Start/From:	
Clock To:	
1st Value:	
2nd Value:	
Value Percent:	5.000
Continuous Index:	
Within 8" of Joint:	NO
Remarks:

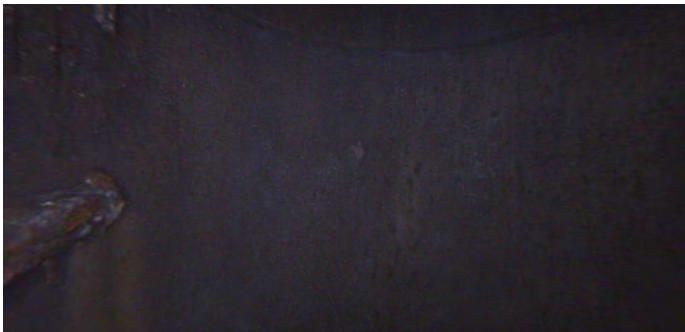
Code:	AMH
Description:	Manhole

Distance (ft):	13.0
Structural Grade:	0
O&M Grade:	0
Clock Start/From:	
Clock To:	
1st Value:	
2nd Value:	
Value Percent:	
Continuous Index:	
Within 8" of Joint:	NO
Remarks:	M-606-028
