## Profile/Photo Observation Report

Date:	<b>05/08/2018</b>	Weather:		Coding:	<b>PACP 6.0</b>
Pipe Length (ft):		Owner:	<b>City of Hobart</b>	Pre Clean:	<b>No Pre-Cleaning</b>
P.O.#:	<b>622</b>	Surveyor:	<b>M. Pielacha</b>	PSR:	<b>P-606-051-023</b>
Customer:	<b>City of Hobart</b>	Clean Date:		Shape:	<b>C</b>

Street:	<b>West 8th Street</b>	Flow Control:	<b>Not Controlled</b>
City:	<b>Hobart, IN</b>	Year Renewed:	
Location:	<b>Light Highway</b>	Tape/Media #:	<b>DEP 622</b>
Purpose:	<b>Routine Assessment</b>	Dia/Height:	<b>18"</b>
Use:	<b>Sanitary</b>	Material:	<b>VCP</b>
Drain Area:		Lining:	
Category:	<b>NA</b>		
Comment:	<b>5-21-2018</b>		
Location Details:		Direction of Survey:	<b>Downstream</b>
US MH:	<b>M-606-051</b>	DS MH:	<b>M-606-023</b>
		Total Length Surveyed (ft):	<b>163.7</b>

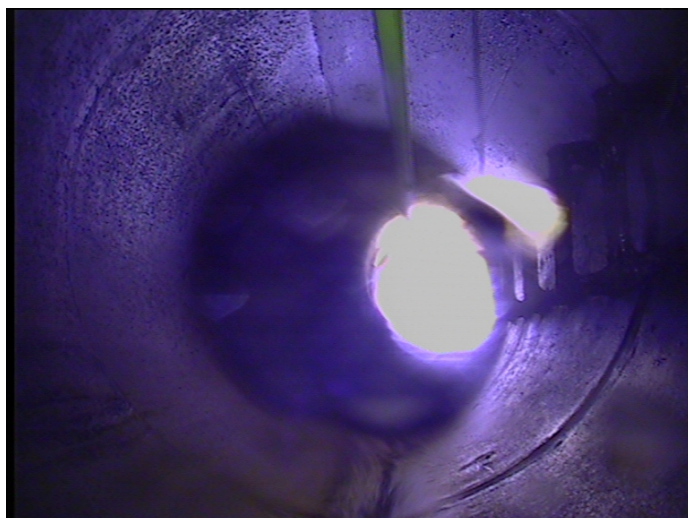
Code: **AMH**  
Description: **Manhole**

Distance (ft): **.0**  
Structural Grade: **0**  
O&M Grade: **0**  
Clock Start/From:  
Clock To:  
1st Value:  
2nd Value:  
Value Percent:  
Continuous Index:  
Within 8" of Joint: **NO**  
Remarks: **M-606-051**

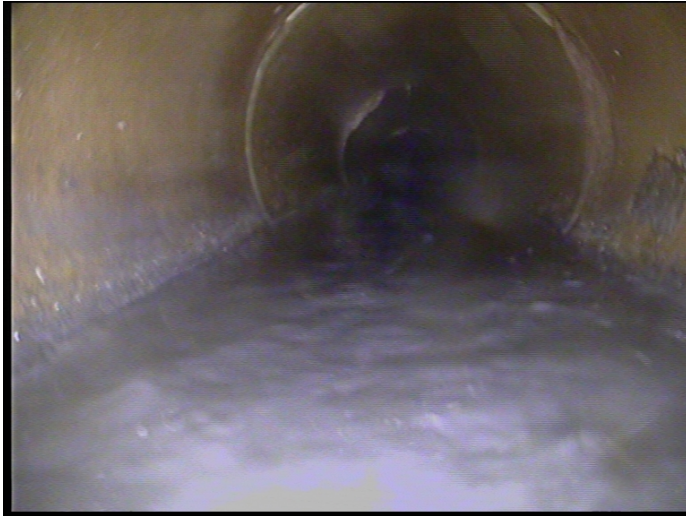
Code: **MWL**  
Description: **Water Level**

Distance (ft): **.0**  
Structural Grade: **0**  
O&M Grade: **0**  
Clock Start/From:  
Clock To:  
1st Value:  
2nd Value:  
Value Percent: **15.000**  
Continuous Index:  
Within 8" of Joint: **NO**  
Remarks:

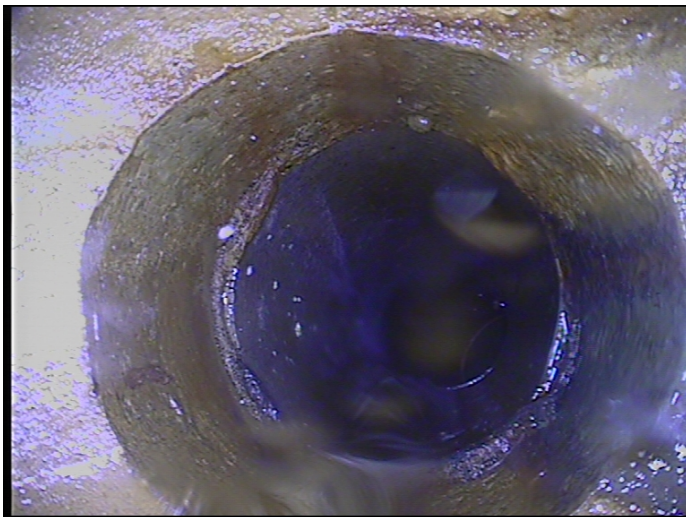
Code: **TFA**  
Description: **Tap Factory Active**

Distance (ft): **39.2**  
Structural Grade: **0**  
O&M Grade: **0**  
Clock Start/From: **12**  
Clock To:  
1st Value: **4.000**  
2nd Value:  
Value Percent:  
Continuous Index:  
Within 8" of Joint: **NO**  
Remarks:

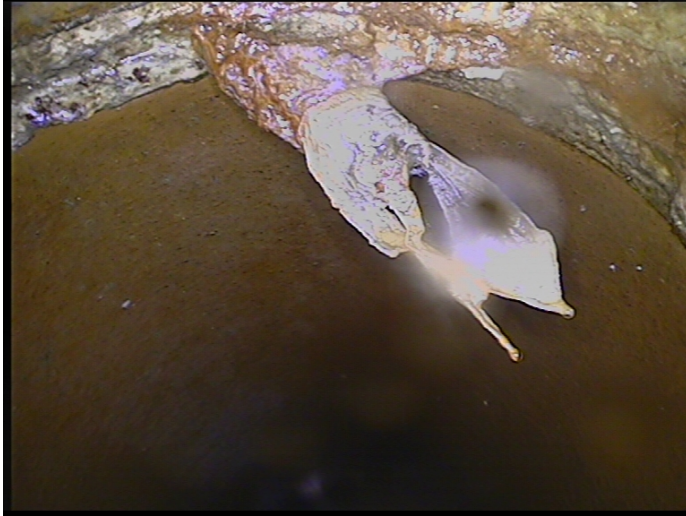
Code:	<b>DAE</b>
Description:	<b>Deposits Attached Encrustation</b>
Distance (ft):	<b>41.3</b>
Structural Grade:	<b>0</b>
O&M Grade:	<b>2</b>
Clock Start/From:	<b>9</b>
Clock To:	<b>3</b>
1st Value:	
2nd Value:	
Value Percent:	<b>10.000</b>
Continuous Index:	
Within 8" of Joint:	<b>YES</b>
Remarks:

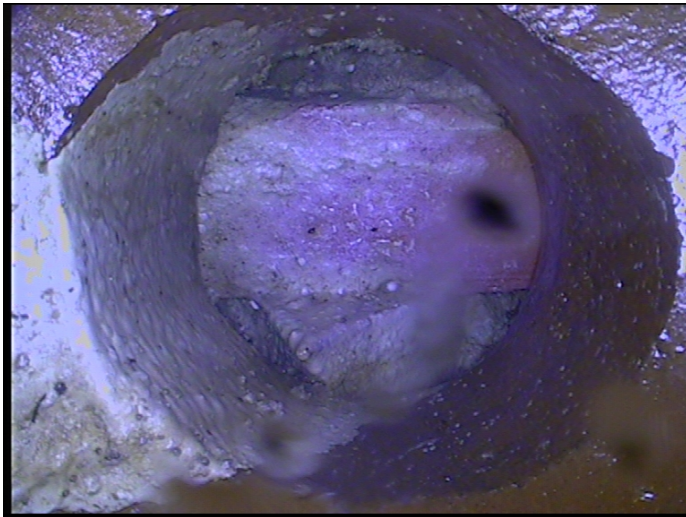
Code:	<b>TFC</b>
Description:	<b>Tap Factory Capped</b>
Distance (ft):	<b>84.5</b>
Structural Grade:	<b>0</b>
O&M Grade:	<b>0</b>
Clock Start/From:	<b>10</b>
Clock To:	
1st Value:	<b>4.000</b>
2nd Value:	
Value Percent:	
Continuous Index:	
Within 8" of Joint:	<b>NO</b>
Remarks:

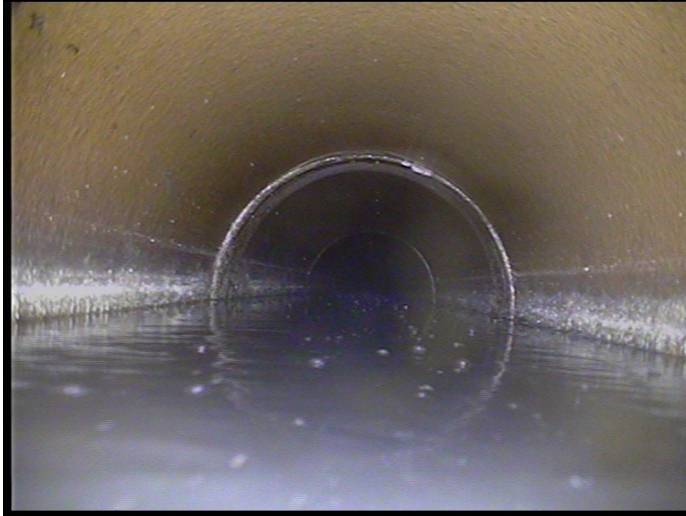
Code:	<b>MSA</b>
Description:	<b>Abandoned Survey</b>
Distance (ft):	<b>163.7</b>
Structural Grade:	<b>0</b>
O&M Grade:	<b>0</b>
Clock Start/From:	
Clock To:	
1st Value:	
2nd Value:	
Value Percent:	
Continuous Index:	
Within 8" of Joint:	<b>NO</b>
Remarks:	<b>deepsediment</b>
