## Profile/Photo Observation Report

Date:	<b>03/12/2024</b>	Weather:		Coding:	<b>PACP 7.0</b>
Pipe Length (ft):	<b>157.0</b>	Owner:	<b>City of Hobart</b>	Pre Clean:	<b>Heavy Cleaning</b>
P.O.#:		Surveyor:	<b>S. Bucklin</b>	PSR:	<b>P-606-052-051</b>
Customer:	<b>City of Hobart</b>	Clean Date:	<b>03/05/2024</b>	Shape:	<b>C</b>

Street:	<b>S ASH ST</b>	Flow Control:	<b>Not Controlled</b>
City:	<b>Hobart, IN</b>	Year Renewed:	
Location:	<b>Local rural streets with light traffic, t</b>	Tape/Media #:	
Purpose:	<b>Sewer System Evaluation Survey (SS</b>	Dia/Height:	<b>12"</b>
Use:	<b>Sanitary Sewage Pipe</b>	Material:	<b>VCP</b>
Drain Area:		Lining:	<b>None</b>
Category:	<b>NA</b>		
Comment:			
Location Details:		Direction of Survey:	<b>Downstream</b>
US MH:	<b>M-606-051</b>	DS MH:	<b>M-606-052</b>
		Total Length Surveyed (ft):	<b>154.7</b>

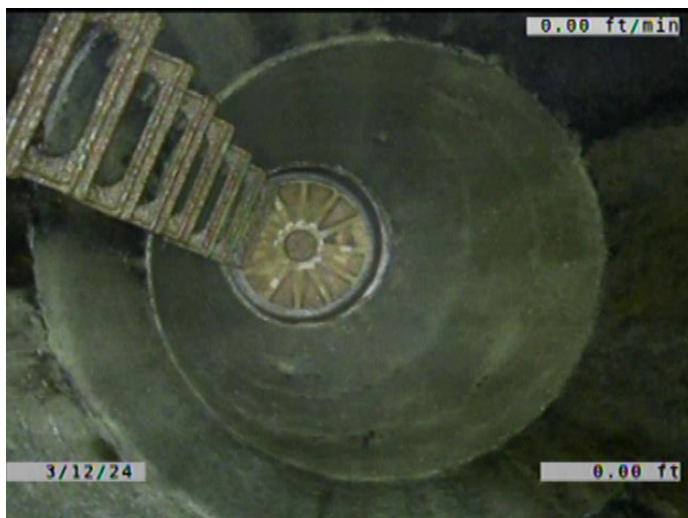
Code: **AMH**  
 Description: **Manhole**

Distance (ft): **.0**  
 Structural Grade: **0**  
 O&M Grade: **0**  
 Clock Start/From:  
 Clock To:  
 1st Value:  
 2nd Value:  
 Value Percent:  
 Continuous Index:  
 Within 8" of Joint: **NO**  
 Remarks: **M-606-051**

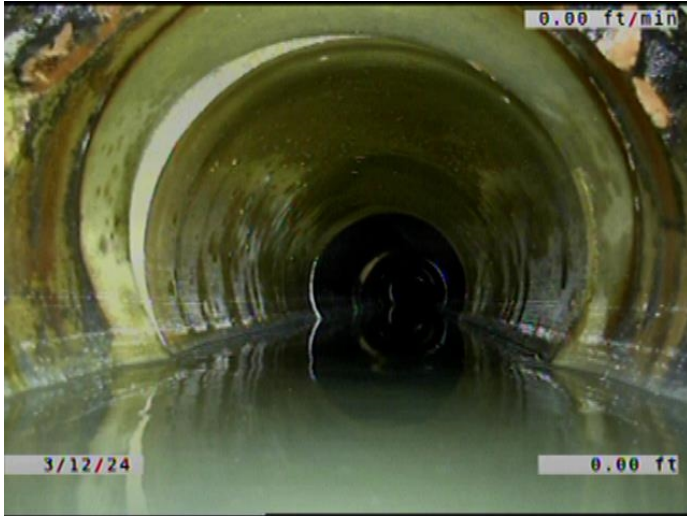
Code:	<b>MWL</b>
Description:	<b>Miscellaneous Water Level</b>
Distance (ft):	<b>.0</b>
Structural Grade:	<b>0</b>
O&M Grade:	<b>0</b>
Clock Start/From:	
Clock To:	
1st Value:	
2nd Value:	
Value Percent:	<b>15.000</b>
Continuous Index:	
Within 8" of Joint:	<b>NO</b>
Remarks:

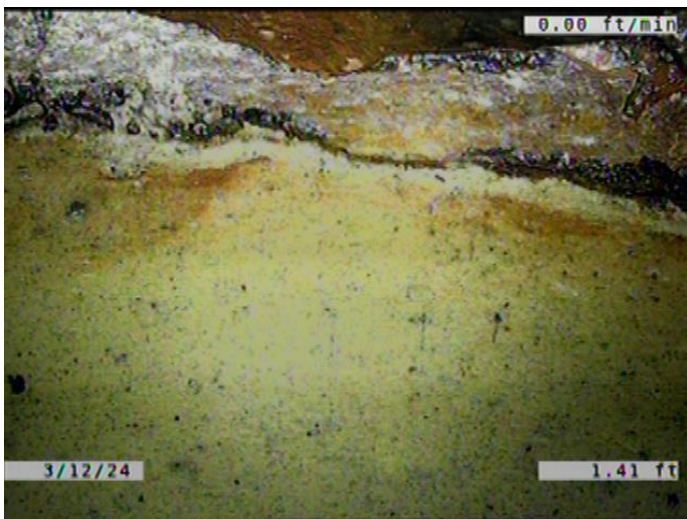
Code:	<b>CM</b>
Description:	<b>Crack Multiple</b>
Distance (ft):	<b>1.4</b>
Structural Grade:	<b>3</b>
O&M Grade:	<b>0</b>
Clock Start/From:	<b>8</b>
Clock To:	<b>4</b>
1st Value:	
2nd Value:	
Value Percent:	
Continuous Index:	
Within 8" of Joint:	<b>YES</b>
Remarks:

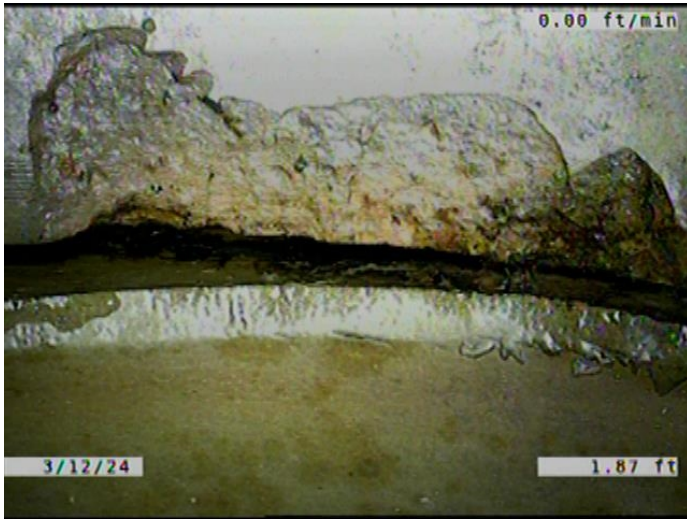
Code: **SZ**  
Description: **Surface Damage Other**

Distance (ft): **1.9**  
Structural Grade: **0**  
O&M Grade: **0**  
Clock Start/From: **2**  
Clock To: **4**  
1st Value:  
2nd Value:  
Value Percent:  
Continuous Index:  
Within 8" of Joint: **YES**  
Remarks: **A PIECE CHIPPED AWAY FROM THE JOINT.**

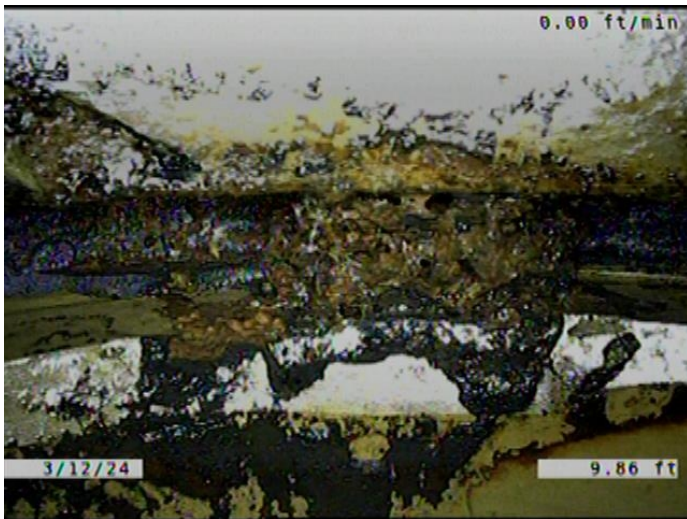
Code: **DAE**  
Description: **Deposits Attached Encrustation**

Distance (ft): **9.9**  
Structural Grade: **0**  
O&M Grade: **2**  
Clock Start/From: **8**  
Clock To: **4**  
1st Value:  
2nd Value:  
Value Percent: **5.000**  
Continuous Index: **S01**  
Within 8" of Joint: **YES**  
Remarks:

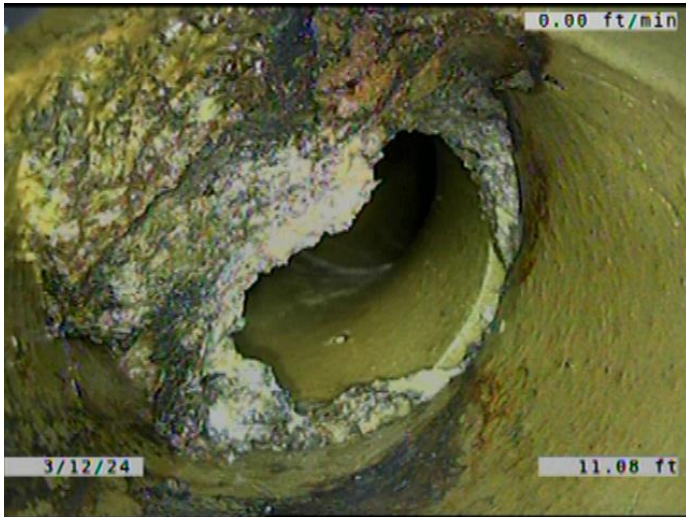
Code: **TFD**  
Description: **Tap Factory Defective**

Distance (ft): **11.1**  
Structural Grade: **0**  
O&M Grade: **3**  
Clock Start/From: **10**  
Clock To:  
1st Value: **6.000**  
2nd Value:  
Value Percent:  
Continuous Index:  
Within 8" of Joint: **YES**  
Remarks: **ENCrustation PLUGGING 75% OF THE SERVICE. ENCRUSTATION COM**

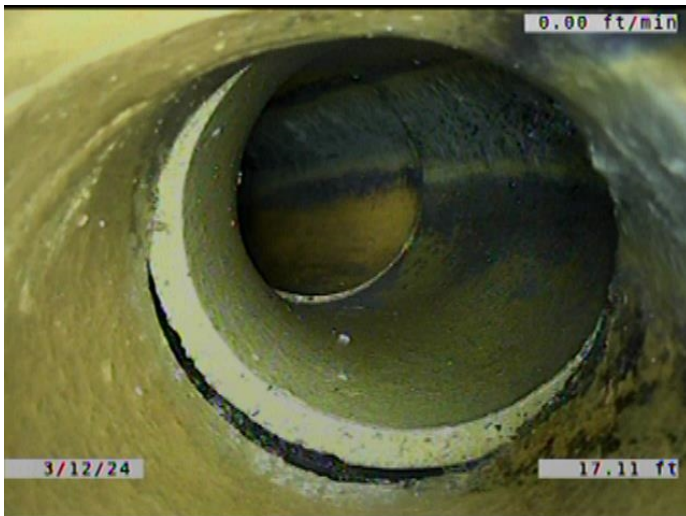
Code: **TFD**  
Description: **Tap Factory Defective**

Distance (ft): **17.1**  
Structural Grade: **0**  
O&M Grade: **3**  
Clock Start/From: **2**  
Clock To:  
1st Value: **6.000**  
2nd Value:  
Value Percent:  
Continuous Index:  
Within 8" of Joint: **YES**  
Remarks: **SERVICE OFFSET. CONSTANTLY RUNNING WATER.**

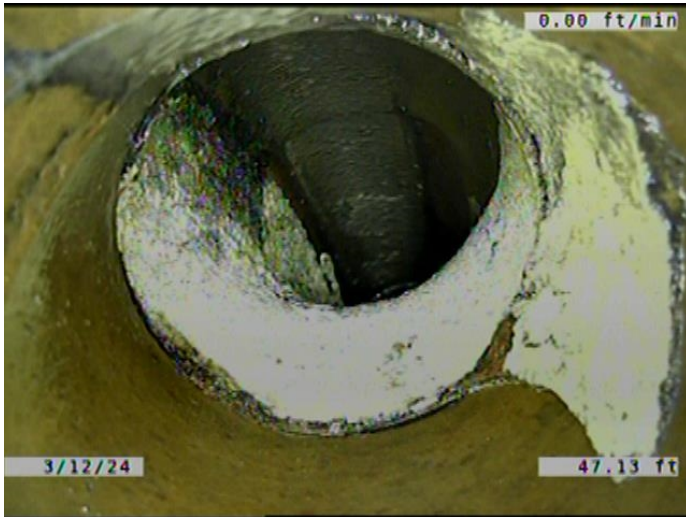
Code: **TFD**  
Description: **Tap Factory Defective**

Distance (ft): **47.1**  
Structural Grade: **0**  
O&M Grade: **3**  
Clock Start/From: **11**  
Clock To:  
1st Value: **6.000**  
2nd Value:  
Value Percent:  
Continuous Index:  
Within 8" of Joint: **YES**  
Remarks: **CONSTANTLY RUNNING WATER.  
ENCrustATION COMING FROM THE**

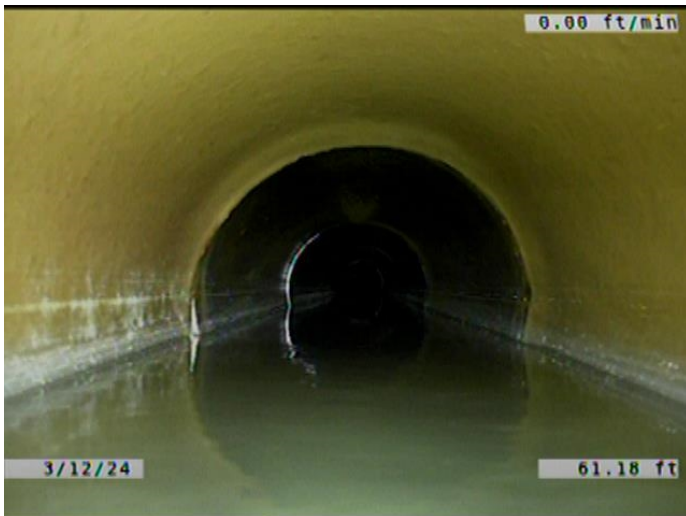
Code: **MWLS**  
Description: **Miscellaneous Water Level Sag**

Distance (ft): **61.2**  
Structural Grade: **2**  
O&M Grade: **0**  
Clock Start/From:  
Clock To:  
1st Value:  
2nd Value:  
Value Percent: **20.000**  
Continuous Index: **S02**  
Within 8" of Joint: **NO**  
Remarks:

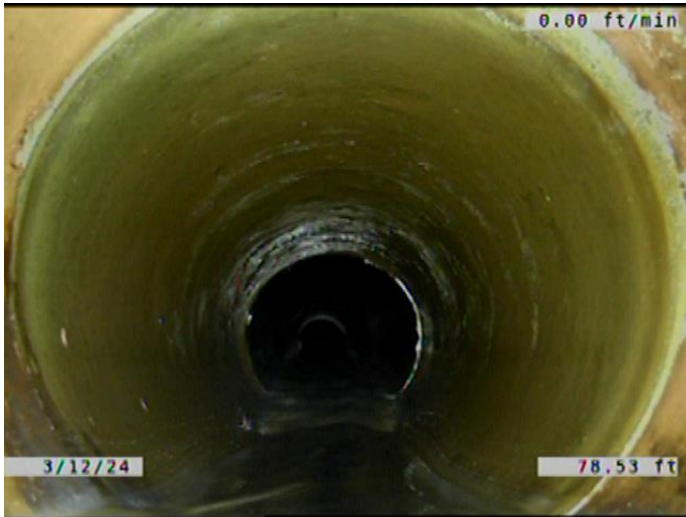
Code: **MWLS**  
Description: **Miscellaneous Water Level Sag**

Distance (ft): **78.5**  
Structural Grade: **2**  
O&M Grade: **0**  
Clock Start/From:  
Clock To:  
1st Value:  
2nd Value:  
Value Percent: **20.000**  
Continuous Index: **F02**  
Within 8" of Joint: **NO**  
Remarks:

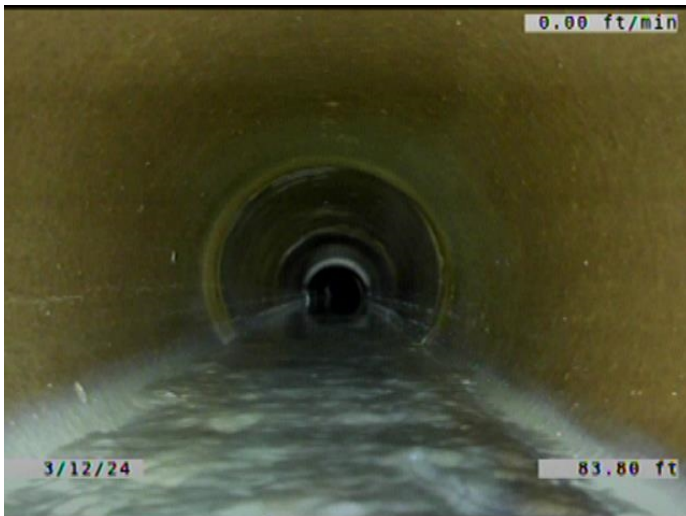
Code: **MWLS**  
Description: **Miscellaneous Water Level Sag**

Distance (ft): **83.8**  
Structural Grade: **2**  
O&M Grade: **0**  
Clock Start/From:  
Clock To:  
1st Value:  
2nd Value:  
Value Percent: **20.000**  
Continuous Index: **S03**  
Within 8" of Joint: **NO**  
Remarks:

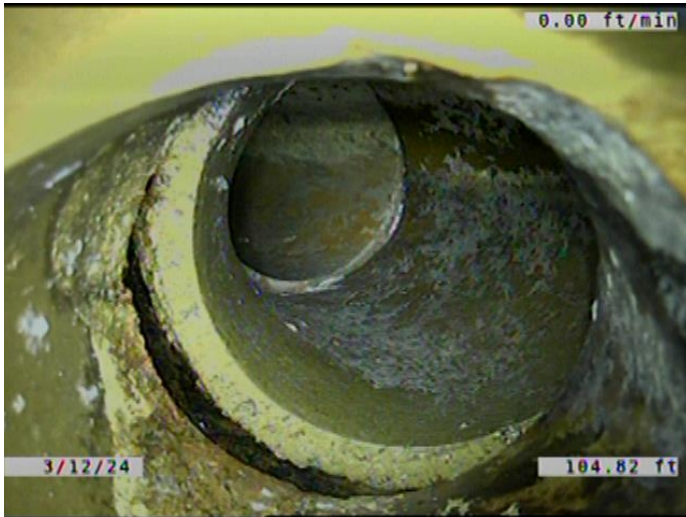
Code: **TFD**  
Description: **Tap Factory Defective**

Distance (ft): **104.8**  
Structural Grade: **0**  
O&M Grade: **3**  
Clock Start/From: **2**  
Clock To:  
1st Value: **6.000**  
2nd Value:  
Value Percent:  
Continuous Index:  
Within 8" of Joint: **YES**  
Remarks: **TAP OFFSET. CONSTANTLY RUNNING WATER. ENCRUSTATION COMING FR**

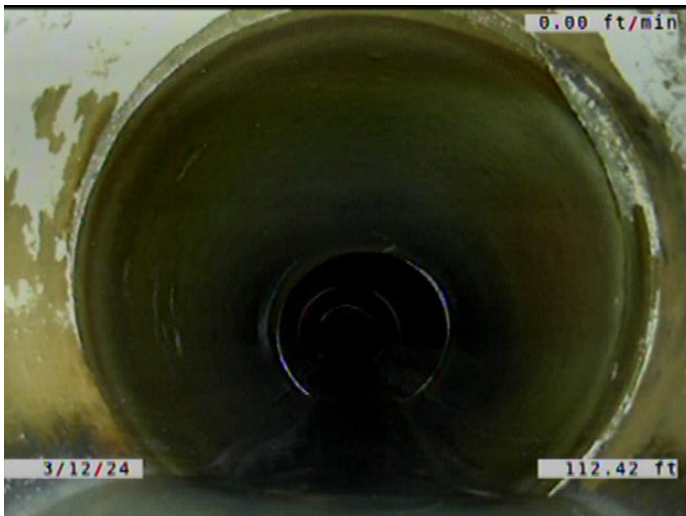
Code: **MWLS**  
Description: **Miscellaneous Water Level Sag**

Distance (ft): **112.4**  
Structural Grade: **2**  
O&M Grade: **0**  
Clock Start/From:  
Clock To:  
1st Value:  
2nd Value:  
Value Percent: **20.000**  
Continuous Index: **F03**  
Within 8" of Joint: **NO**  
Remarks:

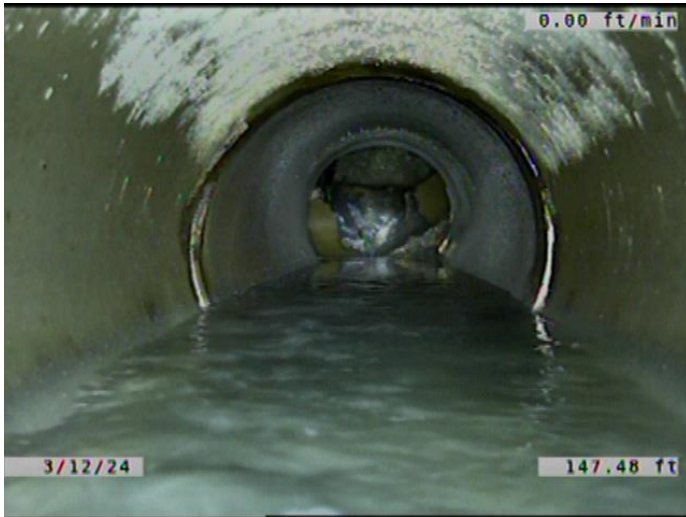
Code: **MWLS**  
Description: **Miscellaneous Water Level Sag**

Distance (ft): **147.5**  
Structural Grade: **2**  
O&M Grade: **0**  
Clock Start/From:  
Clock To:  
1st Value:  
2nd Value:  
Value Percent: **20.000**  
Continuous Index: **S04**  
Within 8" of Joint: **NO**  
Remarks:

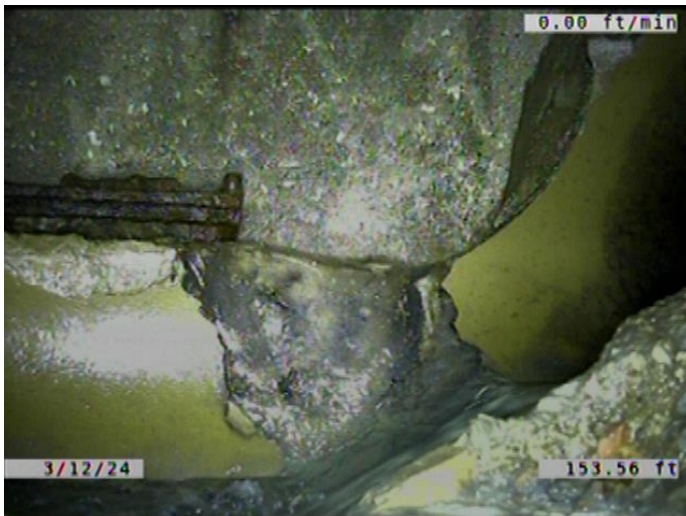
Code: **MWLS**  
Description: **Miscellaneous Water Level Sag**

Distance (ft): **153.6**  
Structural Grade: **2**  
O&M Grade: **0**  
Clock Start/From:  
Clock To:  
1st Value:  
2nd Value:  
Value Percent: **20.000**  
Continuous Index: **F04**  
Within 8" of Joint: **NO**  
Remarks:

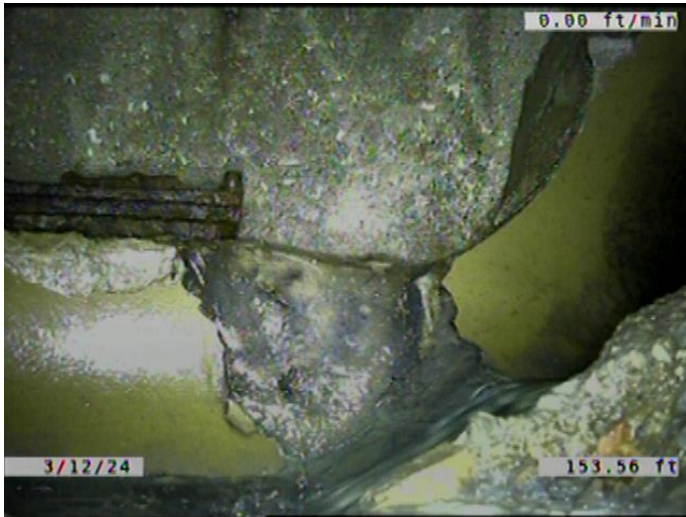
Code:	<b>DAE</b>
Description:	<b>Deposits Attached Encrustation</b>
Distance (ft):	<b>153.6</b>
Structural Grade:	<b>0</b>
O&M Grade:	<b>2</b>
Clock Start/From:	<b>8</b>
Clock To:	<b>4</b>
1st Value:	
2nd Value:	
Value Percent:	<b>5.000</b>
Continuous Index:	<b>F01</b>
Within 8" of Joint:	<b>YES</b>
Remarks:

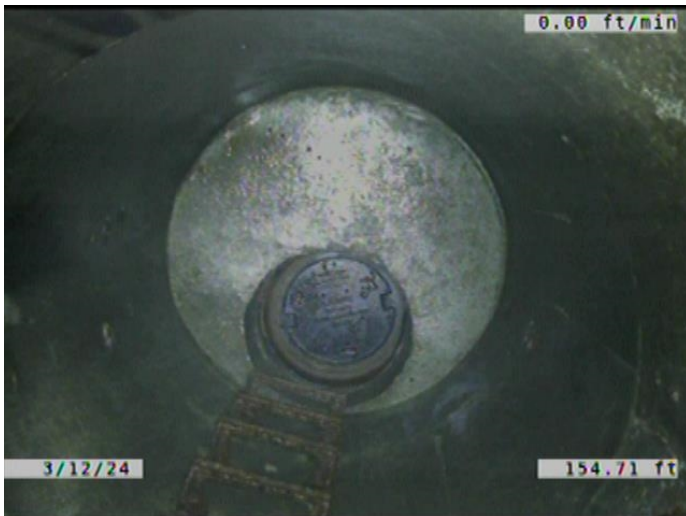
Code:	<b>AMH</b>
Description:	<b>Manhole</b>
Distance (ft):	<b>154.7</b>
Structural Grade:	<b>0</b>
O&M Grade:	<b>0</b>
Clock Start/From:	
Clock To:	
1st Value:	
2nd Value:	
Value Percent:	
Continuous Index:	
Within 8" of Joint:	<b>NO</b>
Remarks:	<b>M-606-052</b>
