## Profile/Photo Observation Report

Street:	<b>S ASH ST</b>	Flow Control:	<b>Not Controlled</b>
City:	<b>Hobart, IN</b>	Year Renewed:	
Location:	<b>Yard</b>	Tape/Media #:	
Purpose:	<b>Routine Assessment</b>	Dia/Height:	<b>12"</b>
Use:	<b>Sanitary</b>	Material:	<b>VCP</b>
Drain Area:	<b>NA</b>	Lining:	
Category:	<b>NA</b>		
Comment:

Location Details:		Direction of Survey:	<b>Upstream</b>
US MH:	<b>M-606-052</b>	DS MH:	<b>M-606-053</b>
		Total Length Surveyed (ft):	<b>46.2</b>

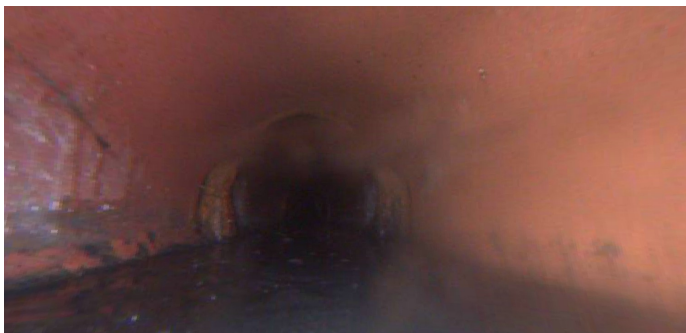
Code: **AMH**  
Description: **Manhole**

Distance (ft): **.0**  
Structural Grade: **0**  
O&M Grade: **0**  
Clock Start/From:  
Clock To:  
1st Value:  
2nd Value:  
Value Percent:  
Continuous Index:  
Within 8" of Joint: **NO**  
Remarks: **M-606-053**

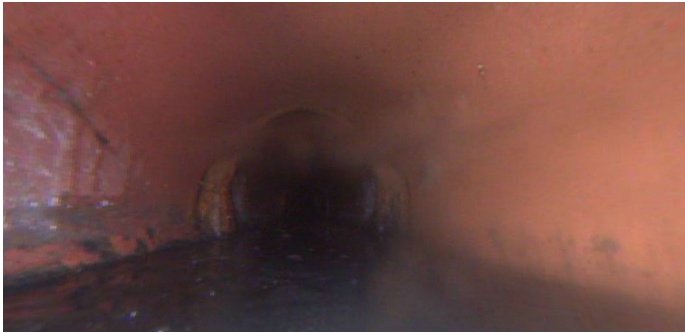
Code:	<b>MWL</b>
Description:	<b>Water Level</b>

Distance (ft):	<b>.0</b>
Structural Grade:	<b>0</b>
O&M Grade:	<b>0</b>
Clock Start/From:	
Clock To:	
1st Value:	
2nd Value:	
Value Percent:	<b>10.000</b>
Continuous Index:	
Within 8" of Joint:	<b>NO</b>
Remarks:

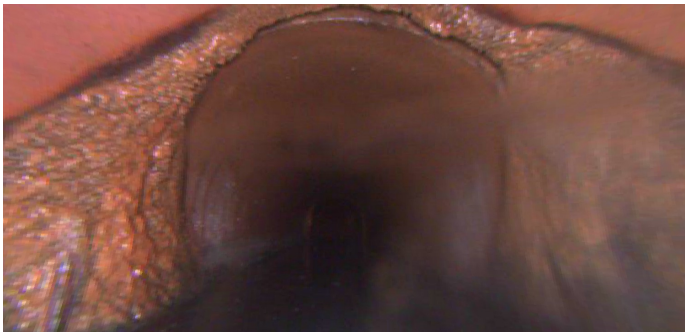
Code:	<b>DAE</b>
Description:	<b>Deposits Attached Encrustation</b>

Distance (ft):	<b>1.9</b>
Structural Grade:	<b>0</b>
O&M Grade:	<b>3</b>
Clock Start/From:	<b>7</b>
Clock To:	<b>5</b>
1st Value:	
2nd Value:	
Value Percent:	<b>15.000</b>
Continuous Index:	<b>S01</b>
Within 8" of Joint:	<b>YES</b>
Remarks:	<b>wandering in % and clock position</b>

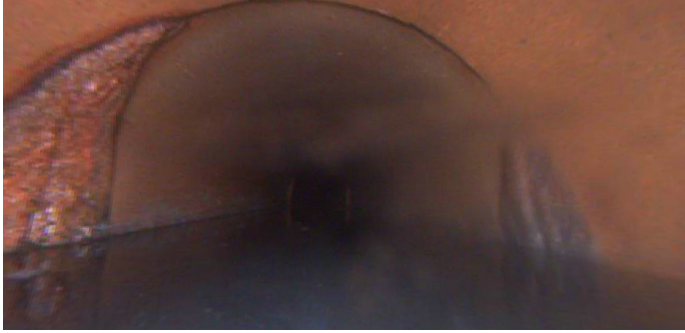
Code: **MWL**  
Description: **Water Level**

Distance (ft): **13.5**  
Structural Grade: **0**  
O&M Grade: **0**  
Clock Start/From:  
Clock To:  
1st Value:  
2nd Value:  
Value Percent: **25.000**  
Continuous Index:  
Within 8" of Joint: **NO**  
Remarks:

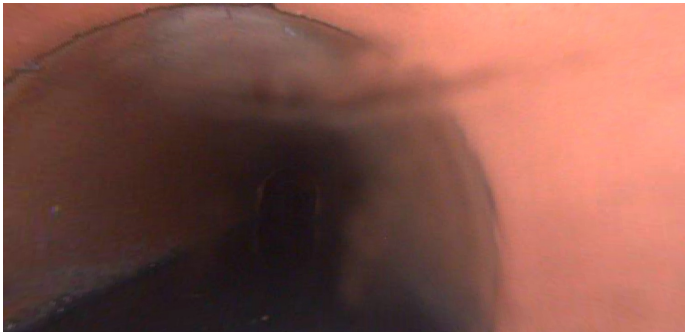
Code: **MWL**  
Description: **Water Level**

Distance (ft): **21.5**  
Structural Grade: **0**  
O&M Grade: **0**  
Clock Start/From:  
Clock To:  
1st Value:  
2nd Value:  
Value Percent: **5.000**  
Continuous Index:  
Within 8" of Joint: **NO**  
Remarks:

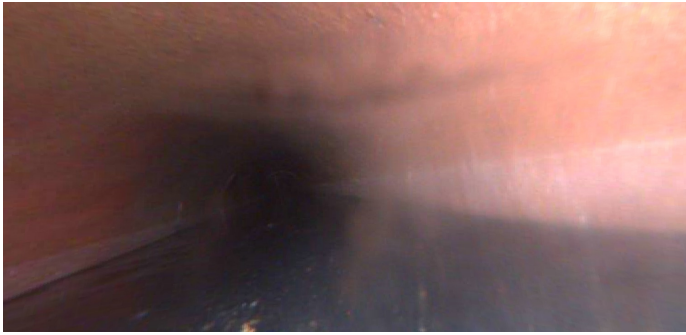
Code: **MSA**  
Description: **Abandoned Survey**

Distance (ft): **46.2**  
Structural Grade: **0**  
O&M Grade: **0**  
Clock Start/From:  
Clock To:  
1st Value:  
2nd Value:  
Value Percent:  
Continuous Index:  
Within 8" of Joint: **NO**  
Remarks: **no blockage**

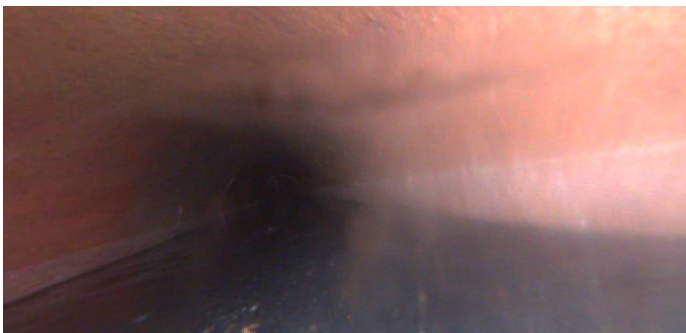
Code: **DAE**  
Description: **Deposits Attached Encrustation**

Distance (ft): **46.2**  
Structural Grade: **0**  
O&M Grade: **3**  
Clock Start/From: **7**  
Clock To: **5**  
1st Value:  
2nd Value:  
Value Percent: **15.000**  
Continuous Index: **F01**  
Within 8" of Joint: **YES**  
Remarks: **wandering in % and clock position**
