Profile/Photo Observation Report

Date:	04/10/2018	Weather:		Coding:	PACP 6.0
Pipe Length (ft):	174.3	Owner:	NA	Pre Clean:	No Pre-Cleaning
P.O.#:		Surveyor:	Byrd Fitzgerald	PSR:	P-606-053-052
Customer:		Clean Date:	01/01/1900	Shape:	C

Street:	FOXCROFT STREET	Flow Control:	Not Controlled
City:	Hobart, IN	Year Renewed:	
Location:	Yard	Tape/Media #:	
Purpose:	Routine Assessment	Dia/Height:	12"
Use:	Sanitary	Material:	VCP
Drain Area:	NA	Lining:	
Category:	NA		
Comment:

Location Details:		Direction of Survey:	Upstream
US MH:	M-606-052	DS MH:	M-606-053
		Total Length Surveyed (ft):	46.2

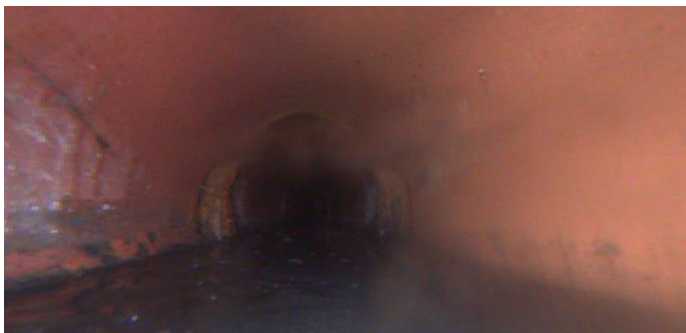
Code: **AMH**
Description: **Manhole**

Distance (ft): **.0**
Structural Grade: **0**
O&M Grade: **0**
Clock Start/From:
Clock To:
1st Value:
2nd Value:
Value Percent:
Continuous Index:
Within 8" of Joint: **NO**
Remarks: **M-606-053**

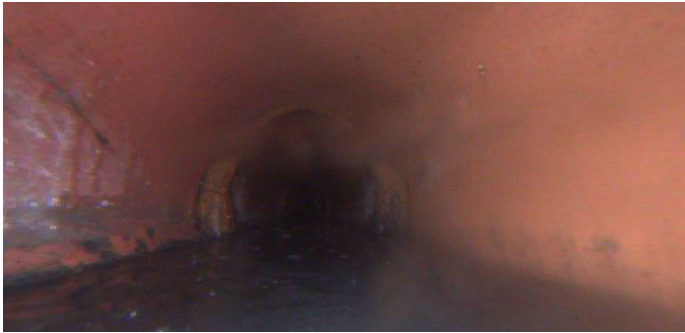
Code:	MWL
Description:	Water Level

Distance (ft):	.0
Structural Grade:	0
O&M Grade:	0
Clock Start/From:	
Clock To:	
1st Value:	
2nd Value:	
Value Percent:	10.000
Continuous Index:	
Within 8" of Joint:	NO
Remarks:

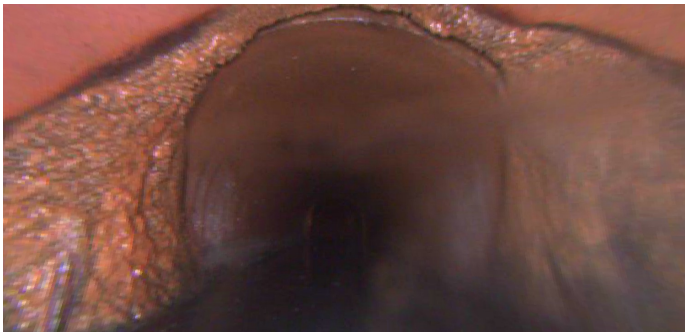
Code:	DAE
Description:	Deposits Attached Encrustation

Distance (ft):	1.9
Structural Grade:	0
O&M Grade:	3
Clock Start/From:	7
Clock To:	5
1st Value:	
2nd Value:	
Value Percent:	15.000
Continuous Index:	S01
Within 8" of Joint:	YES
Remarks:	wandering in % and clock position

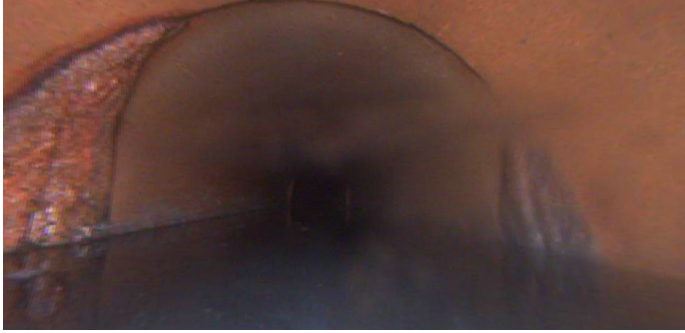
Code: **MWL**
Description: **Water Level**

Distance (ft): **13.5**
Structural Grade: **0**
O&M Grade: **0**
Clock Start/From:
Clock To:
1st Value:
2nd Value:
Value Percent: **25.000**
Continuous Index:
Within 8" of Joint: **NO**
Remarks:

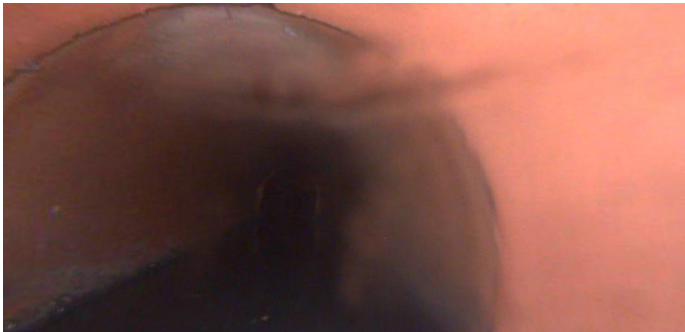
Code: **MWL**
Description: **Water Level**

Distance (ft): **21.5**
Structural Grade: **0**
O&M Grade: **0**
Clock Start/From:
Clock To:
1st Value:
2nd Value:
Value Percent: **5.000**
Continuous Index:
Within 8" of Joint: **NO**
Remarks:

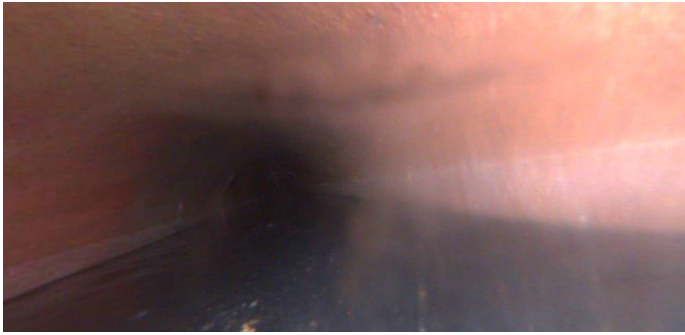
Code: **MSA**
Description: **Abandoned Survey**

Distance (ft): **46.2**
Structural Grade: **0**
O&M Grade: **0**
Clock Start/From:
Clock To:
1st Value:
2nd Value:
Value Percent:
Continuous Index:
Within 8" of Joint: **NO**
Remarks: **no blockage**

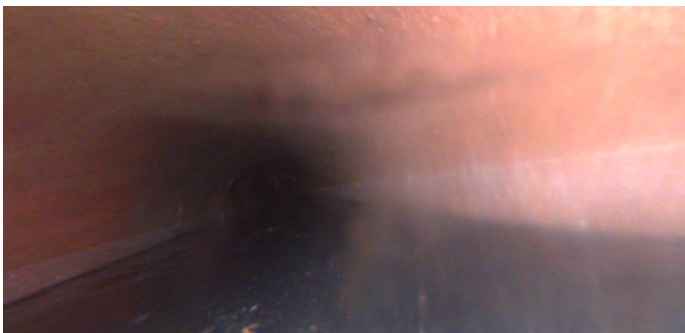
Code: **DAE**
Description: **Deposits Attached Encrustation**

Distance (ft): **46.2**
Structural Grade: **0**
O&M Grade: **3**
Clock Start/From: **7**
Clock To: **5**
1st Value:
2nd Value:
Value Percent: **15.000**
Continuous Index: **F01**
Within 8" of Joint: **YES**
Remarks: **wandering in % and clock position**
