Profile/Photo Observation Report

Date:	03/12/2024	Weather:		Coding:	PACP 7.0
Pipe Length (ft):	174.0	Owner:	City of Hobart	Pre Clean:	Heavy Cleaning
P.O.#:		Surveyor:	S. Bucklin	PSR:	P-606-053-052
Customer:	City of Hobart	Clean Date:	03/04/2024	Shape:	C

Street:	S ASH ST	Flow Control:	Not Controlled
City:	Hobart, IN	Year Renewed:	
Location:	Local rural streets with light traffic, t	Tape/Media #:	
Purpose:	Sewer System Evaluation Survey (SS	Dia/Height:	12"
Use:	Sanitary Sewage Pipe	Material:	VCP
Drain Area:		Lining:	None
Category:	NA		
Comment:			
Location Details:		Direction of Survey:	Downstream
US MH:	M-606-052	DS MH:	M-606-053
		Total Length Surveyed (ft):	171.8

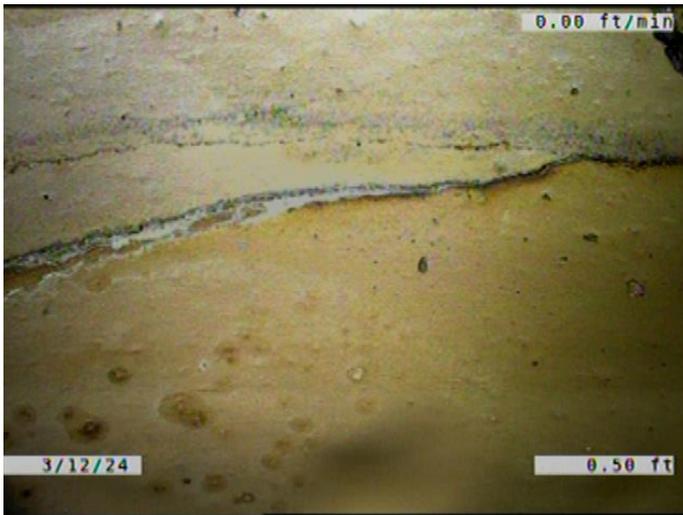
Code: **B**
Description: **Broken**

Distance (ft): **.5**
Structural Grade: **4**
O&M Grade: **0**
Clock Start/From: **9**
Clock To: **3**
1st Value:
2nd Value:
Value Percent:
Continuous Index:
Within 8" of Joint: **YES**
Remarks:

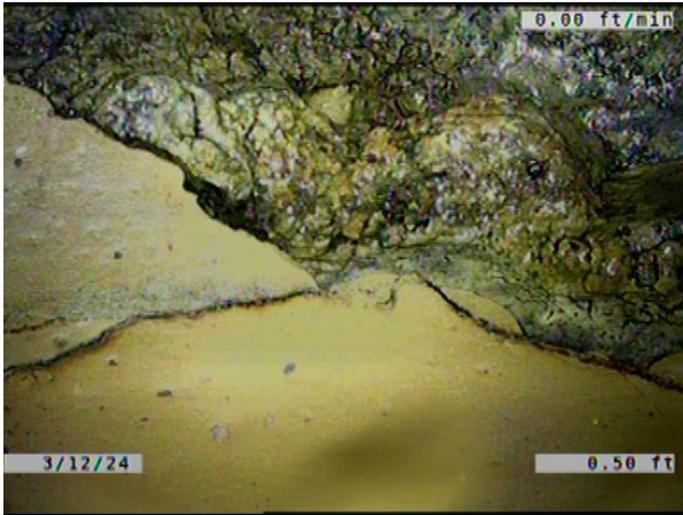
Code: **DAE**
Description: **Deposits Attached Encrustation**

Distance (ft): **.5**
Structural Grade: **0**
O&M Grade: **2**
Clock Start/From: **8**
Clock To: **4**
1st Value:
2nd Value:
Value Percent: **5.000**
Continuous Index: **S01**
Within 8" of Joint: **YES**
Remarks:

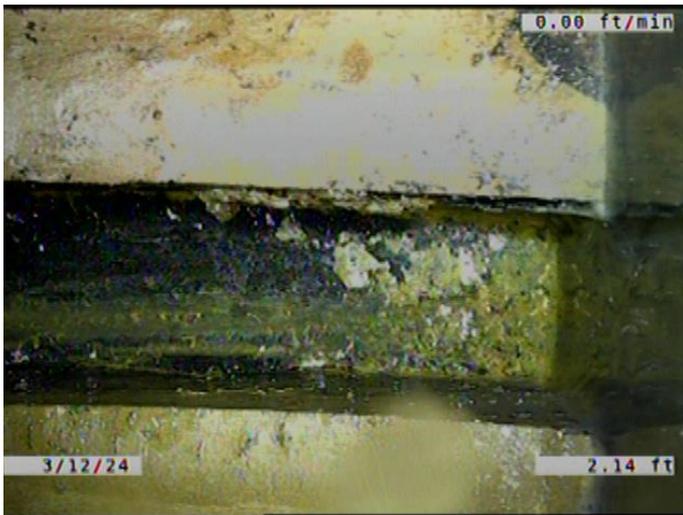
Code: **JAM**
Description: **Joint Angular Medium**

Distance (ft): **2.1**
Structural Grade: **3**
O&M Grade: **0**
Clock Start/From:
Clock To:
1st Value:
2nd Value:
Value Percent:
Continuous Index:
Within 8" of Joint: **NO**
Remarks:

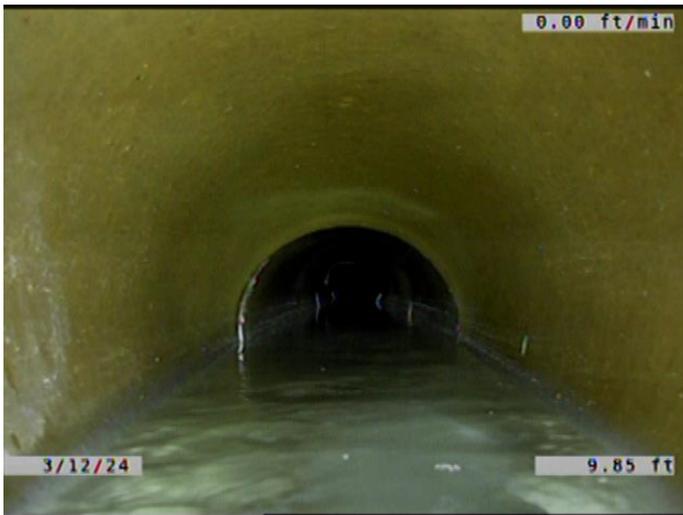
Code: **MWLS**
Description: **Miscellaneous Water Level Sag**

Distance (ft): **9.8**
Structural Grade: **3**
O&M Grade: **0**
Clock Start/From:
Clock To:
1st Value:
2nd Value:
Value Percent: **35.000**
Continuous Index: **S02**
Within 8" of Joint: **NO**
Remarks:

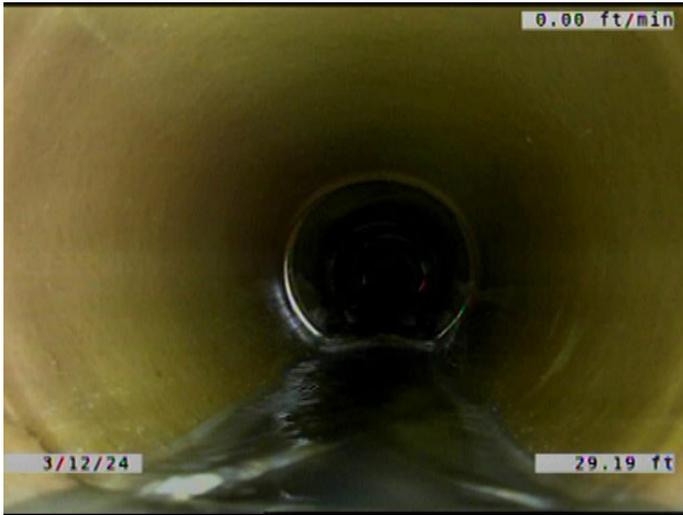
Code: **MWLS**
Description: **Miscellaneous Water Level Sag**

Distance (ft): **29.2**
Structural Grade: **3**
O&M Grade: **0**
Clock Start/From:
Clock To:
1st Value:
2nd Value:
Value Percent: **35.000**
Continuous Index: **F02**
Within 8" of Joint: **NO**
Remarks:

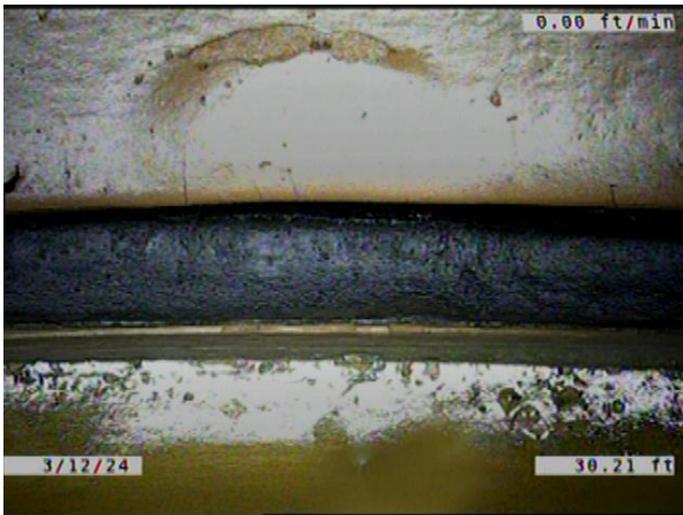
Code: **JAM**
Description: **Joint Angular Medium**

Distance (ft): **30.2**
Structural Grade: **3**
O&M Grade: **0**
Clock Start/From:
Clock To:
1st Value:
2nd Value:
Value Percent:
Continuous Index:
Within 8" of Joint: **NO**
Remarks:

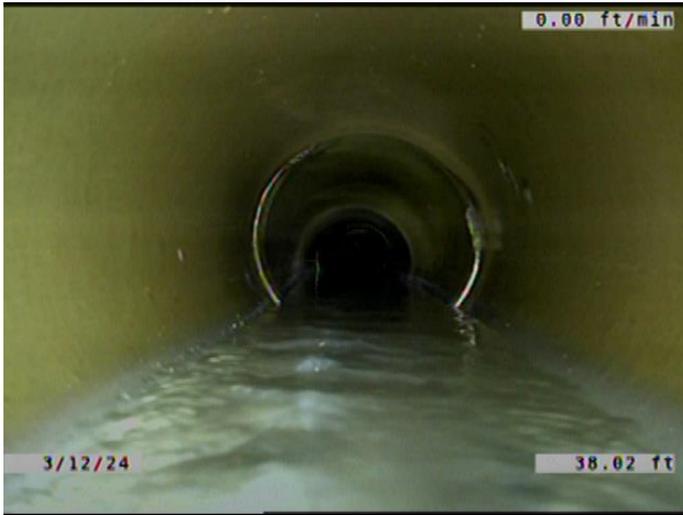
Code: **MWLS**
Description: **Miscellaneous Water Level Sag**

Distance (ft): **38.0**
Structural Grade: **2**
O&M Grade: **0**
Clock Start/From:
Clock To:
1st Value:
2nd Value:
Value Percent: **30.000**
Continuous Index: **S03**
Within 8" of Joint: **NO**
Remarks:

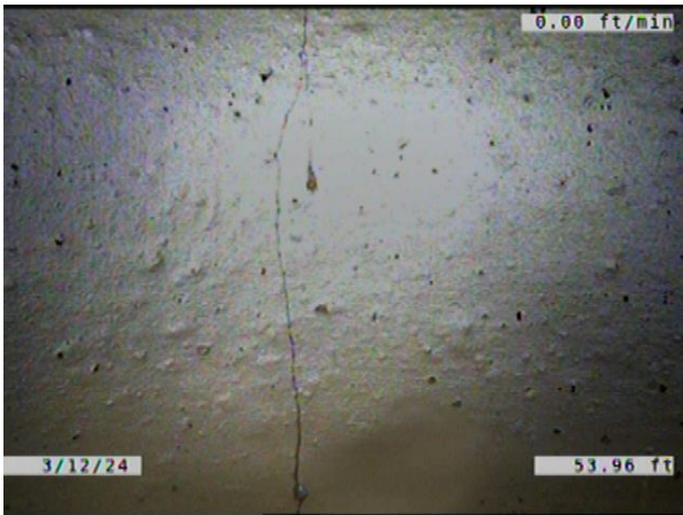
Code: **CM**
Description: **Crack Multiple**

Distance (ft): **54.0**
Structural Grade: **3**
O&M Grade: **0**
Clock Start/From: **11**
Clock To: **1**
1st Value:
2nd Value:
Value Percent:
Continuous Index: **S04**
Within 8" of Joint: **YES**
Remarks:

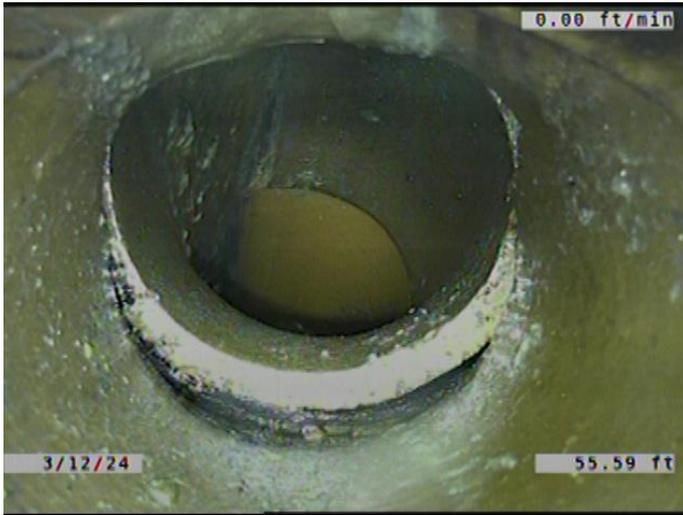
Code: **TFD**
 Description: **Tap Factory Defective**

Distance (ft): **55.6**
 Structural Grade: **0**
 O&M Grade: **3**
 Clock Start/From: **11**
 Clock To:
 1st Value: **6.000**
 2nd Value:
 Value Percent:
 Continuous Index:
 Within 8" of Joint: **YES**
 Remarks: **TAP CRACKED. SERVICE OFFSET. SOIL VISIBLE. WATER CONSTANTLY RUNN**

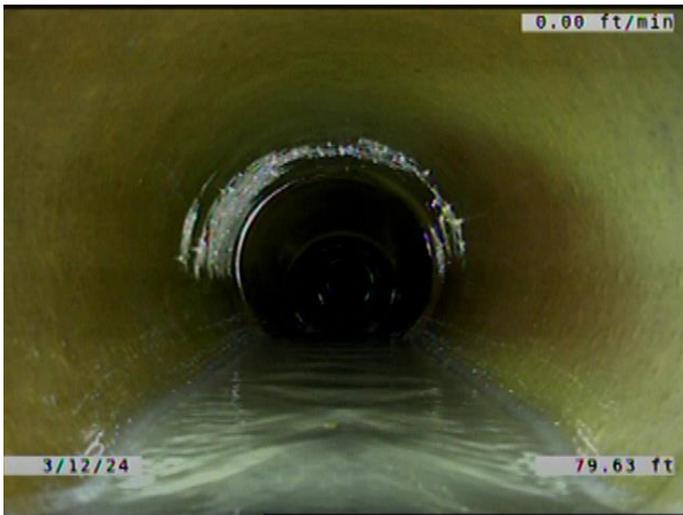
Code: **MWLS**
 Description: **Miscellaneous Water Level Sag**

Distance (ft): **79.6**
 Structural Grade: **2**
 O&M Grade: **0**
 Clock Start/From:
 Clock To:
 1st Value:
 2nd Value:
 Value Percent: **30.000**
 Continuous Index: **F03**
 Within 8" of Joint: **NO**
 Remarks:

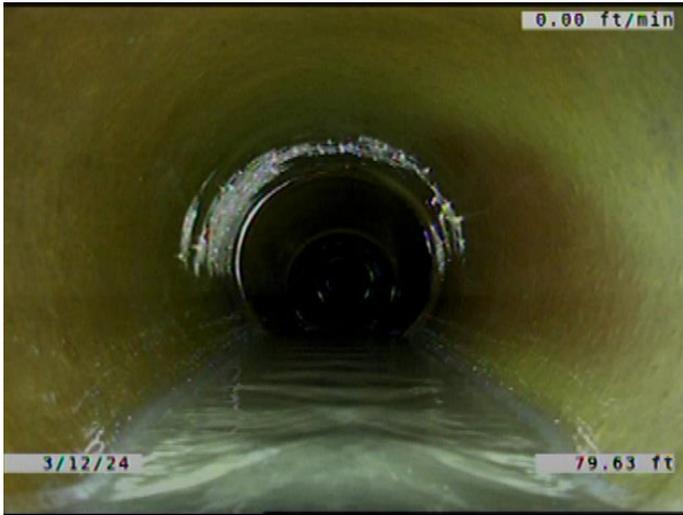
Code: **CM**
 Description: **Crack Multiple**

Distance (ft): **79.6**
 Structural Grade: **3**
 O&M Grade: **0**
 Clock Start/From: **11**
 Clock To: **1**
 1st Value:
 2nd Value:
 Value Percent:
 Continuous Index: **F04**
 Within 8" of Joint: **YES**
 Remarks:

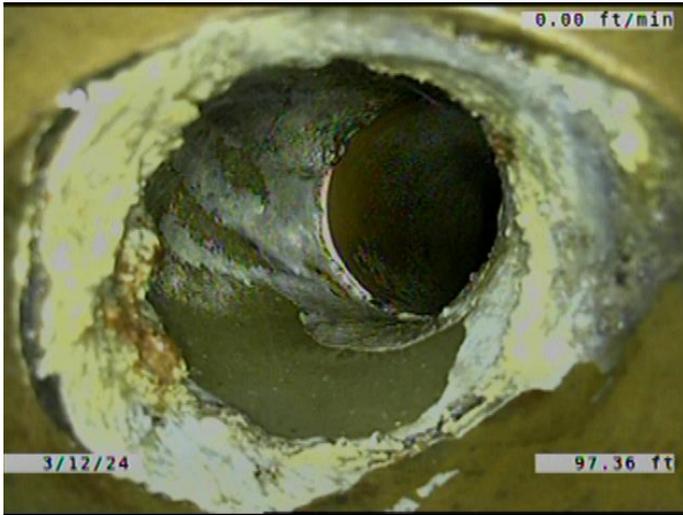
Code: **TFD**
Description: **Tap Factory Defective**

Distance (ft): **97.4**
Structural Grade: **0**
O&M Grade: **3**
Clock Start/From: **11**
Clock To:
1st Value: **6.000**
2nd Value:
Value Percent:
Continuous Index:
Within 8" of Joint: **YES**
Remarks: **ENCrustATION COMING DOWN THE SERVICE AND FROM THE SERVICE TO**

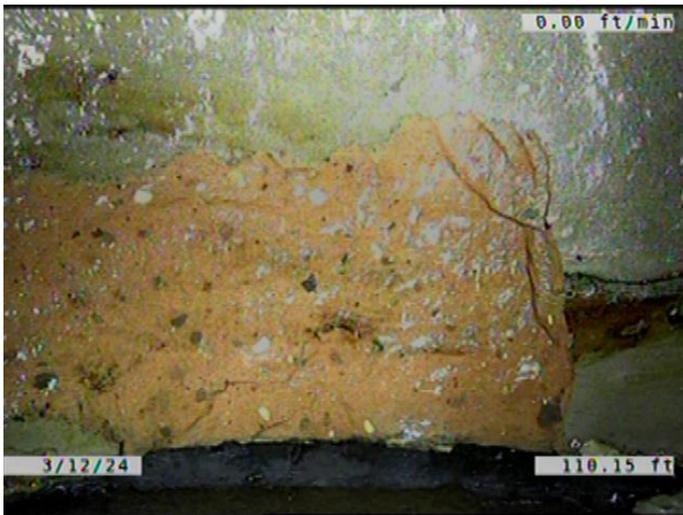
Code: **SZ**
Description: **Surface Damage Other**

Distance (ft): **110.2**
Structural Grade: **0**
O&M Grade: **0**
Clock Start/From: **8**
Clock To: **9**
1st Value:
2nd Value:
Value Percent:
Continuous Index:
Within 8" of Joint: **YES**
Remarks: **A PIECE CHIPPED OFF THE JOINT.**

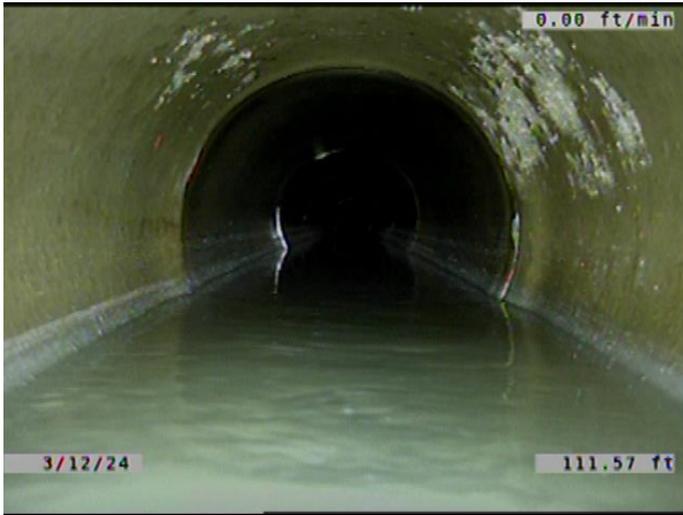
Code: **MWLS**
 Description: **Miscellaneous Water Level Sag**

Distance (ft): **111.6**
 Structural Grade: **2**
 O&M Grade: **0**
 Clock Start/From:
 Clock To:
 1st Value:
 2nd Value:
 Value Percent: **20.000**
 Continuous Index: **S05**
 Within 8" of Joint: **NO**
 Remarks:

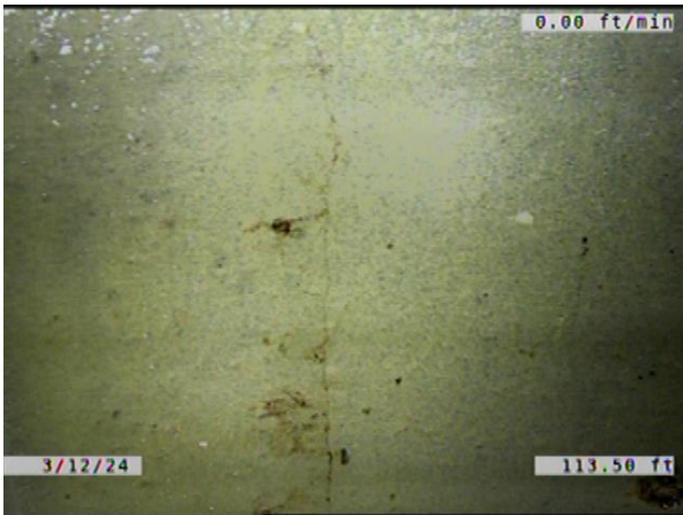
Code: **CL**
 Description: **Crack Longitudinal**

Distance (ft): **113.5**
 Structural Grade: **2**
 O&M Grade: **0**
 Clock Start/From: **9**
 Clock To:
 1st Value:
 2nd Value:
 Value Percent:
 Continuous Index:
 Within 8" of Joint: **YES**
 Remarks:

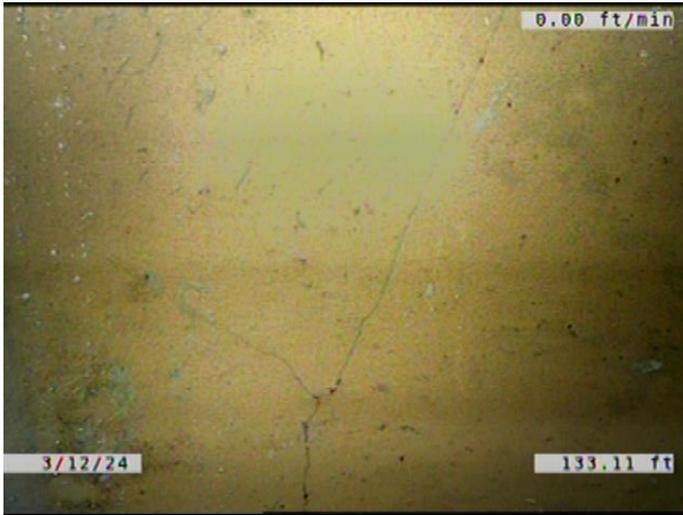
Code: **CM**
Description: **Crack Multiple**

Distance (ft): **133.1**
Structural Grade: **3**
O&M Grade: **0**
Clock Start/From: **8**
Clock To: **2**
1st Value:
2nd Value:
Value Percent:
Continuous Index:
Within 8" of Joint: **YES**
Remarks:

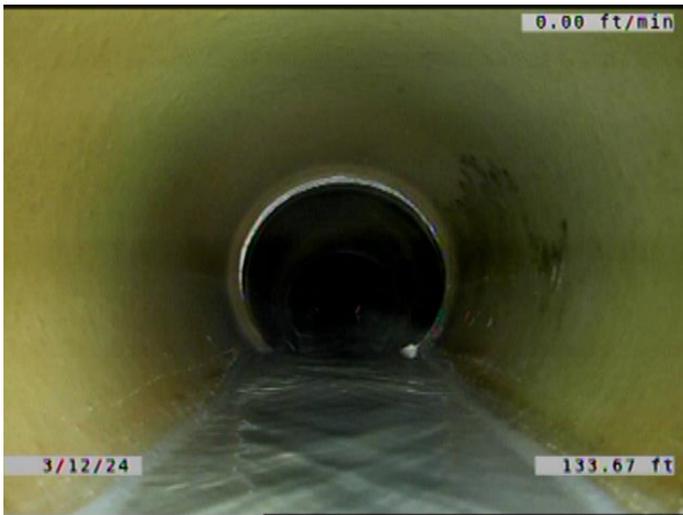
Code: **MWLS**
Description: **Miscellaneous Water Level Sag**

Distance (ft): **133.7**
Structural Grade: **2**
O&M Grade: **0**
Clock Start/From:
Clock To:
1st Value:
2nd Value:
Value Percent: **20.000**
Continuous Index: **F05**
Within 8" of Joint: **NO**
Remarks:

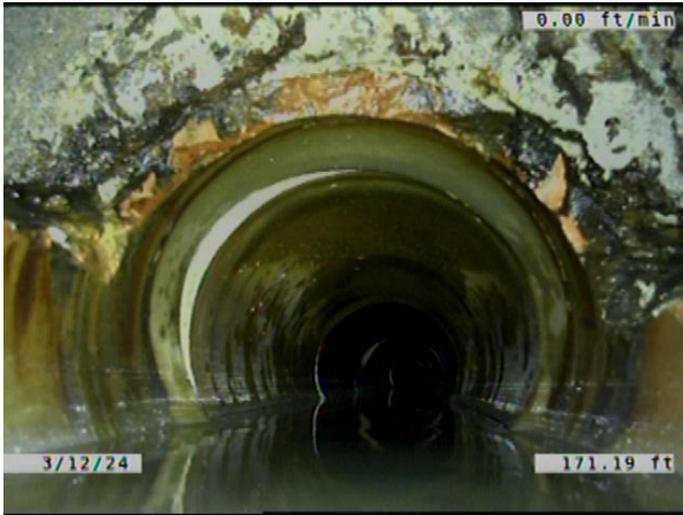
Code: **DAE**
 Description: **Deposits Attached Encrustation**

Distance (ft): **171.2**
 Structural Grade: **0**
 O&M Grade: **2**
 Clock Start/From: **8**
 Clock To: **4**
 1st Value:
 2nd Value:
 Value Percent: **5.000**
 Continuous Index: **F01**
 Within 8" of Joint: **YES**
 Remarks:
