Profile/Photo Observation Report

| Customer: | City of Hobart | Clean Date: | 02/29/2024 | Shape: | C |

| Street: | S ASH ST | Flow Control: | Not Controlled |
| US MH: | M-606-053 | DS MH: | M-606-054 |

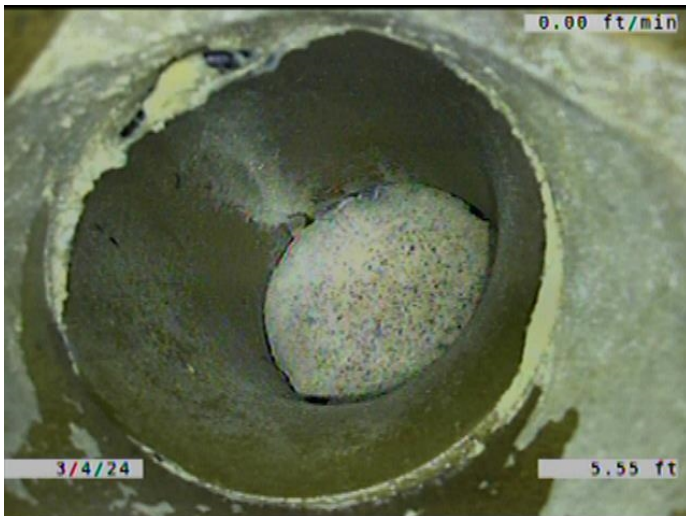
Code: **TFD**
Description: **Tap Factory Defective**

Distance (ft): **5.5**
Structural Grade: **0**
O&M Grade: **3**
Clock Start/From: **11**
Clock To:
1st Value: **6.000**
2nd Value:
Value Percent:
Continuous Index:
Within 8" of Joint: **YES**
Remarks: **CAPPED. ENCRUSTATION COMING FROM TRE SERVICE TO MAIN CONNE**

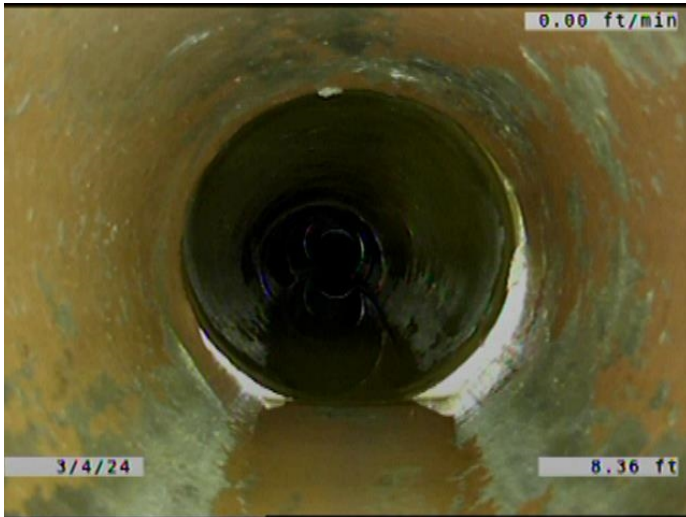
Code: **MWLS**
Description: **Miscellaneous Water Level Sag**

Distance (ft): **8.4**
Structural Grade: **2**
O&M Grade: **0**
Clock Start/From:
Clock To:
1st Value:
2nd Value:
Value Percent: **10.000**
Continuous Index: **S01**
Within 8" of Joint: **NO**
Remarks:

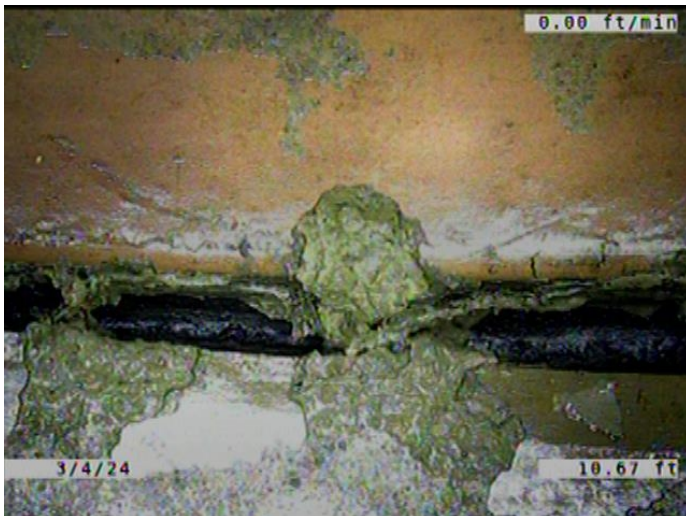
Code: **DAE**
Description: **Deposits Attached Encrustation**

Distance (ft): **10.7**
Structural Grade: **0**
O&M Grade: **2**
Clock Start/From: **7**
Clock To: **5**
1st Value:
2nd Value:
Value Percent: **5.000**
Continuous Index: **S02**
Within 8" of Joint: **YES**
Remarks:

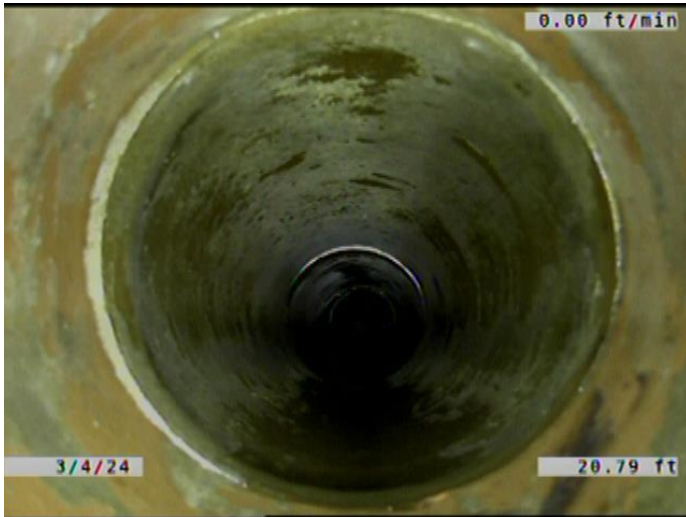
Code: **MWLS**
Description: **Miscellaneous Water Level Sag**

Distance (ft): **20.8**
Structural Grade: **2**
O&M Grade: **0**
Clock Start/From:
Clock To:
1st Value:
2nd Value:
Value Percent: **10.000**
Continuous Index: **F01**
Within 8" of Joint: **NO**
Remarks:

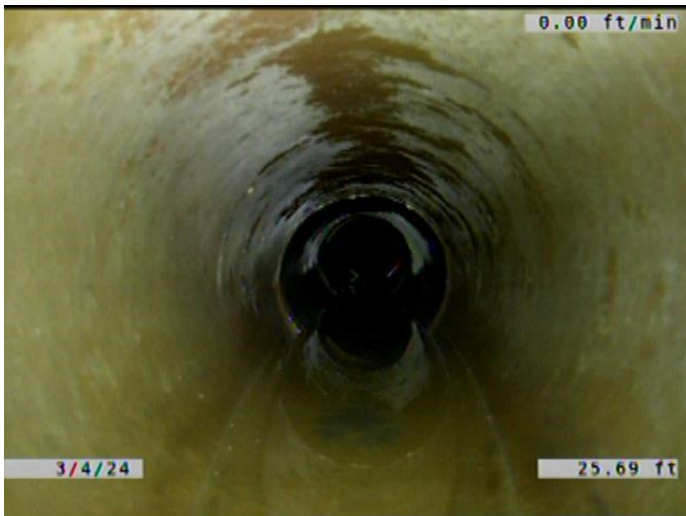
Code: **MWLS**
Description: **Miscellaneous Water Level Sag**

Distance (ft): **25.7**
Structural Grade: **2**
O&M Grade: **0**
Clock Start/From:
Clock To:
1st Value:
2nd Value:
Value Percent: **10.000**
Continuous Index: **S03**
Within 8" of Joint: **NO**
Remarks:

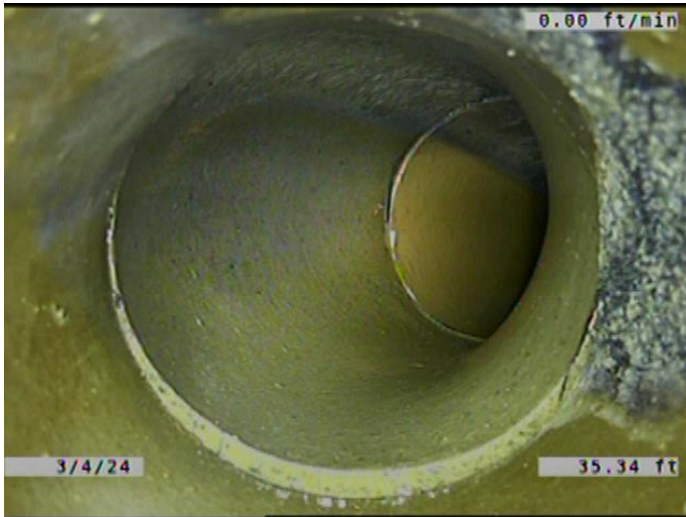
Code: **TFD**
Description: **Tap Factory Defective**

Distance (ft): **35.3**
Structural Grade: **0**
O&M Grade: **3**
Clock Start/From: **11**
Clock To:
1st Value: **6.000**
2nd Value:
Value Percent:
Continuous Index:
Within 8" of Joint: **YES**
Remarks: **ACTIVITY. ENCRUSTATION COMING FROM THE SERVICE TO MAIN CONN**

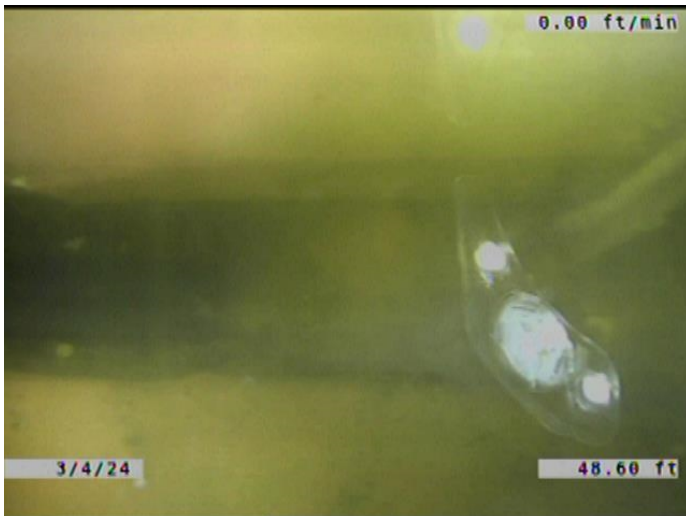
Code: **JAM**
Description: **Joint Angular Medium**

Distance (ft): **48.6**
Structural Grade: **3**
O&M Grade: **0**
Clock Start/From:
Clock To:
1st Value:
2nd Value:
Value Percent:
Continuous Index:
Within 8" of Joint: **NO**
Remarks:

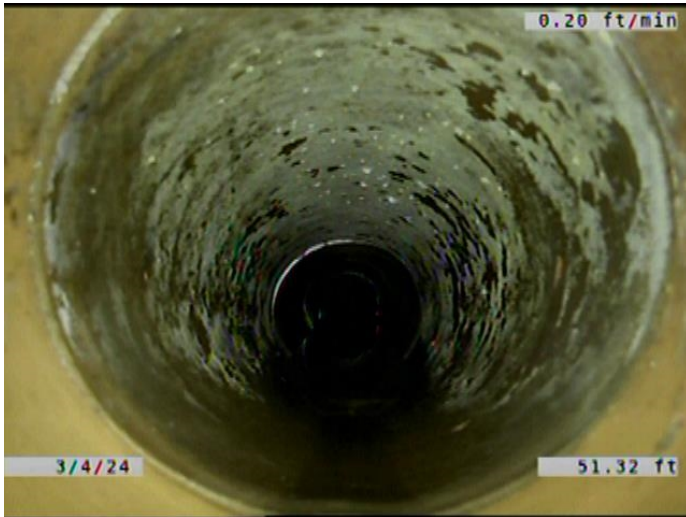
Code: **MWLS**
Description: **Miscellaneous Water Level Sag**

Distance (ft): **51.3**
Structural Grade: **2**
O&M Grade: **0**
Clock Start/From:
Clock To:
1st Value:
2nd Value:
Value Percent: **10.000**
Continuous Index: **F03**
Within 8" of Joint: **NO**
Remarks:

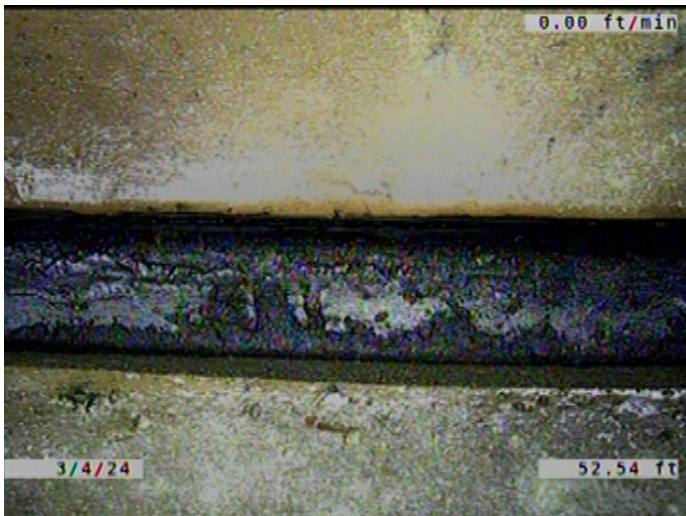
Code: **JAM**
Description: **Joint Angular Medium**

Distance (ft): **52.5**
Structural Grade: **3**
O&M Grade: **0**
Clock Start/From:
Clock To:
1st Value:
2nd Value:
Value Percent:
Continuous Index:
Within 8" of Joint: **NO**
Remarks:

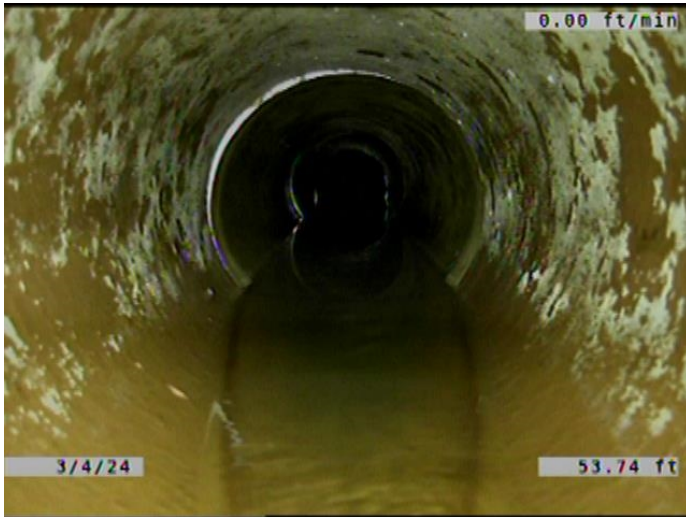
Code: **MWLS**
Description: **Miscellaneous Water Level Sag**

Distance (ft): **53.7**
Structural Grade: **2**
O&M Grade: **0**
Clock Start/From:
Clock To:
1st Value:
2nd Value:
Value Percent: **15.000**
Continuous Index: **S04**
Within 8" of Joint: **NO**
Remarks:

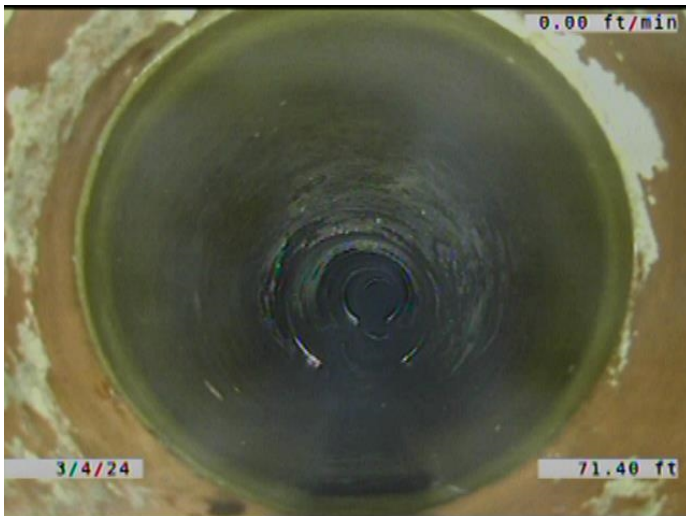
Code: **MWLS**
Description: **Miscellaneous Water Level Sag**

Distance (ft): **71.4**
Structural Grade: **2**
O&M Grade: **0**
Clock Start/From:
Clock To:
1st Value:
2nd Value:
Value Percent: **15.000**
Continuous Index: **F04**
Within 8" of Joint: **NO**
Remarks:

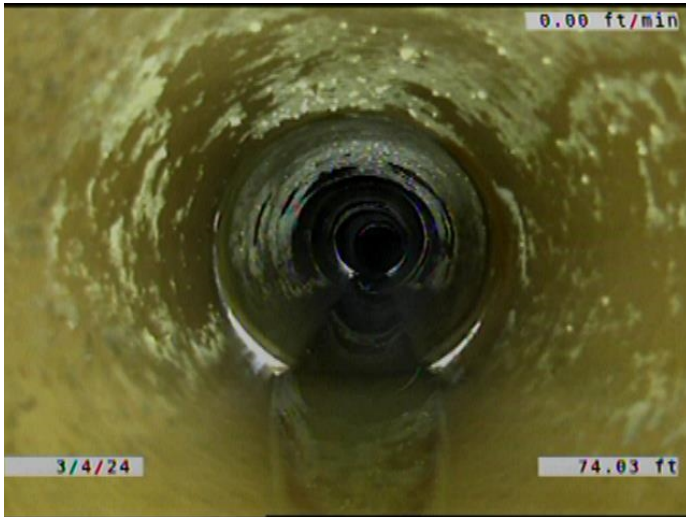
Code: **MWLS**
Description: **Miscellaneous Water Level Sag**

Distance (ft): **74.0**
Structural Grade: **2**
O&M Grade: **0**
Clock Start/From:
Clock To:
1st Value:
2nd Value:
Value Percent: **5.000**
Continuous Index: **S05**
Within 8" of Joint: **NO**
Remarks:

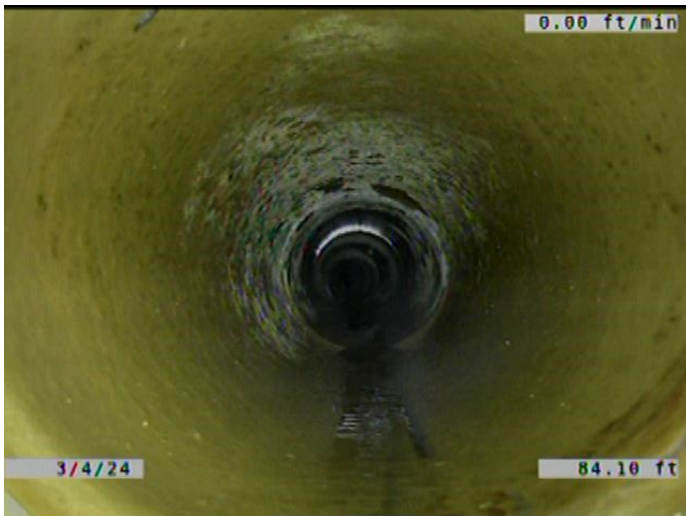
Code: **MWLS**
Description: **Miscellaneous Water Level Sag**

Distance (ft): **84.1**
Structural Grade: **2**
O&M Grade: **0**
Clock Start/From:
Clock To:
1st Value:
2nd Value:
Value Percent: **5.000**
Continuous Index: **F05**
Within 8" of Joint: **NO**
Remarks:

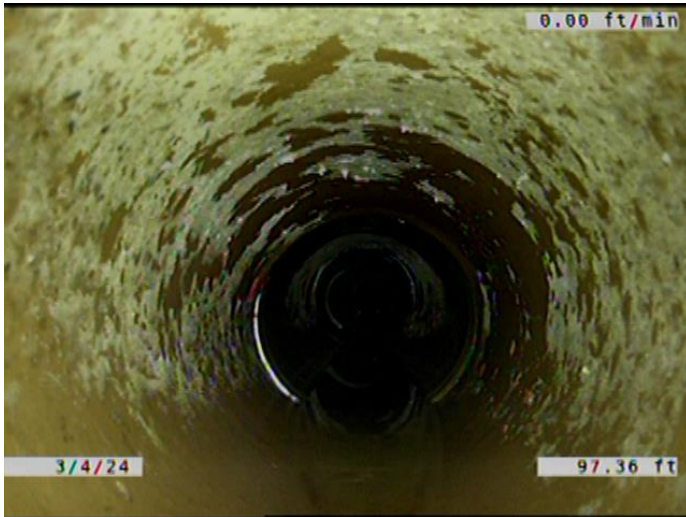
Code: **MWLS**
Description: **Miscellaneous Water Level Sag**

Distance (ft): **97.4**
Structural Grade: **2**
O&M Grade: **0**
Clock Start/From:
Clock To:
1st Value:
2nd Value:
Value Percent: **5.000**
Continuous Index: **S06**
Within 8" of Joint: **NO**
Remarks:

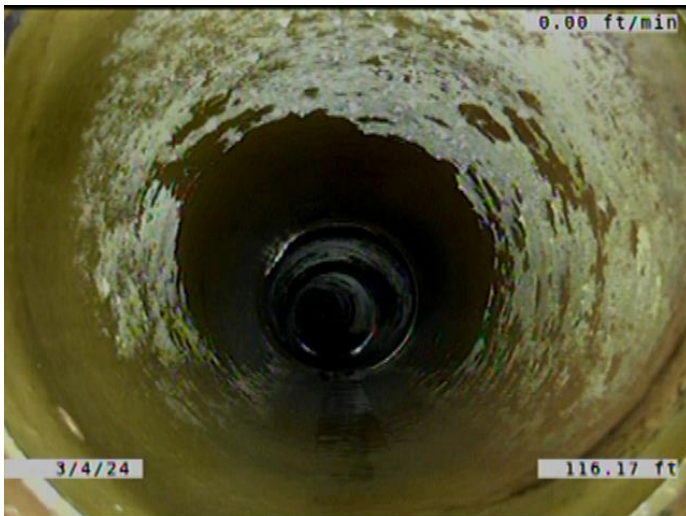
Code: **MWLS**
Description: **Miscellaneous Water Level Sag**

Distance (ft): **116.2**
Structural Grade: **2**
O&M Grade: **0**
Clock Start/From:
Clock To:
1st Value:
2nd Value:
Value Percent: **5.000**
Continuous Index: **F06**
Within 8" of Joint: **NO**
Remarks:

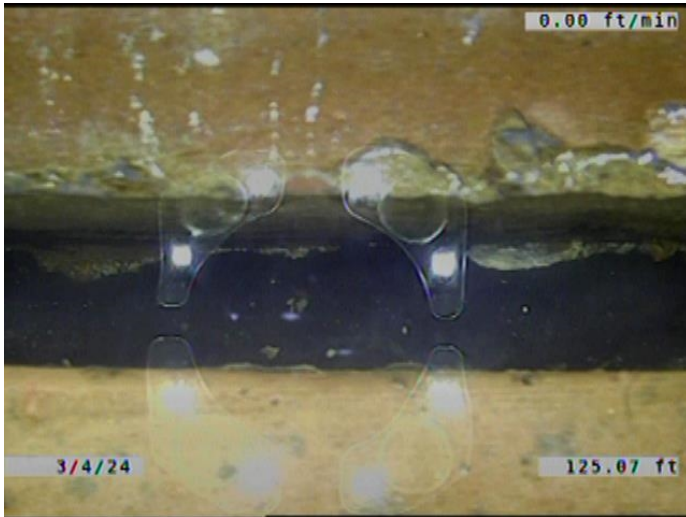
Code: **JAM**
Description: **Joint Angular Medium**

Distance (ft): **125.1**
Structural Grade: **3**
O&M Grade: **0**
Clock Start/From:
Clock To:
1st Value:
2nd Value:
Value Percent:
Continuous Index:
Within 8" of Joint: **NO**
Remarks:

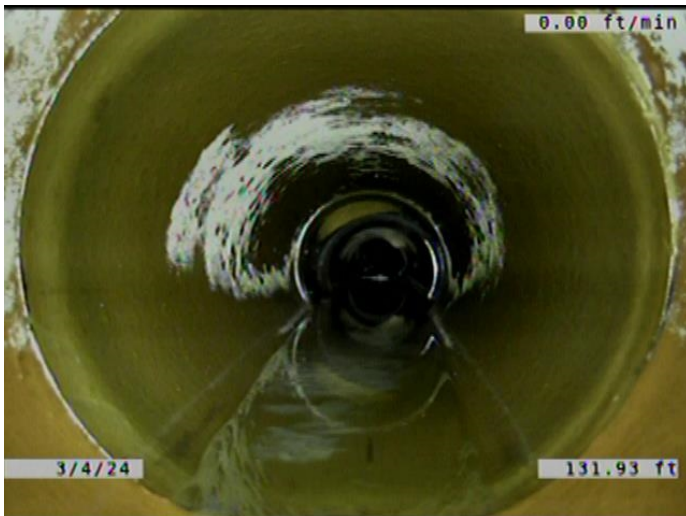
Code: **MWLS**
Description: **Miscellaneous Water Level Sag**

Distance (ft): **131.9**
Structural Grade: **2**
O&M Grade: **0**
Clock Start/From:
Clock To:
1st Value:
2nd Value:
Value Percent: **15.000**
Continuous Index: **S07**
Within 8" of Joint: **NO**
Remarks:

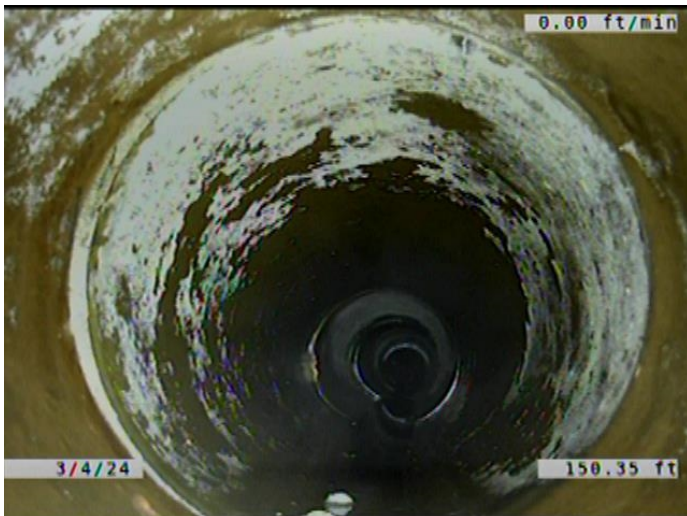
Code: **MWLS**
Description: **Miscellaneous Water Level Sag**

Distance (ft): **150.3**
Structural Grade: **2**
O&M Grade: **0**
Clock Start/From:
Clock To:
1st Value:
2nd Value:
Value Percent: **15.000**
Continuous Index: **F07**
Within 8" of Joint: **NO**
Remarks:

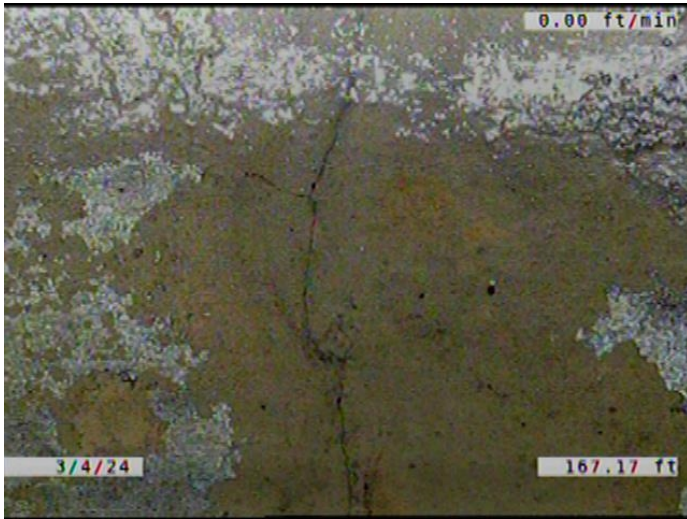
Code: **CM**
Description: **Crack Multiple**

Distance (ft): **167.2**
Structural Grade: **3**
O&M Grade: **0**
Clock Start/From: **11**
Clock To: **2**
1st Value:
2nd Value:
Value Percent:
Continuous Index:
Within 8" of Joint: **YES**
Remarks:

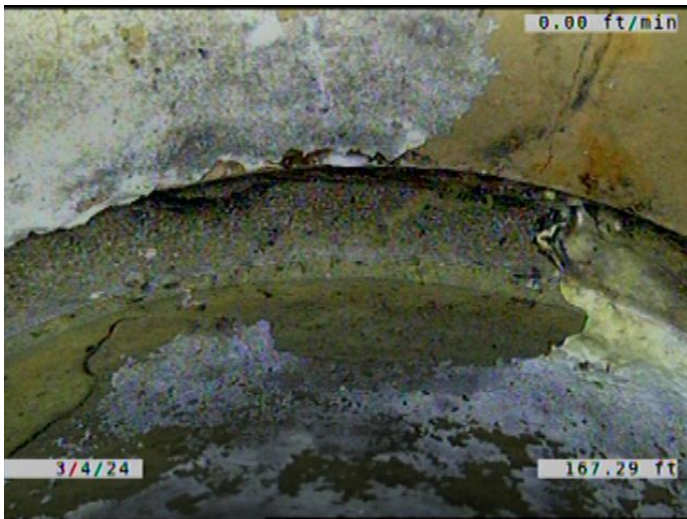
Code: **JOMD**
Description: **Joint Offset Medium Defective**

Distance (ft): **167.3**
Structural Grade: **3**
O&M Grade: **0**
Clock Start/From:
Clock To:
1st Value:
2nd Value:
Value Percent:
Continuous Index:
Within 8" of Joint: **NO**
Remarks:

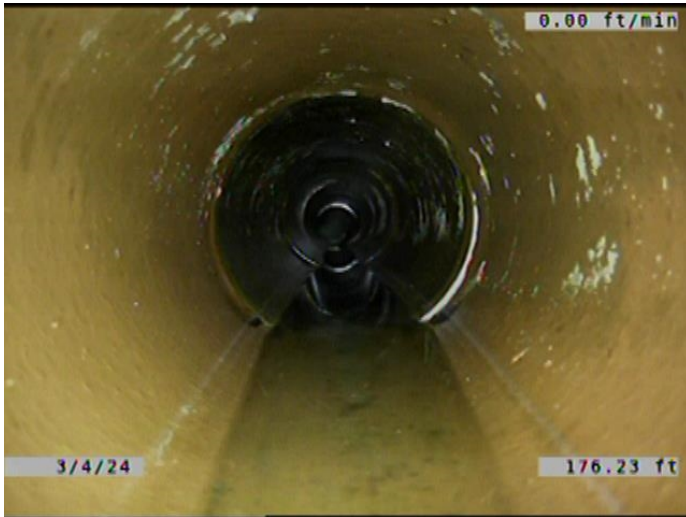
Code: **MWLS**
Description: **Miscellaneous Water Level Sag**

Distance (ft): **176.2**
Structural Grade: **2**
O&M Grade: **0**
Clock Start/From:
Clock To:
1st Value:
2nd Value:
Value Percent: **5.000**
Continuous Index: **S08**
Within 8" of Joint: **NO**
Remarks:

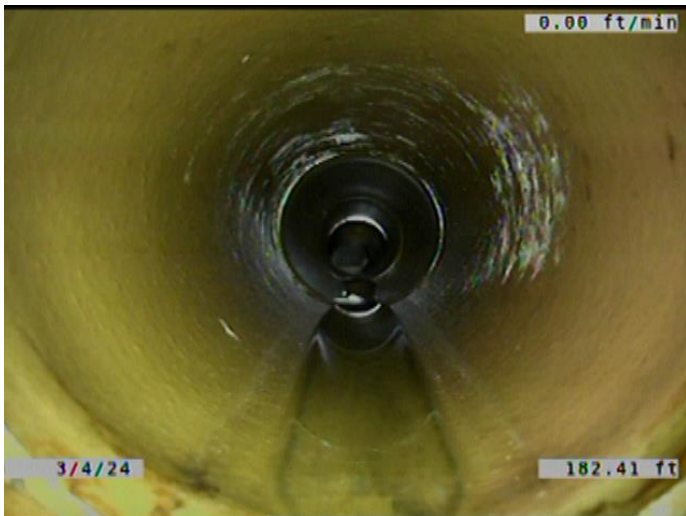
Code: **MWLS**
Description: **Miscellaneous Water Level Sag**

Distance (ft): **182.4**
Structural Grade: **2**
O&M Grade: **0**
Clock Start/From:
Clock To:
1st Value:
2nd Value:
Value Percent: **5.000**
Continuous Index: **F08**
Within 8" of Joint: **NO**
Remarks:

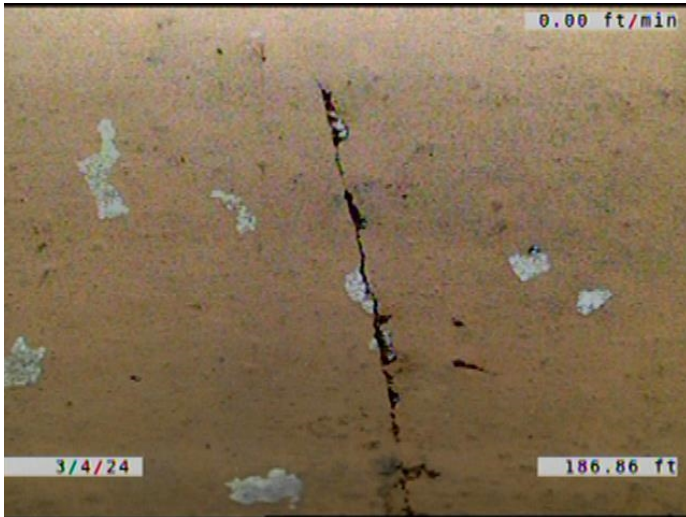
Code: **CL**
Description: **Crack Longitudinal**

Distance (ft): **186.9**
Structural Grade: **2**
O&M Grade: **0**
Clock Start/From: **1**
Clock To:
1st Value:
2nd Value:
Value Percent:
Continuous Index:
Within 8" of Joint: **YES**
Remarks:

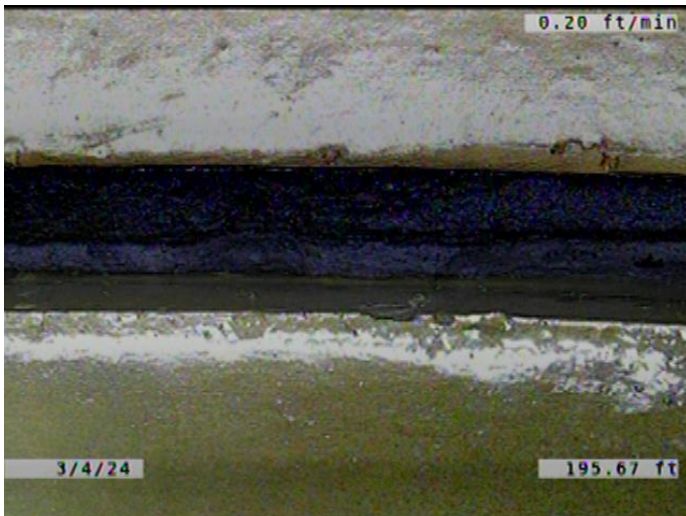
Code: **JAM**
Description: **Joint Angular Medium**

Distance (ft): **195.7**
Structural Grade: **3**
O&M Grade: **0**
Clock Start/From:
Clock To:
1st Value:
2nd Value:
Value Percent:
Continuous Index:
Within 8" of Joint: **NO**
Remarks:

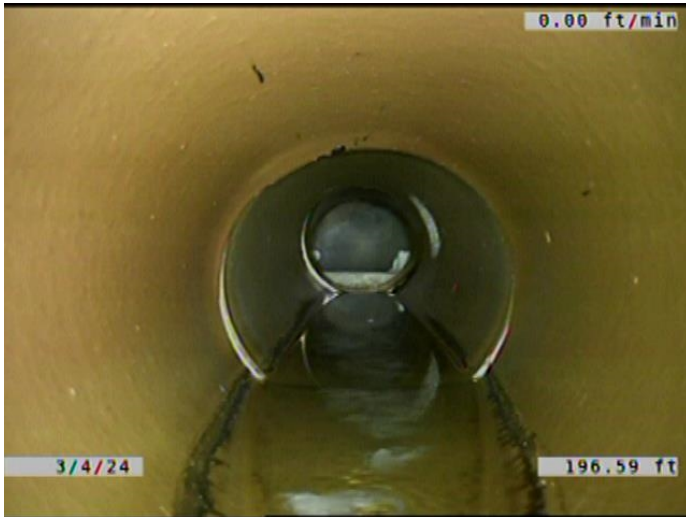
Code: **MWLS**
Description: **Miscellaneous Water Level Sag**

Distance (ft): **196.6**
Structural Grade: **2**
O&M Grade: **0**
Clock Start/From:
Clock To:
1st Value:
2nd Value:
Value Percent: **10.000**
Continuous Index: **S09**
Within 8" of Joint: **NO**
Remarks:

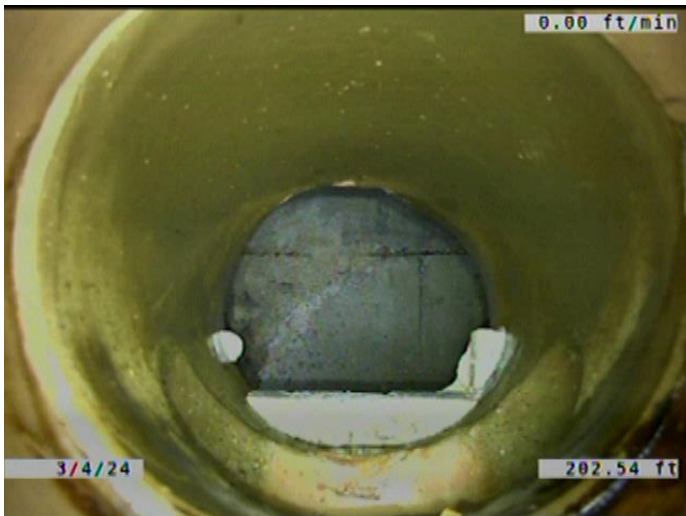
Code: **MWLS**
Description: **Miscellaneous Water Level Sag**

Distance (ft): **202.5**
Structural Grade: **2**
O&M Grade: **0**
Clock Start/From:
Clock To:
1st Value:
2nd Value:
Value Percent: **10.000**
Continuous Index: **F09**
Within 8" of Joint: **NO**
Remarks:

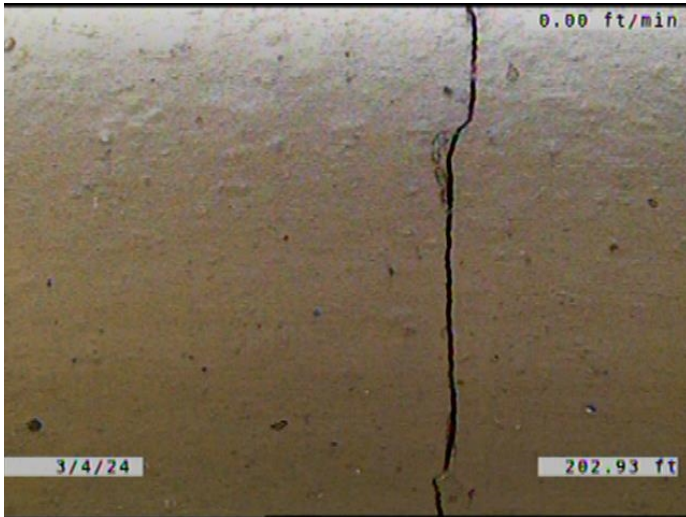
Code: **CL**
Description: **Crack Longitudinal**

Distance (ft): **202.9**
Structural Grade: **2**
O&M Grade: **0**
Clock Start/From: **11**
Clock To:
1st Value:
2nd Value:
Value Percent:
Continuous Index:
Within 8" of Joint: **YES**
Remarks:

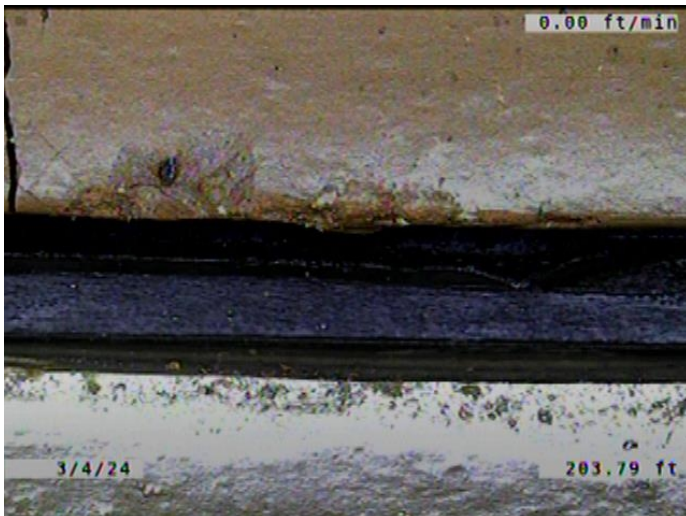
Code: **JAM**
Description: **Joint Angular Medium**

Distance (ft): **203.8**
Structural Grade: **3**
O&M Grade: **0**
Clock Start/From:
Clock To:
1st Value:
2nd Value:
Value Percent:
Continuous Index:
Within 8" of Joint: **NO**
Remarks:

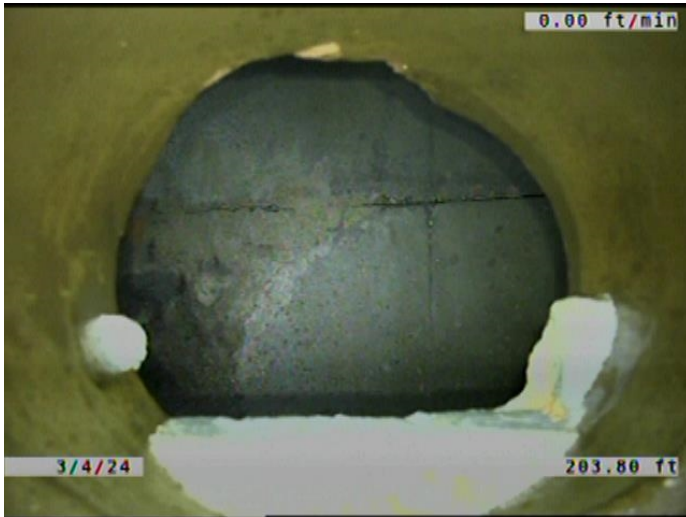
Code: **DAE**
 Description: **Deposits Attached Encrustation**

Distance (ft): **203.8**
 Structural Grade: **0**
 O&M Grade: **2**
 Clock Start/From: **7**
 Clock To: **5**
 1st Value:
 2nd Value:
 Value Percent: **5.000**
 Continuous Index: **F02**
 Within 8" of Joint: **YES**
 Remarks:
