## Profile/Photo Observation Report

Date:	<b>03/04/2024</b>	Weather:		Coding:	<b>PACP 7.0</b>
Pipe Length (ft):	<b>153.0</b>	Owner:	<b>City of Hobart</b>	Pre Clean:	<b>Heavy Cleaning</b>
P.O.#:		Surveyor:	<b>S. Bucklin</b>	PSR:	<b>P-606-062-053</b>
Customer:	<b>City of Hobart</b>	Clean Date:	<b>02/24/2024</b>	Shape:	<b>C</b>

Street:	<b>W 7TH PL</b>	Flow Control:	<b>Not Controlled</b>
City:	<b>Hobart, IN</b>	Year Renewed:	
Location:	<b>Local rural streets with light traffic, t</b>	Tape/Media #:	
Purpose:	<b>Sewer System Evaluation Survey (SS</b>	Dia/Height:	<b>12"</b>
Use:	<b>Sanitary Sewage Pipe</b>	Material:	<b>VCP</b>
Drain Area:		Lining:	<b>None</b>
Category:	<b>NA</b>		
Comment:			
Location Details:		Direction of Survey:	<b>Downstream</b>
US MH:	<b>M-606-053</b>	DS MH:	<b>M-606-062</b>
		Total Length Surveyed (ft):	<b>151.2</b>

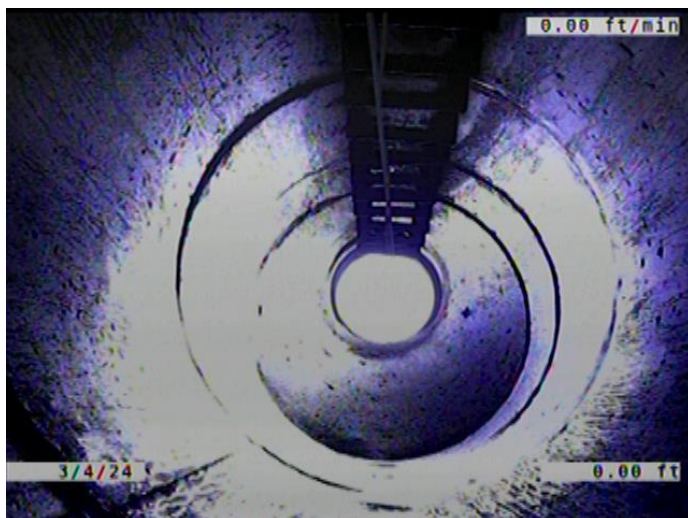
Code: **AMH**  
Description: **Manhole**

Distance (ft): **.0**  
Structural Grade: **0**  
O&M Grade: **0**  
Clock Start/From:  
Clock To:  
1st Value:  
2nd Value:  
Value Percent:  
Continuous Index:  
Within 8" of Joint: **NO**  
Remarks: **M-606-053**

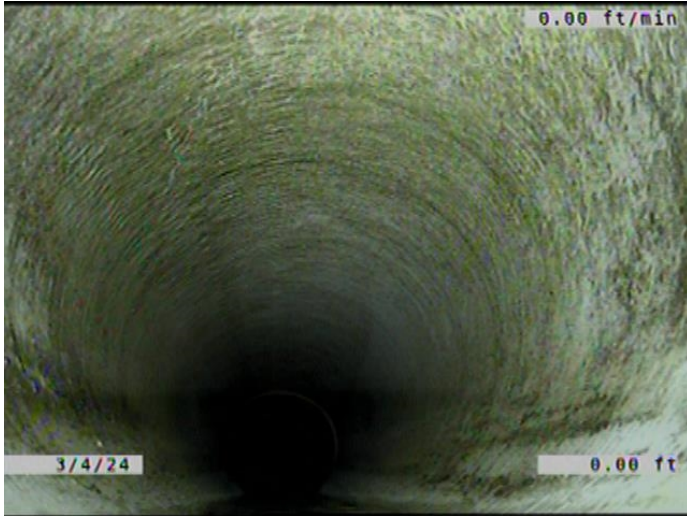
Code:	<b>MWL</b>
Description:	<b>Miscellaneous Water Level</b>
Distance (ft):	<b>.0</b>
Structural Grade:	<b>0</b>
O&M Grade:	<b>0</b>
Clock Start/From:	
Clock To:	
1st Value:	
2nd Value:	
Value Percent:	<b>5.000</b>
Continuous Index:	
Within 8" of Joint:	<b>NO</b>
Remarks:

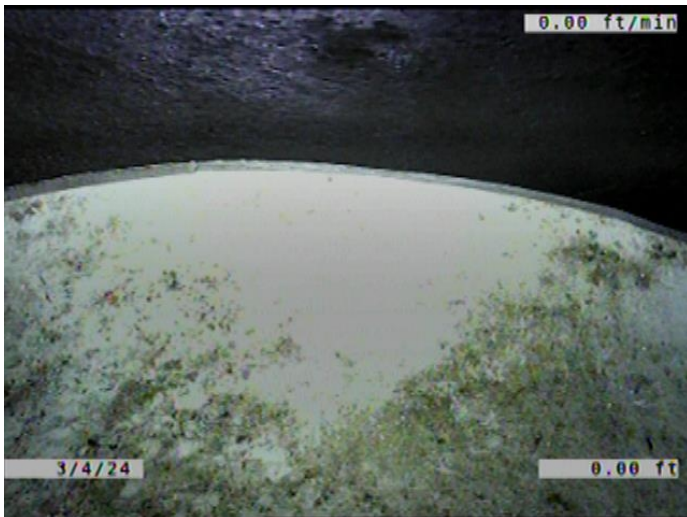
Code:	<b>RPR</b>
Description:	<b>Point Repair Replacement</b>
Distance (ft):	<b>.0</b>
Structural Grade:	<b>0</b>
O&M Grade:	<b>0</b>
Clock Start/From:	
Clock To:	
1st Value:	
2nd Value:	
Value Percent:	
Continuous Index:	<b>S01</b>
Within 8" of Joint:	<b>YES</b>
Remarks:	<b>REPLACED WITH PVC.</b>

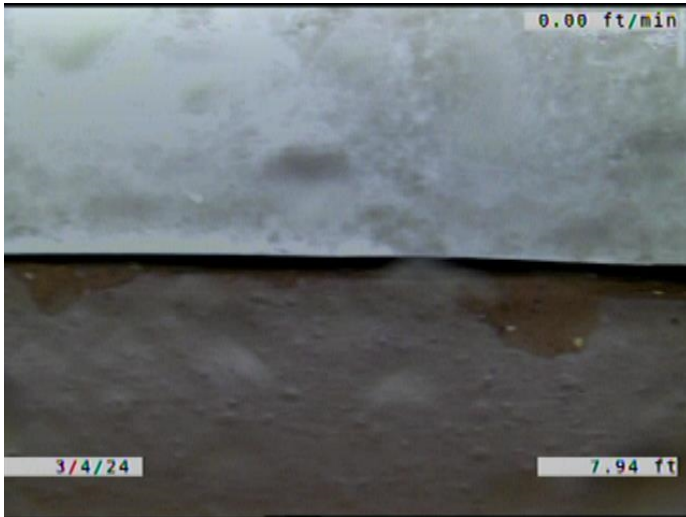
Code: **RPR**  
Description: **Point Repair Replacement**

Distance (ft): **7.9**  
Structural Grade: **0**  
O&M Grade: **0**  
Clock Start/From:  
Clock To:  
1st Value:  
2nd Value:  
Value Percent:  
Continuous Index: **F01**  
Within 8" of Joint: **YES**  
Remarks: **REPLACED WITH PVC.**

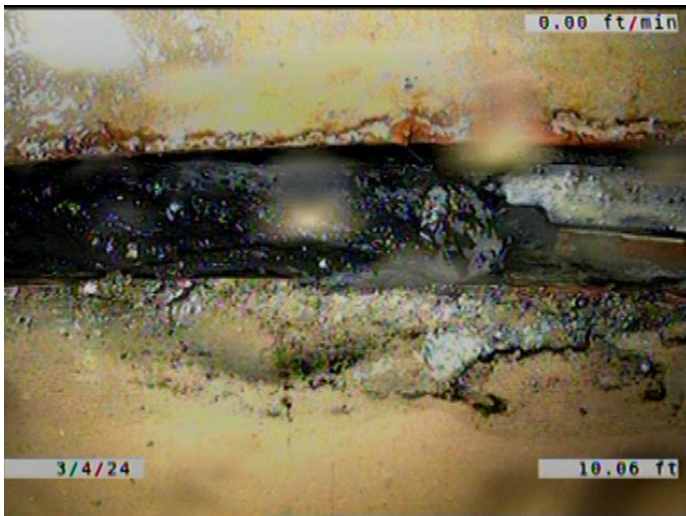
Code: **DAE**  
Description: **Deposits Attached Encrustation**

Distance (ft): **10.1**  
Structural Grade: **0**  
O&M Grade: **2**  
Clock Start/From: **7**  
Clock To: **5**  
1st Value:  
2nd Value:  
Value Percent: **5.000**  
Continuous Index: **S02**  
Within 8" of Joint: **YES**  
Remarks:

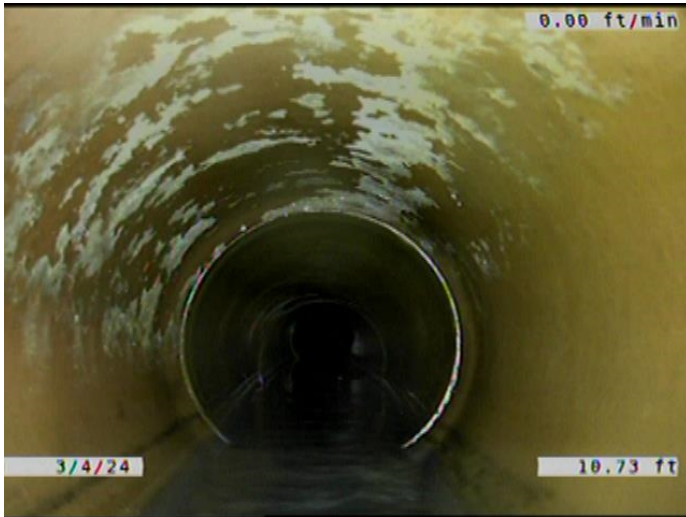
Code: **MWLS**  
Description: **Miscellaneous Water Level Sag**

Distance (ft): **10.7**  
Structural Grade: **2**  
O&M Grade: **0**  
Clock Start/From:  
Clock To:  
1st Value:  
2nd Value:  
Value Percent: **15.000**  
Continuous Index: **S03**  
Within 8" of Joint: **NO**  
Remarks:

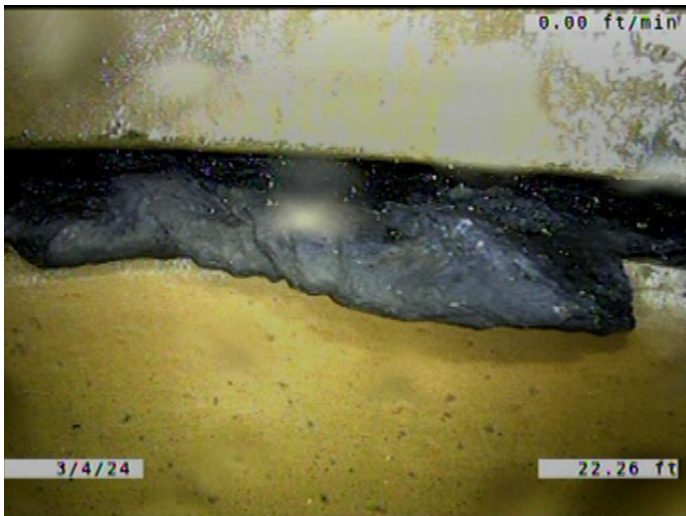
Code: **ISSR**  
Description: **Intruding Sealing Material Sealing Ring**

Distance (ft): **22.3**  
Structural Grade: **0**  
O&M Grade: **2**  
Clock Start/From: **2**  
Clock To: **3**  
1st Value:  
2nd Value:  
Value Percent: **5.000**  
Continuous Index:  
Within 8" of Joint: **NO**  
Remarks:

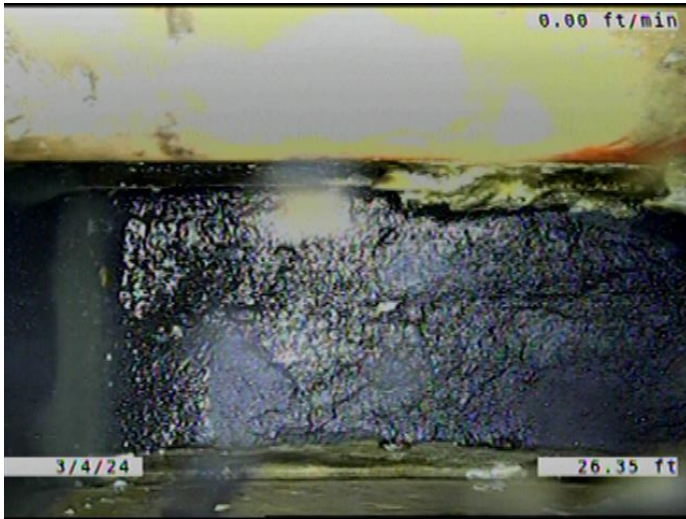
Code: **JSM**  
Description: **Joint Separated Medium**

Distance (ft): **26.4**  
Structural Grade: **3**  
O&M Grade: **0**  
Clock Start/From:  
Clock To:  
1st Value:  
2nd Value:  
Value Percent:  
Continuous Index:  
Within 8" of Joint: **NO**  
Remarks:

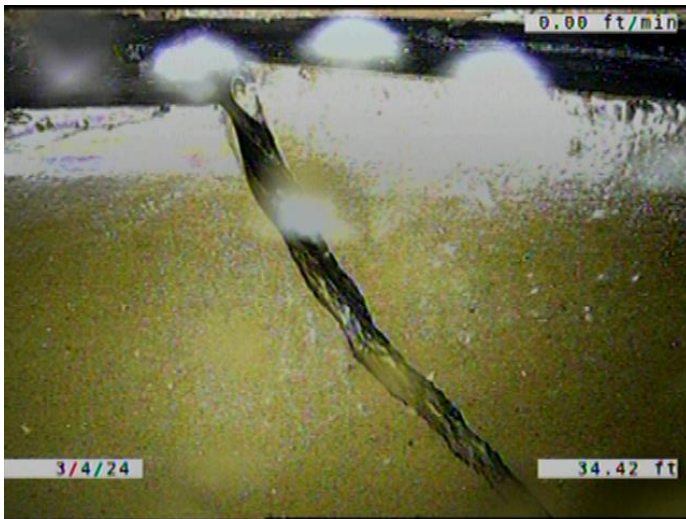
Code: **B**  
Description: **Broken**

Distance (ft): **34.4**  
Structural Grade: **4**  
O&M Grade: **0**  
Clock Start/From: **10**  
Clock To: **1**  
1st Value:  
2nd Value:  
Value Percent:  
Continuous Index:  
Within 8" of Joint: **YES**  
Remarks:

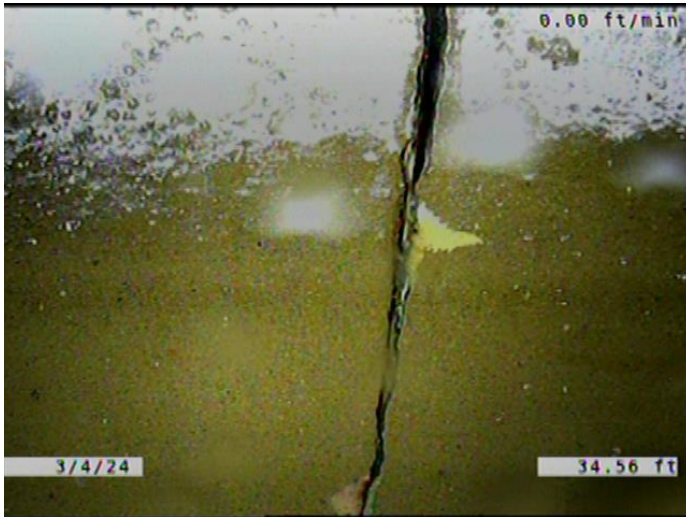
Code: **IWB**  
Description: **Infiltration Weeper Barrel**

Distance (ft): **34.6**  
Structural Grade: **0**  
O&M Grade: **2**  
Clock Start/From: **12**  
Clock To: **1**  
1st Value:  
2nd Value:  
Value Percent:  
Continuous Index:  
Within 8" of Joint: **YES**  
Remarks:

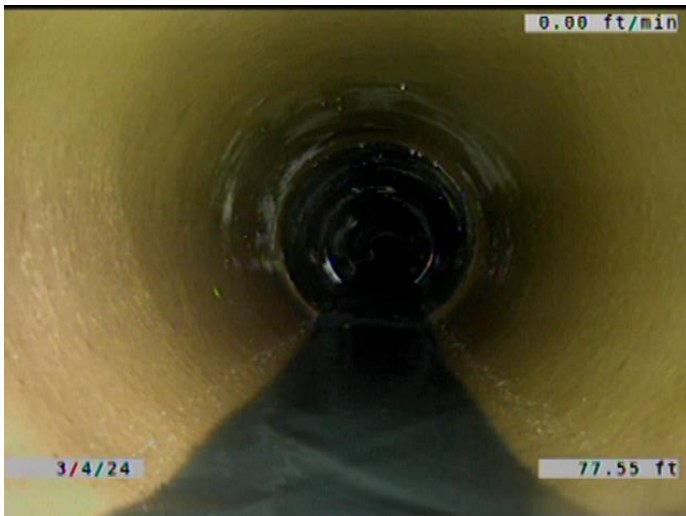
Code: **MWLS**  
Description: **Miscellaneous Water Level Sag**

Distance (ft): **77.6**  
Structural Grade: **2**  
O&M Grade: **0**  
Clock Start/From:  
Clock To:  
1st Value:  
2nd Value:  
Value Percent: **15.000**  
Continuous Index: **F03**  
Within 8" of Joint: **NO**  
Remarks:

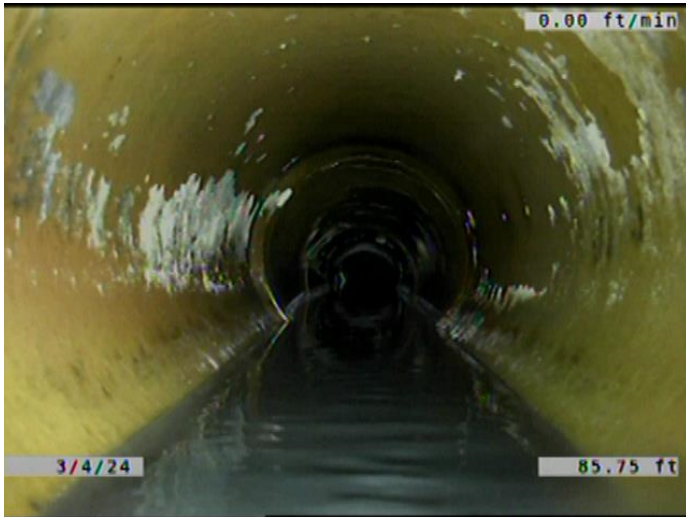
Code: **MWLS**  
Description: **Miscellaneous Water Level Sag**

Distance (ft): **85.7**  
Structural Grade: **2**  
O&M Grade: **0**  
Clock Start/From:  
Clock To:  
1st Value:  
2nd Value:  
Value Percent: **20.000**  
Continuous Index: **S04**  
Within 8" of Joint: **NO**  
Remarks:

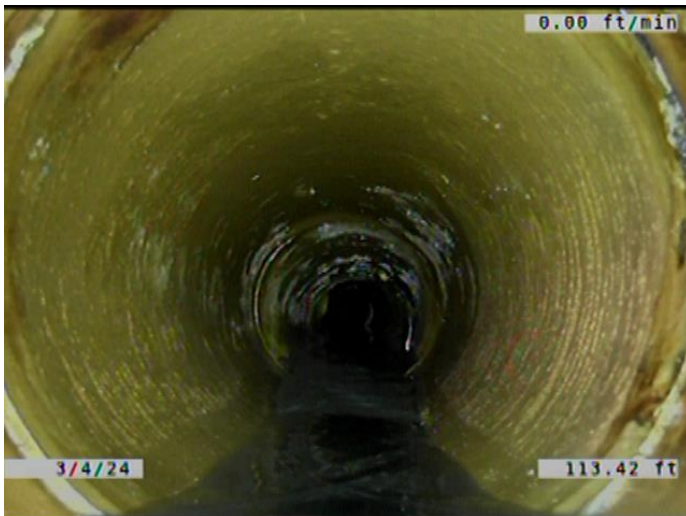
Code: **MWLS**  
Description: **Miscellaneous Water Level Sag**

Distance (ft): **113.4**  
Structural Grade: **2**  
O&M Grade: **0**  
Clock Start/From:  
Clock To:  
1st Value:  
2nd Value:  
Value Percent: **20.000**  
Continuous Index: **F04**  
Within 8" of Joint: **NO**  
Remarks:

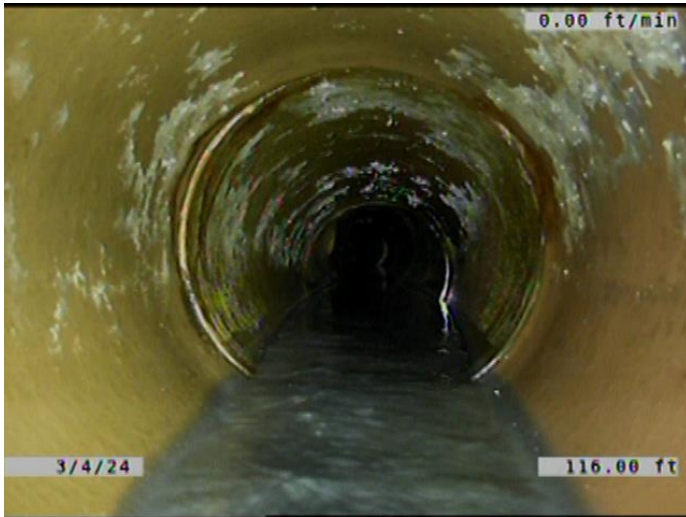
Code: **MWLS**  
 Description: **Miscellaneous Water Level Sag**

Distance (ft): **116.0**  
 Structural Grade: **2**  
 O&M Grade: **0**  
 Clock Start/From:  
 Clock To:  
 1st Value:  
 2nd Value:  
 Value Percent: **15.000**  
 Continuous Index: **S05**  
 Within 8" of Joint: **NO**  
 Remarks:

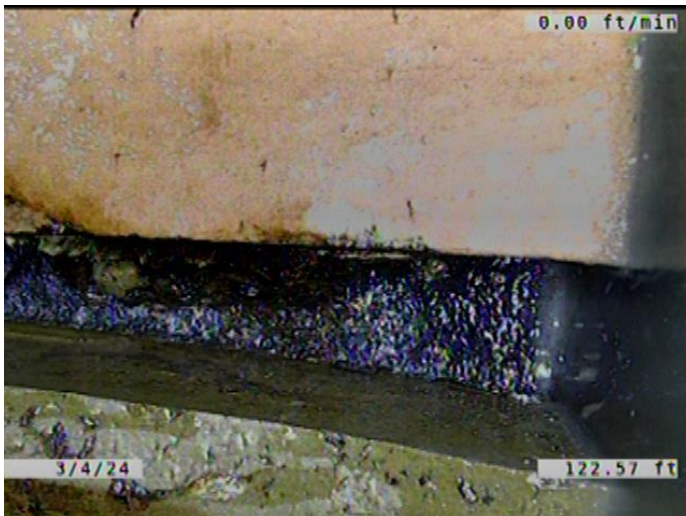
Code: **JAM**  
 Description: **Joint Angular Medium**

Distance (ft): **122.6**  
 Structural Grade: **3**  
 O&M Grade: **0**  
 Clock Start/From:  
 Clock To:  
 1st Value:  
 2nd Value:  
 Value Percent:  
 Continuous Index:  
 Within 8" of Joint: **NO**  
 Remarks:

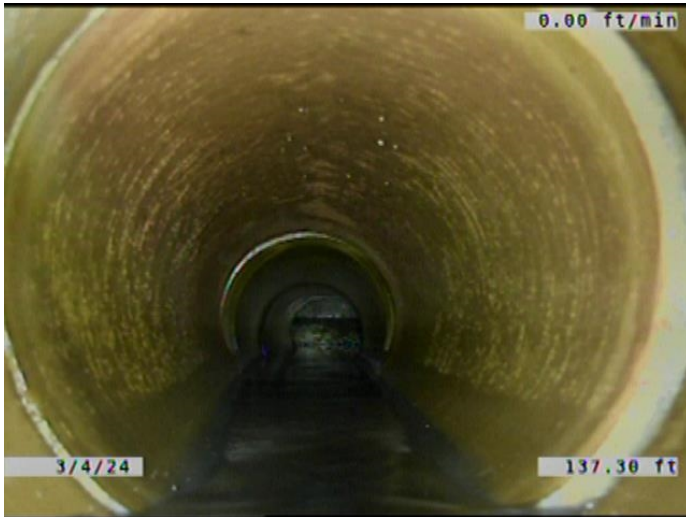
Code: **MWLS**  
Description: **Miscellaneous Water Level Sag**

Distance (ft): **137.3**  
Structural Grade: **2**  
O&M Grade: **0**  
Clock Start/From:  
Clock To:  
1st Value:  
2nd Value:  
Value Percent: **15.000**  
Continuous Index: **F05**  
Within 8" of Joint: **NO**  
Remarks:

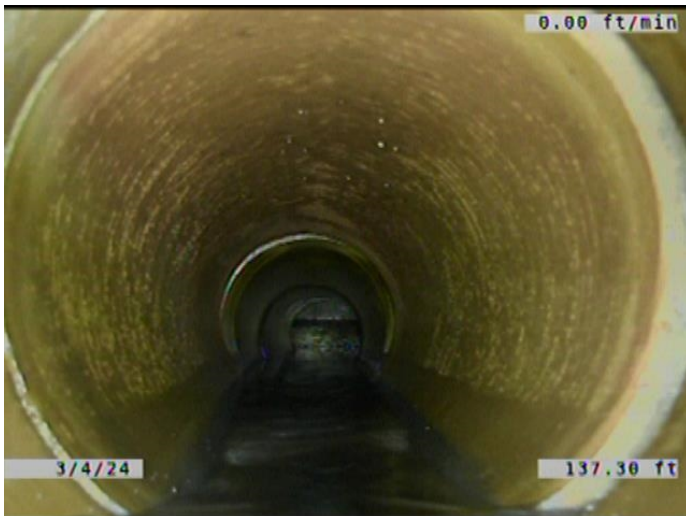
Code: **LL**  
Description: **Line Left**

Distance (ft): **137.3**  
Structural Grade: **0**  
O&M Grade: **1**  
Clock Start/From:  
Clock To:  
1st Value:  
2nd Value:  
Value Percent: **5.000**  
Continuous Index:  
Within 8" of Joint: **NO**  
Remarks:

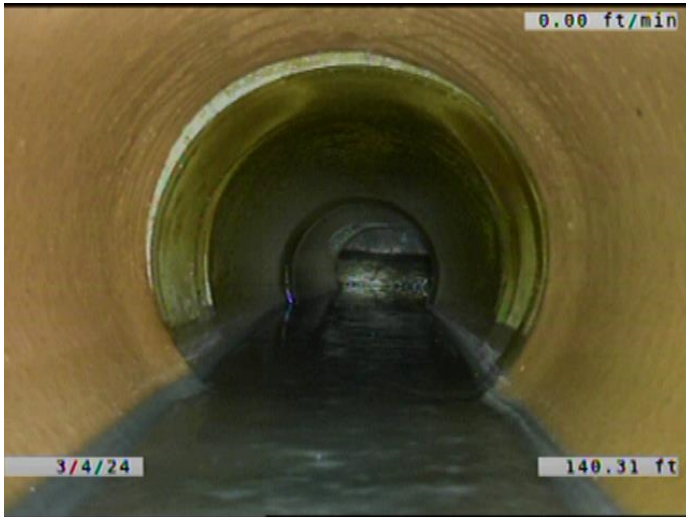
Code:	MWL
Description:	Miscellaneous Water Level
Distance (ft):	140.3
Structural Grade:	0
O&M Grade:	0
Clock Start/From:	
Clock To:	
1st Value:	
2nd Value:	
Value Percent:	15.000
Continuous Index:	
Within 8" of Joint:	NO
Remarks:

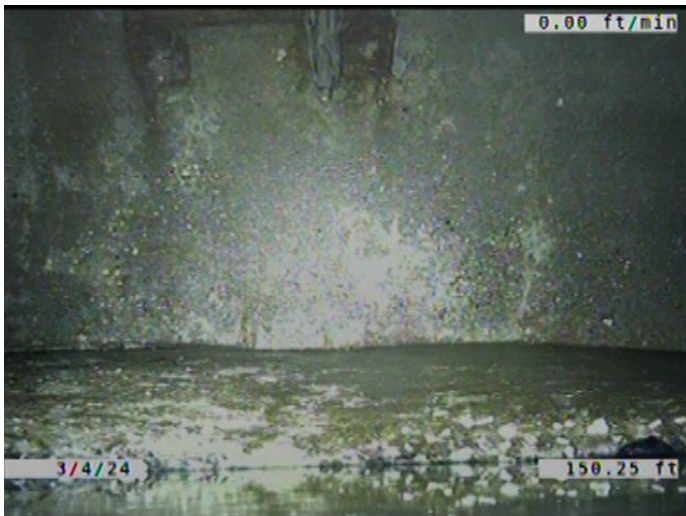
Code:	DAE
Description:	Deposits Attached Encrustation
Distance (ft):	150.2
Structural Grade:	0
O&M Grade:	2
Clock Start/From:	7
Clock To:	5
1st Value:	
2nd Value:	
Value Percent:	5.000
Continuous Index:	F02
Within 8" of Joint:	YES
Remarks:

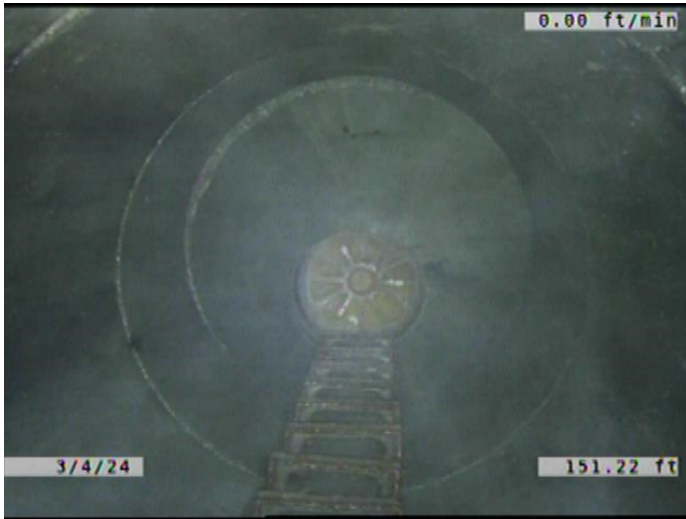
Code:	AMH
Description:	Manhole
Distance (ft):	151.2
Structural Grade:	0
O&M Grade:	0
Clock Start/From:	
Clock To:	
1st Value:	
2nd Value:	
Value Percent:	
Continuous Index:	
Within 8" of Joint:	NO
Remarks:	M-606-062
