Profile/Photo Observation Report

Date:	05/07/2018	Weather:		Coding:	PACP 6.0
Pipe Length (ft):		Owner:	City of Hobart	Pre Clean:	No Pre-Cleaning
P.O.#:	619	Surveyor:	M. Pielacha	PSR:	P-606-055-051
Customer:	City of Hobart	Clean Date:		Shape:	C

Street:	Off of 8th Street	Flow Control:	Not Controlled
City:	Hobart, IN	Year Renewed:	
Location:	Sidewalk	Tape/Media #:	DEP 619
Purpose:	Routine Assessment	Dia/Height:	18"
Use:	Sanitary	Material:	VCP
Drain Area:		Lining:	
Category:	NA		
Comment:	5-21-2018		
Location Details:		Direction of Survey:	Downstream
US MH:	M-606-055	DS MH:	M-606-051
		Total Length Surveyed (ft):	390.6

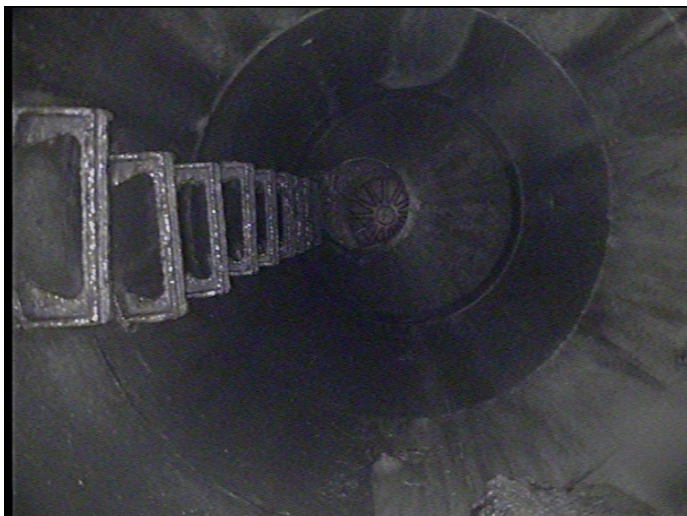
Code: **AMH**
 Description: **Manhole**

Distance (ft): **.0**
 Structural Grade: **0**
 O&M Grade: **0**
 Clock Start/From:
 Clock To:
 1st Value:
 2nd Value:
 Value Percent:
 Continuous Index:
 Within 8" of Joint: **NO**
 Remarks: **M-606-055**

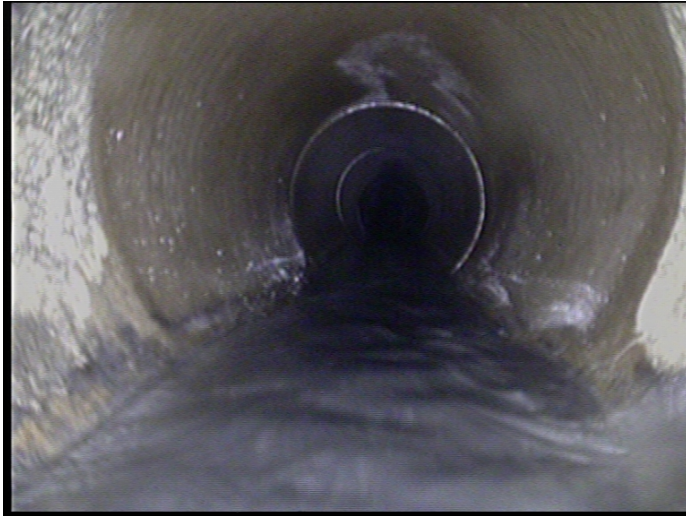
Code: **MWL**
Description: **Water Level**

Distance (ft): **.0**
Structural Grade: **0**
O&M Grade: **0**
Clock Start/From:
Clock To:
1st Value:
2nd Value:
Value Percent: **10.000**
Continuous Index:
Within 8" of Joint: **NO**
Remarks:

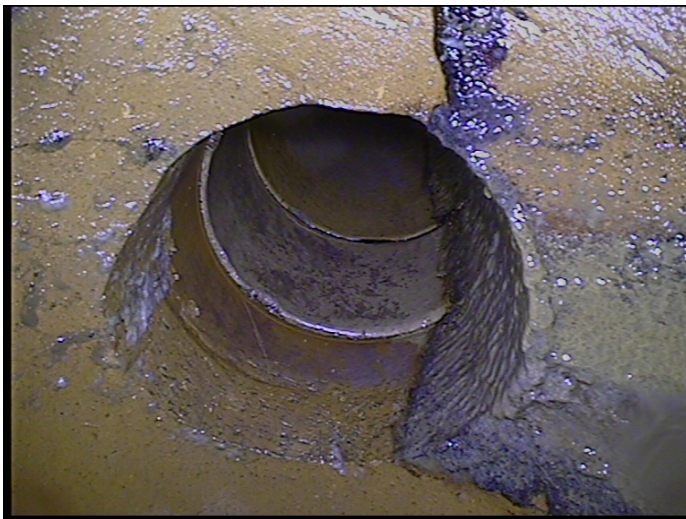
Code: **TF**
Description: **Tap Factory**

Distance (ft): **84.5**
Structural Grade: **0**
O&M Grade: **0**
Clock Start/From: **2**
Clock To:
1st Value: **4.000**
2nd Value:
Value Percent:
Continuous Index:
Within 8" of Joint: **NO**
Remarks:

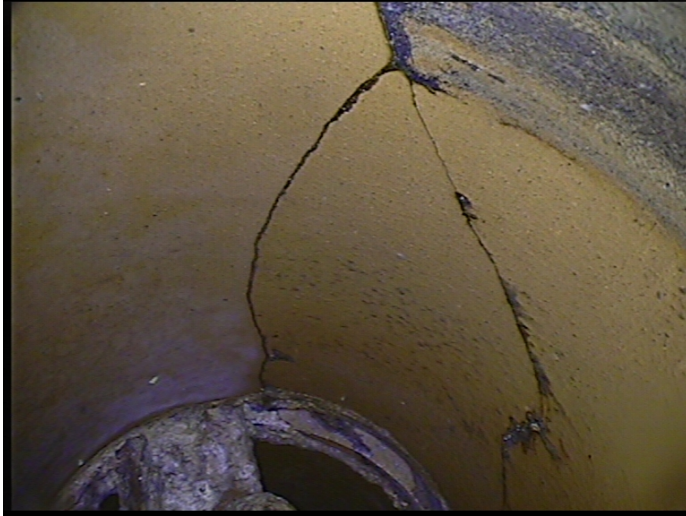
Code:	CM
Description:	Crack Multiple
Distance (ft):	84.5
Structural Grade:	3
O&M Grade:	0
Clock Start/From:	1
Clock To:	3
1st Value:	
2nd Value:	
Value Percent:	
Continuous Index:	
Within 8" of Joint:	YES
Remarks:

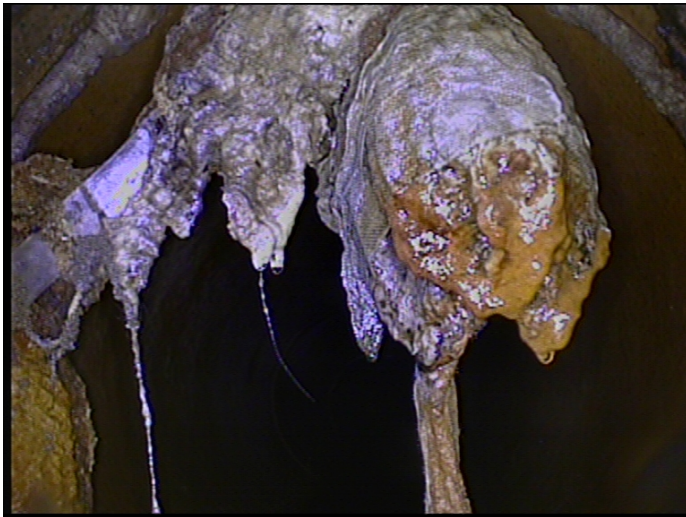
Code:	DAE
Description:	Deposits Attached Encrustation
Distance (ft):	86.2
Structural Grade:	0
O&M Grade:	3
Clock Start/From:	8
Clock To:	2
1st Value:	
2nd Value:	
Value Percent:	20.000
Continuous Index:	
Within 8" of Joint:	YES
Remarks:

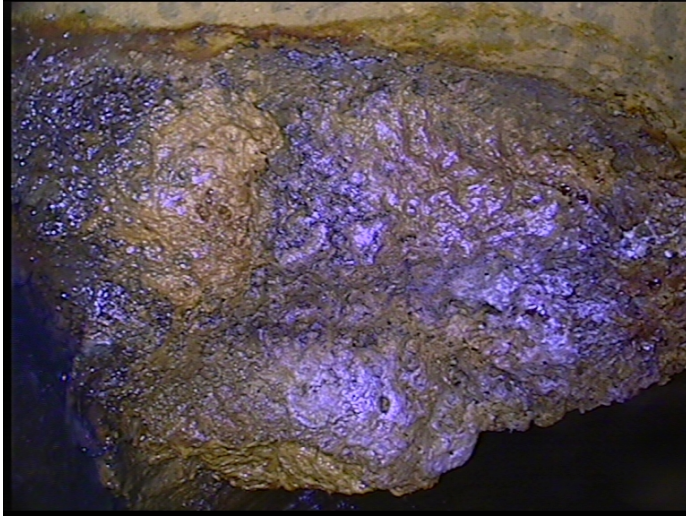
Code: **DAE**
Description: **Deposits Attached Encrustation**

Distance (ft): **131.8**
Structural Grade: **0**
O&M Grade: **2**
Clock Start/From: **7**
Clock To: **10**
1st Value:
2nd Value:
Value Percent: **10.000**
Continuous Index:
Within 8" of Joint: **YES**
Remarks:

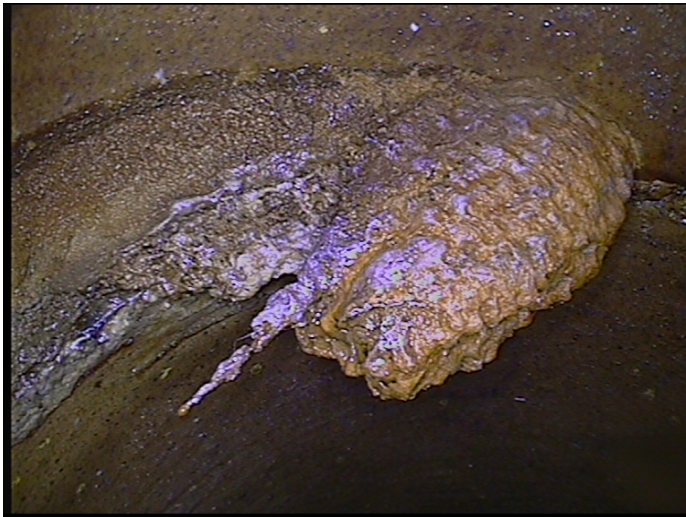
Code: **DAE**
Description: **Deposits Attached Encrustation**

Distance (ft): **182.2**
Structural Grade: **0**
O&M Grade: **2**
Clock Start/From: **11**
Clock To:
1st Value:
2nd Value:
Value Percent: **5.000**
Continuous Index:
Within 8" of Joint: **YES**
Remarks:

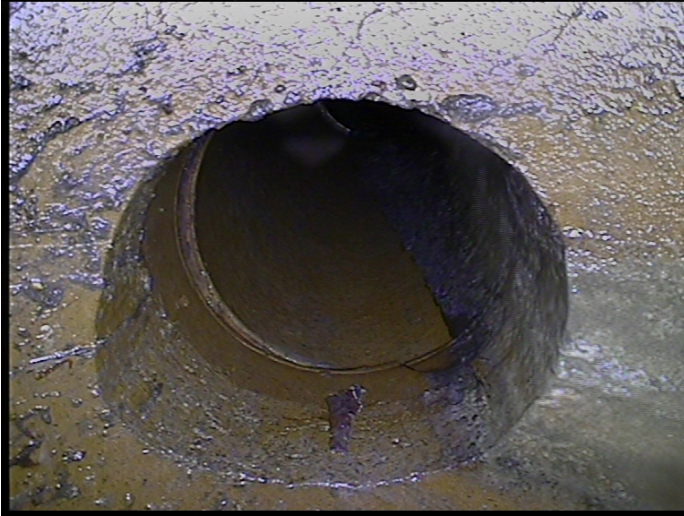
Code: **TFA**
Description: **Tap Factory Active**

Distance (ft): **248.6**
Structural Grade: **0**
O&M Grade: **0**
Clock Start/From: **1**
Clock To:
1st Value: **4.000**
2nd Value:
Value Percent:
Continuous Index:
Within 8" of Joint: **NO**
Remarks:

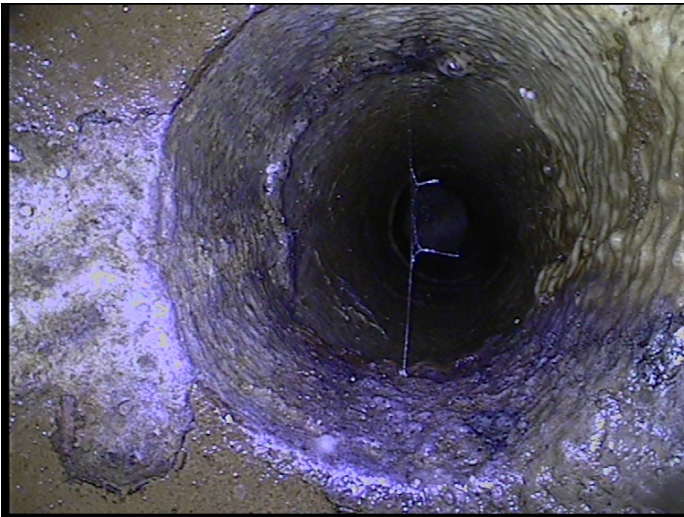
Code: **TF**
Description: **Tap Factory**

Distance (ft): **336.7**
Structural Grade: **0**
O&M Grade: **0**
Clock Start/From: **2**
Clock To:
1st Value: **4.000**
2nd Value:
Value Percent:
Continuous Index:
Within 8" of Joint: **NO**
Remarks:

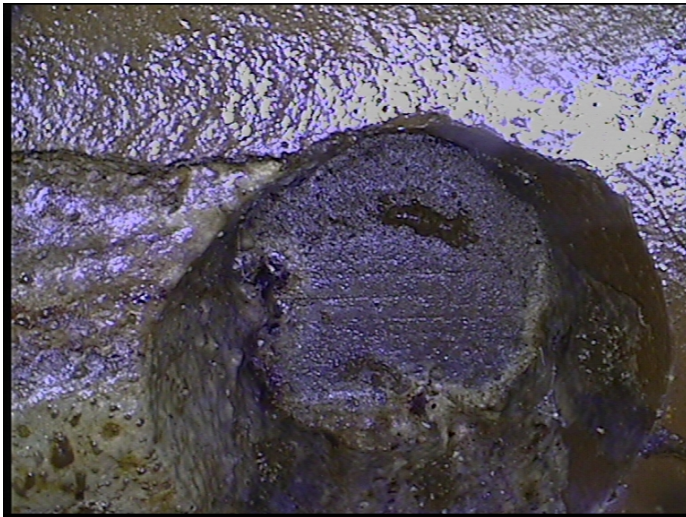
Code: **TFC**
Description: **Tap Factory Capped**

Distance (ft): **339.2**
Structural Grade: **0**
O&M Grade: **0**
Clock Start/From: **12**
Clock To:
1st Value: **4.000**
2nd Value:
Value Percent:
Continuous Index:
Within 8" of Joint: **NO**
Remarks:

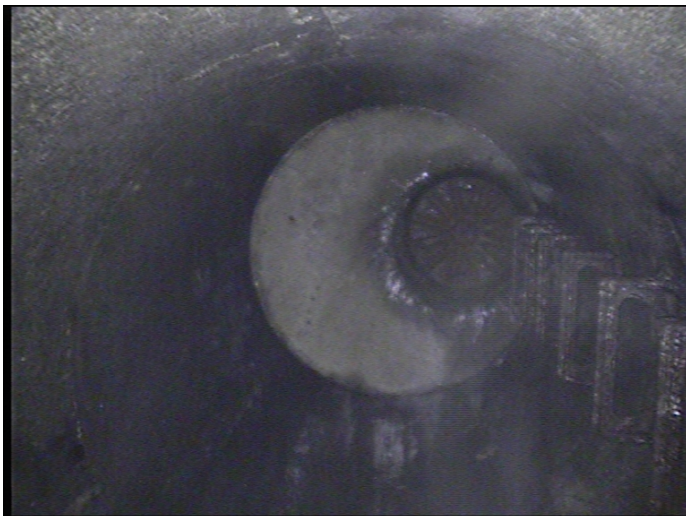
Code: **AMH**
Description: **Manhole**

Distance (ft): **390.6**
Structural Grade: **0**
O&M Grade: **0**
Clock Start/From:
Clock To:
1st Value:
2nd Value:
Value Percent:
Continuous Index:
Within 8" of Joint: **NO**
Remarks: **M-606-051**
