Profile/Photo Observation Report

Date:	05/07/2018	Weather:		Coding:	PACP 6.0
Pipe Length (ft):		Owner:	City of Hobart	Pre Clean:	No Pre-Cleaning
P.O.#:	620	Surveyor:	M. Pielacha	PSR:	P-606-058-057
Customer:	City of Hobart	Clean Date:		Shape:	C

Street:	West 8th Street	Flow Control:	Not Controlled
City:	Hobart, IN	Year Renewed:	
Location:	Light Highway	Tape/Media #:	DEP 620
Purpose:	Routine Assessment	Dia/Height:	18"
Use:	Sanitary	Material:	VCP
Drain Area:		Lining:	
Category:	NA		
Comment:	5-21-2018		
Location Details:		Direction of Survey:	Upstream
US MH:	M-606-058	DS MH:	M-606-057
		Total Length Surveyed (ft):	2.6

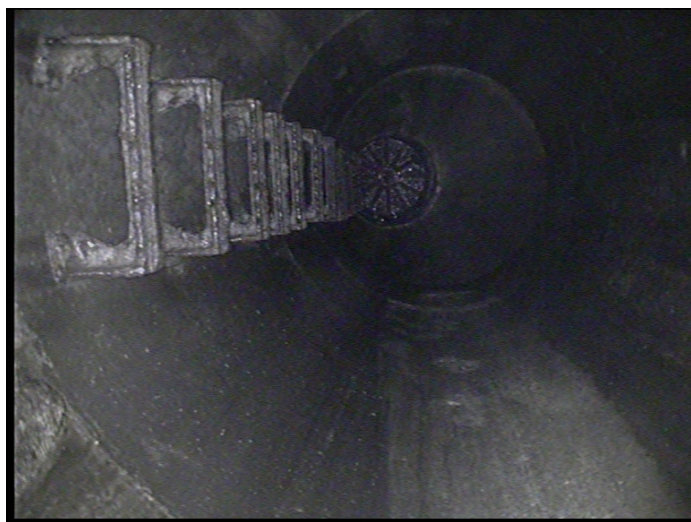
Code: **AMH**
 Description: **Manhole**

Distance (ft): **.0**
 Structural Grade: **0**
 O&M Grade: **0**
 Clock Start/From:
 Clock To:
 1st Value:
 2nd Value:
 Value Percent:
 Continuous Index:
 Within 8" of Joint: **NO**
 Remarks: **M-606-057**

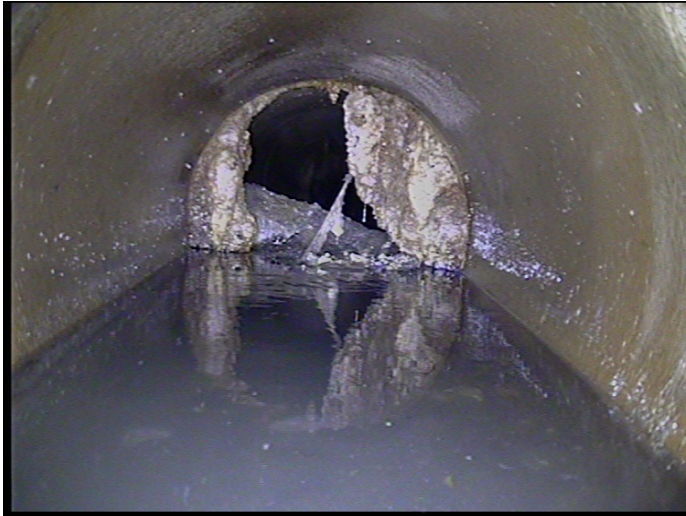
Code: **MWL**
Description: **Water Level**

Distance (ft): **.0**
Structural Grade: **0**
O&M Grade: **0**
Clock Start/From:
Clock To:
1st Value:
2nd Value:
Value Percent: **15.000**
Continuous Index:
Within 8" of Joint: **NO**
Remarks:

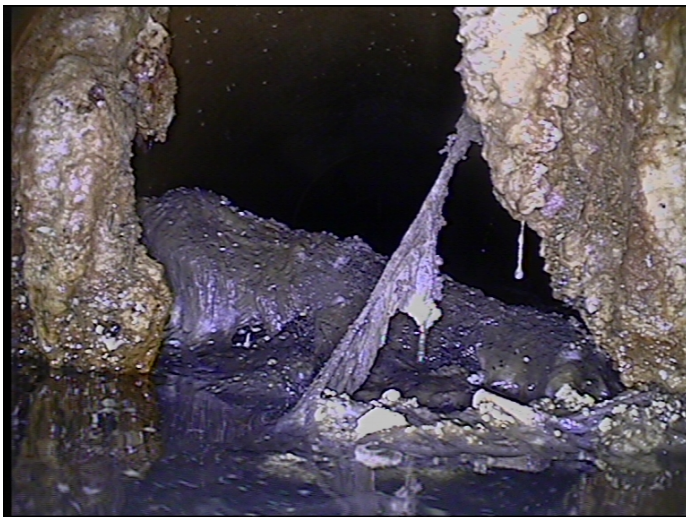
Code: **OBZ**
Description: **Obstacle Other**

Distance (ft): **2.6**
Structural Grade: **0**
O&M Grade: **5**
Clock Start/From: **9**
Clock To: **3**
1st Value:
2nd Value:
Value Percent: **40.000**
Continuous Index:
Within 8" of Joint: **NO**
Remarks: **Debris**

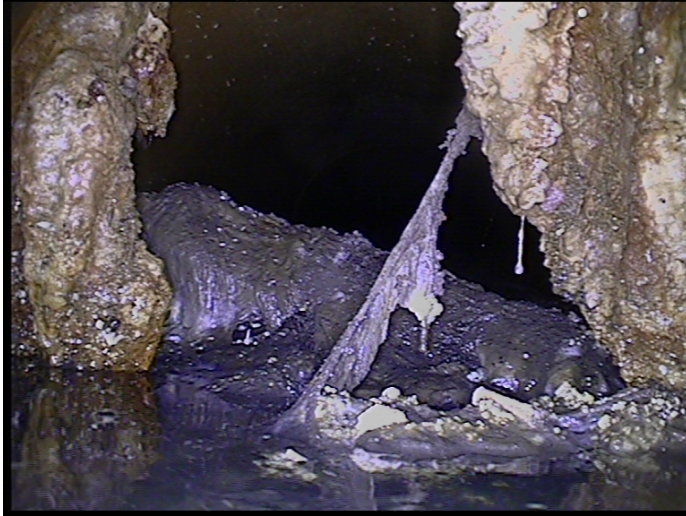
Code:	MSA
Description:	Abandoned Survey
Distance (ft):	2.6
Structural Grade:	0
O&M Grade:	0
Clock Start/From:	
Clock To:	
1st Value:	
2nd Value:	
Value Percent:	
Continuous Index:	
Within 8" of Joint:	NO
Remarks:	debris
