# Profile/Photo Observation Report

Date:	02/09/2022	Weather:		Coding:	PACP 7.0
Pipe Length (ft):	201.5	Owner:	City of Hobart	Pre Clean:	Heavy Cleaning
P.O.#:	YES502259	Surveyor:	S. Bucklin	PSR:	P-606-071-058
Customer:	City of Hobart	Clean Date:	02/06/2022	Shape:	C

Street:	South Washington Street	Flow Control:	Not Controlled
City:	Hobart, IN	Year Renewed:	
Location:	Alley	Tape/Media #:	
Purpose:	Routine Assessment	Dia/Height:	10"
Use:	Sanitary Sewage Pipe	Material:	VCP
Drain Area:		Lining:	None
Category:	NA		
Comment:			
Location Details:		Direction of Survey:	Downstream
US MH:	M-606-058	DS MH:	M-606-071
		Total Length Surveyed (ft):	201.5

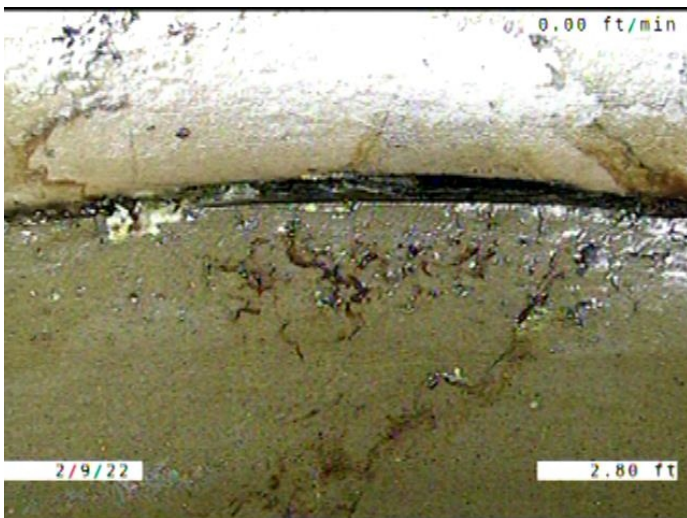
Code: **DAE**  
 Description: **Deposits Attached Encrustation**

Distance (ft): **2.8**  
 Structural Grade: **0**  
 O&M Grade: **2**  
 Clock Start/From: **8**  
 Clock To: **4**  
 1st Value:  
 2nd Value:  
 Value Percent: **5.000**  
 Continuous Index: **S01**  
 Within 8" of Joint: **YES**  
 Remarks:

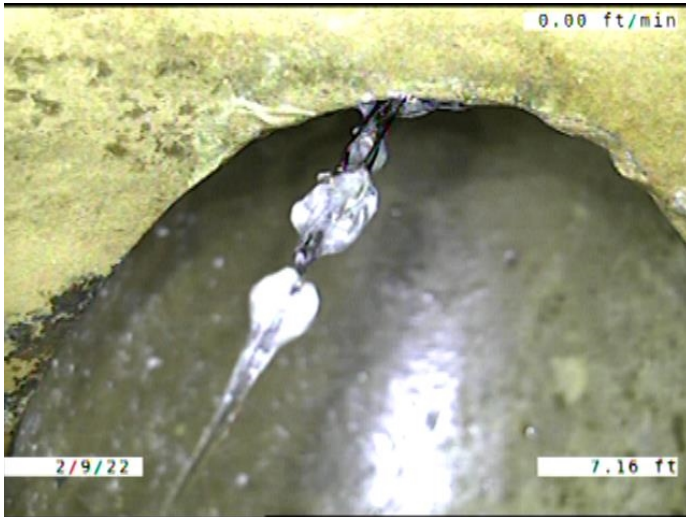
Code: **RFL**  
 Description: **Roots Fine Lateral**

Distance (ft): **7.2**  
 Structural Grade: **0**  
 O&M Grade: **1**  
 Clock Start/From: **11**  
 Clock To:  
 1st Value:  
 2nd Value:  
 Value Percent:  
 Continuous Index:  
 Within 8" of Joint: **NO**  
 Remarks:

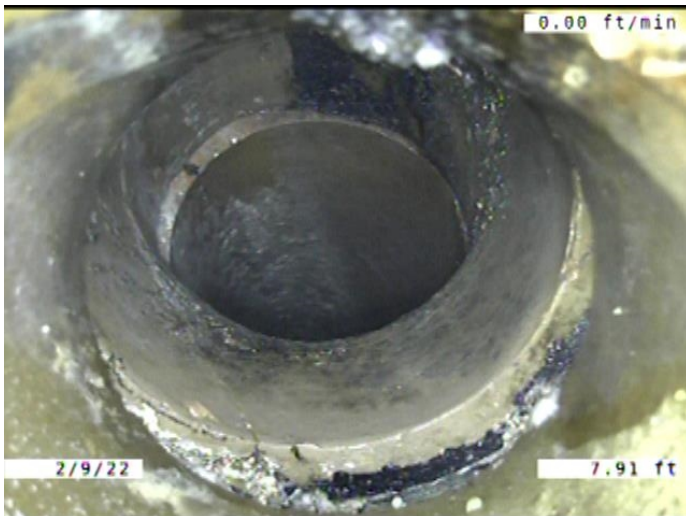
Code: **TFA**  
 Description: **Tap Factory Activity**

Distance (ft): **7.9**  
 Structural Grade: **0**  
 O&M Grade: **0**  
 Clock Start/From: **12**  
 Clock To:  
 1st Value: **6.000**  
 2nd Value:  
 Value Percent:  
 Continuous Index:  
 Within 8" of Joint: **YES**  
 Remarks: **SERVICE LINE CRACKED.  
 CONSTANTLY RUNNING WATER. OFF**

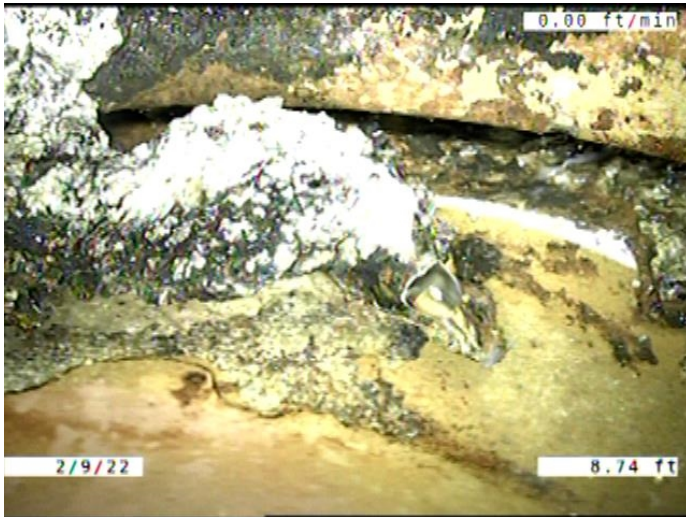
Code: **IDJ**  
 Description: **Infiltration Dripper Joint**

Distance (ft): **8.7**  
 Structural Grade: **0**  
 O&M Grade: **3**  
 Clock Start/From: **1**  
 Clock To:  
 1st Value:  
 2nd Value:  
 Value Percent:  
 Continuous Index:  
 Within 8" of Joint: **YES**  
 Remarks:

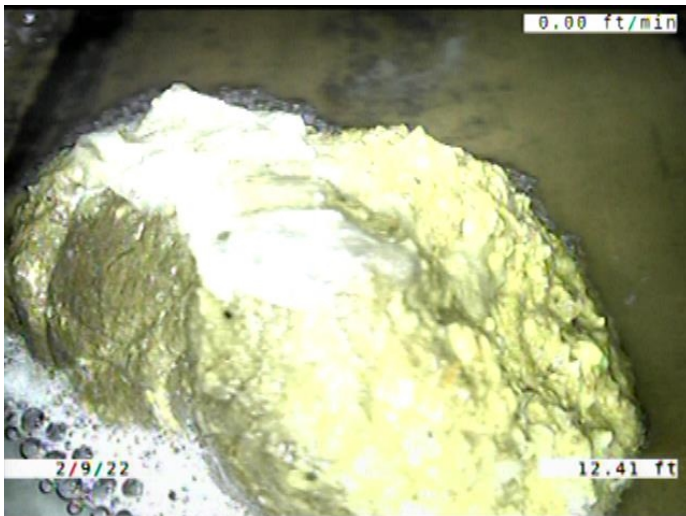
Code: **OBZ**  
 Description: **Obstruction Other**

Distance (ft): **12.4**  
 Structural Grade: **0**  
 O&M Grade: **2**  
 Clock Start/From: **6**  
 Clock To:  
 1st Value:  
 2nd Value:  
 Value Percent: **5.000**  
 Continuous Index:  
 Within 8" of Joint: **YES**  
 Remarks: **A PIECE OF ENCRUSTATION THAT HAS BEEN CUT OFF THE PIPE WALL.**

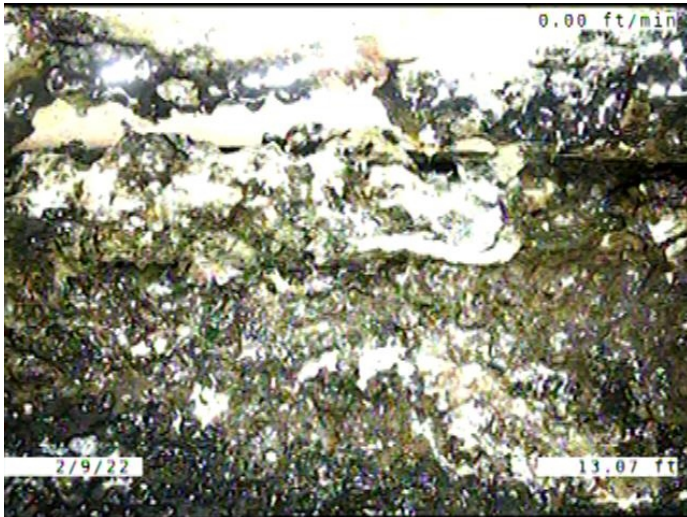
Code: **IWJ**  
 Description: **Infiltration Weeper Joint**

Distance (ft): **13.1**  
 Structural Grade: **0**  
 O&M Grade: **2**  
 Clock Start/From: **1**  
 Clock To:  
 1st Value:  
 2nd Value:  
 Value Percent:  
 Continuous Index:  
 Within 8" of Joint: **YES**  
 Remarks:

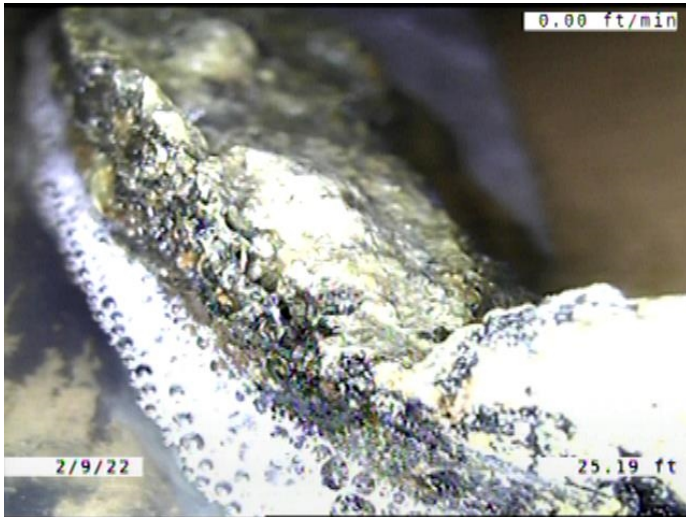
Code:	<b>OBZ</b>
Description:	<b>Obstruction Other</b>
Distance (ft):	<b>25.2</b>
Structural Grade:	<b>0</b>
O&M Grade:	<b>2</b>
Clock Start/From:	<b>5</b>
Clock To:	<b>6</b>
1st Value:	
2nd Value:	
Value Percent:	<b>5.000</b>
Continuous Index:	
Within 8" of Joint:	<b>YES</b>
Remarks:	<b>A PIECE OF ENCRUSTATION THAT WAS CUT OFF THE PIPE WALL.</b>

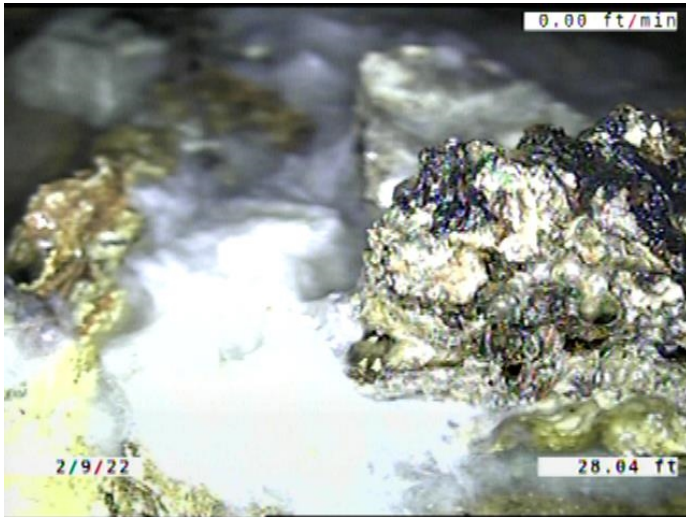
Code: **OBZ**  
 Description: **Obstruction Other**

Distance (ft): **28.0**  
 Structural Grade: **0**  
 O&M Grade: **2**  
 Clock Start/From: **5**  
 Clock To: **7**  
 1st Value:  
 2nd Value:  
 Value Percent: **5.000**  
 Continuous Index:  
 Within 8" of Joint: **YES**  
 Remarks: **A PIECE OF ENCRUSTATION THAT WAS CUT OFF THE PIPE WALL.**

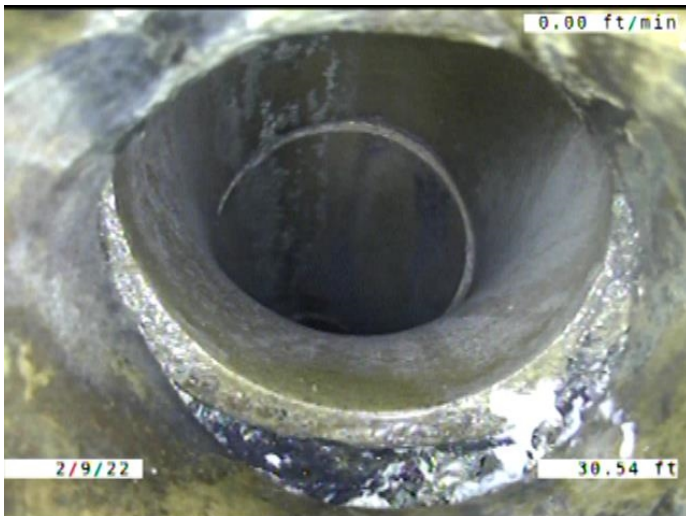
Code: **TF**  
 Description: **Tap Factory**

Distance (ft): **30.5**  
 Structural Grade: **0**  
 O&M Grade: **0**  
 Clock Start/From: **12**  
 Clock To:  
 1st Value: **6.000**  
 2nd Value:  
 Value Percent:  
 Continuous Index:  
 Within 8" of Joint: **YES**  
 Remarks: **LARGE OFFSET SOIL VISIBLE AT THE SERVICE TO MAIN CONNECTION.**

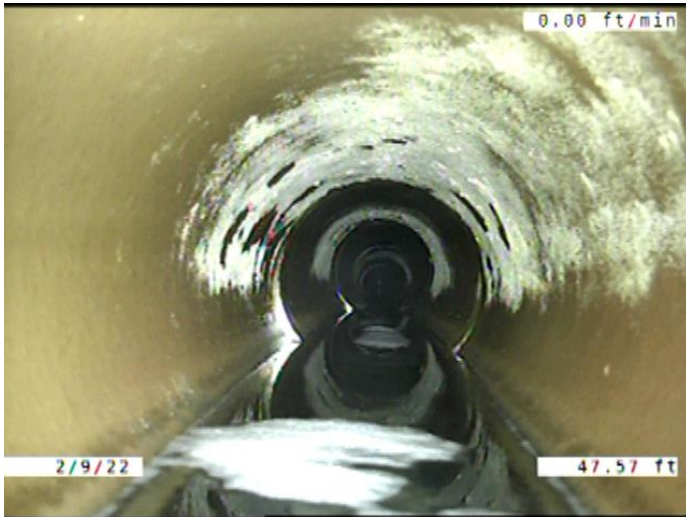
Code: **MWLS**  
Description: **Miscellaneous Water Level Sag**

Distance (ft): **47.6**  
Structural Grade: **2**  
O&M Grade: **0**  
Clock Start/From:  
Clock To:  
1st Value:  
2nd Value:  
Value Percent: **10.000**  
Continuous Index: **S02**  
Within 8" of Joint: **NO**  
Remarks:

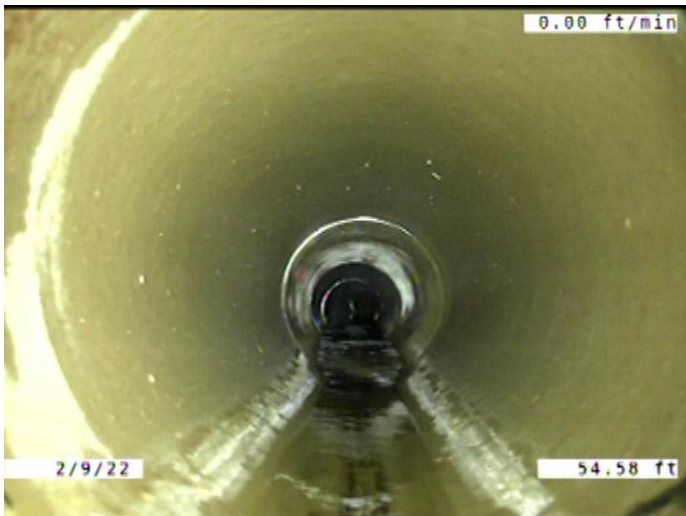
Code: **MWLS**  
Description: **Miscellaneous Water Level Sag**

Distance (ft): **54.6**  
Structural Grade: **2**  
O&M Grade: **0**  
Clock Start/From:  
Clock To:  
1st Value:  
2nd Value:  
Value Percent: **10.000**  
Continuous Index: **F02**  
Within 8" of Joint: **NO**  
Remarks:

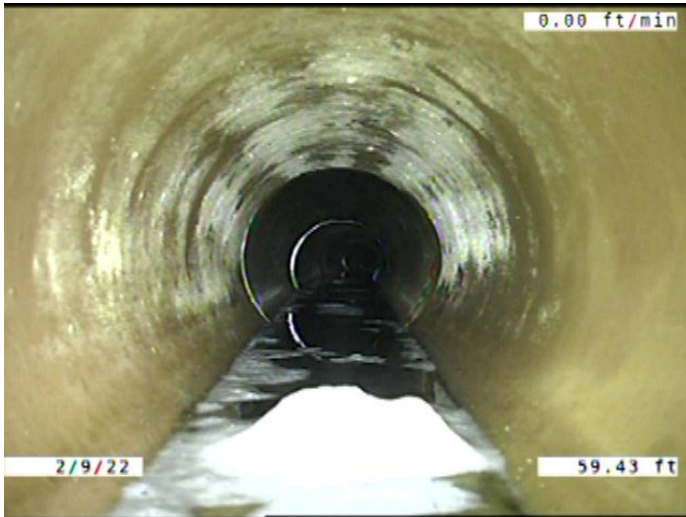
Code: **MWLS**  
 Description: **Miscellaneous Water Level Sag**

Distance (ft): **59.4**  
 Structural Grade: **2**  
 O&M Grade: **0**  
 Clock Start/From:  
 Clock To:  
 1st Value:  
 2nd Value:  
 Value Percent: **10.000**  
 Continuous Index: **S03**  
 Within 8" of Joint: **NO**  
 Remarks:

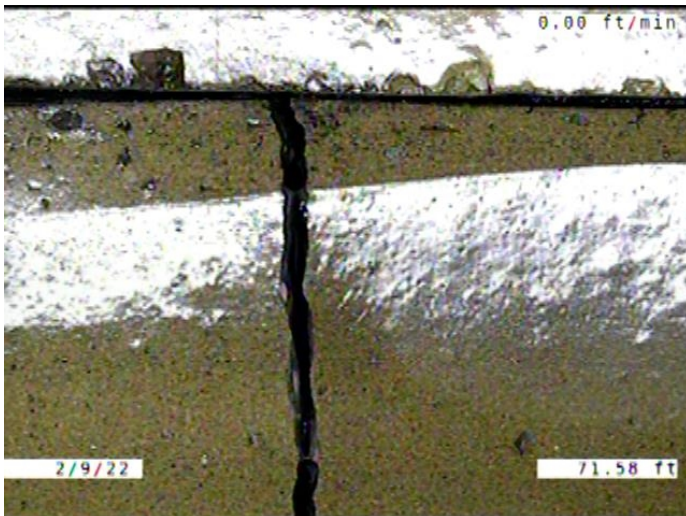
Code: **FM**  
 Description: **Fracture Multiple**

Distance (ft): **71.6**  
 Structural Grade: **4**  
 O&M Grade: **0**  
 Clock Start/From: **11**  
 Clock To: **2**  
 1st Value:  
 2nd Value:  
 Value Percent:  
 Continuous Index:  
 Within 8" of Joint: **YES**  
 Remarks: **Goes into tap and out again**

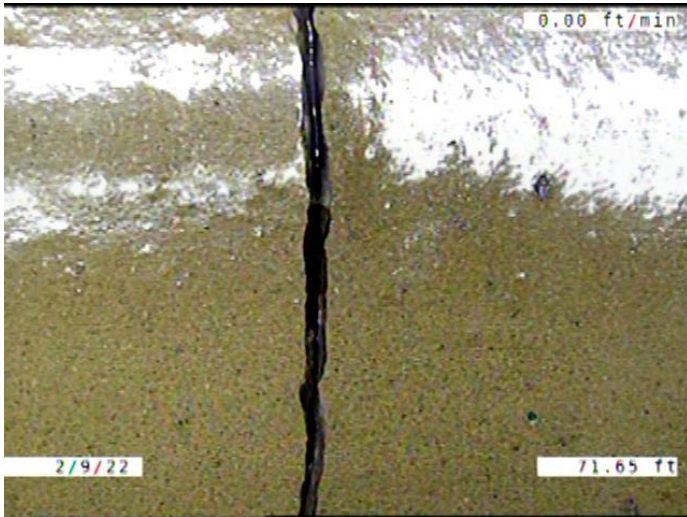
Code: **IWB**  
 Description: **Infiltration Weeper Barrel**

Distance (ft): **71.7**  
 Structural Grade: **0**  
 O&M Grade: **2**  
 Clock Start/From: **12**  
 Clock To:  
 1st Value:  
 2nd Value:  
 Value Percent:  
 Continuous Index:  
 Within 8" of Joint: **YES**  
 Remarks:

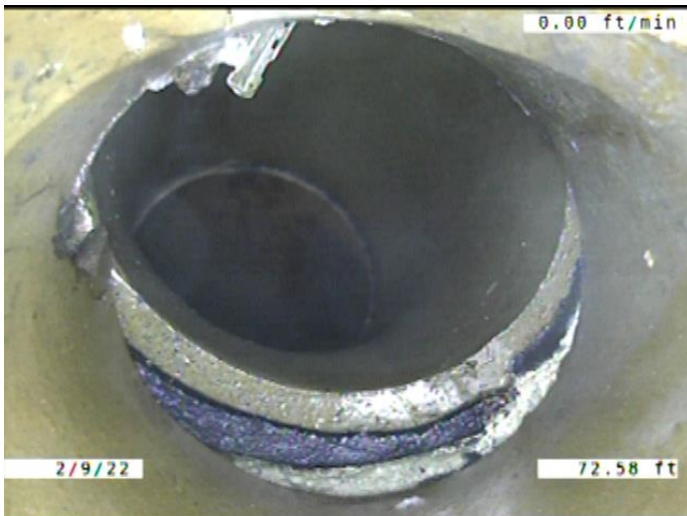
Code: **TFD**  
 Description: **Tap Factory Defective**

Distance (ft): **72.6**  
 Structural Grade: **0**  
 O&M Grade: **3**  
 Clock Start/From: **12**  
 Clock To:  
 1st Value: **6.000**  
 2nd Value:  
 Value Percent:  
 Continuous Index:  
 Within 8" of Joint: **YES**  
 Remarks: **TAP BROKEN. LARGE OFFSET ON THE SERVICE TO MAIN CONNECTION.**

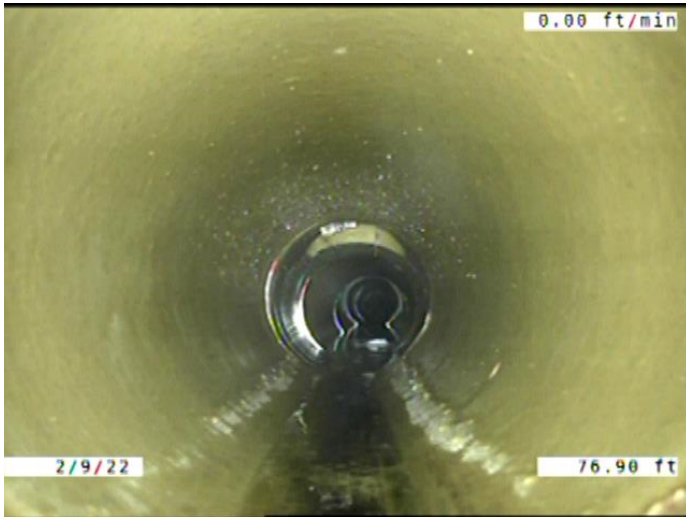
Code: **MWLS**  
Description: **Miscellaneous Water Level Sag**

Distance (ft): **76.9**  
Structural Grade: **2**  
O&M Grade: **0**  
Clock Start/From:  
Clock To:  
1st Value:  
2nd Value:  
Value Percent: **10.000**  
Continuous Index: **F03**  
Within 8" of Joint: **NO**  
Remarks:

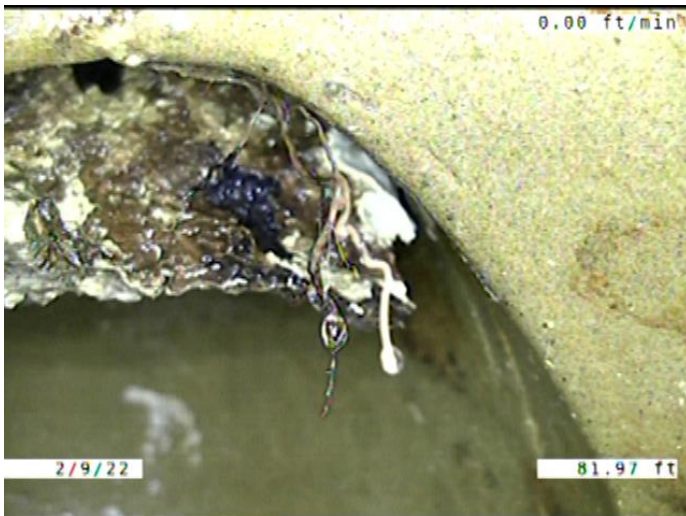
Code: **RFL**  
Description: **Roots Fine Lateral**

Distance (ft): **82.0**  
Structural Grade: **0**  
O&M Grade: **1**  
Clock Start/From: **1**  
Clock To:  
1st Value:  
2nd Value:  
Value Percent:  
Continuous Index:  
Within 8" of Joint: **NO**  
Remarks:

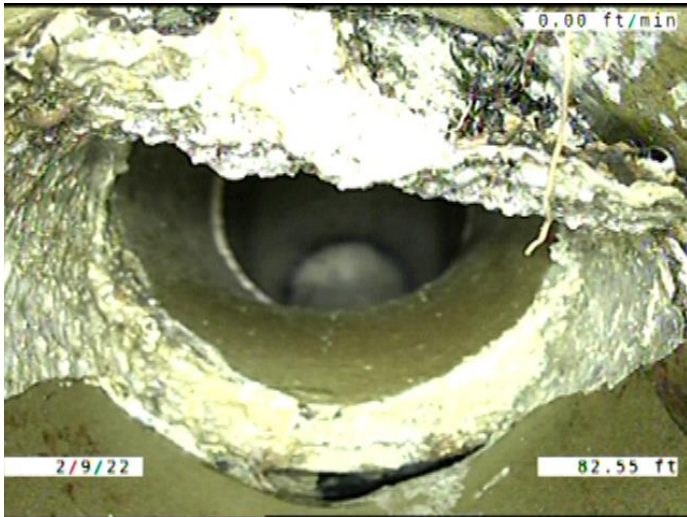
Code:	<b>TF</b>
Description:	<b>Tap Factory</b>
Distance (ft):	<b>82.5</b>
Structural Grade:	<b>0</b>
O&M Grade:	<b>0</b>
Clock Start/From:	<b>12</b>
Clock To:	
1st Value:	<b>6.000</b>
2nd Value:	
Value Percent:	
Continuous Index:	
Within 8" of Joint:	<b>YES</b>
Remarks:	<b>ENCrustATION COMING FROM THE SERVICE TO MAIN CONNECTION. CO</b>

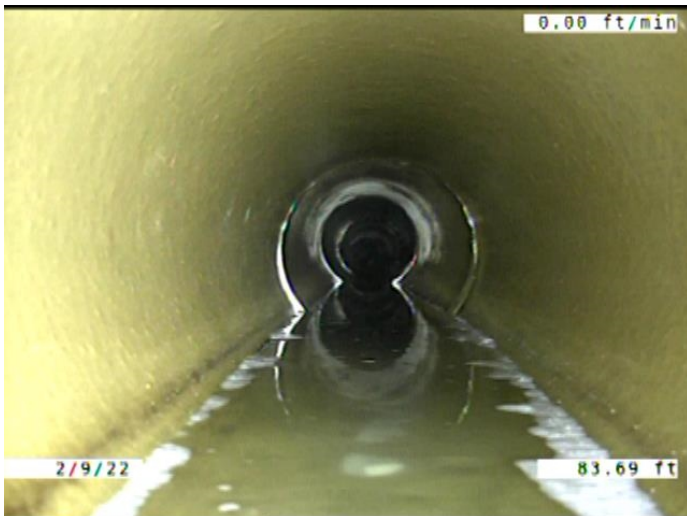
Code:	<b>MWLS</b>
Description:	<b>Miscellaneous Water Level Sag</b>
Distance (ft):	<b>83.7</b>
Structural Grade:	<b>2</b>
O&M Grade:	<b>0</b>
Clock Start/From:	
Clock To:	
1st Value:	
2nd Value:	
Value Percent:	<b>10.000</b>
Continuous Index:	<b>S04</b>
Within 8" of Joint:	<b>NO</b>
Remarks:

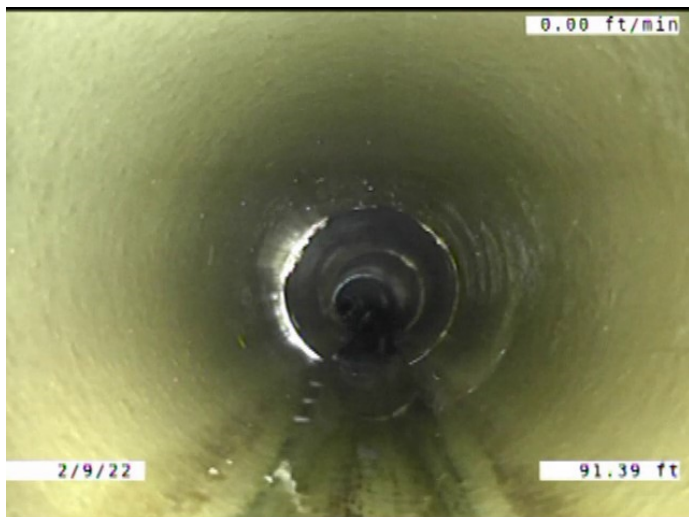
Code: **MWLS**  
 Description: **Miscellaneous Water Level Sag**

Distance (ft): **91.4**  
 Structural Grade: **2**  
 O&M Grade: **0**  
 Clock Start/From:  
 Clock To:  
 1st Value:  
 2nd Value:  
 Value Percent: **10.000**  
 Continuous Index: **F04**  
 Within 8" of Joint: **NO**  
 Remarks:

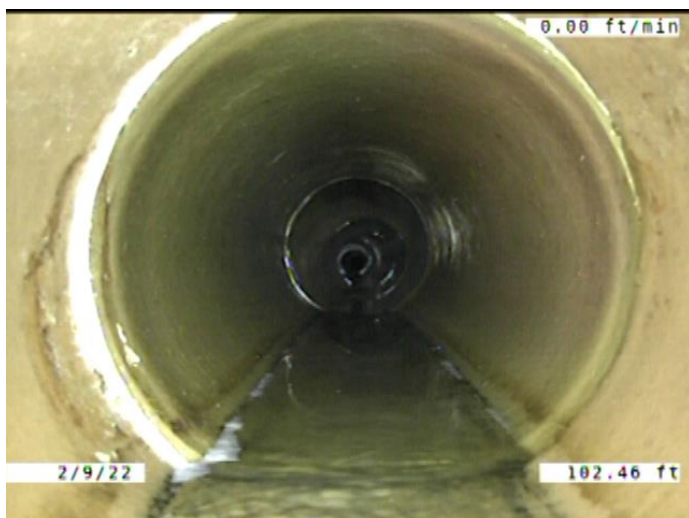
Code: **MWLS**  
 Description: **Miscellaneous Water Level Sag**

Distance (ft): **102.5**  
 Structural Grade: **2**  
 O&M Grade: **0**  
 Clock Start/From:  
 Clock To:  
 1st Value:  
 2nd Value:  
 Value Percent: **10.000**  
 Continuous Index: **S05**  
 Within 8" of Joint: **NO**  
 Remarks:

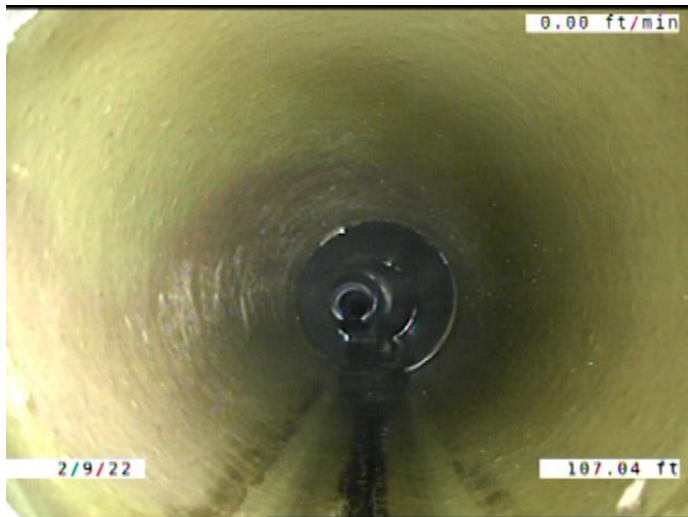
Code: **MWLS**  
 Description: **Miscellaneous Water Level Sag**

Distance (ft): **107.0**  
 Structural Grade: **2**  
 O&M Grade: **0**  
 Clock Start/From:  
 Clock To:  
 1st Value:  
 2nd Value:  
 Value Percent: **10.000**  
 Continuous Index: **F05**  
 Within 8" of Joint: **NO**  
 Remarks:

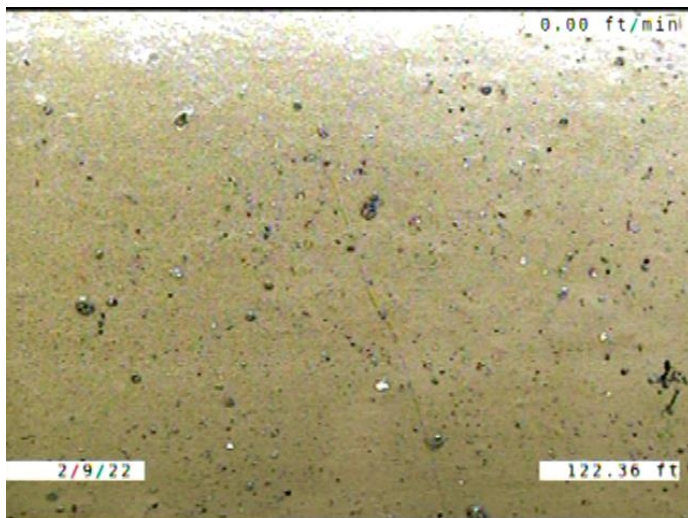
Code: **CS**  
 Description: **Crack Spiral**

Distance (ft): **122.4**  
 Structural Grade: **2**  
 O&M Grade: **0**  
 Clock Start/From: **12**  
 Clock To: **1**  
 1st Value:  
 2nd Value:  
 Value Percent:  
 Continuous Index:  
 Within 8" of Joint: **YES**  
 Remarks:

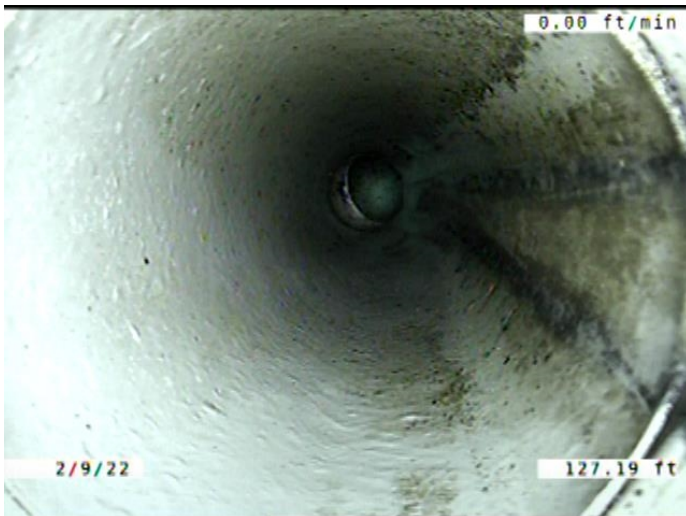
Code: **TF**  
Description: **Tap Factory**

Distance (ft): **127.2**  
Structural Grade: **0**  
O&M Grade: **0**  
Clock Start/From: **2**  
Clock To:  
1st Value: **6.000**  
2nd Value:  
Value Percent:  
Continuous Index:  
Within 8" of Joint: **YES**  
Remarks: **CONSTANTLY RUNNING WATER.**

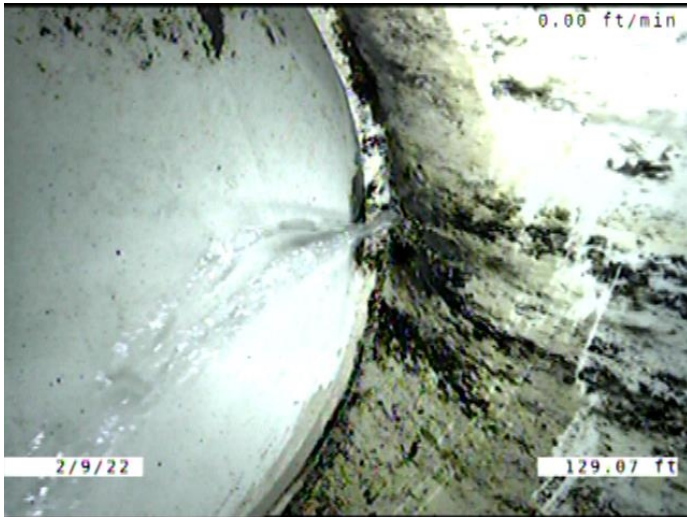
Code: **IRC**  
Description: **Infiltration Runner Connection**

Distance (ft): **129.1**  
Structural Grade: **0**  
O&M Grade: **4**  
Clock Start/From: **12**  
Clock To: **1**  
1st Value:  
2nd Value:  
Value Percent:  
Continuous Index:  
Within 8" of Joint: **YES**  
Remarks:

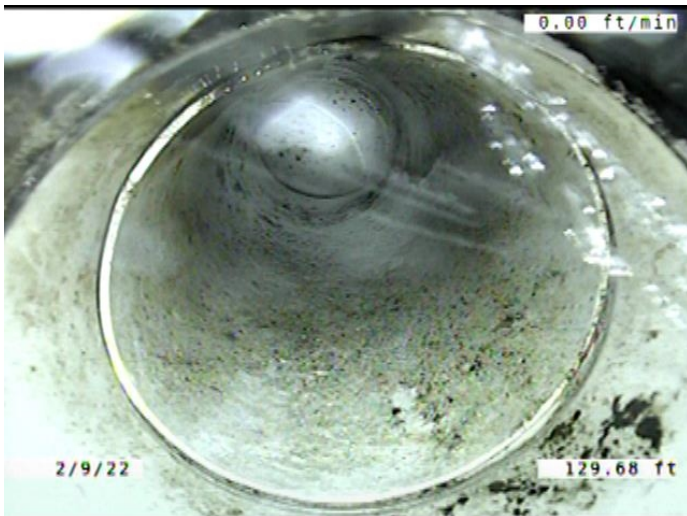
Code: **TF**  
Description: **Tap Factory**

Distance (ft): **129.7**  
Structural Grade: **0**  
O&M Grade: **0**  
Clock Start/From: **12**  
Clock To:  
1st Value: **6.000**  
2nd Value:  
Value Percent:  
Continuous Index:  
Within 8" of Joint: **YES**  
Remarks: **CONSTANTLY RUNNING WATER.**

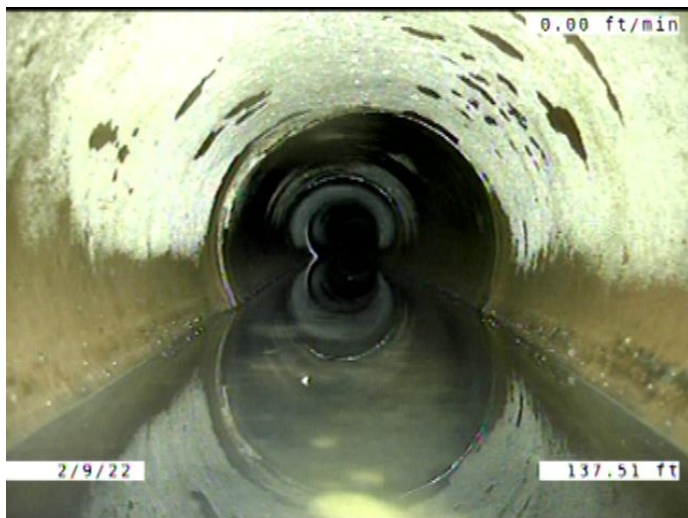
Code:	<b>MWLS</b>
Description:	<b>Miscellaneous Water Level Sag</b>
Distance (ft):	<b>137.5</b>
Structural Grade:	<b>2</b>
O&M Grade:	<b>0</b>
Clock Start/From:	
Clock To:	
1st Value:	
2nd Value:	
Value Percent:	<b>10.000</b>
Continuous Index:	<b>S06</b>
Within 8" of Joint:	<b>NO</b>
Remarks:

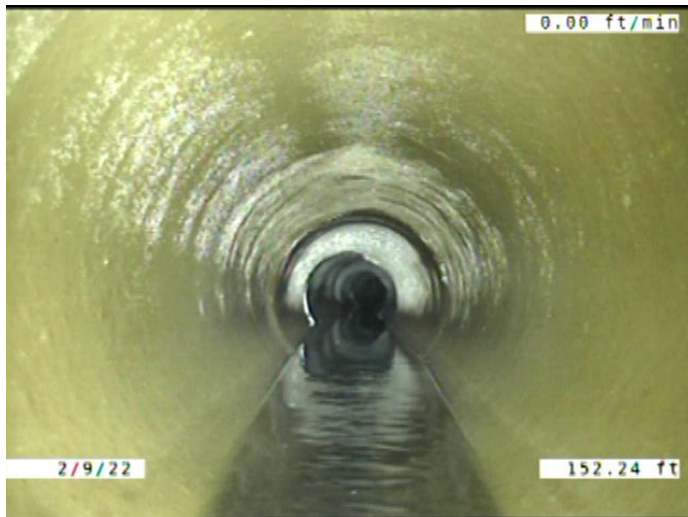
Code: **MWLS**  
 Description: **Miscellaneous Water Level Sag**

Distance (ft): **152.2**  
 Structural Grade: **2**  
 O&M Grade: **0**  
 Clock Start/From:  
 Clock To:  
 1st Value:  
 2nd Value:  
 Value Percent: **10.000**  
 Continuous Index: **F06**  
 Within 8" of Joint: **NO**  
 Remarks:

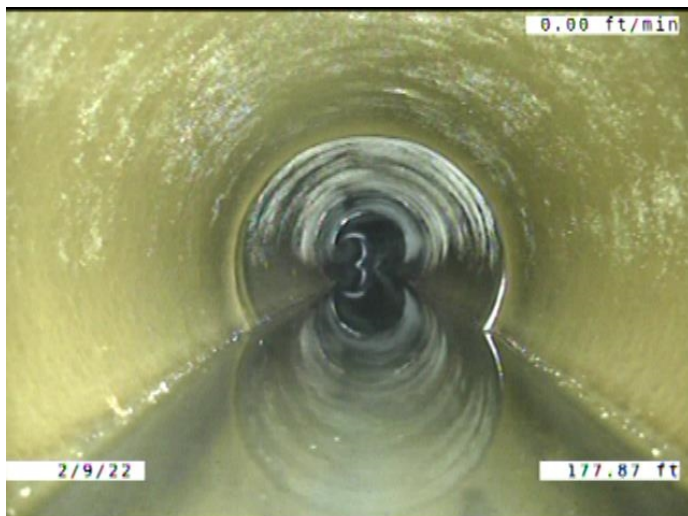
Code: **MWLS**  
 Description: **Miscellaneous Water Level Sag**

Distance (ft): **177.9**  
 Structural Grade: **2**  
 O&M Grade: **0**  
 Clock Start/From:  
 Clock To:  
 1st Value:  
 2nd Value:  
 Value Percent: **15.000**  
 Continuous Index: **S07**  
 Within 8" of Joint: **NO**  
 Remarks:

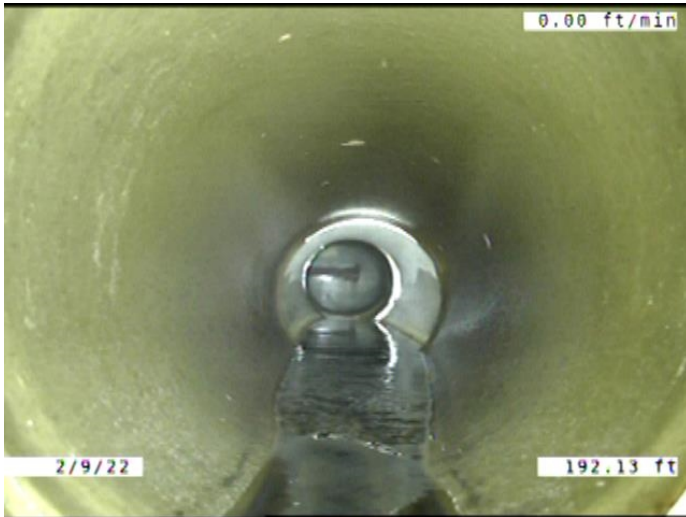
Code: **MWLS**  
Description: **Miscellaneous Water Level Sag**

Distance (ft): **192.1**  
Structural Grade: **2**  
O&M Grade: **0**  
Clock Start/From:  
Clock To:  
1st Value:  
2nd Value:  
Value Percent: **15.000**  
Continuous Index: **F07**  
Within 8" of Joint: **NO**  
Remarks:

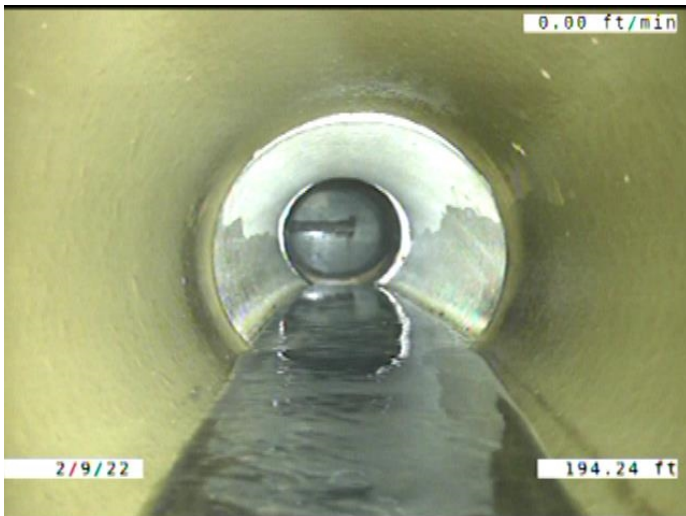
Code: **MWLS**  
Description: **Miscellaneous Water Level Sag**

Distance (ft): **194.2**  
Structural Grade: **2**  
O&M Grade: **0**  
Clock Start/From:  
Clock To:  
1st Value:  
2nd Value:  
Value Percent: **10.000**  
Continuous Index: **S08**  
Within 8" of Joint: **NO**  
Remarks:

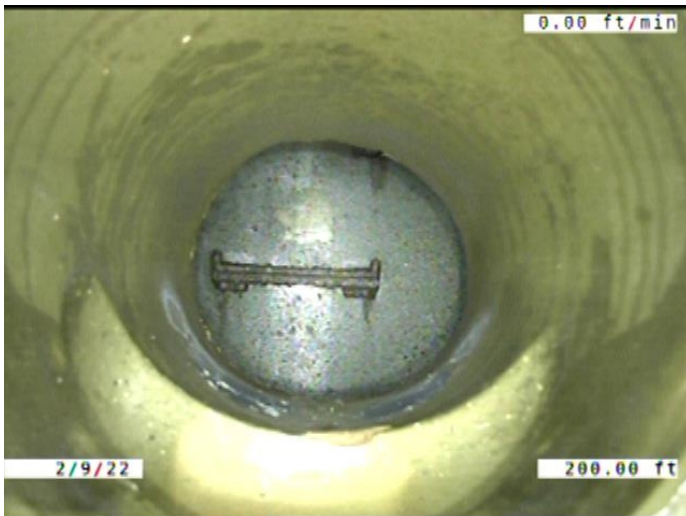
Code: **MWLS**  
Description: **Miscellaneous Water Level Sag**

Distance (ft): **200.0**  
Structural Grade: **2**  
O&M Grade: **0**  
Clock Start/From:  
Clock To:  
1st Value:  
2nd Value:  
Value Percent: **10.000**  
Continuous Index: **F08**  
Within 8" of Joint: **NO**  
Remarks:

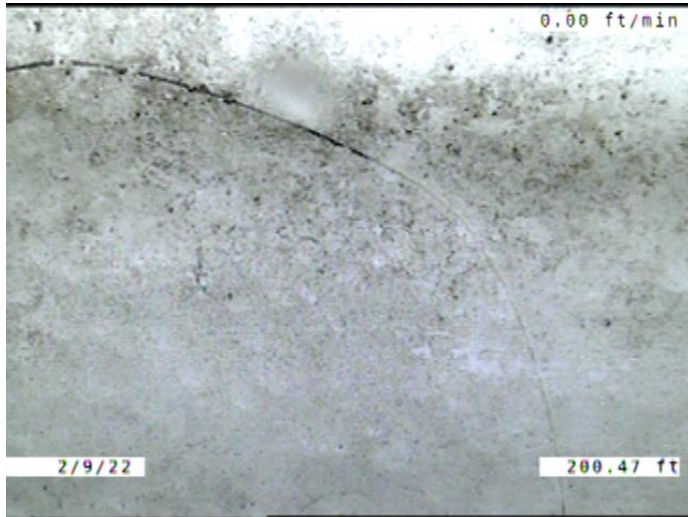
Code: **CS**  
 Description: **Crack Spiral**

Distance (ft): **200.5**  
 Structural Grade: **2**  
 O&M Grade: **0**  
 Clock Start/From: **10**  
 Clock To: **12**  
 1st Value:  
 2nd Value:  
 Value Percent:  
 Continuous Index:  
 Within 8" of Joint: **YES**  
 Remarks:

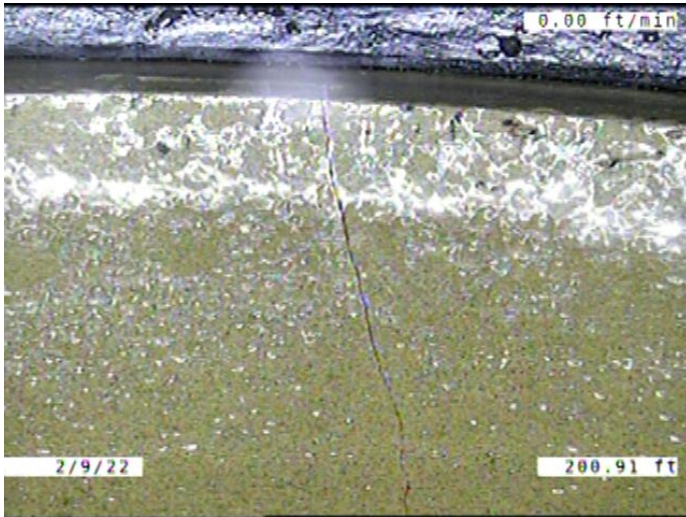
Code: **CS**  
 Description: **Crack Spiral**

Distance (ft): **200.9**  
 Structural Grade: **2**  
 O&M Grade: **0**  
 Clock Start/From: **11**  
 Clock To: **12**  
 1st Value:  
 2nd Value:  
 Value Percent:  
 Continuous Index:  
 Within 8" of Joint: **YES**  
 Remarks:

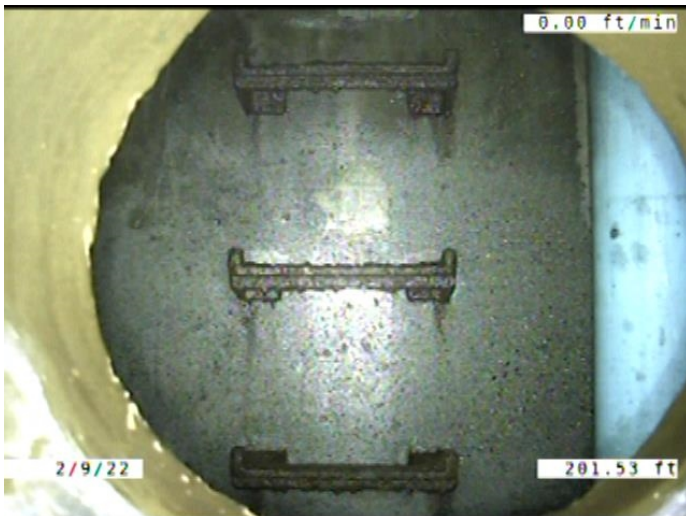
Code: **DAE**  
 Description: **Deposits Attached Encrustation**

Distance (ft): **201.5**  
 Structural Grade: **0**  
 O&M Grade: **2**  
 Clock Start/From: **8**  
 Clock To: **4**  
 1st Value:  
 2nd Value:  
 Value Percent: **5.000**  
 Continuous Index: **F01**  
 Within 8" of Joint: **YES**  
 Remarks:
