Profile/Photo Observation Report

Date:	02/23/2024	Weather:		Coding:	PACP 7.0
Pipe Length (ft):	230.0	Owner:	City of Hobart	Pre Clean:	Heavy Cleaning
P.O.#:	YES502259	Surveyor:	S. Bucklin	PSR:	P-606-060-061
Customer:	City of Hobart	Clean Date:	12/12/2023	Shape:	C

Street:	S PENNSYLVANIA ST	Flow Control:	Not Controlled
City:	Hobart, IN	Year Renewed:	
Location:	Easement/Right of Way	Tape/Media #:	
Purpose:	Sewer System Evaluation Survey (SS)	Dia/Height:	10"
Use:	Sanitary Sewage Pipe	Material:	VCP
Drain Area:		Lining:	None
Category:	NA		
Comment:			
Location Details:		Direction of Survey:	Downstream
US MH:	M-606-061	DS MH:	M-606-060
		Total Length Surveyed (ft):	231.2

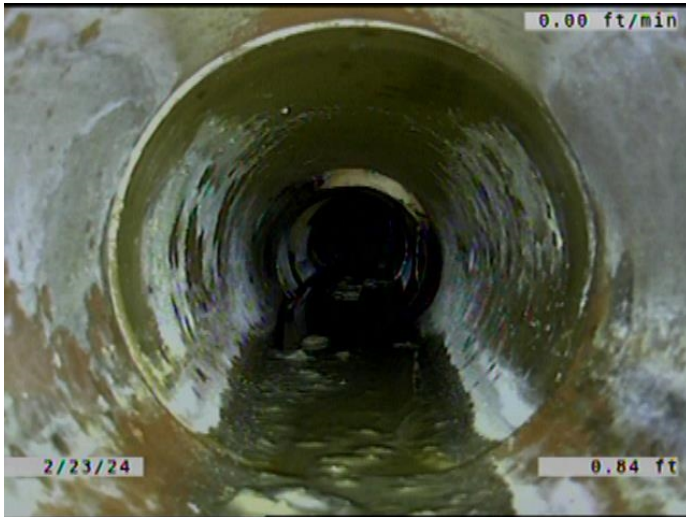
Code: **DSF**
Description: **Deposits Settled Fine**

Distance (ft): **.8**
Structural Grade: **0**
O&M Grade: **2**
Clock Start/From: **5**
Clock To: **7**
1st Value:
2nd Value:
Value Percent: **5.000**
Continuous Index: **S01**
Within 8" of Joint: **YES**
Remarks:

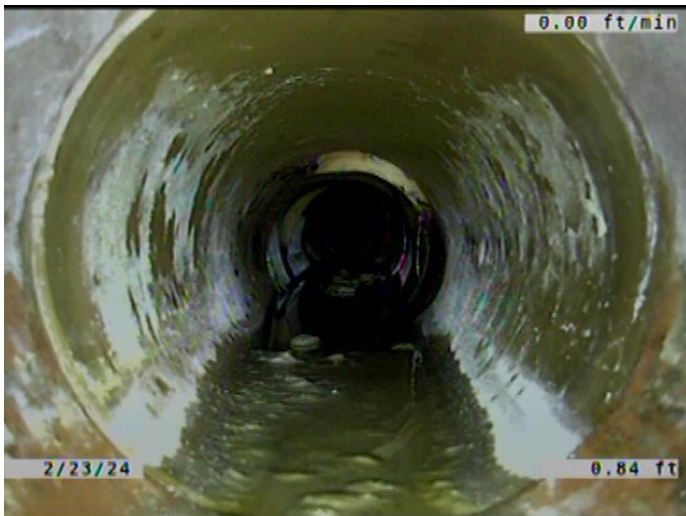
Code: **MWLS**
Description: **Miscellaneous Water Level Sag**

Distance (ft): **.8**
Structural Grade: **2**
O&M Grade: **0**
Clock Start/From:
Clock To:
1st Value:
2nd Value:
Value Percent: **15.000**
Continuous Index: **S02**
Within 8" of Joint: **NO**
Remarks:

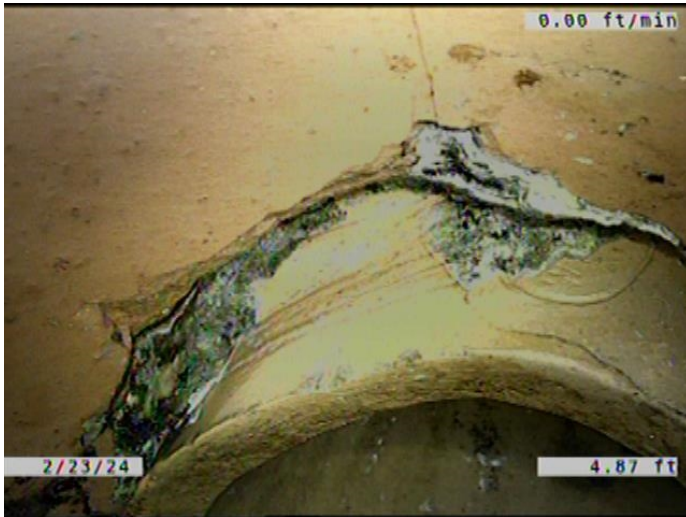
Code: **FM**
Description: **Fracture Multiple**

Distance (ft): **4.9**
Structural Grade: **4**
O&M Grade: **0**
Clock Start/From: **11**
Clock To: **3**
1st Value:
2nd Value:
Value Percent:
Continuous Index:
Within 8" of Joint: **YES**
Remarks:

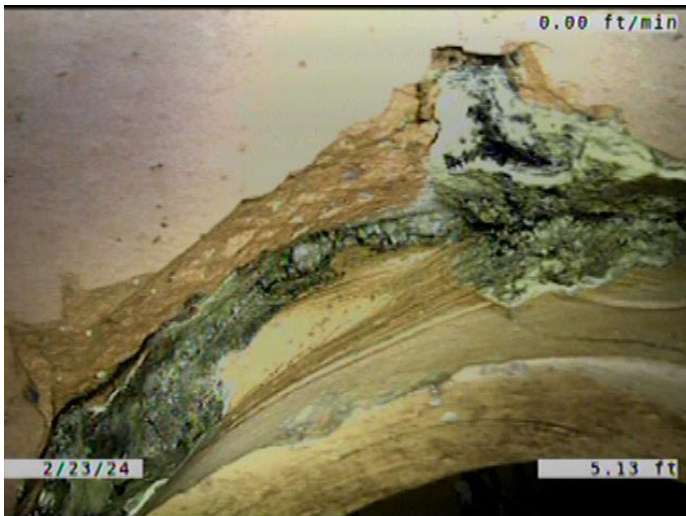
Code: **DAE**
Description: **Deposits Attached Encrustation**

Distance (ft): **5.1**
Structural Grade: **0**
O&M Grade: **2**
Clock Start/From: **11**
Clock To: **3**
1st Value:
2nd Value:
Value Percent: **5.000**
Continuous Index:
Within 8" of Joint: **YES**
Remarks:

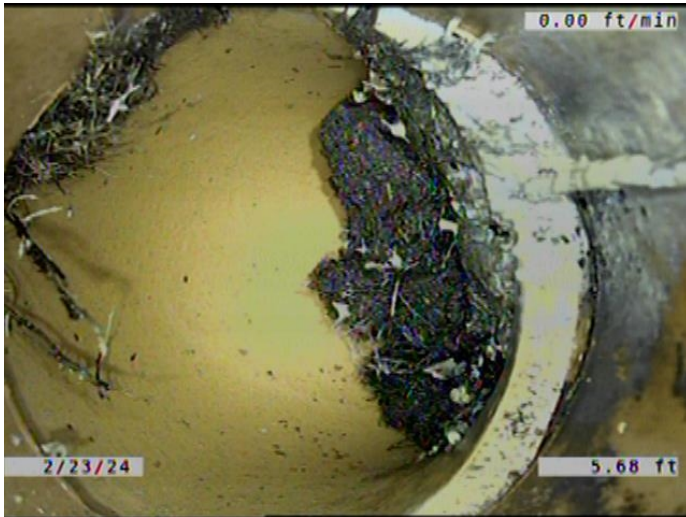
Code: **RFL**
Description: **Roots Fine Lateral**

Distance (ft): **5.7**
Structural Grade: **0**
O&M Grade: **1**
Clock Start/From: **1**
Clock To:
1st Value:
2nd Value:
Value Percent:
Continuous Index:
Within 8" of Joint: **NO**
Remarks:

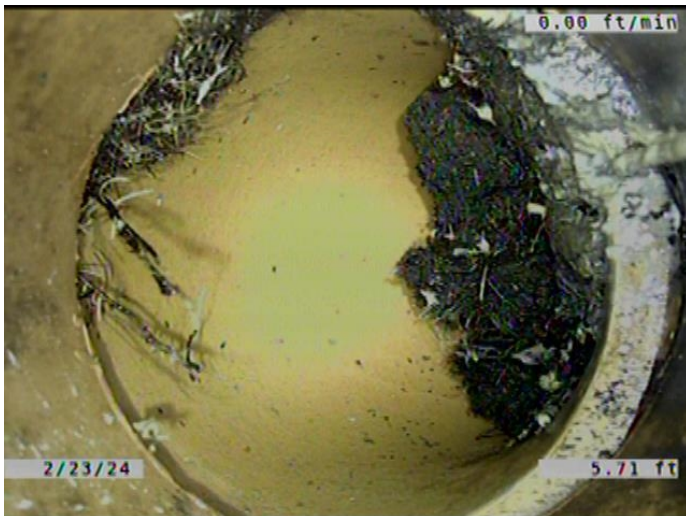
Code: **TBI**
Description: **Tap Break-in Intruding**

Distance (ft): **5.7**
Structural Grade: **0**
O&M Grade: **2**
Clock Start/From: **1**
Clock To:
1st Value: **6.000**
2nd Value: **1.000**
Value Percent:
Continuous Index:
Within 8" of Joint: **YES**
Remarks: **JOINTS OFFSET. ROOTS GROWING IN THE JOINTS INTO THE MAIN. CONST**

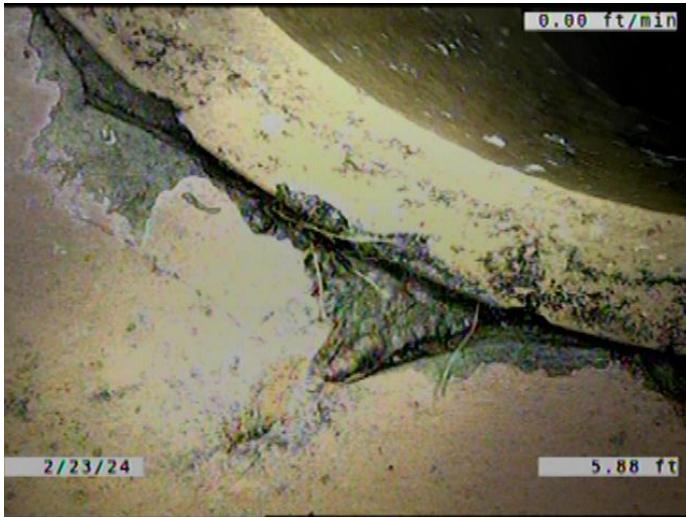
Code: **RFC**
Description: **Roots Fine Connection**

Distance (ft): **5.9**
Structural Grade: **0**
O&M Grade: **1**
Clock Start/From: **12**
Clock To:
1st Value:
2nd Value:
Value Percent:
Continuous Index:
Within 8" of Joint: **NO**
Remarks:

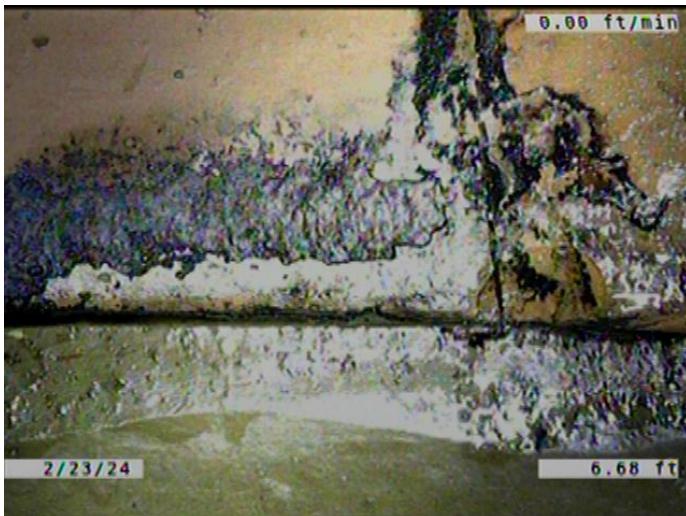
Code: **DAE**
Description: **Deposits Attached Encrustation**

Distance (ft): **6.7**
Structural Grade: **0**
O&M Grade: **2**
Clock Start/From: **12**
Clock To: **4**
1st Value:
2nd Value:
Value Percent: **5.000**
Continuous Index:
Within 8" of Joint: **YES**
Remarks:

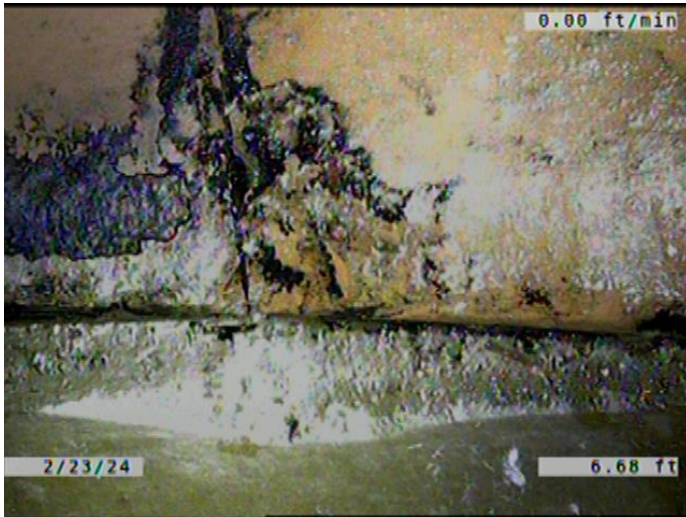
Code: **IRJ**
 Description: **Infiltration Runner Joint**

Distance (ft): **6.7**
 Structural Grade: **0**
 O&M Grade: **4**
 Clock Start/From: **2**
 Clock To:
 1st Value:
 2nd Value:
 Value Percent:
 Continuous Index:
 Within 8" of Joint: **YES**
 Remarks:

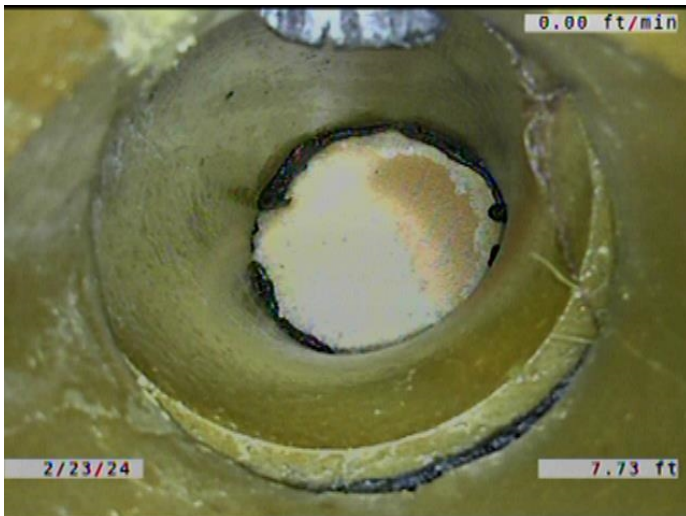
Code: **TFC**
 Description: **Tap Factory Capped**

Distance (ft): **7.7**
 Structural Grade: **0**
 O&M Grade: **0**
 Clock Start/From: **10**
 Clock To:
 1st Value: **6.000**
 2nd Value:
 Value Percent:
 Continuous Index:
 Within 8" of Joint: **YES**
 Remarks: **ROOTS AND ENCRUSTATION
 COMING FROM THE SERVICE TO MA**

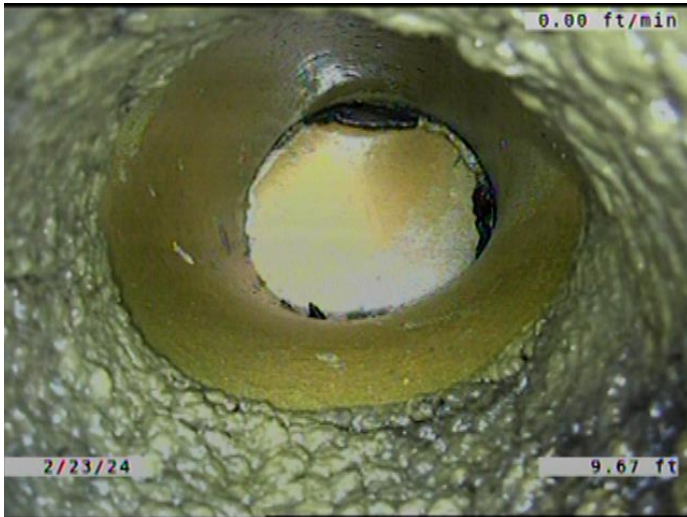
Code:	TFD
Description:	Tap Factory Defective
Distance (ft):	9.7
Structural Grade:	0
O&M Grade:	3
Clock Start/From:	1
Clock To:	
1st Value:	6.000
2nd Value:	
Value Percent:	
Continuous Index:	
Within 8" of Joint:	YES
Remarks:	CAPPED. ENCRUSTATION COMING FROM THE SERVICE TO MAIN CONN

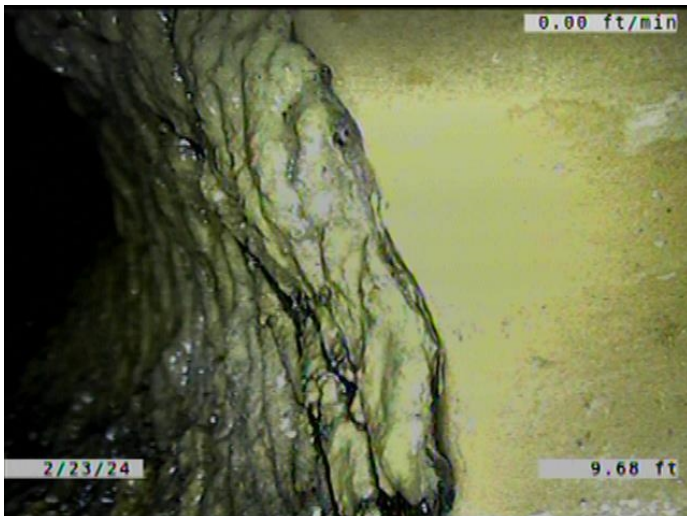
Code:	DAE
Description:	Deposits Attached Encrustation
Distance (ft):	9.7
Structural Grade:	0
O&M Grade:	2
Clock Start/From:	11
Clock To:	2
1st Value:	
2nd Value:	
Value Percent:	5.000
Continuous Index:	
Within 8" of Joint:	YES
Remarks:

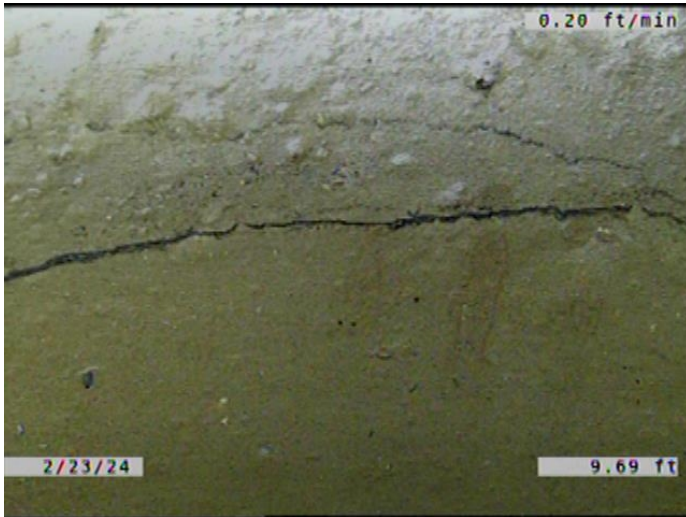
Code: **CM**
Description: **Crack Multiple**

Distance (ft): **9.7**
Structural Grade: **3**
O&M Grade: **0**
Clock Start/From: **9**
Clock To: **4**
1st Value:
2nd Value:
Value Percent:
Continuous Index:
Within 8" of Joint: **YES**
Remarks:

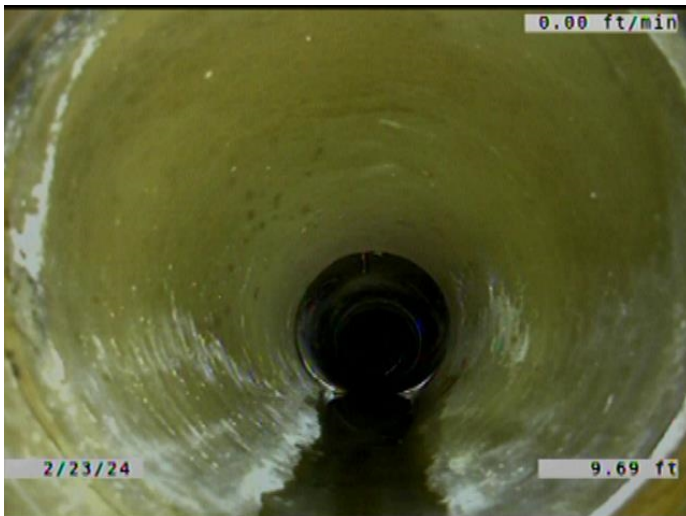
Code: **MWLS**
Description: **Miscellaneous Water Level Sag**

Distance (ft): **9.7**
Structural Grade: **2**
O&M Grade: **0**
Clock Start/From:
Clock To:
1st Value:
2nd Value:
Value Percent: **15.000**
Continuous Index: **F02**
Within 8" of Joint: **NO**
Remarks:

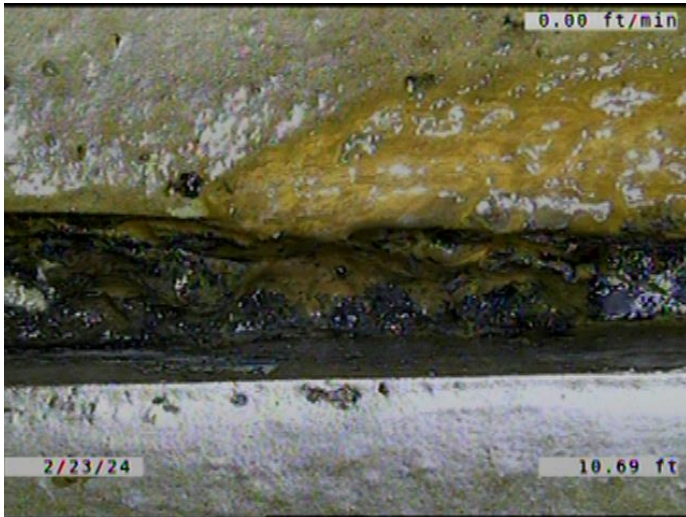
Code: **IRJ**
Description: **Infiltration Runner Joint**

Distance (ft): **10.7**
Structural Grade: **0**
O&M Grade: **4**
Clock Start/From: **2**
Clock To:
1st Value:
2nd Value:
Value Percent:
Continuous Index:
Within 8" of Joint: **YES**
Remarks:

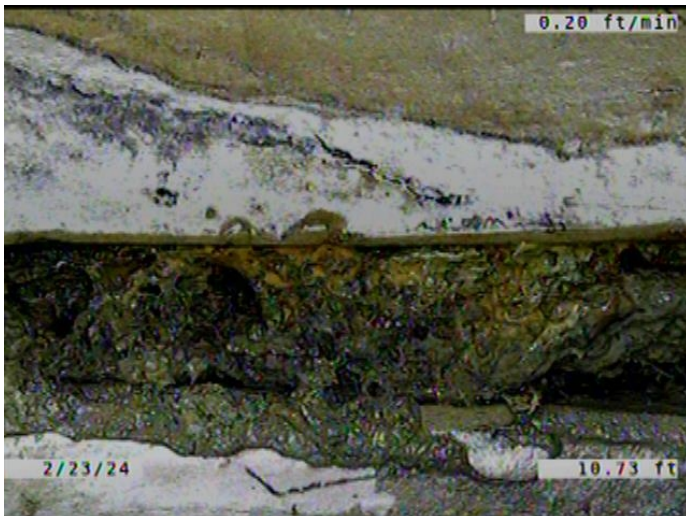
Code: **DAE**
Description: **Deposits Attached Encrustation**

Distance (ft): **10.7**
Structural Grade: **0**
O&M Grade: **2**
Clock Start/From: **7**
Clock To: **5**
1st Value:
2nd Value:
Value Percent: **5.000**
Continuous Index: **S03**
Within 8" of Joint: **YES**
Remarks:

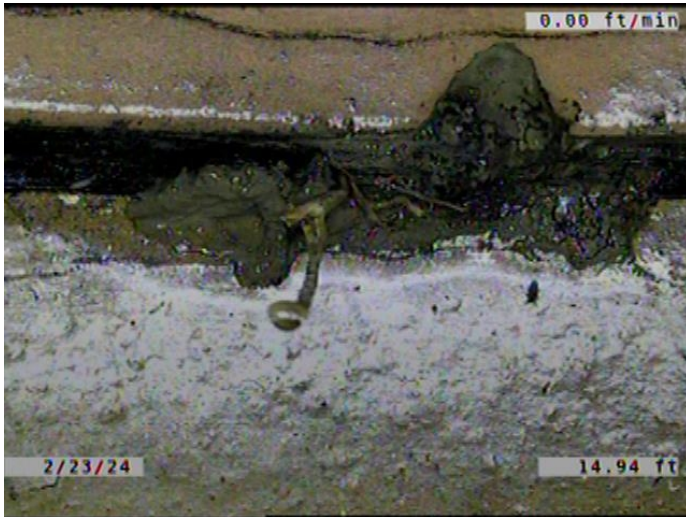
Code: **RFJ**
Description: **Roots Fine Joint**

Distance (ft): **14.9**
Structural Grade: **0**
O&M Grade: **1**
Clock Start/From: **12**
Clock To:
1st Value:
2nd Value:
Value Percent:
Continuous Index:
Within 8" of Joint: **YES**
Remarks:

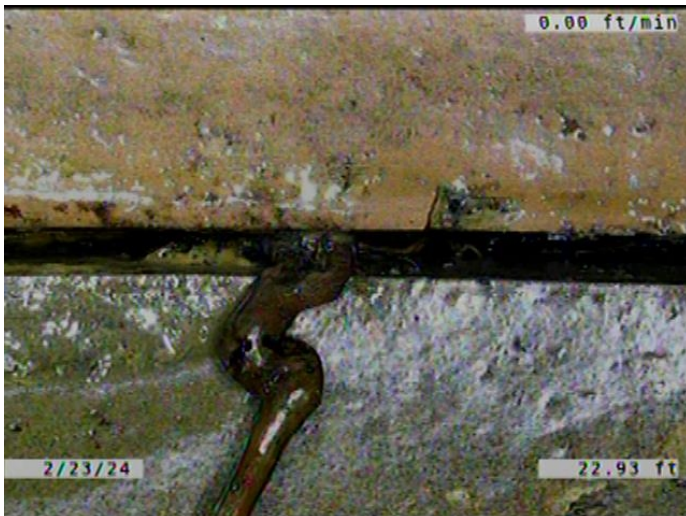
Code: **IRJ**
Description: **Infiltration Runner Joint**

Distance (ft): **22.9**
Structural Grade: **0**
O&M Grade: **4**
Clock Start/From: **10**
Clock To:
1st Value:
2nd Value:
Value Percent:
Continuous Index:
Within 8" of Joint: **YES**
Remarks:

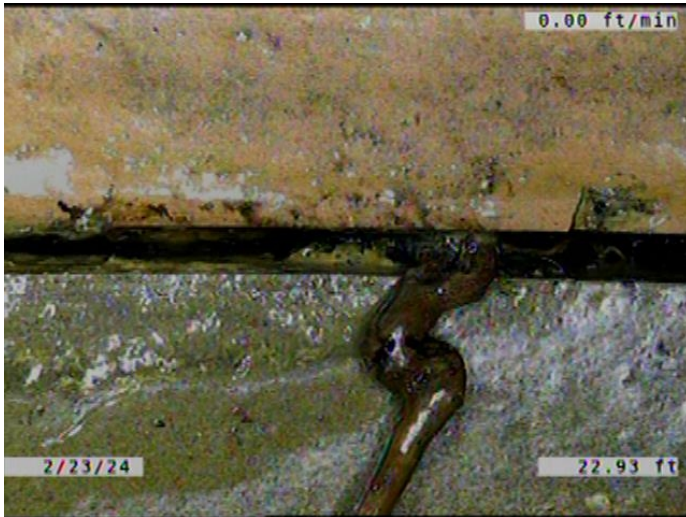
Code: **RFJ**
Description: **Roots Fine Joint**

Distance (ft): **22.9**
Structural Grade: **0**
O&M Grade: **1**
Clock Start/From: **10**
Clock To:
1st Value:
2nd Value:
Value Percent:
Continuous Index:
Within 8" of Joint: **YES**
Remarks:

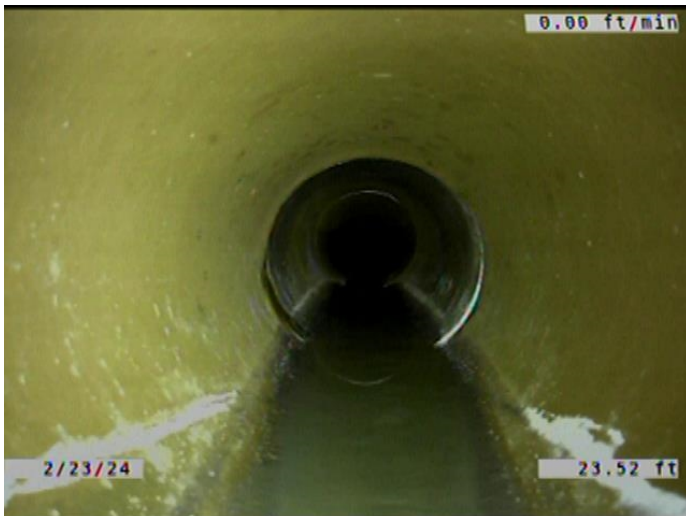
Code: **MWLS**
Description: **Miscellaneous Water Level Sag**

Distance (ft): **23.5**
Structural Grade: **2**
O&M Grade: **0**
Clock Start/From:
Clock To:
1st Value:
2nd Value:
Value Percent: **10.000**
Continuous Index: **S04**
Within 8" of Joint: **NO**
Remarks:

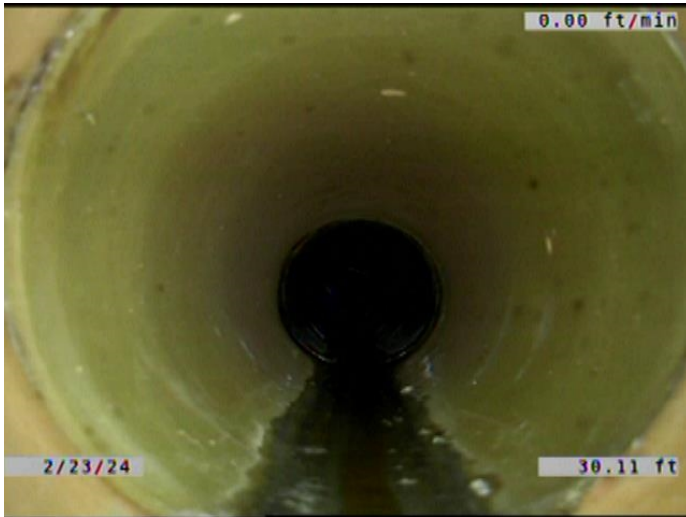
Code: **MWLS**
Description: **Miscellaneous Water Level Sag**

Distance (ft): **30.1**
Structural Grade: **2**
O&M Grade: **0**
Clock Start/From:
Clock To:
1st Value:
2nd Value:
Value Percent: **10.000**
Continuous Index: **F04**
Within 8" of Joint: **NO**
Remarks:

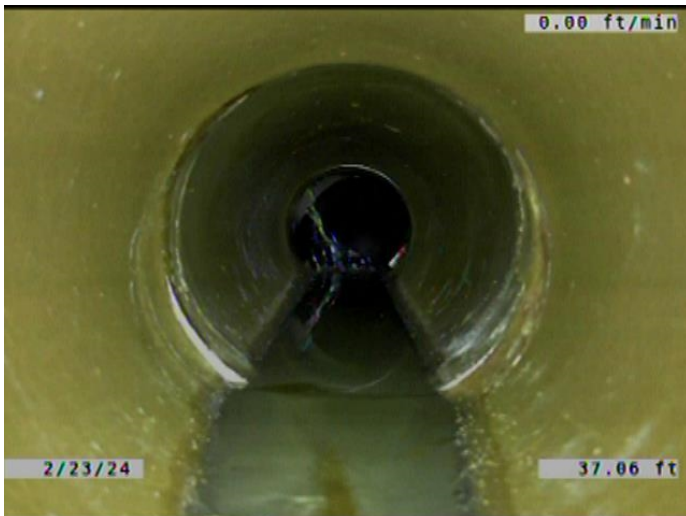
Code: **MWLS**
Description: **Miscellaneous Water Level Sag**

Distance (ft): **37.1**
Structural Grade: **2**
O&M Grade: **0**
Clock Start/From:
Clock To:
1st Value:
2nd Value:
Value Percent: **10.000**
Continuous Index: **S05**
Within 8" of Joint: **NO**
Remarks:

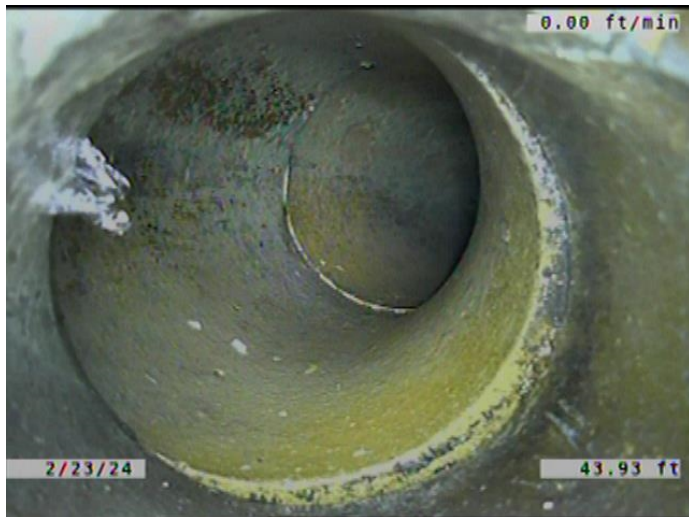
Code: **TFA**
Description: **Tap Factory Activity**

Distance (ft): **43.9**
Structural Grade: **0**
O&M Grade: **0**
Clock Start/From: **10**
Clock To:
1st Value: **6.000**
2nd Value:
Value Percent:
Continuous Index:
Within 8" of Joint: **YES**
Remarks: **SERVICE OFFSET.**

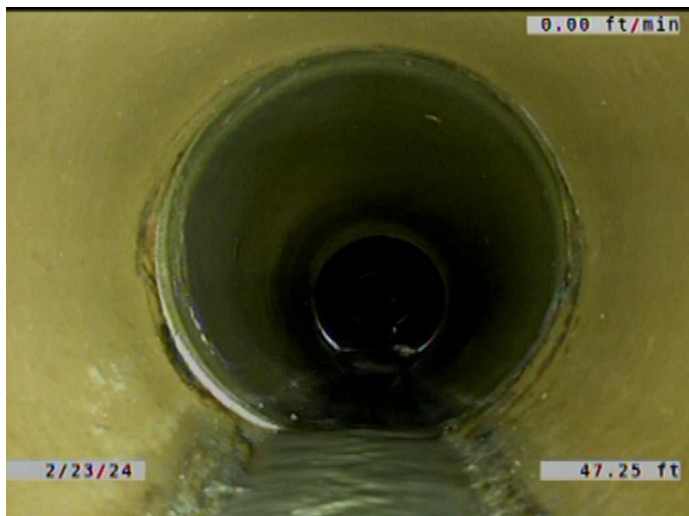
Code: **MWLS**
Description: **Miscellaneous Water Level Sag**

Distance (ft): **47.3**
Structural Grade: **2**
O&M Grade: **0**
Clock Start/From:
Clock To:
1st Value:
2nd Value:
Value Percent: **10.000**
Continuous Index: **F05**
Within 8" of Joint: **NO**
Remarks:

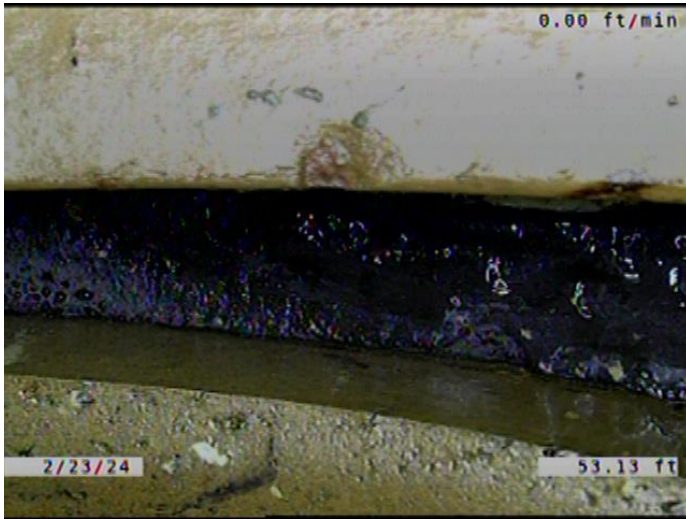
Code: **IRJ**
Description: **Infiltration Runner Joint**

Distance (ft): **53.1**
Structural Grade: **0**
O&M Grade: **4**
Clock Start/From: **3**
Clock To:
1st Value:
2nd Value:
Value Percent:
Continuous Index:
Within 8" of Joint: **YES**
Remarks:

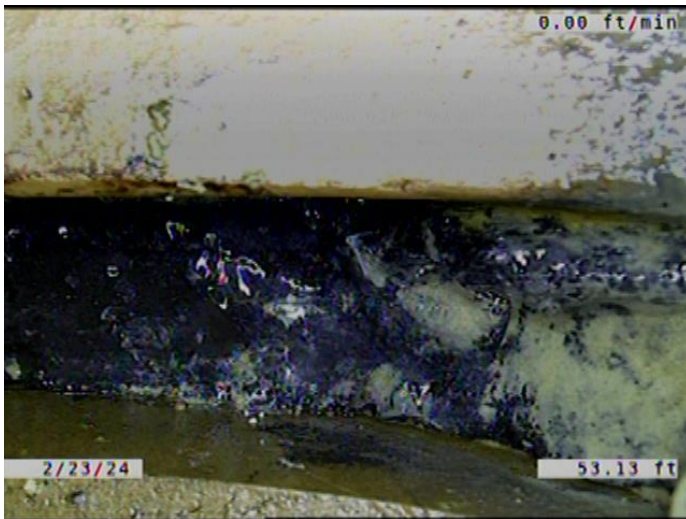
Code: **JAM**
Description: **Joint Angular Medium**

Distance (ft): **53.1**
Structural Grade: **3**
O&M Grade: **0**
Clock Start/From:
Clock To:
1st Value:
2nd Value:
Value Percent:
Continuous Index:
Within 8" of Joint: **NO**
Remarks:

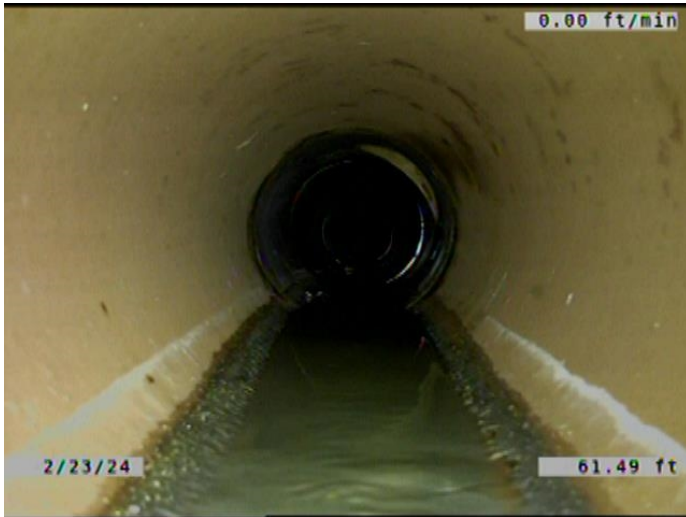
Code: **MWLS**
Description: **Miscellaneous Water Level Sag**

Distance (ft): **61.5**
Structural Grade: **2**
O&M Grade: **0**
Clock Start/From:
Clock To:
1st Value:
2nd Value:
Value Percent: **10.000**
Continuous Index: **S06**
Within 8" of Joint: **NO**
Remarks:

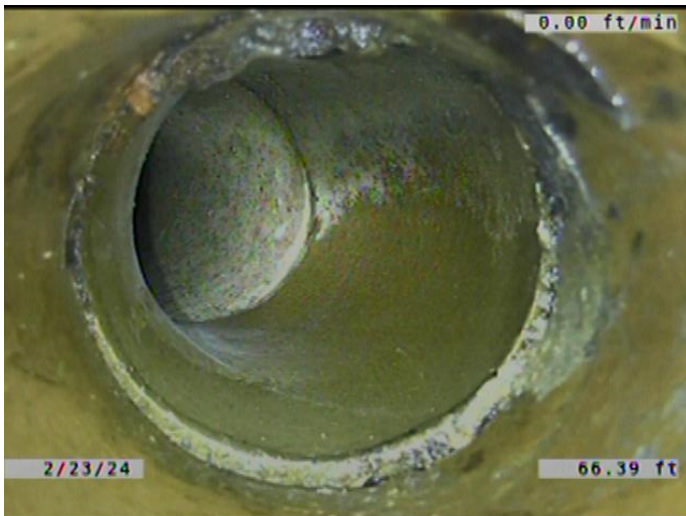
Code: **TF**
Description: **Tap Factory**

Distance (ft): **66.4**
Structural Grade: **0**
O&M Grade: **0**
Clock Start/From: **2**
Clock To:
1st Value: **6.000**
2nd Value:
Value Percent:
Continuous Index:
Within 8" of Joint: **YES**
Remarks: **ENCRUSTATION COMING FROM THE SERVICE TO MAIN CONNECTION.**

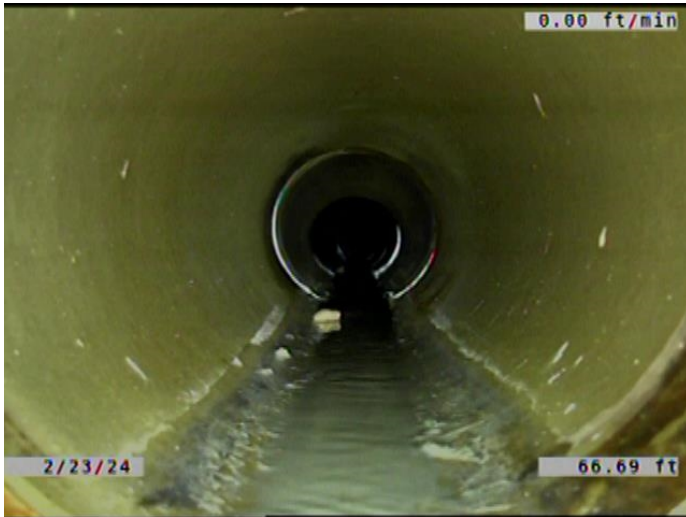
Code: **MWLS**
Description: **Miscellaneous Water Level Sag**

Distance (ft): **66.7**
Structural Grade: **2**
O&M Grade: **0**
Clock Start/From:
Clock To:
1st Value:
2nd Value:
Value Percent: **10.000**
Continuous Index: **F06**
Within 8" of Joint: **NO**
Remarks:

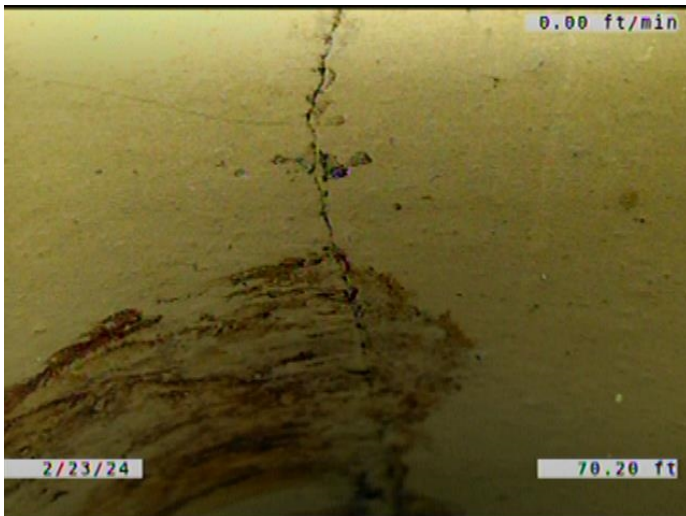
Code: **CM**
Description: **Crack Multiple**

Distance (ft): **70.2**
Structural Grade: **3**
O&M Grade: **0**
Clock Start/From: **10**
Clock To: **11**
1st Value:
2nd Value:
Value Percent:
Continuous Index:
Within 8" of Joint: **YES**
Remarks:

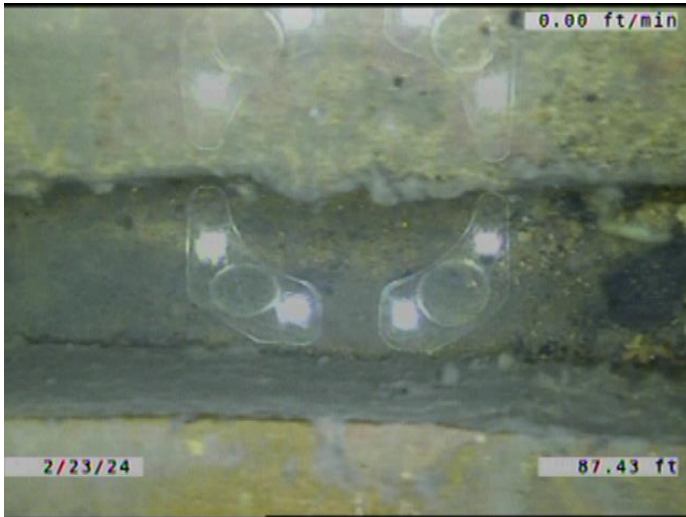
Code: **JAM**
Description: **Joint Angular Medium**

Distance (ft): **87.4**
Structural Grade: **3**
O&M Grade: **0**
Clock Start/From:
Clock To:
1st Value:
2nd Value:
Value Percent:
Continuous Index:
Within 8" of Joint: **NO**
Remarks:

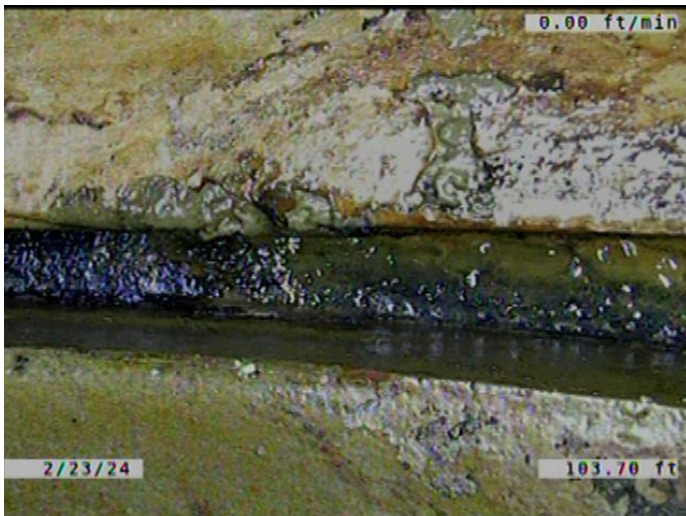
Code: **IRJ**
Description: **Infiltration Runner Joint**

Distance (ft): **103.7**
Structural Grade: **0**
O&M Grade: **4**
Clock Start/From: **2**
Clock To:
1st Value:
2nd Value:
Value Percent:
Continuous Index:
Within 8" of Joint: **YES**
Remarks:

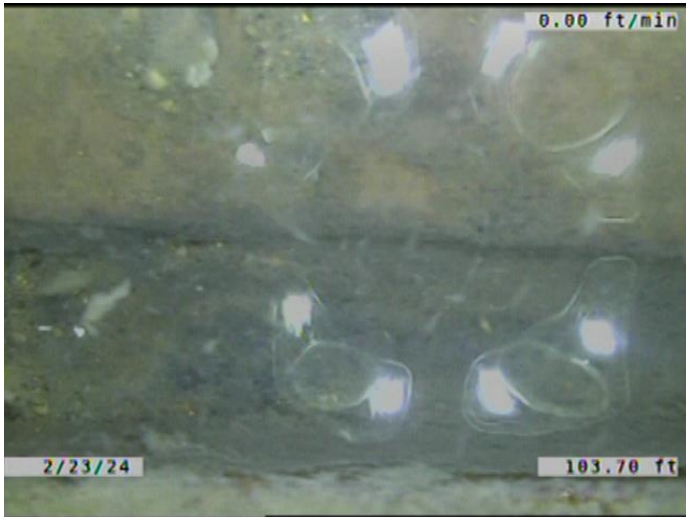
Code: **JAM**
Description: **Joint Angular Medium**

Distance (ft): **103.7**
Structural Grade: **3**
O&M Grade: **0**
Clock Start/From:
Clock To:
1st Value:
2nd Value:
Value Percent:
Continuous Index:
Within 8" of Joint: **NO**
Remarks:

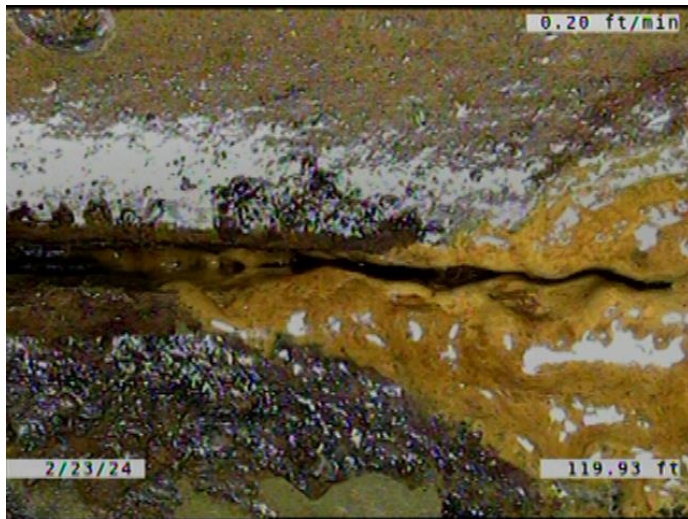
Code: **IDJ**
 Description: **Infiltration Dripper Joint**

Distance (ft): **119.9**
 Structural Grade: **0**
 O&M Grade: **3**
 Clock Start/From: **2**
 Clock To:
 1st Value:
 2nd Value:
 Value Percent:
 Continuous Index:
 Within 8" of Joint: **YES**
 Remarks:

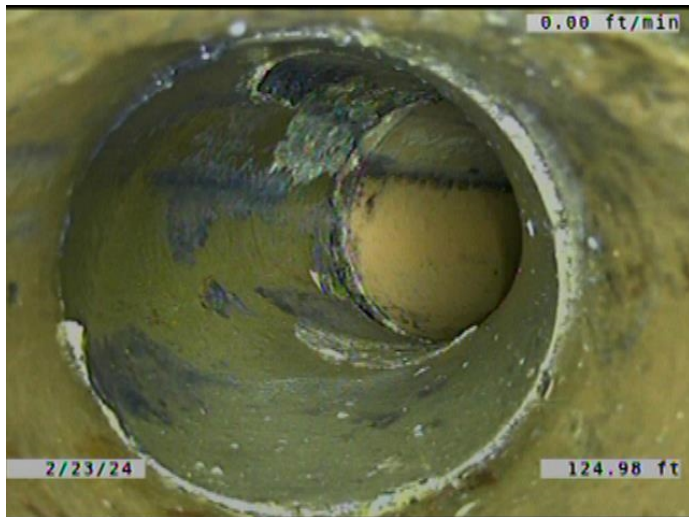
Code: **TF**
 Description: **Tap Factory**

Distance (ft): **125.0**
 Structural Grade: **0**
 O&M Grade: **0**
 Clock Start/From: **10**
 Clock To:
 1st Value: **6.000**

2nd Value:
 Value Percent:
 Continuous Index:
 Within 8" of Joint: **YES**
 Remarks: **ROOTS AND ENCRUSTATION COMING FROM THE JOINTS.**

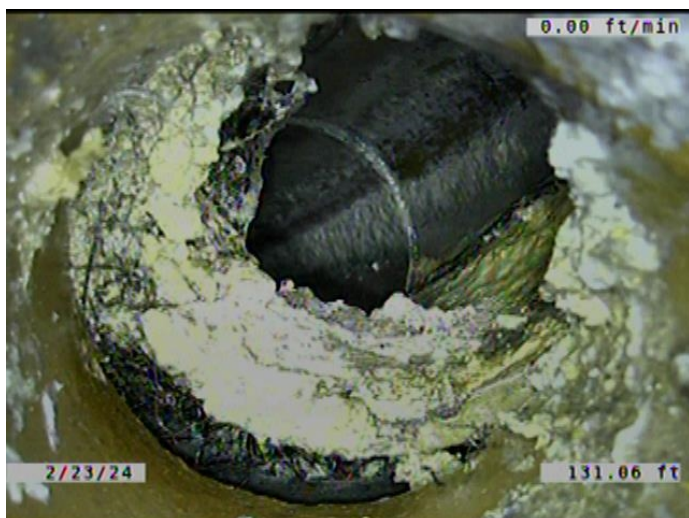
Code: **TFD**
 Description: **Tap Factory Defective**

Distance (ft): **131.1**
 Structural Grade: **0**
 O&M Grade: **3**
 Clock Start/From: **1**
 Clock To:
 1st Value: **6.000**

2nd Value:
 Value Percent:
 Continuous Index:
 Within 8" of Joint: **YES**
 Remarks: **SERVICE LARGE OFFSET. ROOTS AND ENCRUSTATION COMING FROM THE**

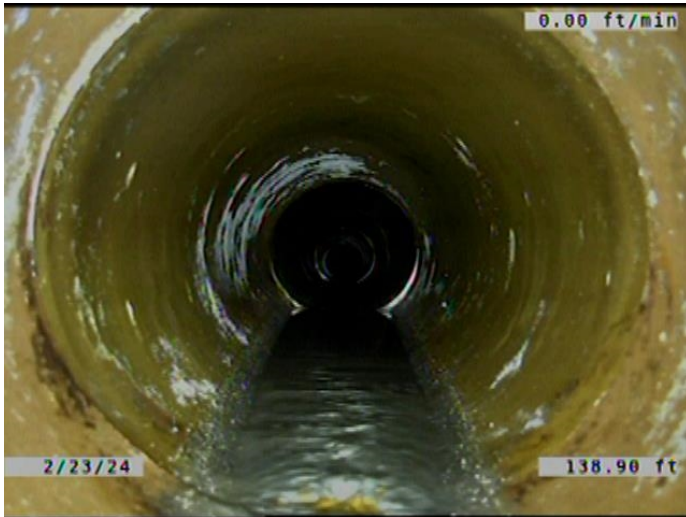
Code: **MWLS**
Description: **Miscellaneous Water Level Sag**

Distance (ft): **138.9**
Structural Grade: **2**
O&M Grade: **0**
Clock Start/From:
Clock To:
1st Value:
2nd Value:
Value Percent: **10.000**
Continuous Index: **S08**
Within 8" of Joint: **NO**
Remarks:

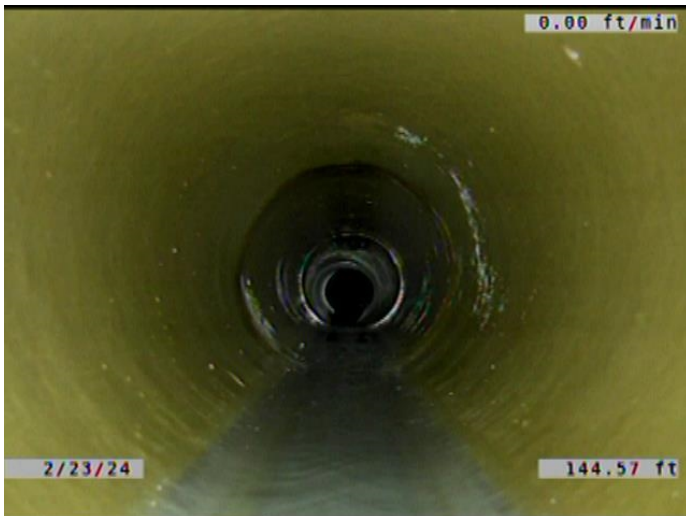
Code: **MWLS**
Description: **Miscellaneous Water Level Sag**

Distance (ft): **144.6**
Structural Grade: **2**
O&M Grade: **0**
Clock Start/From:
Clock To:
1st Value:
2nd Value:
Value Percent: **10.000**
Continuous Index: **F08**
Within 8" of Joint: **NO**
Remarks:

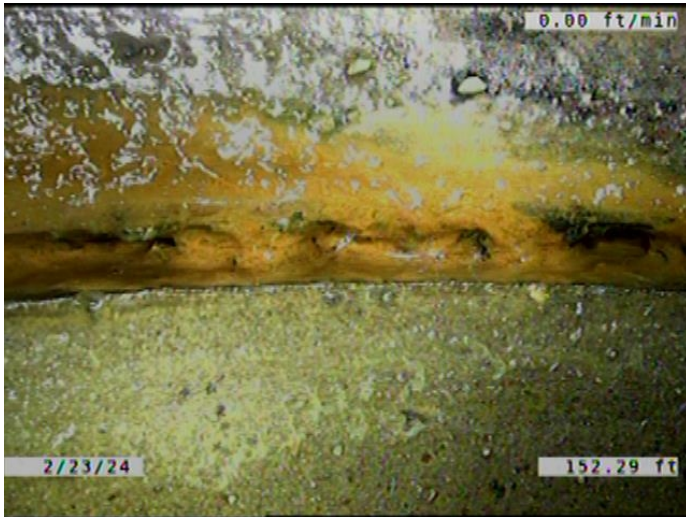
Code: **IRJ**
Description: **Infiltration Runner Joint**

Distance (ft): **152.3**
Structural Grade: **0**
O&M Grade: **4**
Clock Start/From: **9**
Clock To: **10**
1st Value:
2nd Value:
Value Percent:
Continuous Index:
Within 8" of Joint: **YES**
Remarks:

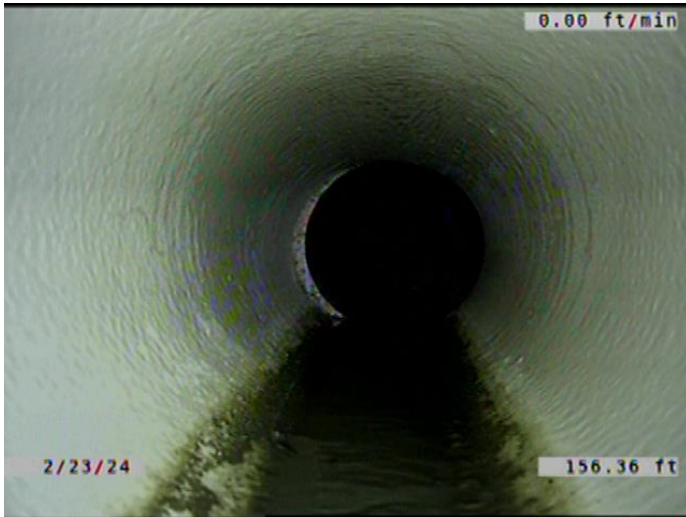
Code: **MWLS**
Description: **Miscellaneous Water Level Sag**

Distance (ft): **156.4**
Structural Grade: **2**
O&M Grade: **0**
Clock Start/From:
Clock To:
1st Value:
2nd Value:
Value Percent: **10.000**
Continuous Index: **S10**
Within 8" of Joint: **NO**
Remarks:

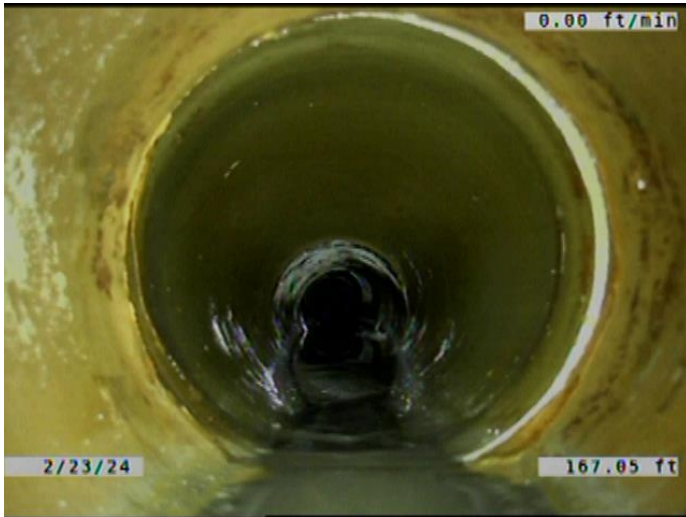
Code: **MWLS**
Description: **Miscellaneous Water Level Sag**

Distance (ft): **167.0**
Structural Grade: **2**
O&M Grade: **0**
Clock Start/From:
Clock To:
1st Value:
2nd Value:
Value Percent: **10.000**
Continuous Index: **F10**
Within 8" of Joint: **NO**
Remarks:

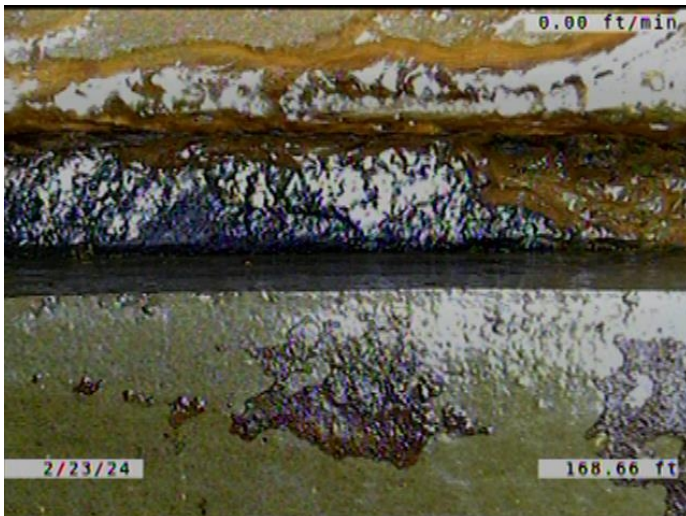
Code: **JAM**
Description: **Joint Angular Medium**

Distance (ft): **168.7**
Structural Grade: **3**
O&M Grade: **0**
Clock Start/From:
Clock To:
1st Value:
2nd Value:
Value Percent:
Continuous Index:
Within 8" of Joint: **NO**
Remarks:

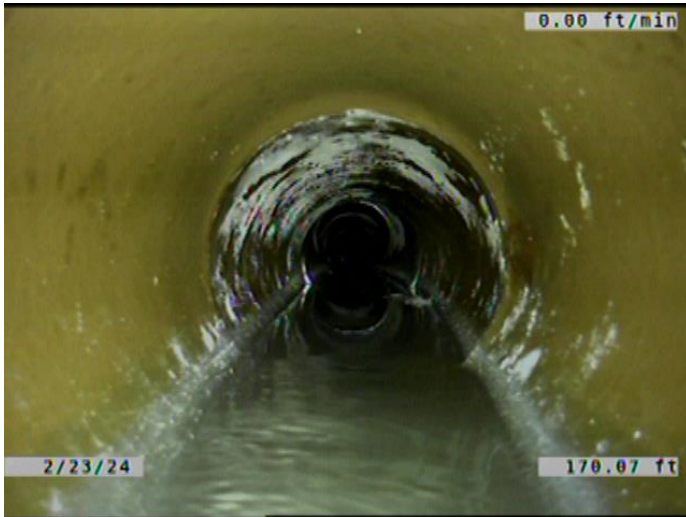
Code: **MWLS**
Description: **Miscellaneous Water Level Sag**

Distance (ft): **170.1**
Structural Grade: **2**
O&M Grade: **0**
Clock Start/From:
Clock To:
1st Value:
2nd Value:
Value Percent: **15.000**
Continuous Index: **S11**
Within 8" of Joint: **NO**
Remarks:

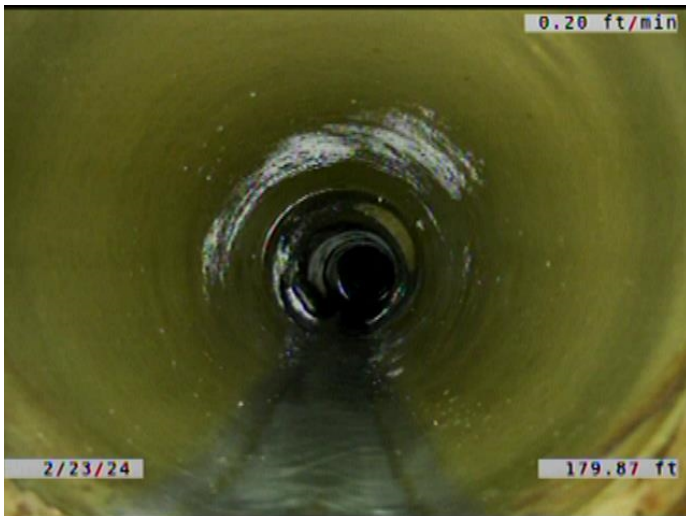
Code: **MWLS**
Description: **Miscellaneous Water Level Sag**

Distance (ft): **179.9**
Structural Grade: **2**
O&M Grade: **0**
Clock Start/From:
Clock To:
1st Value:
2nd Value:
Value Percent: **15.000**
Continuous Index: **F11**
Within 8" of Joint: **NO**
Remarks:

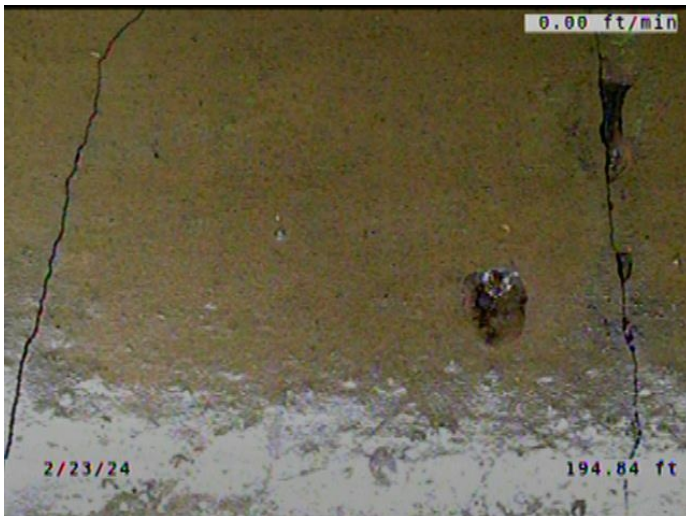
Code: **CM**
Description: **Crack Multiple**

Distance (ft): **194.8**
Structural Grade: **3**
O&M Grade: **0**
Clock Start/From: **11**
Clock To: **3**
1st Value:
2nd Value:
Value Percent:
Continuous Index:
Within 8" of Joint: **YES**
Remarks:

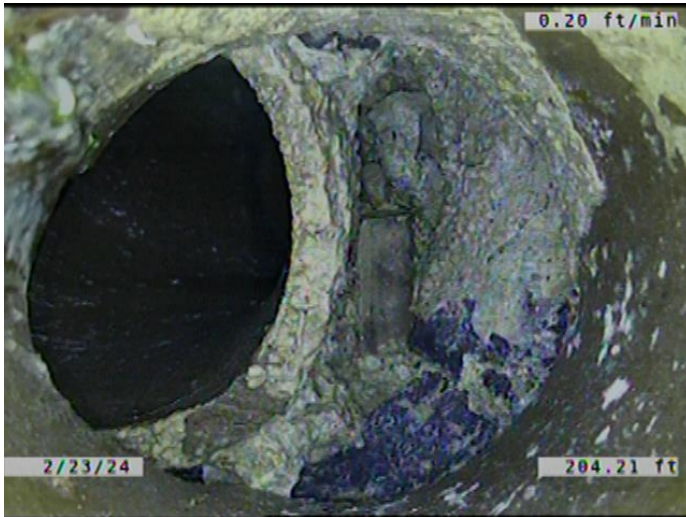
Code: **TFD**
 Description: **Tap Factory Defective**

Distance (ft): **204.2**
 Structural Grade: **0**
 O&M Grade: **3**
 Clock Start/From: **11**
 Clock To:
 1st Value: **6.000**
 2nd Value:
 Value Percent:
 Continuous Index:
 Within 8" of Joint: **YES**
 Remarks: **ACTIVITY. SERVICE LARGE OFFSET. WATER EXITING THE PIPE.**

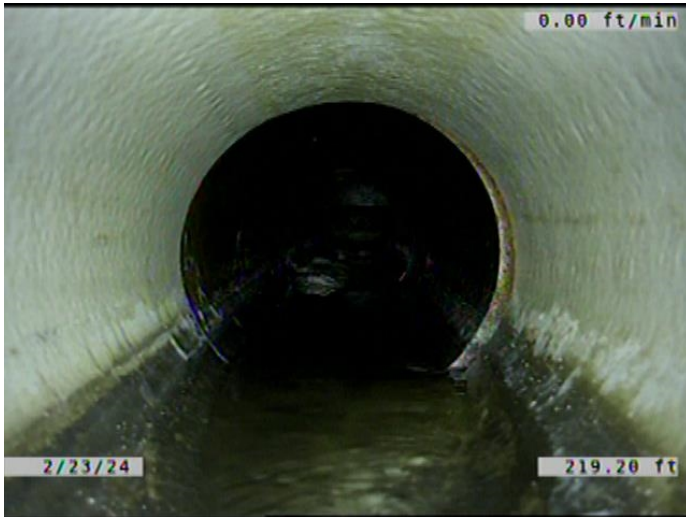
Code: **MWLS**
Description: **Miscellaneous Water Level Sag**

Distance (ft): **219.2**
Structural Grade: **2**
O&M Grade: **0**
Clock Start/From:
Clock To:
1st Value:
2nd Value:
Value Percent: **10.000**
Continuous Index: **S13**
Within 8" of Joint: **NO**
Remarks:

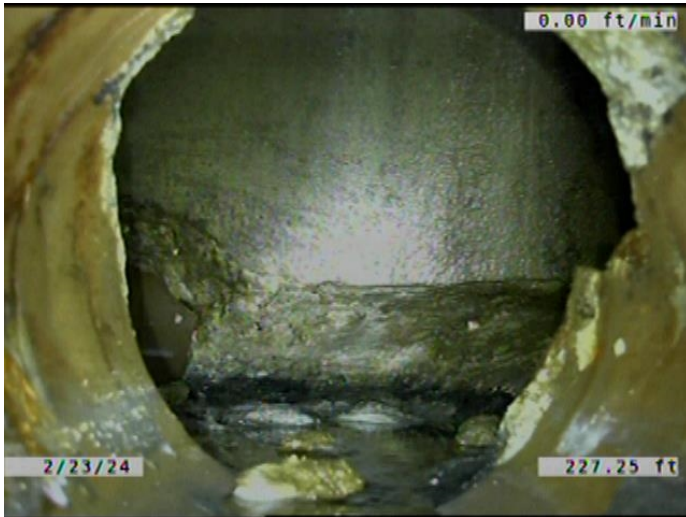
Code: **MWLS**
Description: **Miscellaneous Water Level Sag**

Distance (ft): **227.2**
Structural Grade: **2**
O&M Grade: **0**
Clock Start/From:
Clock To:
1st Value:
2nd Value:
Value Percent: **10.000**
Continuous Index: **F13**
Within 8" of Joint: **NO**
Remarks:

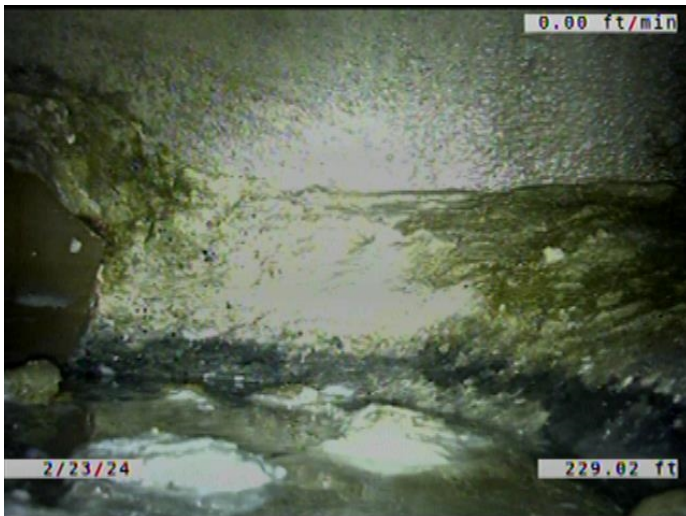
Code: **DSF**
Description: **Deposits Settled Fine**

Distance (ft): **229.0**
Structural Grade: **0**
O&M Grade: **2**
Clock Start/From: **5**
Clock To: **7**
1st Value:
2nd Value:
Value Percent: **5.000**
Continuous Index: **F01**
Within 8" of Joint: **YES**
Remarks:

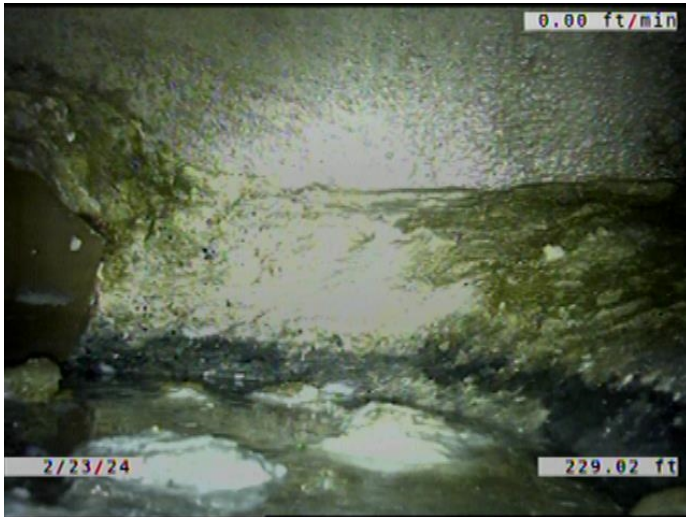
Code:	DAE
Description:	Deposits Attached Encrustation
Distance (ft):	229.0
Structural Grade:	0
O&M Grade:	2
Clock Start/From:	7
Clock To:	5
1st Value:	
2nd Value:	
Value Percent:	5.000
Continuous Index:	F03
Within 8" of Joint:	YES
Remarks:
