## Profile/Photo Observation Report

Date:	<b>03/04/2024</b>	Weather:		Coding:	<b>PACP 7.0</b>
Pipe Length (ft):	<b>146.0</b>	Owner:	<b>City of Hobart</b>	Pre Clean:	<b>Heavy Cleaning</b>
P.O.#:		Surveyor:	<b>S. Bucklin</b>	PSR:	<b>P-606-061-062</b>
Customer:	<b>City of Hobart</b>	Clean Date:	<b>02/21/2024</b>	Shape:	<b>C</b>

Location Details:	<b>END OF THE DRIVEWAY AT 502 W 7</b>	Direction of Survey:	<b>Upstream</b>
US MH:	<b>M-606-061</b>	DS MH:	<b>M-606-062</b>
		Total Length Surveyed (ft):	<b>169.8</b>

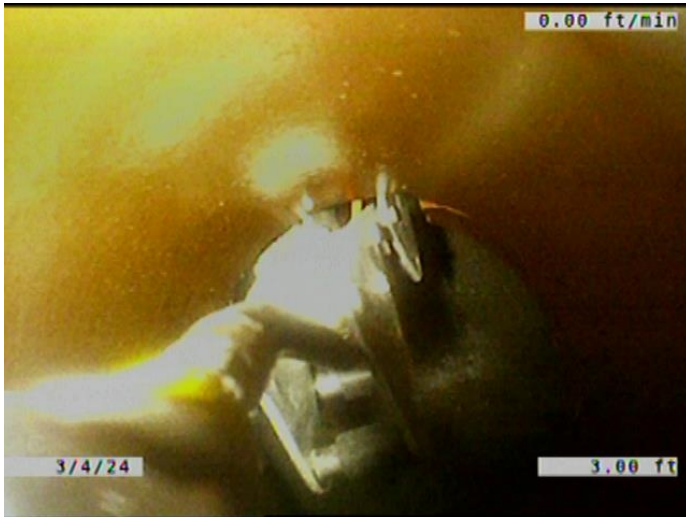
Code: **MGO**  
Description: **Miscellaneous General Observation**

Distance (ft): **3.0**  
Structural Grade: **0**  
O&M Grade: **0**  
Clock Start/From:  
Clock To:  
1st Value:  
2nd Value:  
Value Percent:  
Continuous Index:  
Within 8" of Joint: **NO**  
Remarks: **DROP INTO THE MANHOLE. HAD TO START IN THE PIPE.**

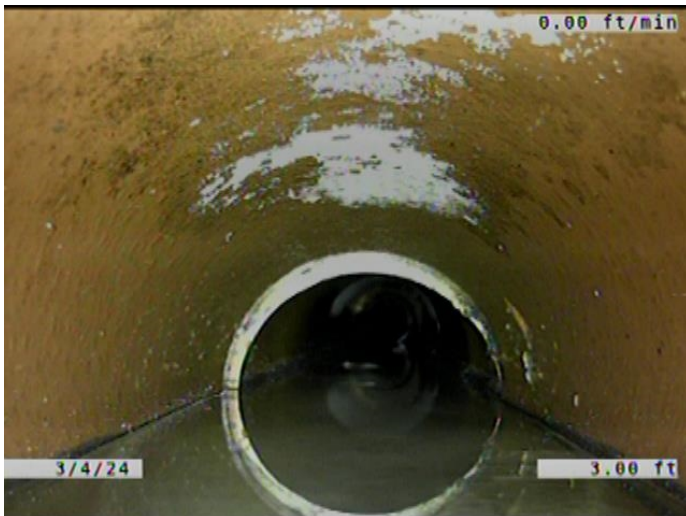
Code: **MWLS**  
Description: **Miscellaneous Water Level Sag**

Distance (ft): **3.0**  
Structural Grade: **3**  
O&M Grade: **0**  
Clock Start/From:  
Clock To:  
1st Value:  
2nd Value:  
Value Percent: **50.000**  
Continuous Index: **S01**  
Within 8" of Joint: **NO**  
Remarks:

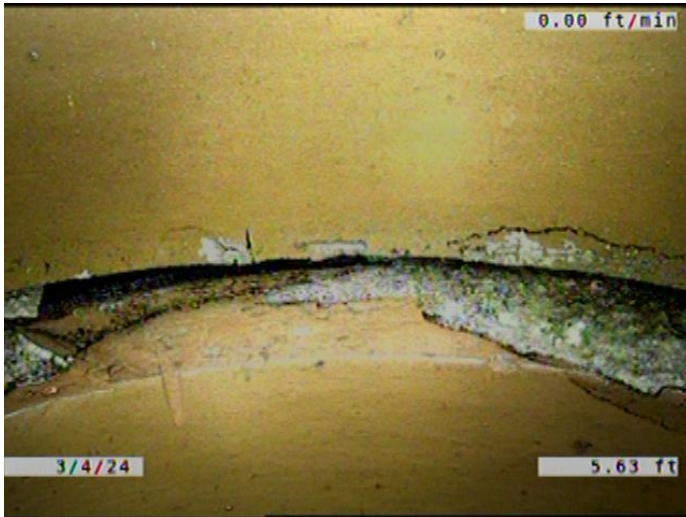
Code: **JOMD**  
Description: **Joint Offset Medium Defective**

Distance (ft): **5.6**  
Structural Grade: **3**  
O&M Grade: **0**  
Clock Start/From:  
Clock To:  
1st Value:  
2nd Value:  
Value Percent:  
Continuous Index:  
Within 8" of Joint: **NO**  
Remarks:

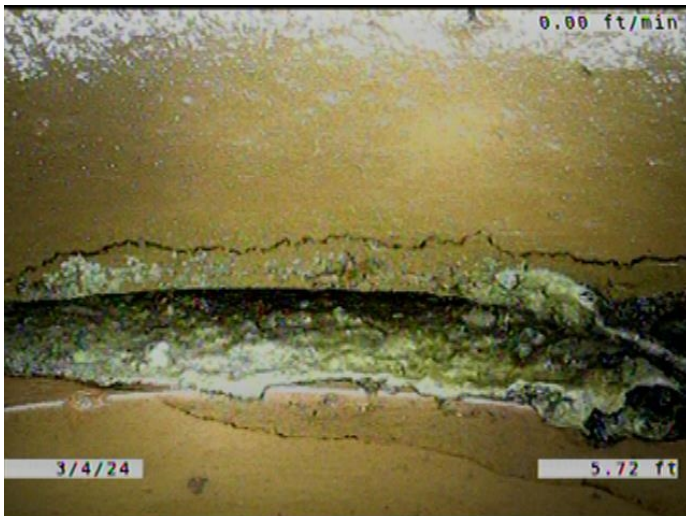
Code: **DAE**  
Description: **Deposits Attached Encrustation**

Distance (ft): **5.7**  
Structural Grade: **0**  
O&M Grade: **2**  
Clock Start/From: **7**  
Clock To: **5**  
1st Value:  
2nd Value:  
Value Percent: **5.000**  
Continuous Index: **S02**  
Within 8" of Joint: **YES**  
Remarks:

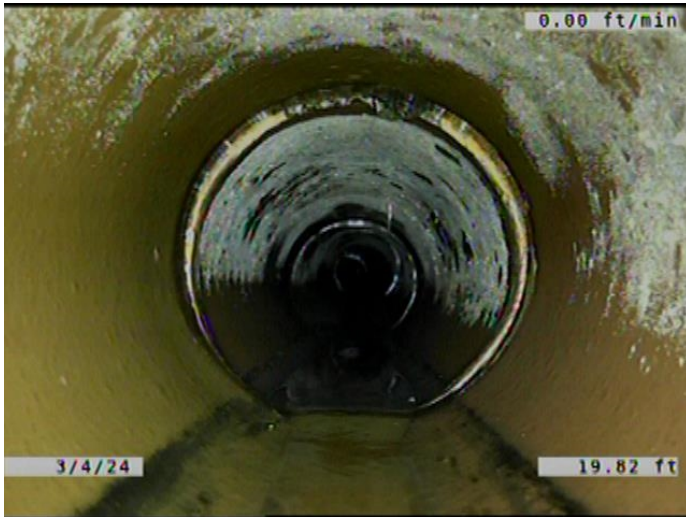
Code: **MWLS**  
Description: **Miscellaneous Water Level Sag**

Distance (ft): **19.8**  
Structural Grade: **3**  
O&M Grade: **0**  
Clock Start/From:  
Clock To:  
1st Value:  
2nd Value:  
Value Percent: **50.000**  
Continuous Index: **F01**  
Within 8" of Joint: **NO**  
Remarks:

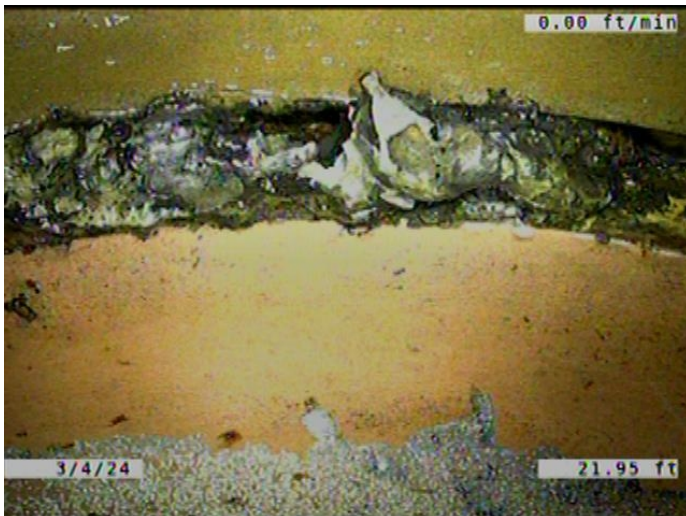
Code: **IDJ**  
Description: **Infiltration Dripper Joint**

Distance (ft): **21.9**  
Structural Grade: **0**  
O&M Grade: **3**  
Clock Start/From: **12**  
Clock To: **1**  
1st Value:  
2nd Value:  
Value Percent:  
Continuous Index:  
Within 8" of Joint: **YES**  
Remarks:

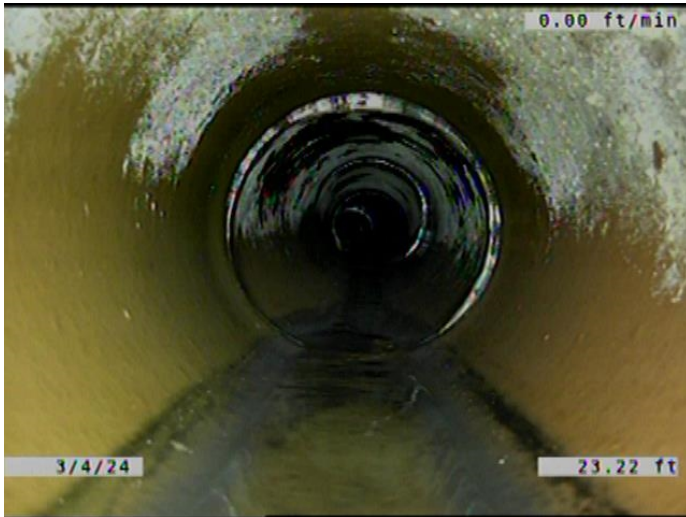
Code: **MWLS**  
Description: **Miscellaneous Water Level Sag**

Distance (ft): **23.2**  
Structural Grade: **2**  
O&M Grade: **0**  
Clock Start/From:  
Clock To:  
1st Value:  
2nd Value:  
Value Percent: **5.000**  
Continuous Index:  
Within 8" of Joint: **NO**  
Remarks:

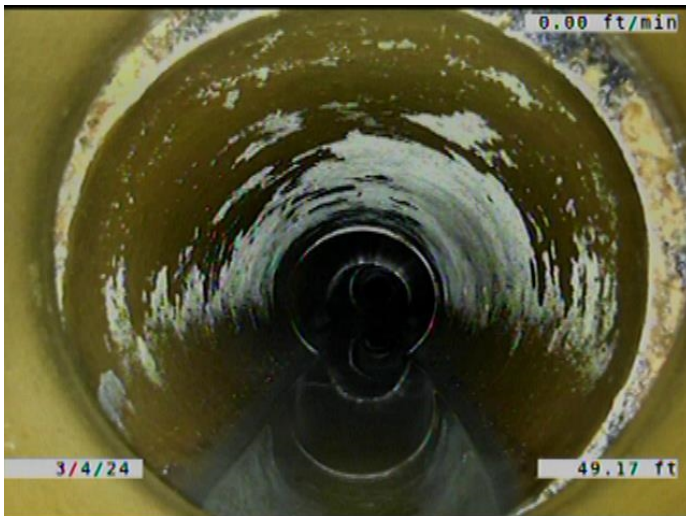
Code: **MWLS**  
Description: **Miscellaneous Water Level Sag**

Distance (ft): **49.2**  
Structural Grade: **2**  
O&M Grade: **0**  
Clock Start/From:  
Clock To:  
1st Value:  
2nd Value:  
Value Percent: **10.000**  
Continuous Index: **S03**  
Within 8" of Joint: **NO**  
Remarks:

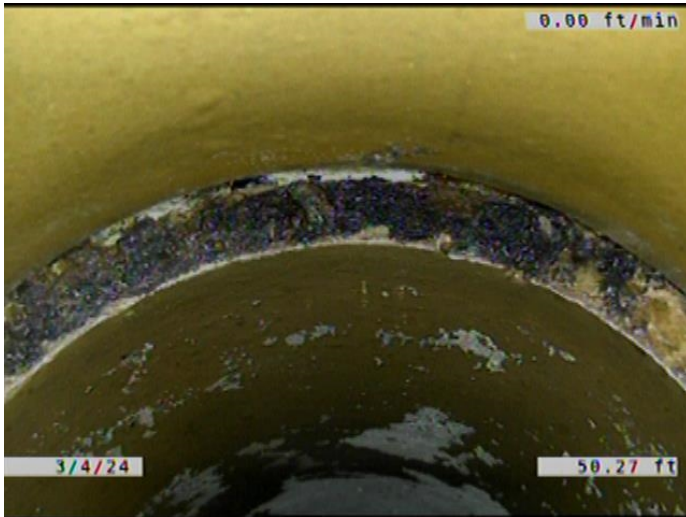
Code: **JOMD**  
Description: **Joint Offset Medium Defective**

Distance (ft): **50.3**  
Structural Grade: **3**  
O&M Grade: **0**  
Clock Start/From:  
Clock To:  
1st Value:  
2nd Value:  
Value Percent:  
Continuous Index:  
Within 8" of Joint: **NO**  
Remarks:

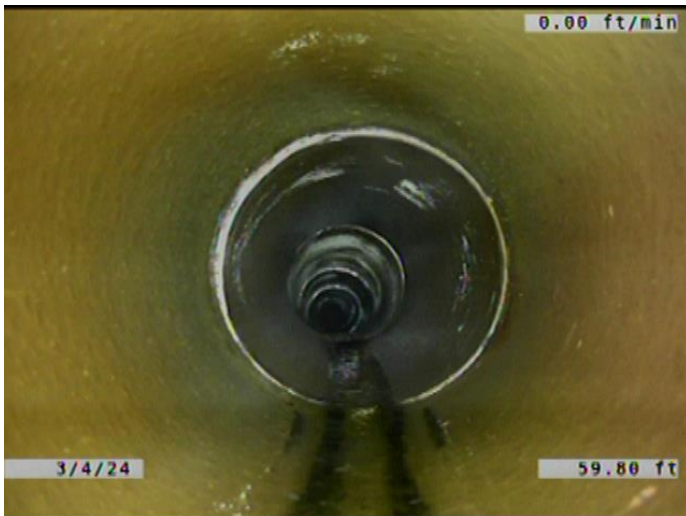
Code: **MWLS**  
Description: **Miscellaneous Water Level Sag**

Distance (ft): **59.8**  
Structural Grade: **2**  
O&M Grade: **0**  
Clock Start/From:  
Clock To:  
1st Value:  
2nd Value:  
Value Percent: **10.000**  
Continuous Index: **F03**  
Within 8" of Joint: **NO**  
Remarks:

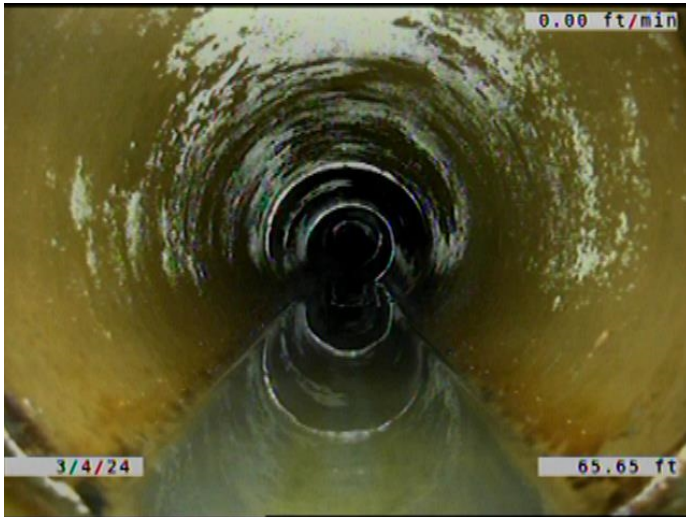
Code: **MWLS**  
Description: **Miscellaneous Water Level Sag**

Distance (ft): **65.6**  
Structural Grade: **2**  
O&M Grade: **0**  
Clock Start/From:  
Clock To:  
1st Value:  
2nd Value:  
Value Percent: **10.000**  
Continuous Index: **S04**  
Within 8" of Joint: **NO**  
Remarks:

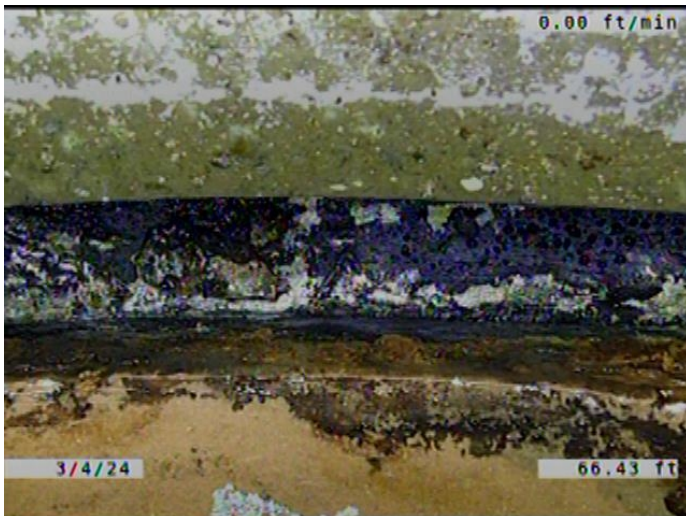
Code: **JAM**  
Description: **Joint Angular Medium**

Distance (ft): **66.4**  
Structural Grade: **3**  
O&M Grade: **0**  
Clock Start/From:  
Clock To:  
1st Value:  
2nd Value:  
Value Percent:  
Continuous Index:  
Within 8" of Joint: **NO**  
Remarks:

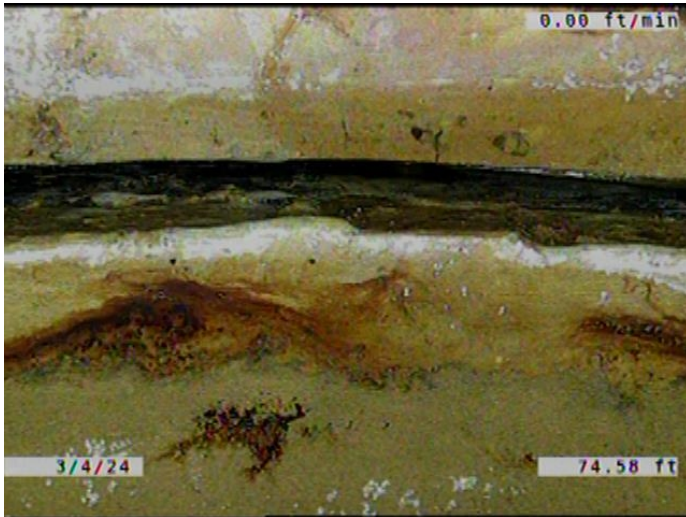
Code: **IDJ**  
Description: **Infiltration Dripper Joint**

Distance (ft): **74.6**  
Structural Grade: **0**  
O&M Grade: **3**  
Clock Start/From: **12**  
Clock To:  
1st Value:  
2nd Value:  
Value Percent:  
Continuous Index:  
Within 8" of Joint: **YES**  
Remarks:

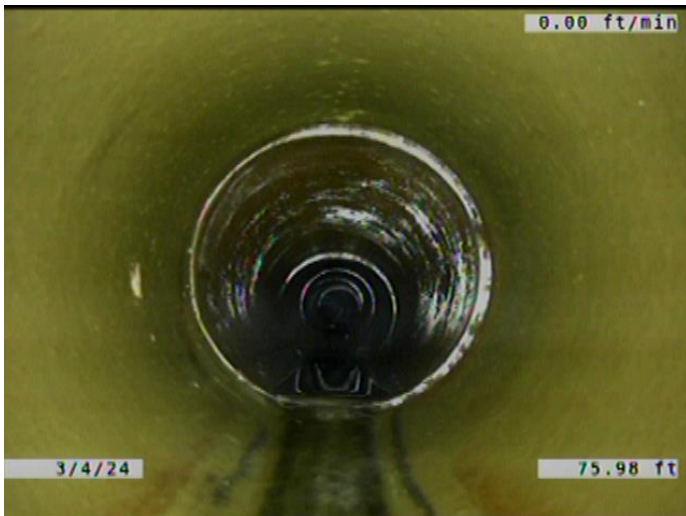
Code: **MWLS**  
Description: **Miscellaneous Water Level Sag**

Distance (ft): **76.0**  
Structural Grade: **2**  
O&M Grade: **0**  
Clock Start/From:  
Clock To:  
1st Value:  
2nd Value:  
Value Percent: **10.000**  
Continuous Index: **F04**  
Within 8" of Joint: **NO**  
Remarks:

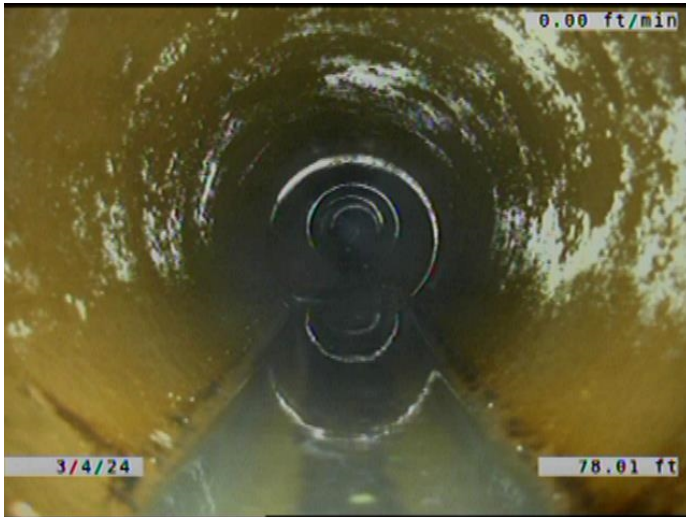
Code: **MWLS**  
Description: **Miscellaneous Water Level Sag**

Distance (ft): **78.0**  
Structural Grade: **2**  
O&M Grade: **0**  
Clock Start/From:  
Clock To:  
1st Value:  
2nd Value:  
Value Percent: **5.000**  
Continuous Index: **S05**  
Within 8" of Joint: **NO**  
Remarks:

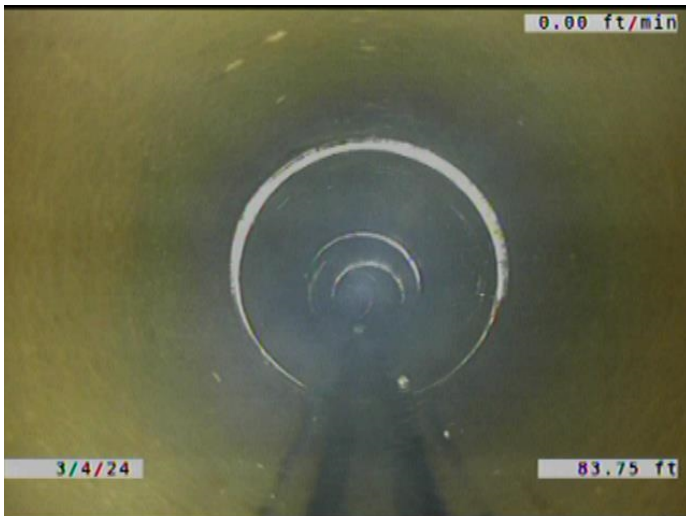
Code: **MWLS**  
Description: **Miscellaneous Water Level Sag**

Distance (ft): **83.8**  
Structural Grade: **2**  
O&M Grade: **0**  
Clock Start/From:  
Clock To:  
1st Value:  
2nd Value:  
Value Percent: **5.000**  
Continuous Index: **F05**  
Within 8" of Joint: **NO**  
Remarks:

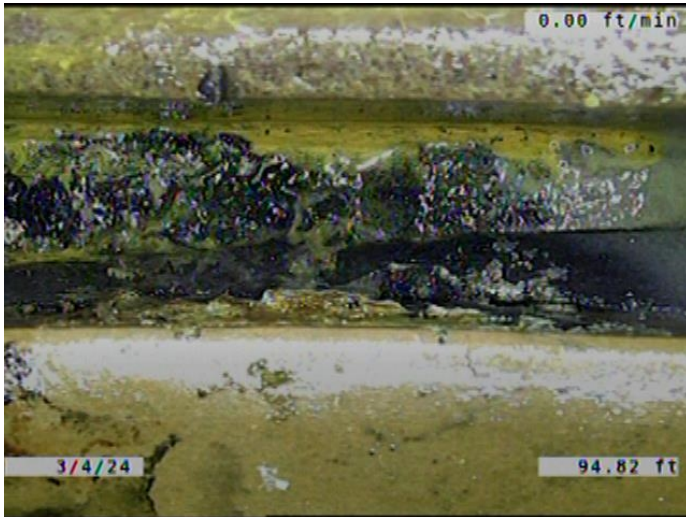
Code: **JAM**  
Description: **Joint Angular Medium**

Distance (ft): **94.8**  
Structural Grade: **3**  
O&M Grade: **0**  
Clock Start/From:  
Clock To:  
1st Value:  
2nd Value:  
Value Percent:  
Continuous Index:  
Within 8" of Joint: **NO**  
Remarks:

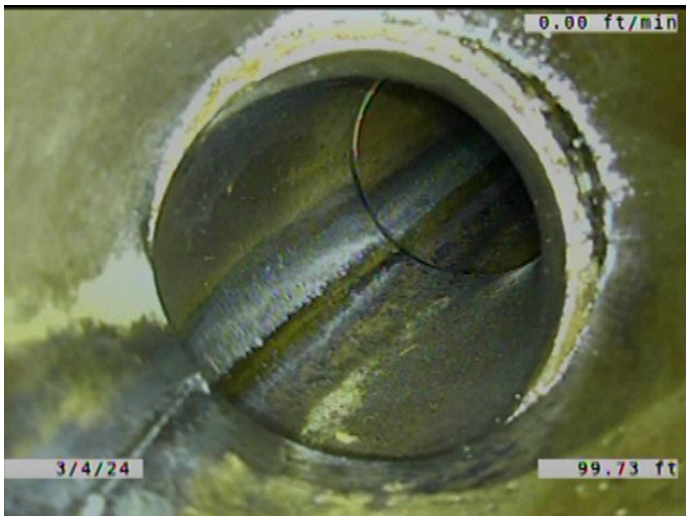
Code: **TFD**  
Description: **Tap Factory Defective**

Distance (ft): **99.7**  
Structural Grade: **0**  
O&M Grade: **3**  
Clock Start/From: **11**  
Clock To:  
1st Value: **6.000**  
2nd Value:  
Value Percent:  
Continuous Index:  
Within 8" of Joint: **YES**  
Remarks: **SERVICE OFFSET.**

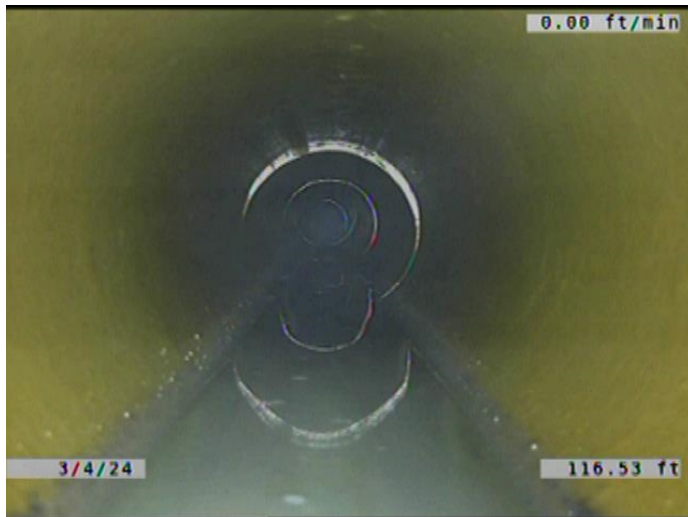
Code: **MWLS**  
Description: **Miscellaneous Water Level Sag**

Distance (ft): **116.5**  
Structural Grade: **2**  
O&M Grade: **0**  
Clock Start/From:  
Clock To:  
1st Value:  
2nd Value:  
Value Percent: **10.000**  
Continuous Index: **S06**  
Within 8" of Joint: **NO**  
Remarks:

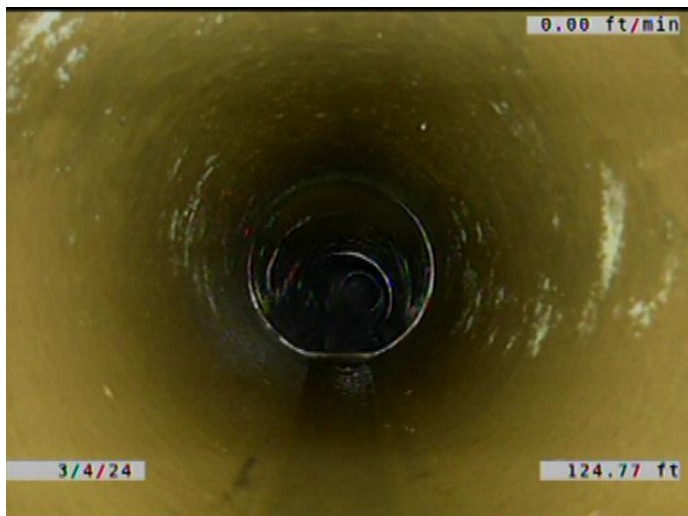
Code: **MWLS**  
Description: **Miscellaneous Water Level Sag**

Distance (ft): **124.8**  
Structural Grade: **2**  
O&M Grade: **0**  
Clock Start/From:  
Clock To:  
1st Value:  
2nd Value:  
Value Percent: **10.000**  
Continuous Index: **F06**  
Within 8" of Joint: **NO**  
Remarks:

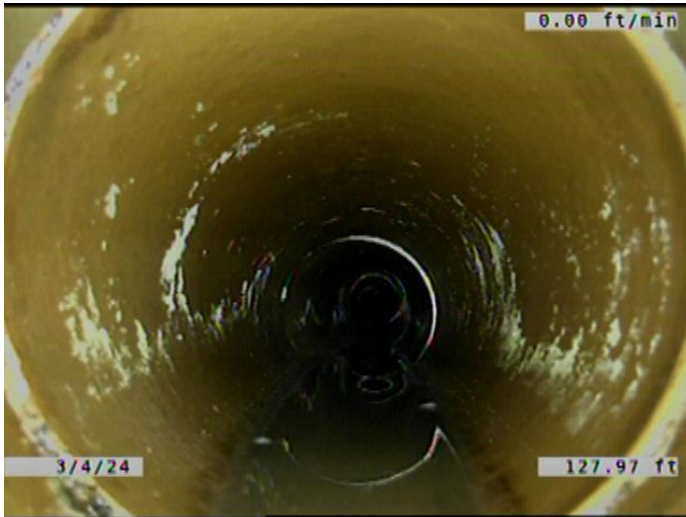
Code: **MWLS**  
Description: **Miscellaneous Water Level Sag**

Distance (ft): **128.0**  
Structural Grade: **2**  
O&M Grade: **0**  
Clock Start/From:  
Clock To:  
1st Value:  
2nd Value:  
Value Percent: **10.000**  
Continuous Index: **S07**  
Within 8" of Joint: **NO**  
Remarks:

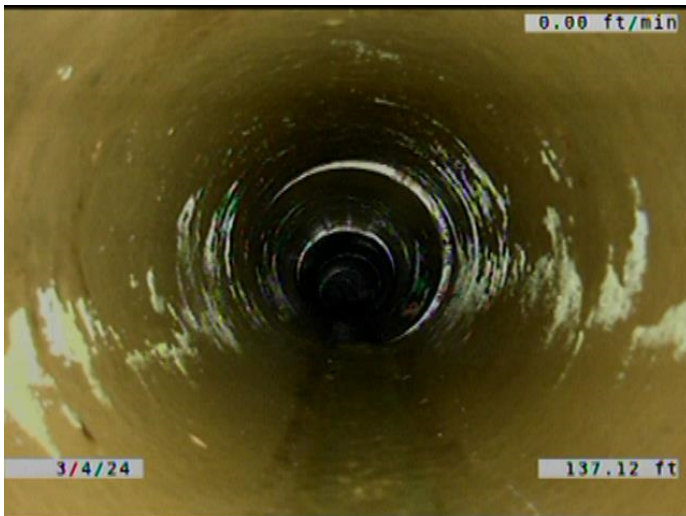
Code: **MWLS**  
Description: **Miscellaneous Water Level Sag**

Distance (ft): **137.1**  
Structural Grade: **2**  
O&M Grade: **0**  
Clock Start/From:  
Clock To:  
1st Value:  
2nd Value:  
Value Percent: **10.000**  
Continuous Index: **F07**  
Within 8" of Joint: **NO**  
Remarks:

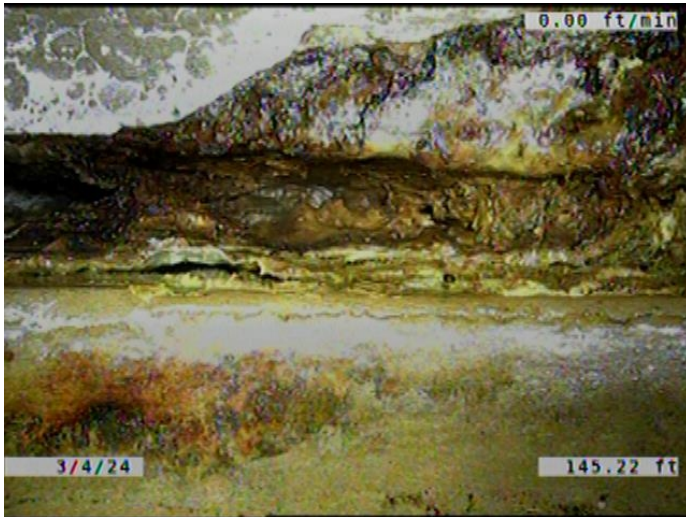
Code: **JAM**  
Description: **Joint Angular Medium**

Distance (ft): **145.2**  
Structural Grade: **3**  
O&M Grade: **0**  
Clock Start/From:  
Clock To:  
1st Value:  
2nd Value:  
Value Percent:  
Continuous Index:  
Within 8" of Joint: **NO**  
Remarks:

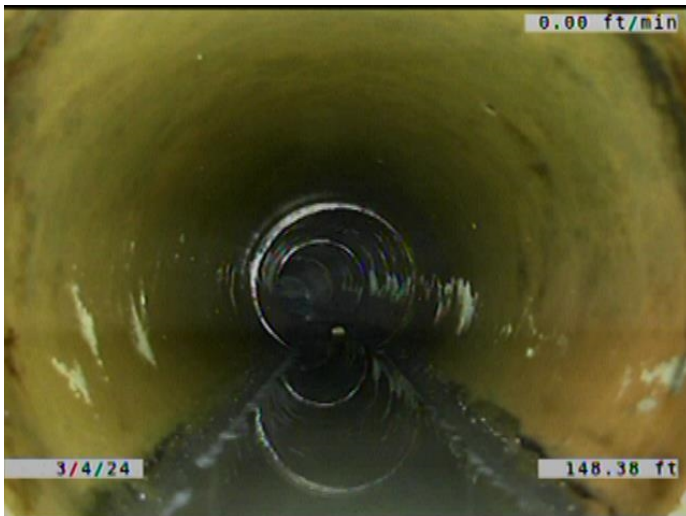
Code: **LL**  
Description: **Line Left**

Distance (ft): **148.4**  
Structural Grade: **0**  
O&M Grade: **1**  
Clock Start/From:  
Clock To:  
1st Value:  
2nd Value:  
Value Percent: **5.000**  
Continuous Index:  
Within 8" of Joint: **NO**  
Remarks:

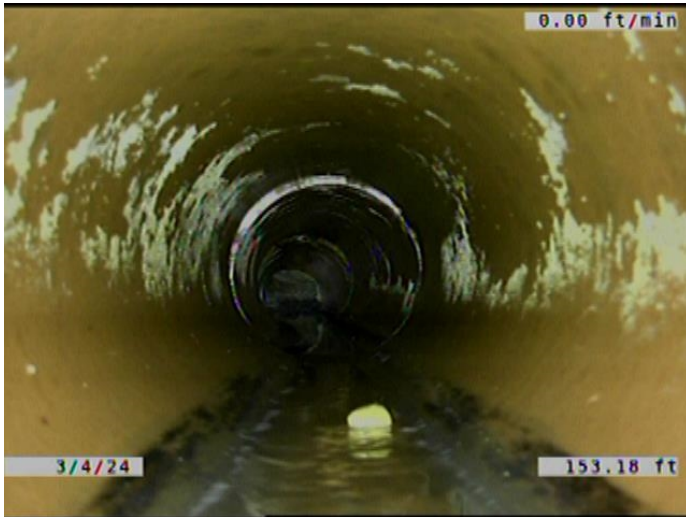
Code: **LL**  
Description: **Line Left**

Distance (ft): **153.2**  
Structural Grade: **0**  
O&M Grade: **1**  
Clock Start/From:  
Clock To:  
1st Value:  
2nd Value:  
Value Percent: **5.000**  
Continuous Index:  
Within 8" of Joint: **NO**  
Remarks:

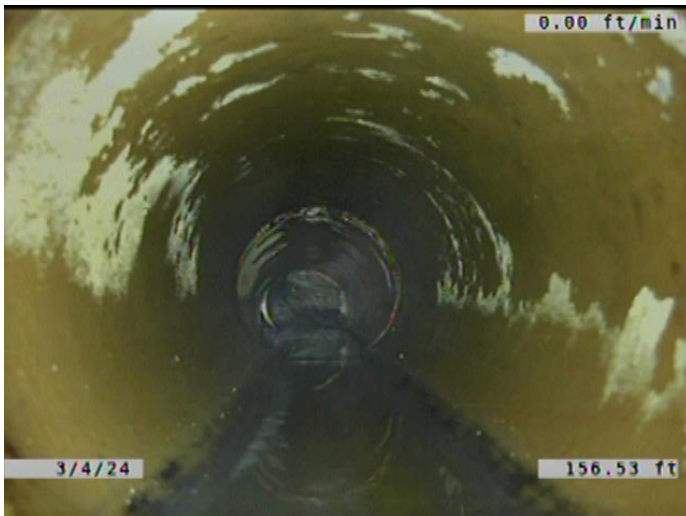
Code: **MWLS**  
Description: **Miscellaneous Water Level Sag**

Distance (ft): **156.5**  
Structural Grade: **2**  
O&M Grade: **0**  
Clock Start/From:  
Clock To:  
1st Value:  
2nd Value:  
Value Percent: **10.000**  
Continuous Index: **S08**  
Within 8" of Joint: **NO**  
Remarks:

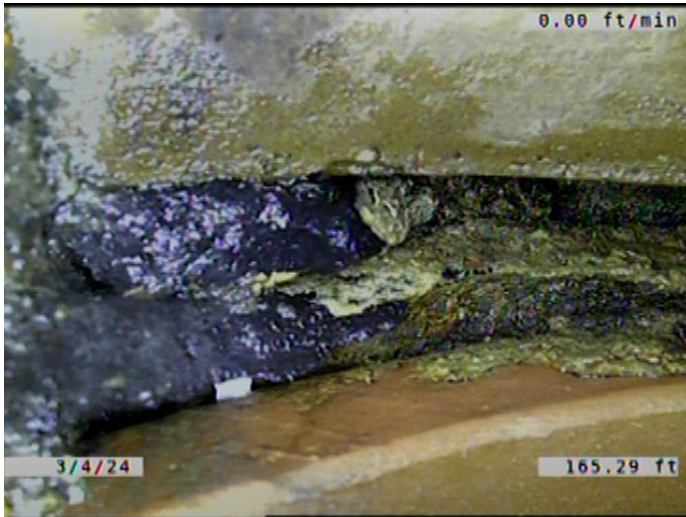
Code: **JOMD**  
Description: **Joint Offset Medium Defective**

Distance (ft): **165.3**  
Structural Grade: **3**  
O&M Grade: **0**  
Clock Start/From:  
Clock To:  
1st Value:  
2nd Value:  
Value Percent:  
Continuous Index:  
Within 8" of Joint: **NO**  
Remarks:

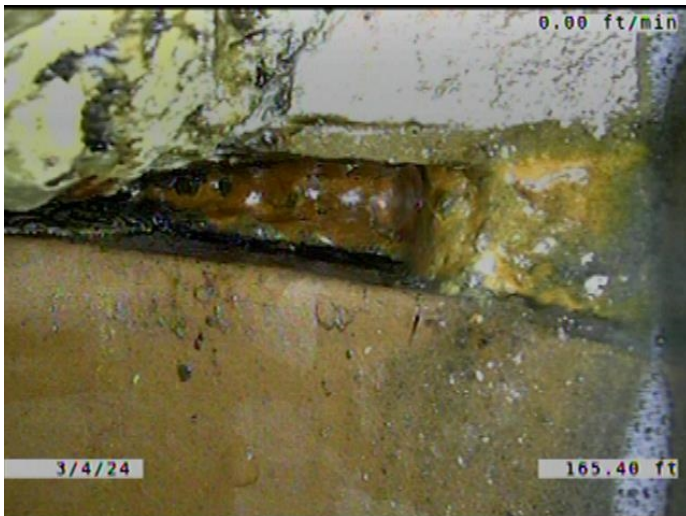
Code: **JAM**  
Description: **Joint Angular Medium**

Distance (ft): **165.4**  
Structural Grade: **3**  
O&M Grade: **0**  
Clock Start/From:  
Clock To:  
1st Value:  
2nd Value:  
Value Percent:  
Continuous Index:  
Within 8" of Joint: **NO**  
Remarks:

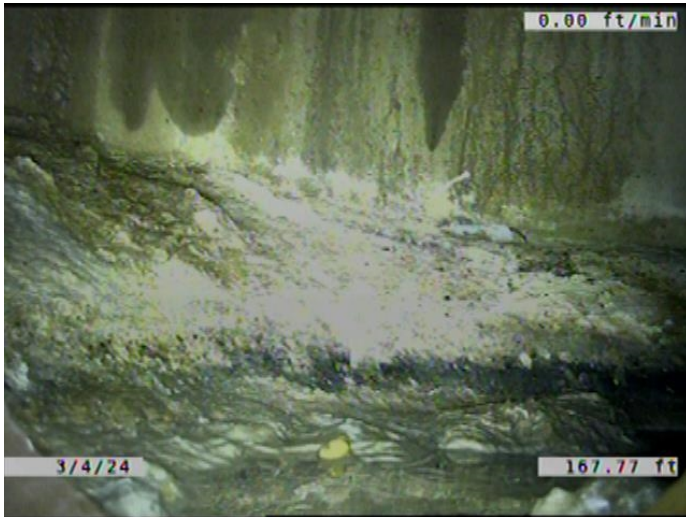
Code: **MWLS**  
Description: **Miscellaneous Water Level Sag**

Distance (ft): **167.8**  
Structural Grade: **2**  
O&M Grade: **0**  
Clock Start/From:  
Clock To:  
1st Value:  
2nd Value:  
Value Percent: **10.000**  
Continuous Index: **F08**  
Within 8" of Joint: **NO**  
Remarks:

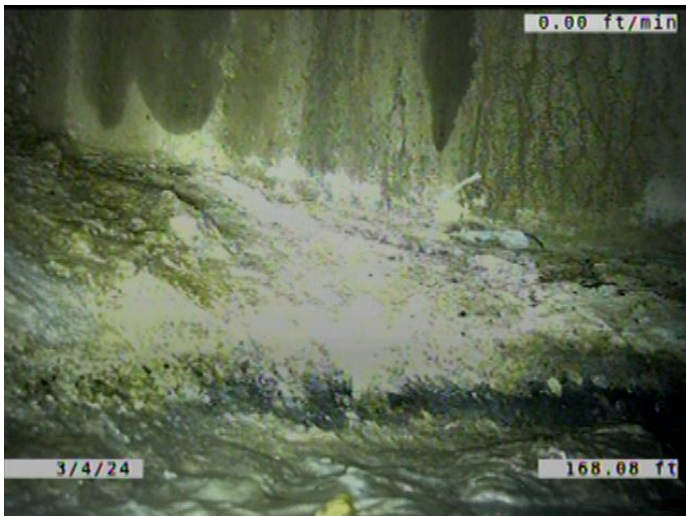
Code: **DAE**  
Description: **Deposits Attached Encrustation**

Distance (ft): **168.1**  
Structural Grade: **0**  
O&M Grade: **2**  
Clock Start/From: **7**  
Clock To: **5**  
1st Value:  
2nd Value:  
Value Percent: **5.000**  
Continuous Index: **F02**  
Within 8" of Joint: **YES**  
Remarks:
