Profile/Photo Observation Report

Date:	02/28/2024	Weather:		Coding:	PACP 7.0
Pipe Length (ft):	95.0	Owner:	City of Hobart	Pre Clean:	Heavy Cleaning
P.O.#:		Surveyor:	S. Bucklin	PSR:	P-606-063-062
Customer:	City of Hobart	Clean Date:	02/17/2024	Shape:	C

Street:	W 7TH PL	Flow Control:	Not Controlled
City:	Hobart, IN	Year Renewed:	
Location:	Other	Tape/Media #:	
Purpose:	Sewer System Evaluation Survey (SS	Dia/Height:	12"
Use:	Sanitary Sewage Pipe	Material:	VCP
Drain Area:		Lining:	None
Category:	NA		
Comment:			
Location Details:	THE END OF 502 W 7TH PL DRIVEWA	Direction of Survey:	Downstream
US MH:	M-606-062	DS MH:	M-606-063
		Total Length Surveyed (ft):	71.8

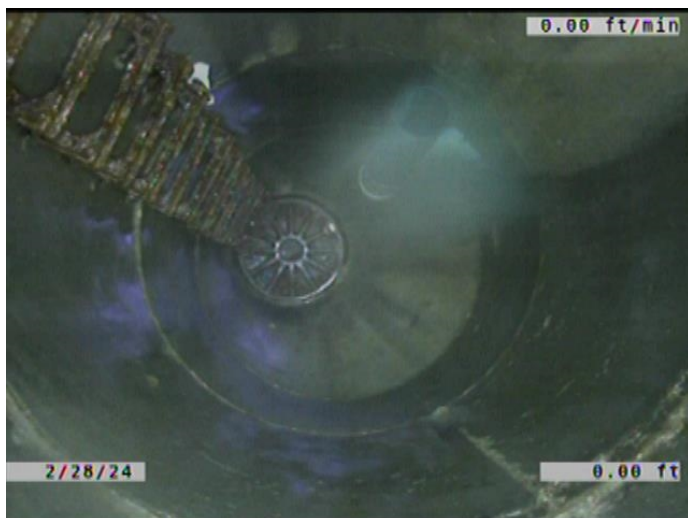
Code: **AMH**
 Description: **Manhole**

Distance (ft): **.0**
 Structural Grade: **0**
 O&M Grade: **0**
 Clock Start/From:
 Clock To:
 1st Value:
 2nd Value:
 Value Percent:
 Continuous Index:
 Within 8" of Joint: **NO**
 Remarks: **M-606-062**

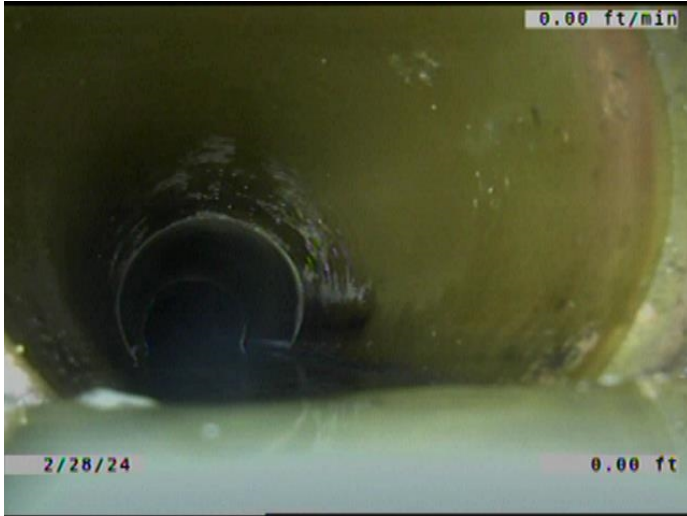
Code: **MWL**
Description: **Miscellaneous Water Level**

Distance (ft): **.0**
Structural Grade: **0**
O&M Grade: **0**
Clock Start/From:
Clock To:
1st Value:
2nd Value:
Value Percent: **10.000**
Continuous Index:
Within 8" of Joint: **NO**
Remarks:

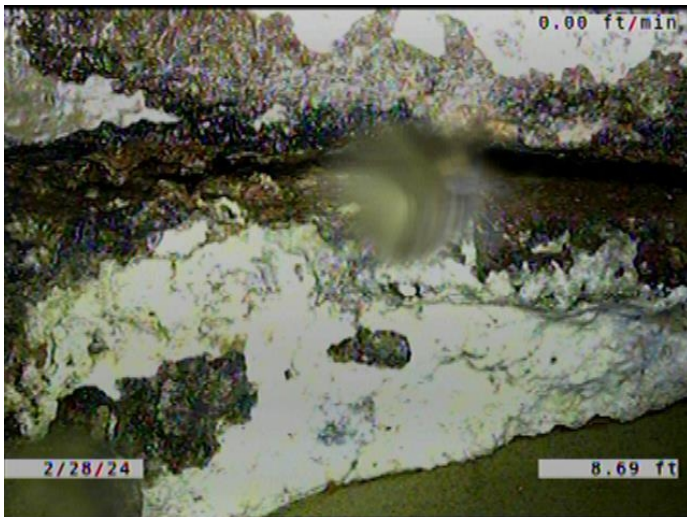
Code: **DAE**
Description: **Deposits Attached Encrustation**

Distance (ft): **8.7**
Structural Grade: **0**
O&M Grade: **2**
Clock Start/From: **7**
Clock To: **5**
1st Value:
2nd Value:
Value Percent: **5.000**
Continuous Index: **S01**
Within 8" of Joint: **YES**
Remarks:

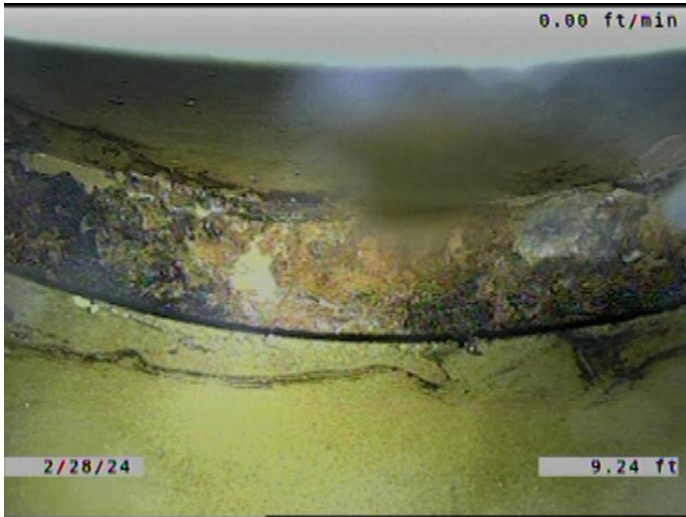
Code: **JOMD**
Description: **Joint Offset Medium Defective**

Distance (ft): **9.2**
Structural Grade: **3**
O&M Grade: **0**
Clock Start/From:
Clock To:
1st Value:
2nd Value:
Value Percent:
Continuous Index:
Within 8" of Joint: **NO**
Remarks:

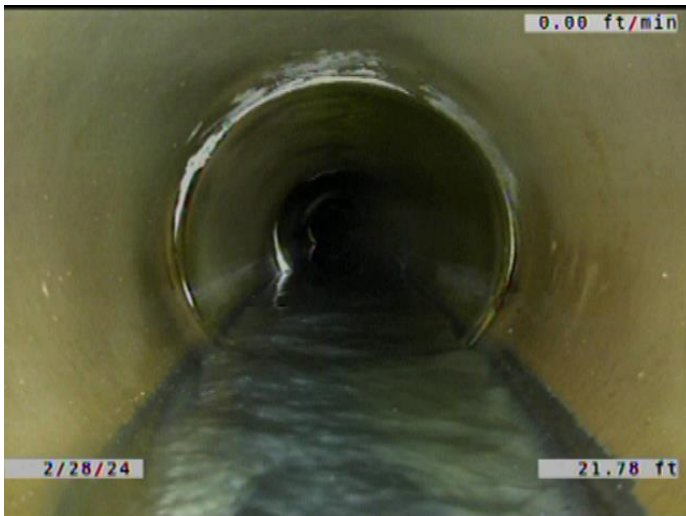
Code: **MWLS**
Description: **Miscellaneous Water Level Sag**

Distance (ft): **21.8**
Structural Grade: **2**
O&M Grade: **0**
Clock Start/From:
Clock To:
1st Value:
2nd Value:
Value Percent: **15.000**
Continuous Index: **S02**
Within 8" of Joint: **NO**
Remarks:

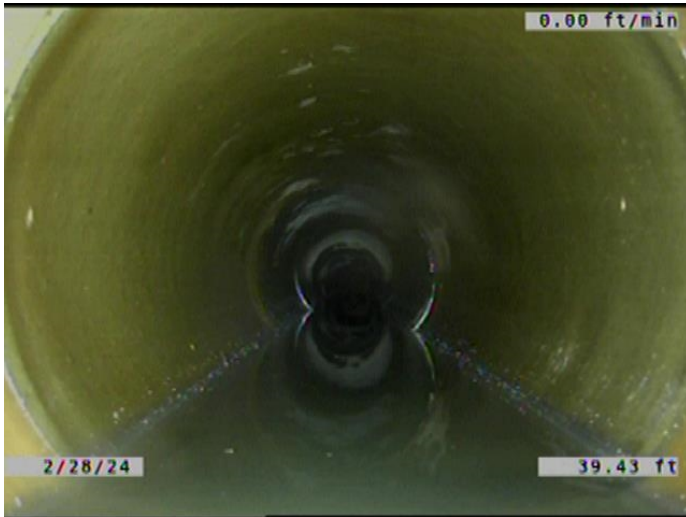
Code: **MWLS**
Description: **Miscellaneous Water Level Sag**

Distance (ft): **39.4**
Structural Grade: **2**
O&M Grade: **0**
Clock Start/From:
Clock To:
1st Value:
2nd Value:
Value Percent: **15.000**
Continuous Index: **F02**
Within 8" of Joint: **NO**
Remarks:

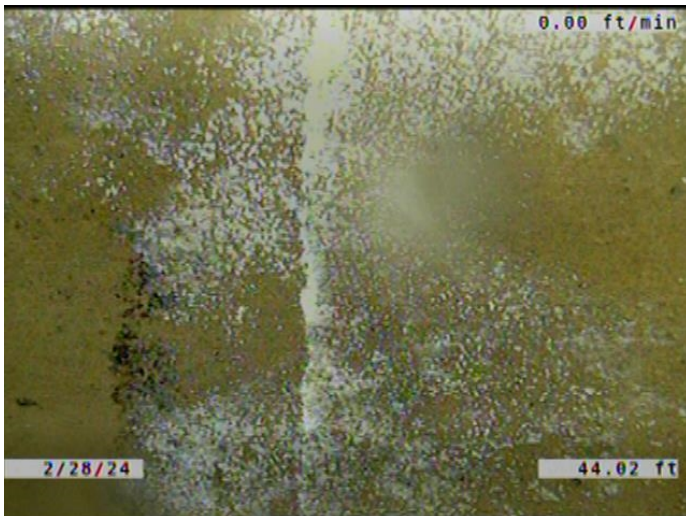
Code: **CL**
Description: **Crack Longitudinal**

Distance (ft): **44.0**
Structural Grade: **2**
O&M Grade: **0**
Clock Start/From: **2**
Clock To:
1st Value:
2nd Value:
Value Percent:
Continuous Index:
Within 8" of Joint: **YES**
Remarks:

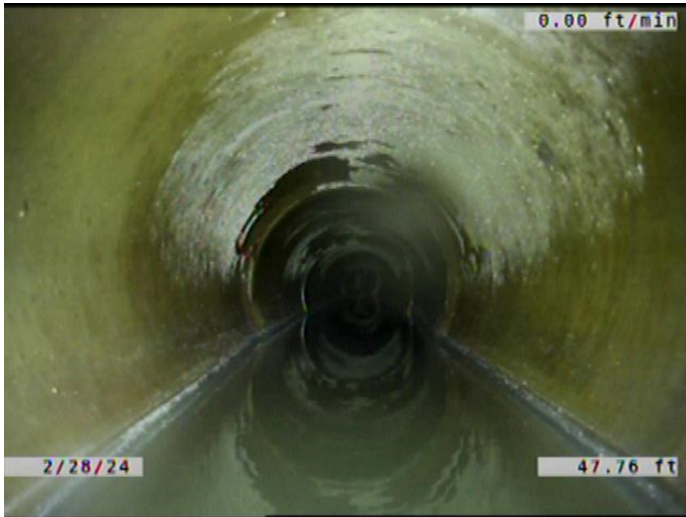
Code: **MWLS**
Description: **Miscellaneous Water Level Sag**

Distance (ft): **47.7**
Structural Grade: **2**
O&M Grade: **0**
Clock Start/From:
Clock To:
1st Value:
2nd Value:
Value Percent: **15.000**
Continuous Index: **S03**
Within 8" of Joint: **NO**
Remarks:

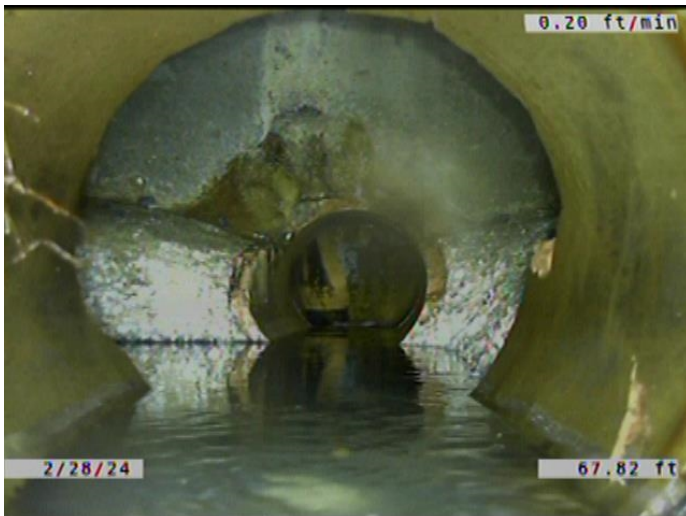
Code: **MWLS**
Description: **Miscellaneous Water Level Sag**

Distance (ft): **67.8**
Structural Grade: **2**
O&M Grade: **0**
Clock Start/From:
Clock To:
1st Value:
2nd Value:
Value Percent: **15.000**
Continuous Index: **F03**
Within 8" of Joint: **NO**
Remarks:

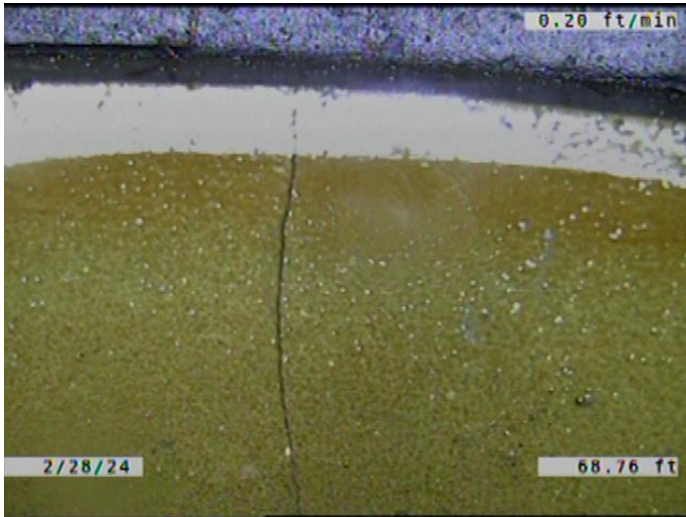
Code: **CS**
Description: **Crack Spiral**

Distance (ft): **68.8**
Structural Grade: **2**
O&M Grade: **0**
Clock Start/From: **11**
Clock To: **12**
1st Value:
2nd Value:
Value Percent:
Continuous Index:
Within 8" of Joint: **YES**
Remarks:

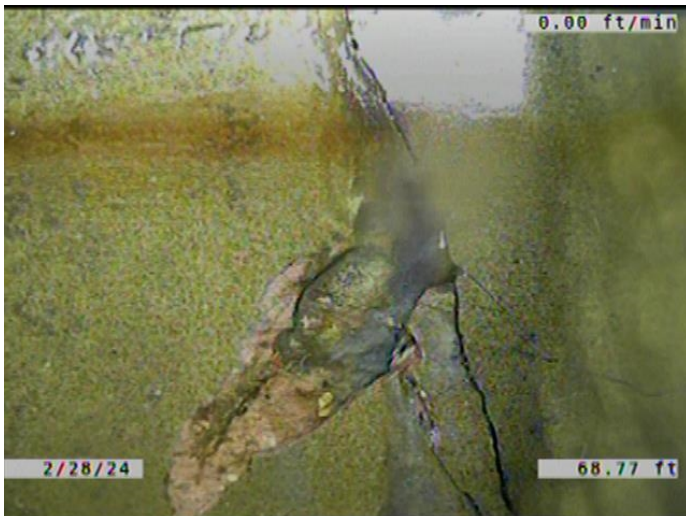
Code: **B**
Description: **Broken**

Distance (ft): **68.8**
Structural Grade: **4**
O&M Grade: **0**
Clock Start/From: **4**
Clock To: **6**
1st Value:
2nd Value:
Value Percent:
Continuous Index:
Within 8" of Joint: **YES**
Remarks:

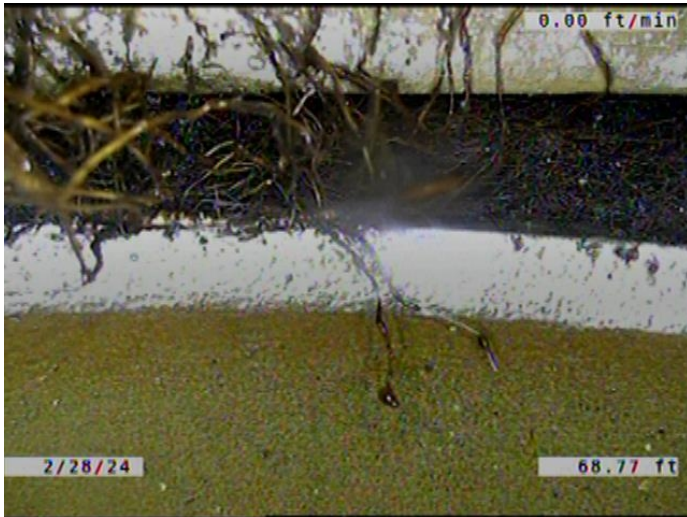
Code: **RFJ**
Description: **Roots Fine Joint**

Distance (ft): **68.8**
Structural Grade: **0**
O&M Grade: **1**
Clock Start/From: **9**
Clock To: **3**
1st Value:
2nd Value:
Value Percent:
Continuous Index:
Within 8" of Joint: **YES**
Remarks:

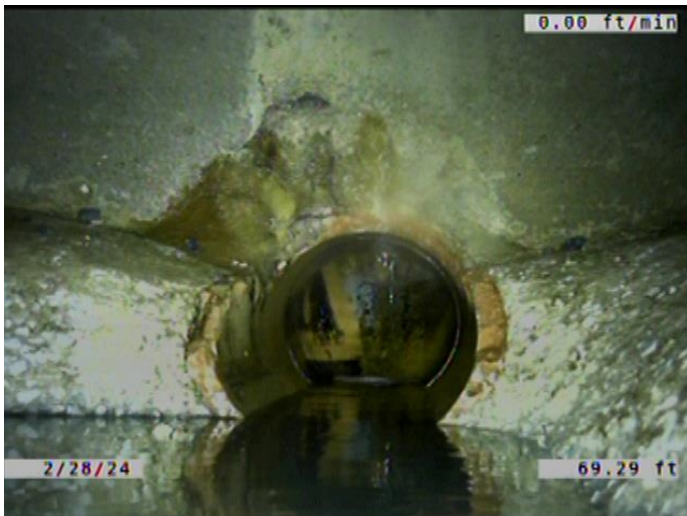
Code: **DAE**
Description: **Deposits Attached Encrustation**

Distance (ft): **69.3**
Structural Grade: **0**
O&M Grade: **2**
Clock Start/From: **7**
Clock To: **5**
1st Value:
2nd Value:
Value Percent: **5.000**
Continuous Index: **F01**
Within 8" of Joint: **YES**
Remarks:

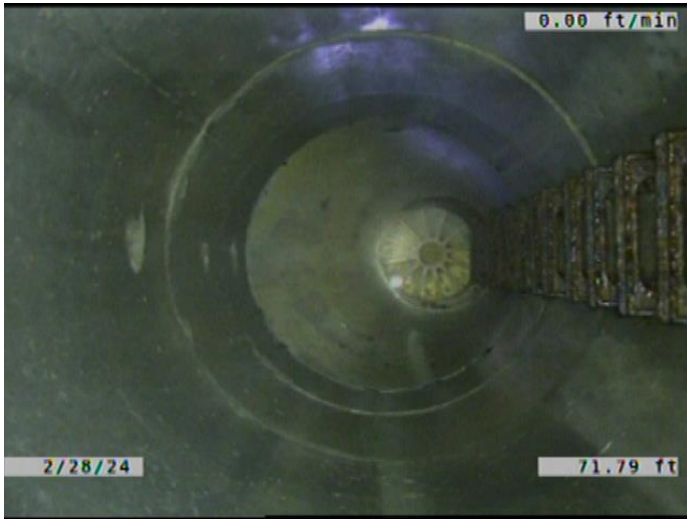
Code:	AMH
Description:	Manhole
Distance (ft):	71.8
Structural Grade:	0
O&M Grade:	0
Clock Start/From:	
Clock To:	
1st Value:	
2nd Value:	
Value Percent:	
Continuous Index:	
Within 8" of Joint:	NO
Remarks:	M-606-063
