## Profile/Photo Observation Report

Street:	<b>FOXCROFT STREET</b>	Flow Control:	<b>Not Controlled</b>
City:	<b>Hobart, IN</b>	Year Renewed:	
Location:	<b>Yard</b>	Tape/Media #:	
Purpose:	<b>Routine Assessment</b>	Dia/Height:	<b>12"</b>
Use:	<b>Sanitary</b>	Material:	<b>VCP</b>
Drain Area:	<b>NA</b>	Lining:	
Category:	<b>NA</b>		
Comment:	<b>False O_C, flow direction is marked wrong.</b>		
Location Details:		Direction of Survey:	<b>Upstream</b>
US MH:	<b>M-606-063</b>	DS MH:	<b>M-606-064</b>
		Total Length Surveyed (ft):	<b>5.8</b>

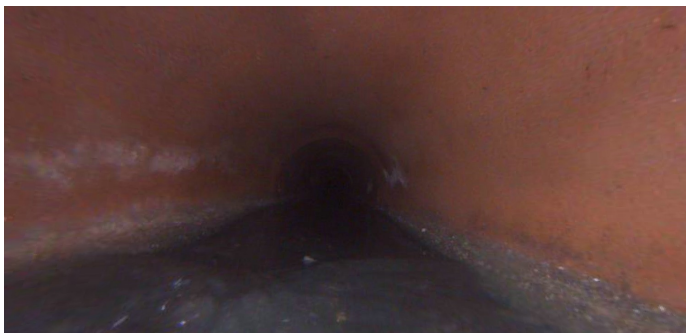
Code: **AMH**  
Description: **Manhole**

Distance (ft): **.0**  
Structural Grade: **0**  
O&M Grade: **0**  
Clock Start/From:  
Clock To:  
1st Value:  
2nd Value:  
Value Percent:  
Continuous Index:  
Within 8" of Joint: **NO**  
Remarks: **M-606-064**

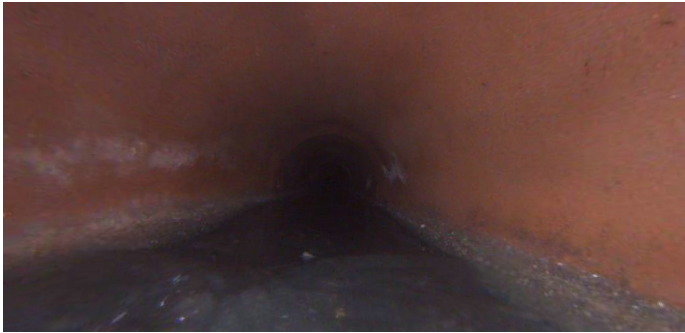
Code:	<b>MWL</b>
Description:	<b>Water Level</b>

Distance (ft):	<b>.0</b>
Structural Grade:	<b>0</b>
O&M Grade:	<b>0</b>
Clock Start/From:	
Clock To:	
1st Value:	
2nd Value:	
Value Percent:	<b>20.000</b>
Continuous Index:	
Within 8" of Joint:	<b>NO</b>
Remarks:

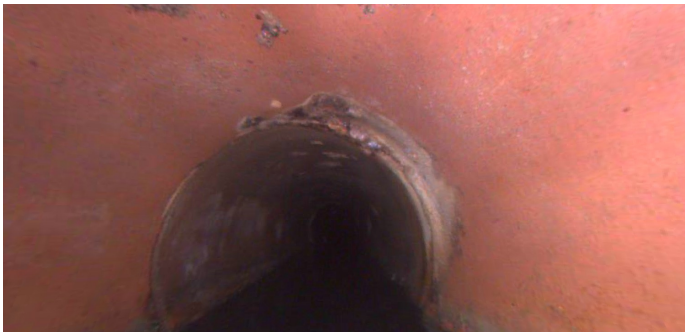
Code:	<b>MSA</b>
Description:	<b>Abandoned Survey</b>

Distance (ft):	<b>5.8</b>
Structural Grade:	<b>0</b>
O&M Grade:	<b>0</b>
Clock Start/From:	
Clock To:	
1st Value:	
2nd Value:	
Value Percent:	
Continuous Index:	
Within 8" of Joint:	<b>NO</b>
Remarks:	<b>DEBRIS UNDER WATER</b>
