## Profile/Photo Observation Report

Street:	<b>ALLEY BETWEEN W 7TH ST &amp; W 7TH</b>	Flow Control:	<b>Not Controlled</b>
City:	<b>Hobart, IN</b>	Year Renewed:	
Location:	<b>Yard</b>	Tape/Media #:	
Purpose:	<b>Routine Assessment</b>	Dia/Height:	<b>10"</b>
Use:	<b>Sanitary</b>	Material:	<b>VCP</b>
Drain Area:	<b>NA</b>	Lining:	
Category:	<b>NA</b>		
Comment:

Location Details:		Direction of Survey:	<b>Upstream</b>
US MH:	<b>M-606-064</b>	DS MH:	<b>M-606-065</b>
		Total Length Surveyed (ft):	<b>5.6</b>

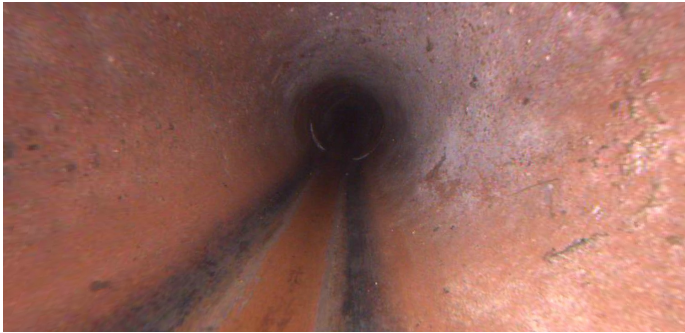
Code:	<b>MWL</b>
Description:	<b>Water Level</b>

Distance (ft):	<b>.0</b>
Structural Grade:	<b>0</b>
O&M Grade:	<b>0</b>
Clock Start/From:	
Clock To:	
1st Value:	
2nd Value:	
Value Percent:	<b>5.000</b>
Continuous Index:	
Within 8" of Joint:	<b>NO</b>
Remarks:

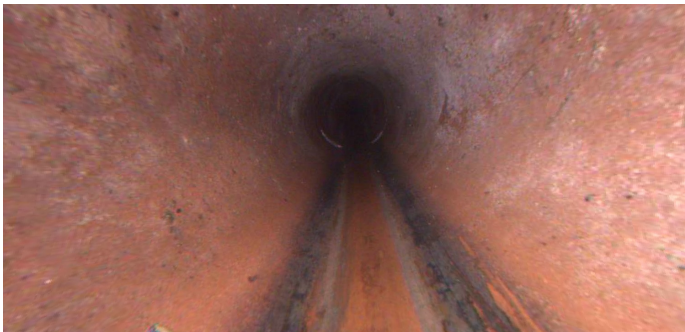
Code:	<b>MSA</b>
Description:	<b>Abandoned Survey</b>

Distance (ft):	<b>5.6</b>
Structural Grade:	<b>0</b>
O&M Grade:	<b>0</b>
Clock Start/From:	
Clock To:	
1st Value:	
2nd Value:	
Value Percent:	
Continuous Index:	
Within 8" of Joint:	<b>NO</b>
Remarks:	<b>UNKNOWN</b>
