Profile/Photo Observation Report

Date:	02/16/2024	Weather:		Coding:	PACP 7.0
Pipe Length (ft):	170.0	Owner:	City of Hobart	Pre Clean:	Heavy Cleaning
P.O.#:	YES502259	Surveyor:	S. Bucklin	PSR:	P-606-065-064
Customer:	City of Hobart	Clean Date:	12/08/2023	Shape:	C

Street:	S PENNSYLVANIA ST	Flow Control:	Not Controlled
City:	Hobart, IN	Year Renewed:	
Location:	Easement/Right of Way	Tape/Media #:	
Purpose:	Routine Assessment	Dia/Height:	10"
Use:	Sanitary Sewage Pipe	Material:	VCP
Drain Area:		Lining:	None
Category:	NA		
Comment:

Location Details:		Direction of Survey:	Downstream
US MH:	M-606-064	DS MH:	M-606-065
		Total Length Surveyed (ft):	165.4

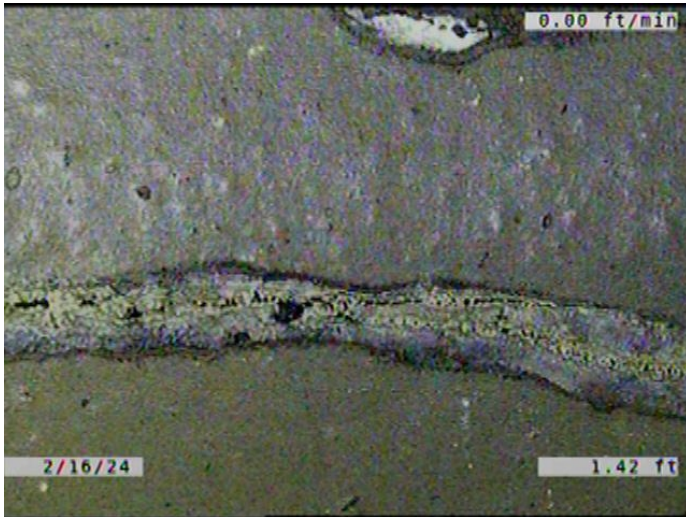
Code: **CC**
Description: **Crack Circumferential**

Distance (ft): **1.4**
Structural Grade: **1**
O&M Grade: **0**
Clock Start/From: **10**
Clock To: **2**
1st Value:
2nd Value:
Value Percent:
Continuous Index:
Within 8" of Joint: **YES**
Remarks:

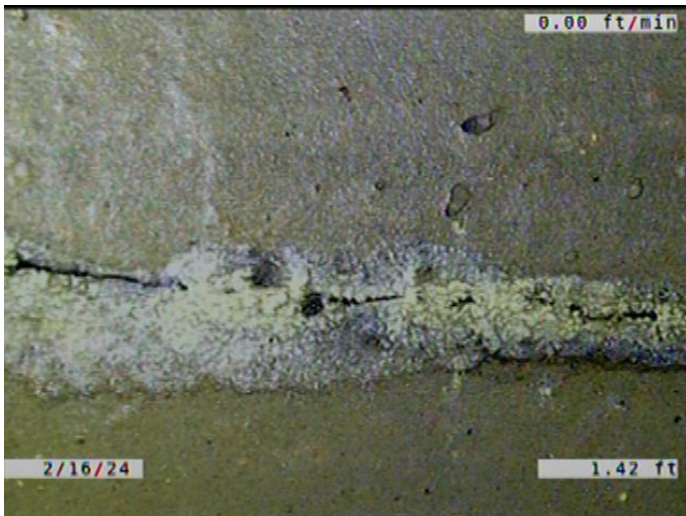
Code: **DAE**
Description: **Deposits Attached Encrustation**

Distance (ft): **1.4**
Structural Grade: **0**
O&M Grade: **2**
Clock Start/From: **7**
Clock To: **5**
1st Value:
2nd Value:
Value Percent: **5.000**
Continuous Index: **S01**
Within 8" of Joint: **YES**
Remarks:

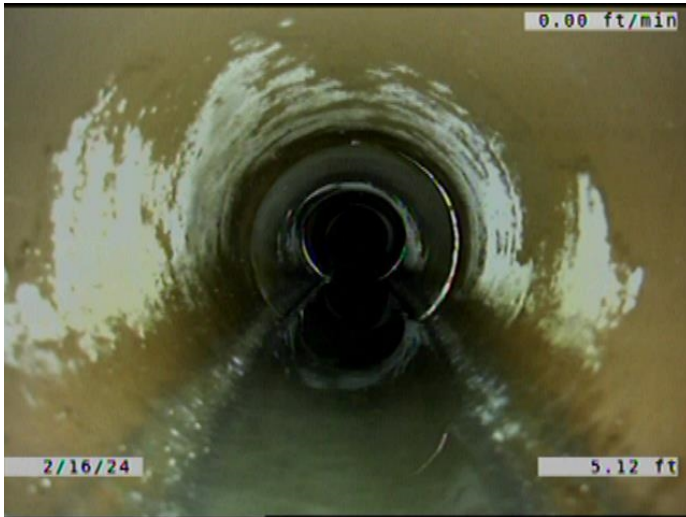
Code: **MWLS**
Description: **Miscellaneous Water Level Sag**

Distance (ft): **5.1**
Structural Grade: **2**
O&M Grade: **0**
Clock Start/From:
Clock To:
1st Value:
2nd Value:
Value Percent: **10.000**
Continuous Index: **S02**
Within 8" of Joint: **NO**
Remarks:

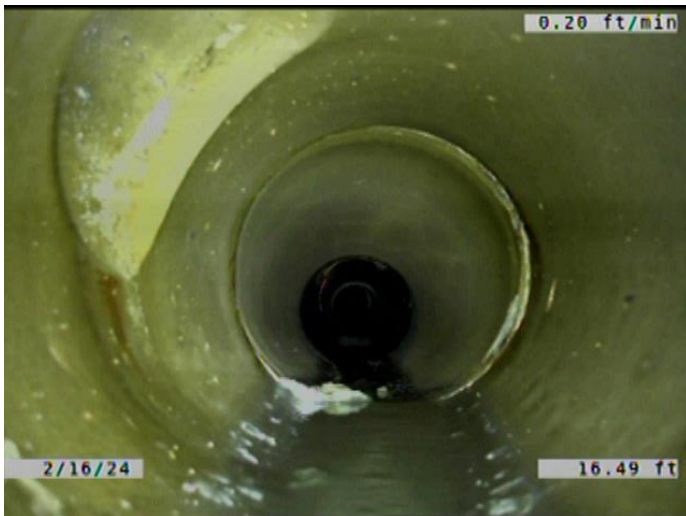
Code: **MWLS**
Description: **Miscellaneous Water Level Sag**

Distance (ft): **16.5**
Structural Grade: **2**
O&M Grade: **0**
Clock Start/From:
Clock To:
1st Value:
2nd Value:
Value Percent: **10.000**
Continuous Index: **F02**
Within 8" of Joint: **NO**
Remarks:

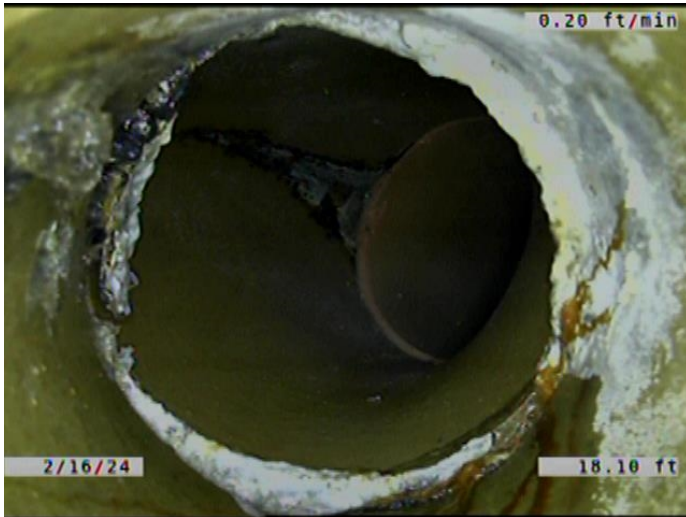
Code:	TFD
Description:	Tap Factory Defective
Distance (ft):	18.1
Structural Grade:	0
O&M Grade:	3
Clock Start/From:	10
Clock To:	
1st Value:	6.000
2nd Value:	
Value Percent:	
Continuous Index:	
Within 8" of Joint:	YES
Remarks:	ENCrustATION COMING FROM THE SERVICE TO MAIN CONNECTION INT

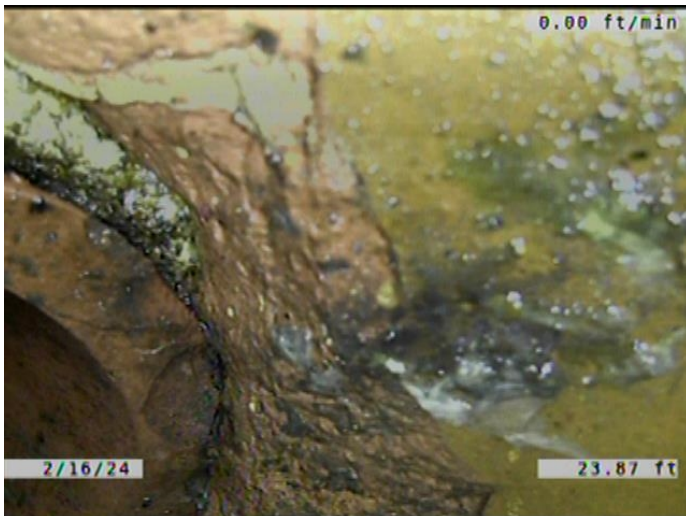
Code:	SSS
Description:	Surface Damage Surface Spalling
Distance (ft):	23.9
Structural Grade:	2
O&M Grade:	0
Clock Start/From:	10
Clock To:	1
1st Value:	
2nd Value:	
Value Percent:	
Continuous Index:	
Within 8" of Joint:	YES
Remarks:

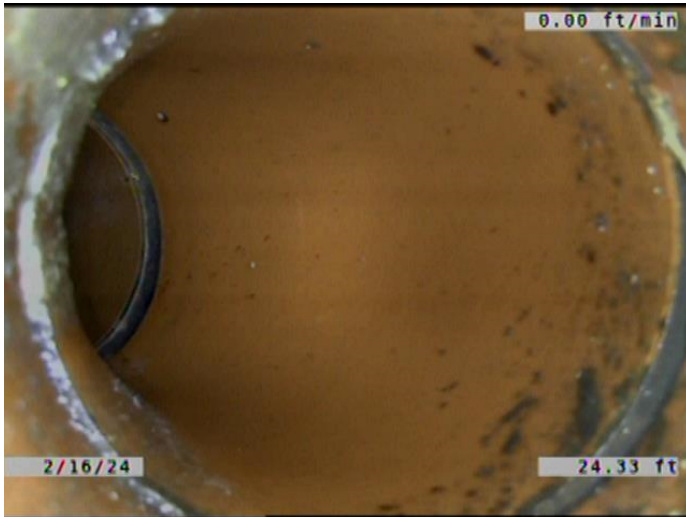
Code: **TBI**
Description: **Tap Break-in Intruding**

Distance (ft): **24.3**
Structural Grade: **0**
O&M Grade: **2**
Clock Start/From: **11**
Clock To:
1st Value: **6.000**
2nd Value: **1.000**
Value Percent:
Continuous Index:
Within 8" of Joint: **YES**
Remarks: **CONSTANTLY DRIPPING WATER.**

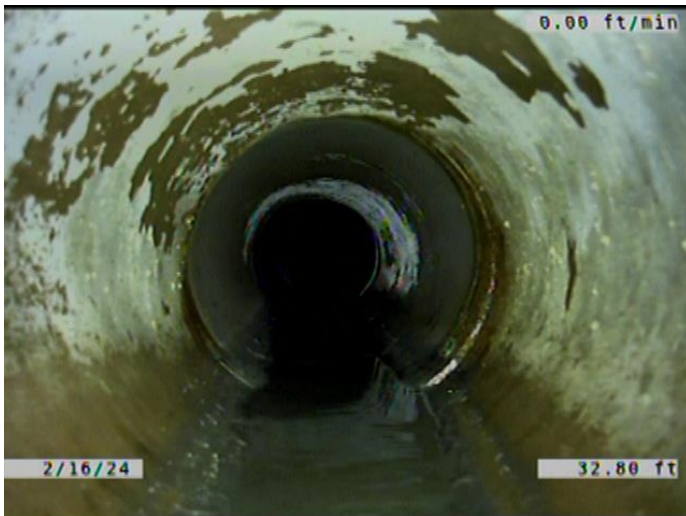
Code: **MWLS**
Description: **Miscellaneous Water Level Sag**

Distance (ft): **32.8**
Structural Grade: **2**
O&M Grade: **0**
Clock Start/From:
Clock To:
1st Value:
2nd Value:
Value Percent: **5.000**
Continuous Index: **S03**
Within 8" of Joint: **NO**
Remarks:

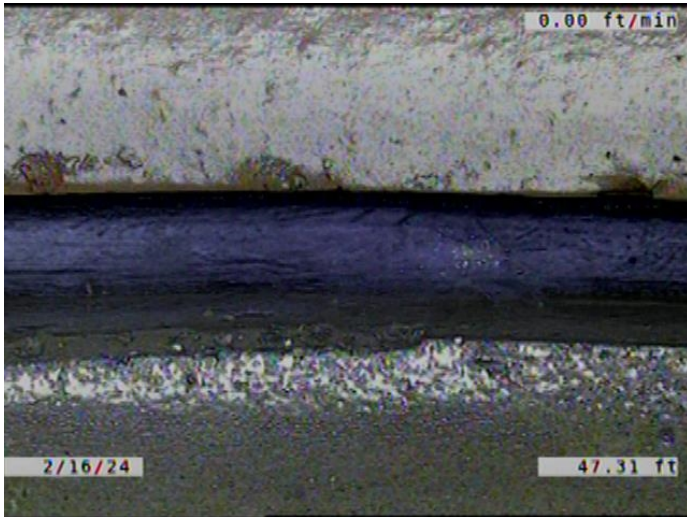
Code: **JAM**
Description: **Joint Angular Medium**

Distance (ft): **47.3**
Structural Grade: **3**
O&M Grade: **0**
Clock Start/From:
Clock To:
1st Value:
2nd Value:
Value Percent:
Continuous Index:
Within 8" of Joint: **NO**
Remarks:

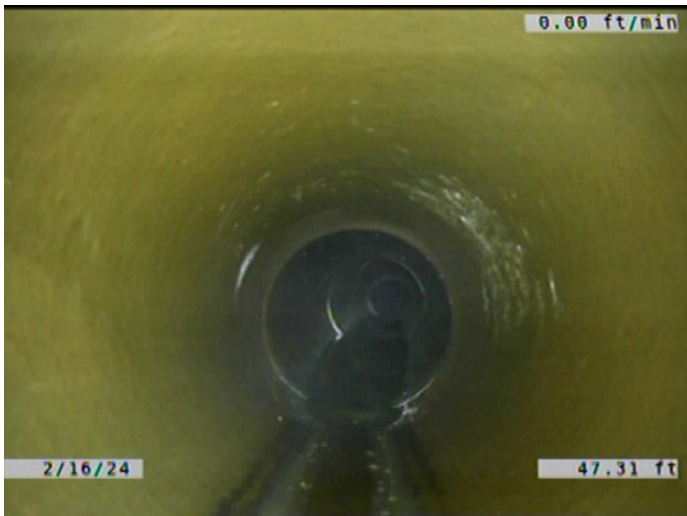
Code: **MWLS**
Description: **Miscellaneous Water Level Sag**

Distance (ft): **47.3**
Structural Grade: **2**
O&M Grade: **0**
Clock Start/From:
Clock To:
1st Value:
2nd Value:
Value Percent: **5.000**
Continuous Index: **F03**
Within 8" of Joint: **NO**
Remarks:

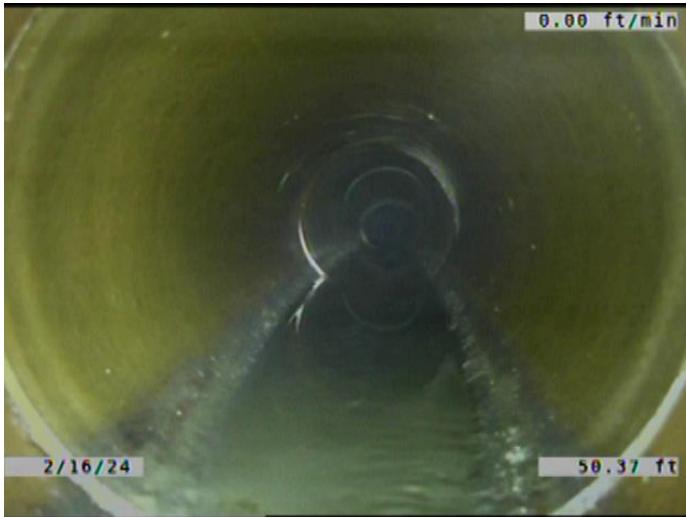
Code: **MWLS**
Description: **Miscellaneous Water Level Sag**

Distance (ft): **50.4**
Structural Grade: **2**
O&M Grade: **0**
Clock Start/From:
Clock To:
1st Value:
2nd Value:
Value Percent: **5.000**
Continuous Index: **S04**
Within 8" of Joint: **NO**
Remarks:

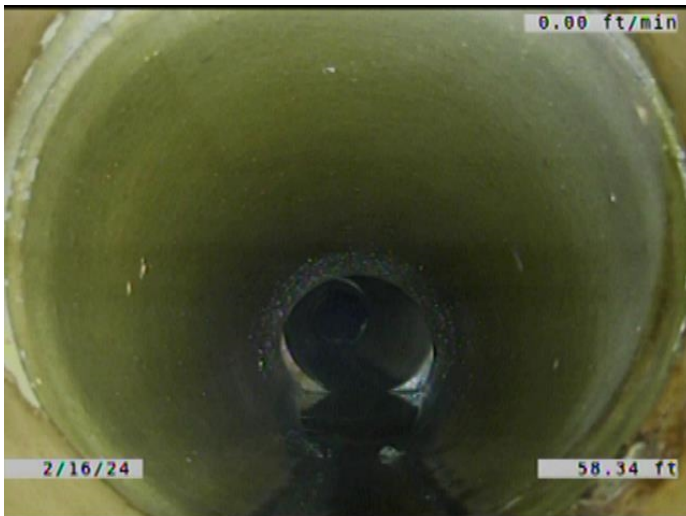
Code: **MWLS**
Description: **Miscellaneous Water Level Sag**

Distance (ft): **58.3**
Structural Grade: **2**
O&M Grade: **0**
Clock Start/From:
Clock To:
1st Value:
2nd Value:
Value Percent: **5.000**
Continuous Index: **F04**
Within 8" of Joint: **NO**
Remarks:

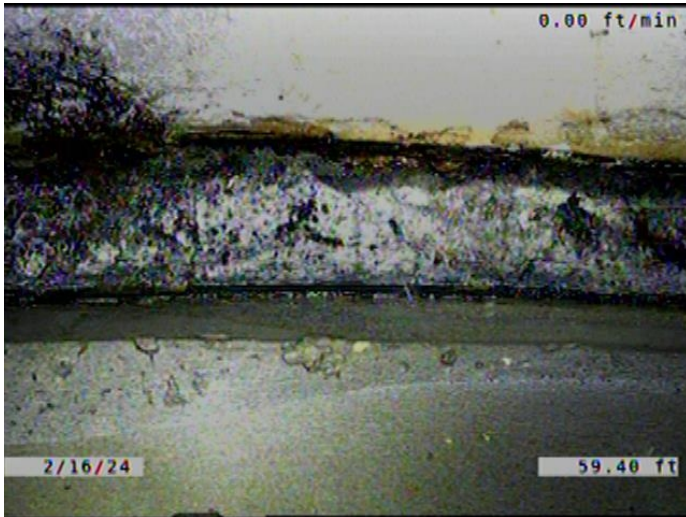
Code: **JAM**
Description: **Joint Angular Medium**

Distance (ft): **59.4**
Structural Grade: **3**
O&M Grade: **0**
Clock Start/From:
Clock To:
1st Value:
2nd Value:
Value Percent:
Continuous Index:
Within 8" of Joint: **NO**
Remarks:

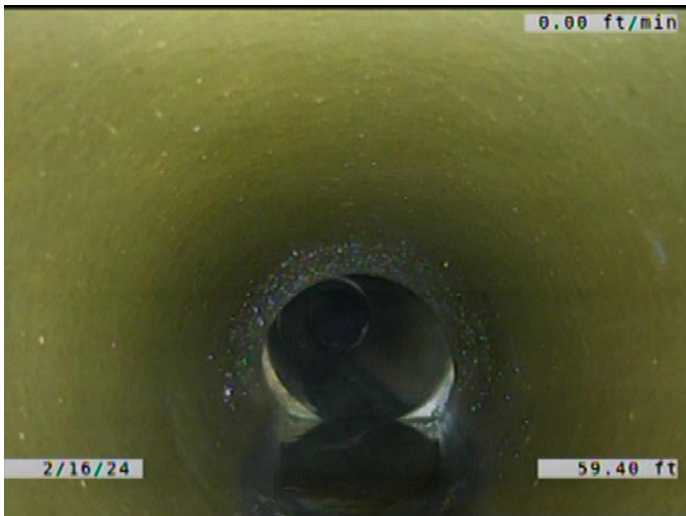
Code: **LD**
Description: **Line Down**

Distance (ft): **59.4**
Structural Grade: **0**
O&M Grade: **1**
Clock Start/From:
Clock To:
1st Value:
2nd Value:
Value Percent: **5.000**
Continuous Index:
Within 8" of Joint: **NO**
Remarks:

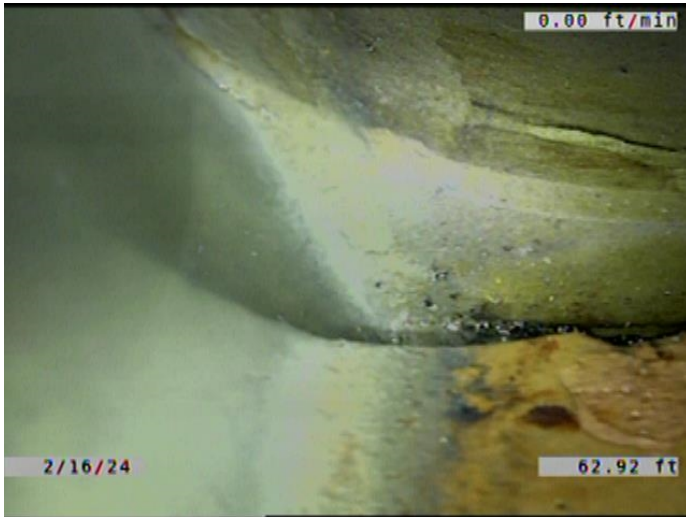
Code: **JOMD**
Description: **Joint Offset Medium Defective**

Distance (ft): **62.9**
Structural Grade: **3**
O&M Grade: **0**
Clock Start/From:
Clock To:
1st Value:
2nd Value:
Value Percent:
Continuous Index:
Within 8" of Joint: **NO**
Remarks:

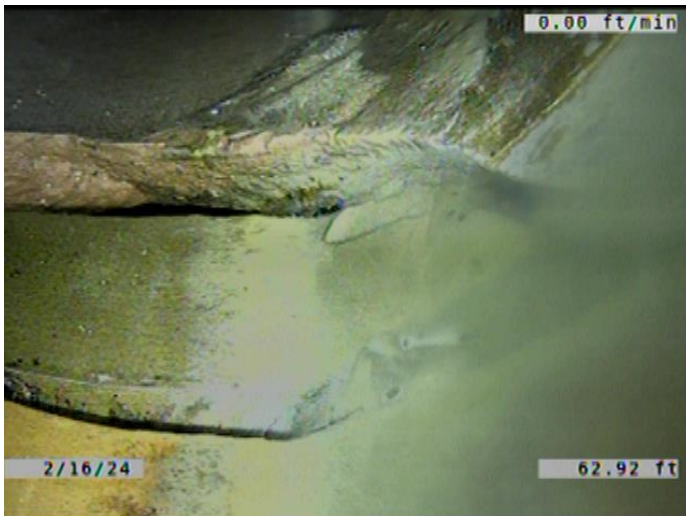
Code: **BVV**
Description: **Broken Void Visible**

Distance (ft): **62.9**
Structural Grade: **5**
O&M Grade: **0**
Clock Start/From: **7**
Clock To: **10**
1st Value:
2nd Value:
Value Percent:
Continuous Index:
Within 8" of Joint: **YES**
Remarks: **WATER LOOKS TO BE EXITING THE PIPE.**

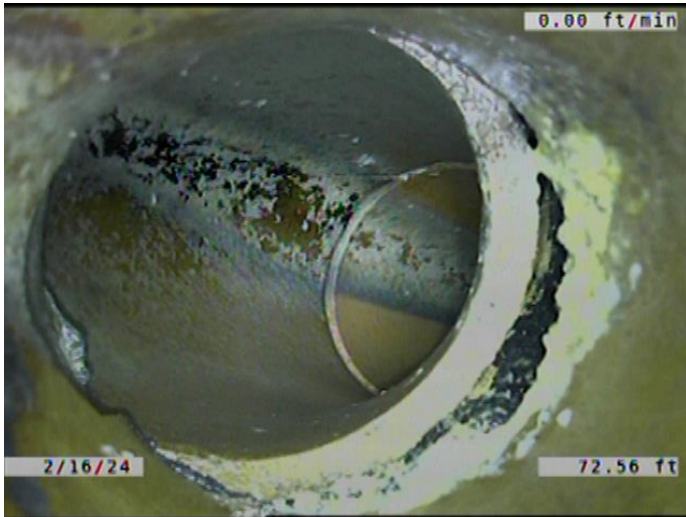
Code: **TFD**
Description: **Tap Factory Defective**

Distance (ft): **72.6**
Structural Grade: **0**
O&M Grade: **3**
Clock Start/From: **10**
Clock To:
1st Value: **6.000**
2nd Value:
Value Percent:
Continuous Index:
Within 8" of Joint: **YES**
Remarks: **TAP BROKEN. SERVICE HAS DROPPED. SOIL VISIBLE.**

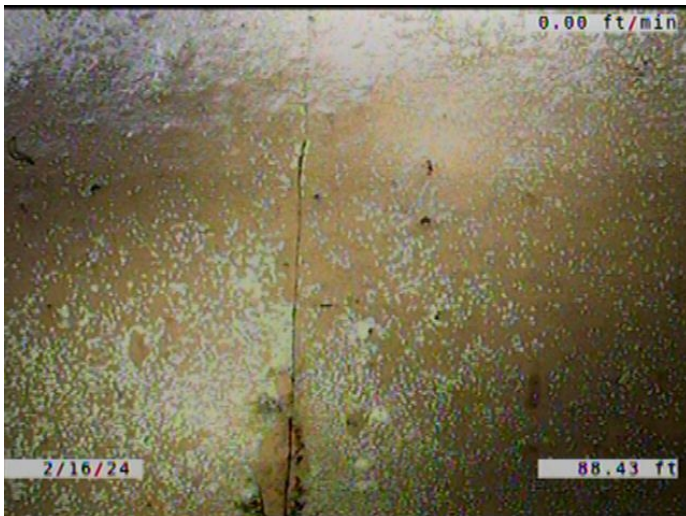
Code: **CL**
Description: **Crack Longitudinal**

Distance (ft): **88.4**
Structural Grade: **2**
O&M Grade: **0**
Clock Start/From: **11**
Clock To:
1st Value:
2nd Value:
Value Percent:
Continuous Index:
Within 8" of Joint: **YES**
Remarks:

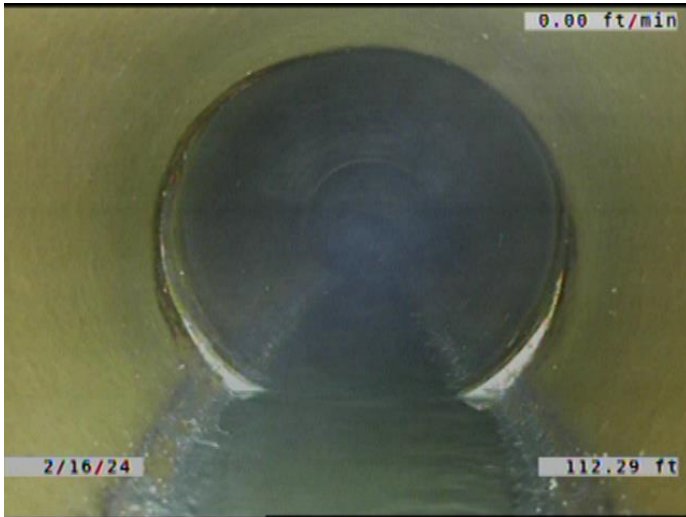
Code: **MWLS**
Description: **Miscellaneous Water Level Sag**

Distance (ft): **112.3**
Structural Grade: **2**
O&M Grade: **0**
Clock Start/From:
Clock To:
1st Value:
2nd Value:
Value Percent: **5.000**
Continuous Index: **S05**
Within 8" of Joint: **NO**
Remarks:

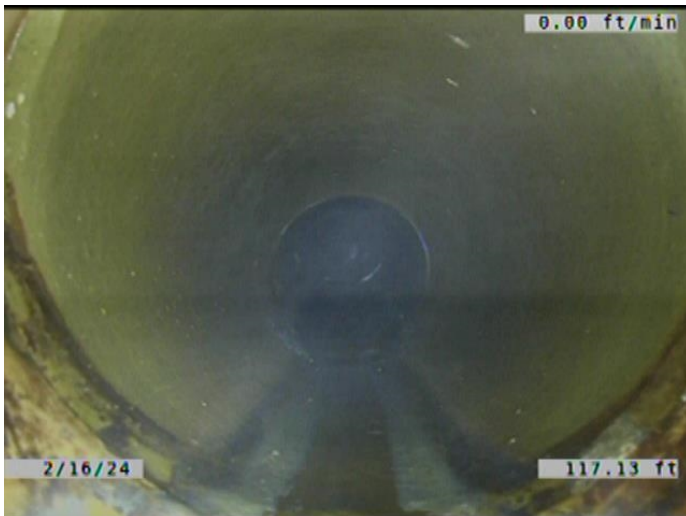
Code: **MWLS**
Description: **Miscellaneous Water Level Sag**

Distance (ft): **117.1**
Structural Grade: **2**
O&M Grade: **0**
Clock Start/From:
Clock To:
1st Value:
2nd Value:
Value Percent: **5.000**
Continuous Index: **F05**
Within 8" of Joint: **NO**
Remarks:

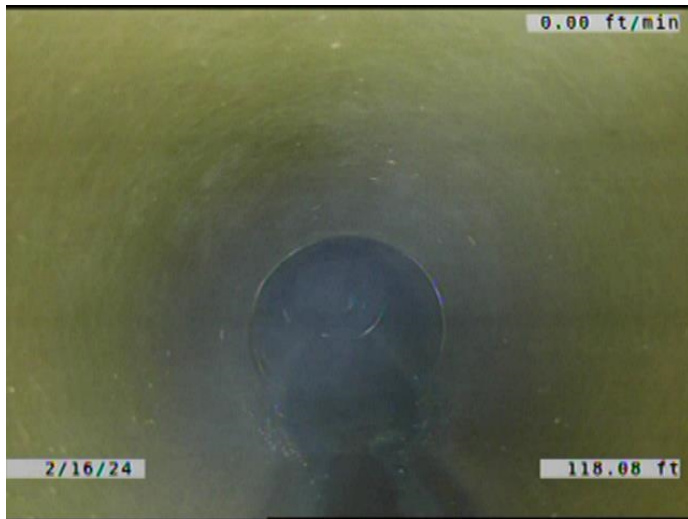
Code: **LD**
Description: **Line Down**

Distance (ft): **118.1**
Structural Grade: **0**
O&M Grade: **1**
Clock Start/From:
Clock To:
1st Value:
2nd Value:
Value Percent: **5.000**
Continuous Index:
Within 8" of Joint: **NO**
Remarks:

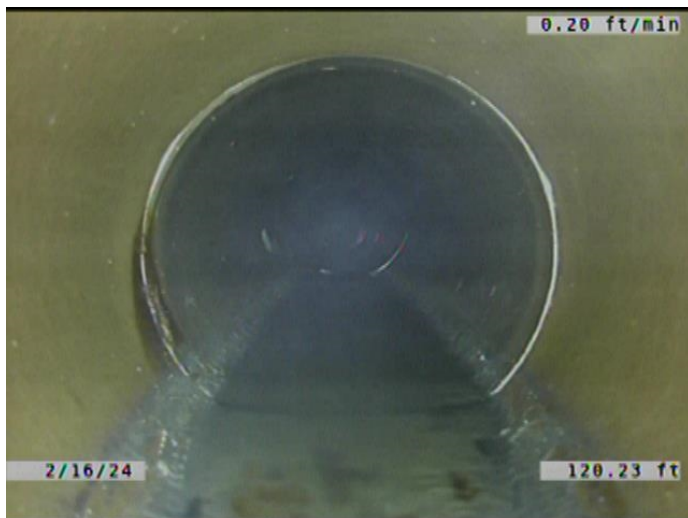
Code: **MWLS**
Description: **Miscellaneous Water Level Sag**

Distance (ft): **120.2**
Structural Grade: **2**
O&M Grade: **0**
Clock Start/From:
Clock To:
1st Value:
2nd Value:
Value Percent: **5.000**
Continuous Index: **S06**
Within 8" of Joint: **NO**
Remarks:

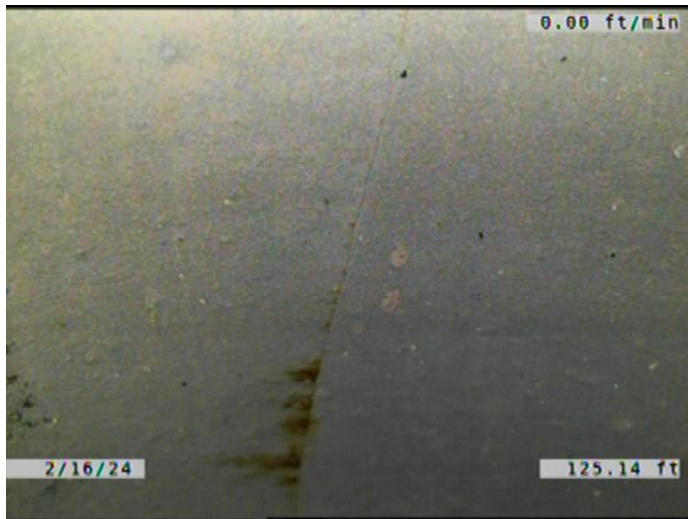
Code: **CL**
Description: **Crack Longitudinal**

Distance (ft): **125.1**
Structural Grade: **2**
O&M Grade: **0**
Clock Start/From: **10**
Clock To:
1st Value:
2nd Value:
Value Percent:
Continuous Index:
Within 8" of Joint: **YES**
Remarks:

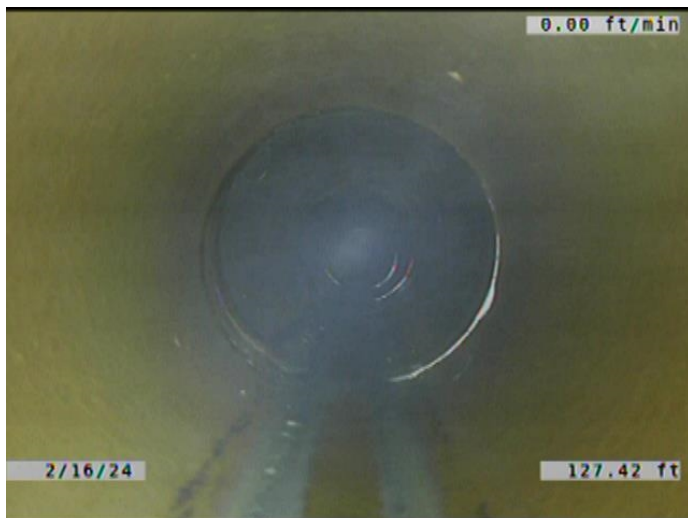
Code: **MWLS**
Description: **Miscellaneous Water Level Sag**

Distance (ft): **127.4**
Structural Grade: **2**
O&M Grade: **0**
Clock Start/From:
Clock To:
1st Value:
2nd Value:
Value Percent: **5.000**
Continuous Index: **F06**
Within 8" of Joint: **NO**
Remarks:

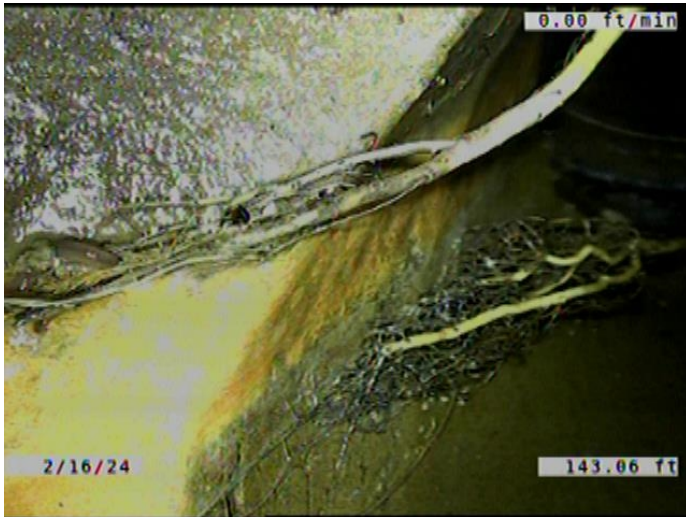
Code: **RFC**
Description: **Roots Fine Connection**

Distance (ft): **143.1**
Structural Grade: **0**
O&M Grade: **1**
Clock Start/From: **10**
Clock To: **11**
1st Value:
2nd Value:
Value Percent:
Continuous Index:
Within 8" of Joint: **NO**
Remarks:

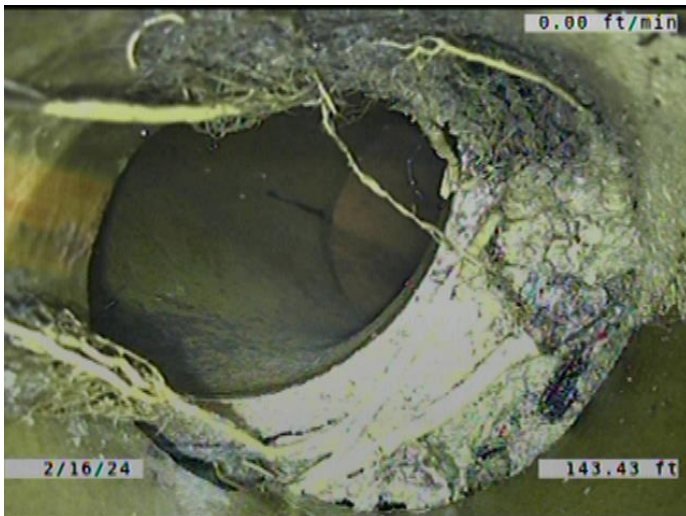
Code: **TFD**
Description: **Tap Factory Defective**

Distance (ft): **143.4**
Structural Grade: **0**
O&M Grade: **3**
Clock Start/From: **10**
Clock To:
1st Value: **6.000**
2nd Value:
Value Percent:
Continuous Index:
Within 8" of Joint: **YES**
Remarks: **TAP BROKEN. SERVICE HAS DROPPED. SOIL VISIBLE. ROOTS GRO**

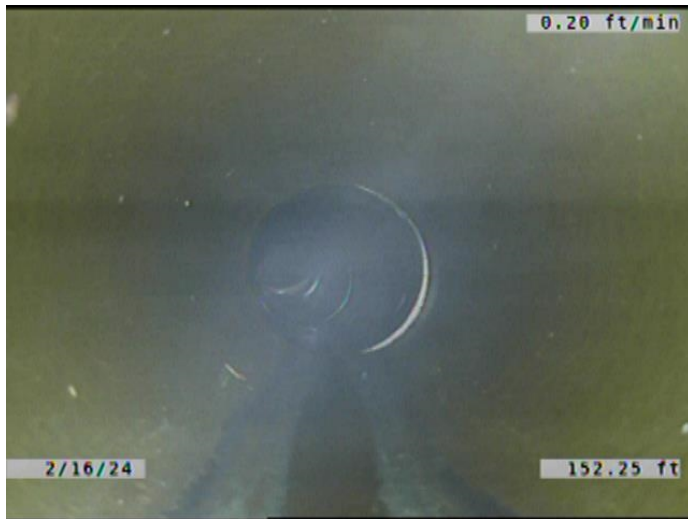
Code: **LL**
Description: **Line Left**

Distance (ft): **152.2**
Structural Grade: **0**
O&M Grade: **1**
Clock Start/From:
Clock To:
1st Value:
2nd Value:
Value Percent: **5.000**
Continuous Index:
Within 8" of Joint: **NO**
Remarks:

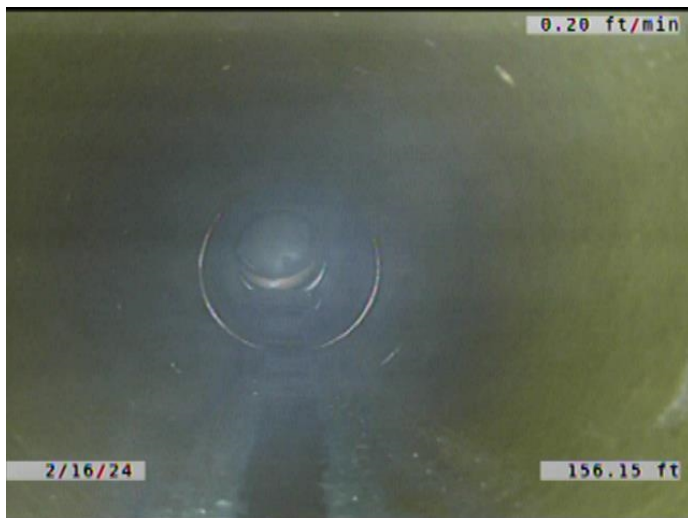
Code: **LL**
Description: **Line Left**

Distance (ft): **156.1**
Structural Grade: **0**
O&M Grade: **1**
Clock Start/From:
Clock To:
1st Value:
2nd Value:
Value Percent: **5.000**
Continuous Index:
Within 8" of Joint: **NO**
Remarks:

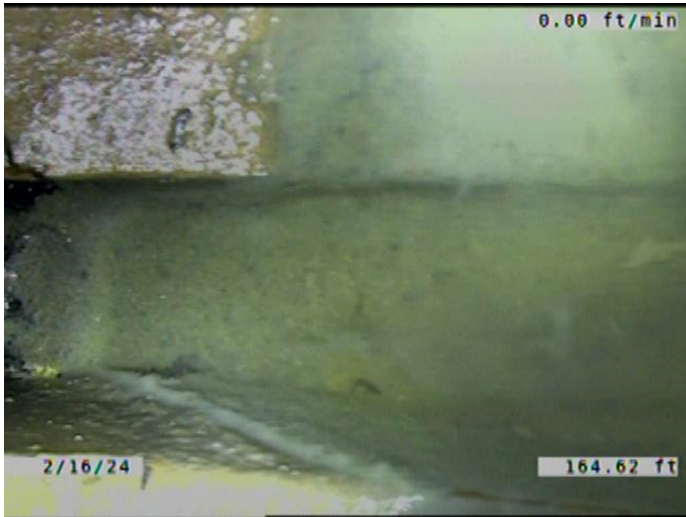
Code: **JAM**
Description: **Joint Angular Medium**

Distance (ft): **164.6**
Structural Grade: **3**
O&M Grade: **0**
Clock Start/From:
Clock To:
1st Value:
2nd Value:
Value Percent:
Continuous Index:
Within 8" of Joint: **NO**
Remarks:

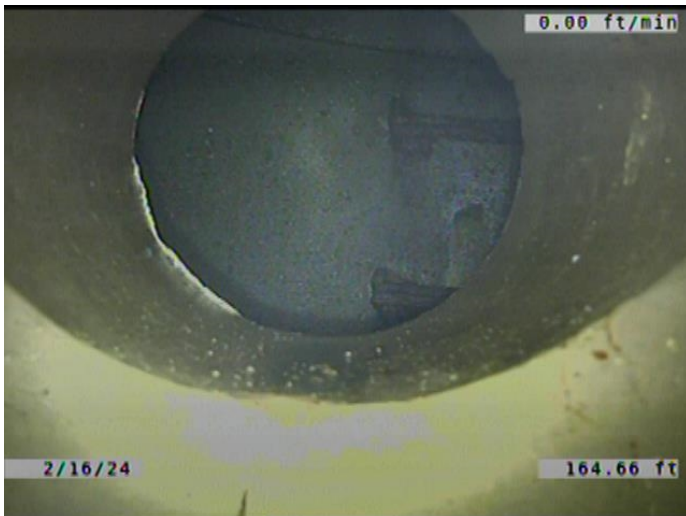
Code: **DAE**
Description: **Deposits Attached Encrustation**

Distance (ft): **164.7**
Structural Grade: **0**
O&M Grade: **2**
Clock Start/From: **7**
Clock To: **5**
1st Value:
2nd Value:
Value Percent: **5.000**
Continuous Index: **F01**
Within 8" of Joint: **YES**
Remarks:
