Profile/Photo Observation Report

Date:	04/09/2018	Weather:		Coding:	PACP 6.0
Pipe Length (ft):	170.1	Owner:	NA	Pre Clean:	No Pre-Cleaning
P.O.#:		Surveyor:	Jen Costello	PSR:	P-606-067-064
Customer:		Clean Date:	01/01/1900	Shape:	C

Street:	ALLEY BETWEEN W 7TH ST & W 7TH	Flow Control:	Not Controlled
City:	Hobart, IN	Year Renewed:	
Location:	Yard	Tape/Media #:	
Purpose:	Routine Assessment	Dia/Height:	12"
Use:	Sanitary	Material:	VCP
Drain Area:	NA	Lining:	
Category:	NA		
Comment:	Flow direction is marked wrong.		
Location Details:		Direction of Survey:	Upstream
US MH:	M-606-064	DS MH:	M-606-067
		Total Length Surveyed (ft):	12.2

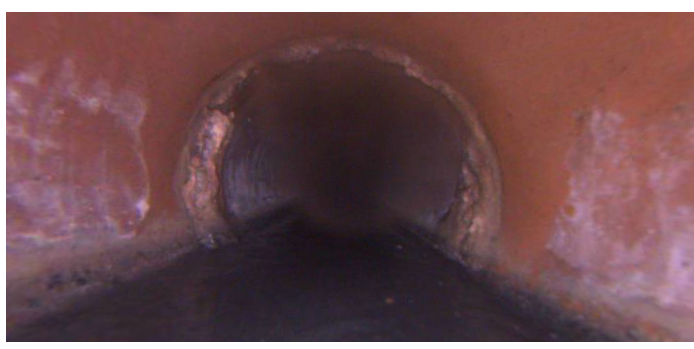
Code: **AMH**
Description: **Manhole**

Distance (ft): **.0**
Structural Grade: **0**
O&M Grade: **0**
Clock Start/From:
Clock To:
1st Value:
2nd Value:
Value Percent:
Continuous Index:
Within 8" of Joint: **NO**
Remarks: **M-606-067**

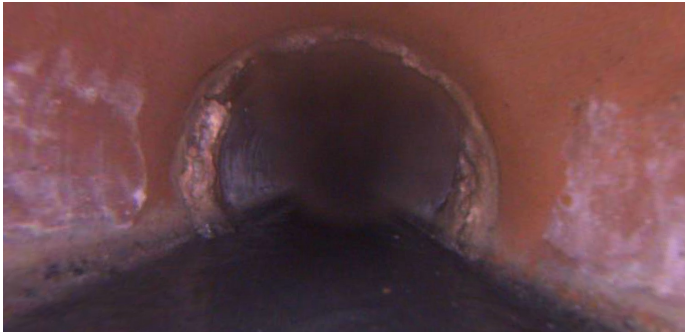
Code:	MWL
Description:	Water Level

Distance (ft):	.0
Structural Grade:	0
O&M Grade:	0
Clock Start/From:	
Clock To:	
1st Value:	
2nd Value:	
Value Percent:	20.000
Continuous Index:	
Within 8" of Joint:	NO
Remarks:

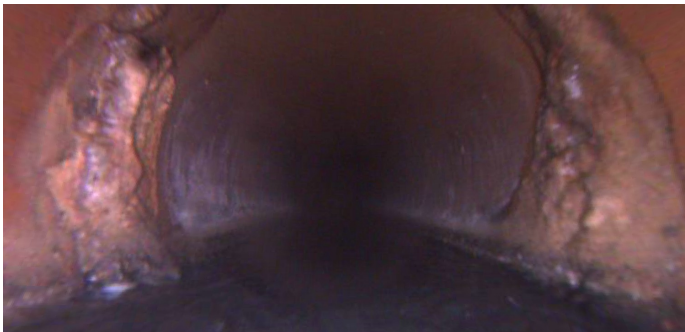
Code:	DAE
Description:	Deposits Attached Encrustation

Distance (ft):	.3
Structural Grade:	0
O&M Grade:	2
Clock Start/From:	8
Clock To:	4
1st Value:	
2nd Value:	
Value Percent:	10.000
Continuous Index:	
Within 8" of Joint:	YES
Remarks:

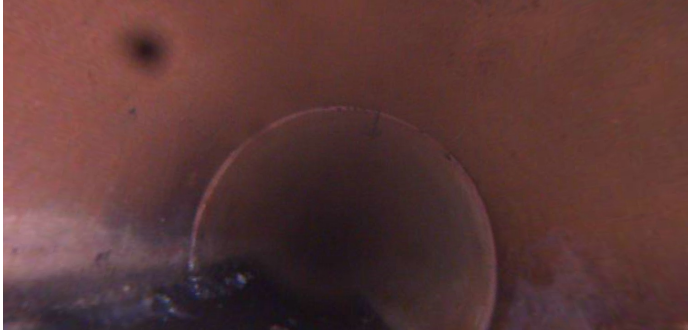
Code:	MSA
Description:	Abandoned Survey
Distance (ft):	12.2
Structural Grade:	0
O&M Grade:	0
Clock Start/From:	
Clock To:	
1st Value:	
2nd Value:	
Value Percent:	
Continuous Index:	
Within 8" of Joint:	NO
Remarks:	dae
