Profile/Photo Observation Report

Street:	FOXCROFT STREET	Flow Control:	Not Controlled
City:	Hobart, IN	Year Renewed:	
Location:	Yard	Tape/Media #:	
Purpose:	Routine Assessment	Dia/Height:	12"
Use:	Sanitary	Material:	VCP
Drain Area:	NA	Lining:	
Category:	NA		
Comment:	Flow direction is marked wrong.		
Location Details:		Direction of Survey:	Upstream
US MH:	M-606-064	DS MH:	M-606-067
		Total Length Surveyed (ft):	12.2

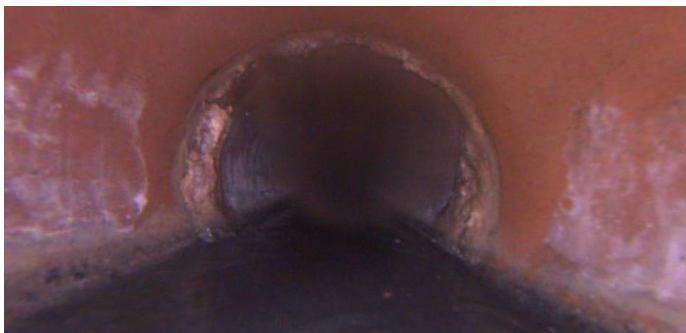
Code: **AMH**
Description: **Manhole**

Distance (ft): **.0**
Structural Grade: **0**
O&M Grade: **0**
Clock Start/From:
Clock To:
1st Value:
2nd Value:
Value Percent:
Continuous Index:
Within 8" of Joint: **NO**
Remarks: **M-606-067**

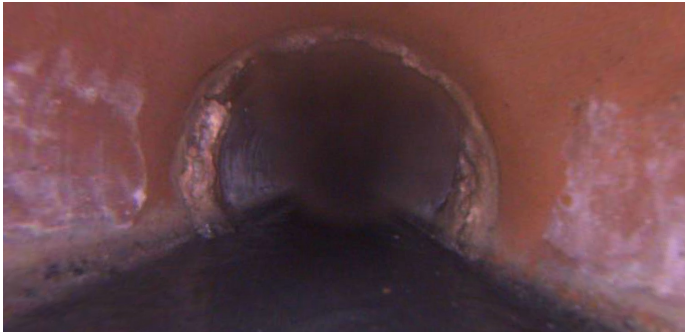
Code:	MWL
Description:	Water Level

Distance (ft):	.0
Structural Grade:	0
O&M Grade:	0
Clock Start/From:	
Clock To:	
1st Value:	
2nd Value:	
Value Percent:	20.000
Continuous Index:	
Within 8" of Joint:	NO
Remarks:

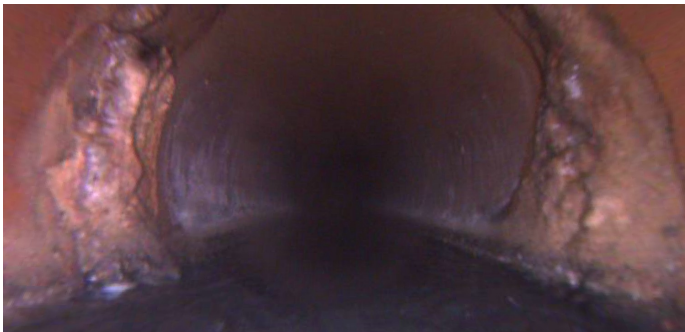
Code:	DAE
Description:	Deposits Attached Encrustation

Distance (ft):	.3
Structural Grade:	0
O&M Grade:	2
Clock Start/From:	8
Clock To:	4
1st Value:	
2nd Value:	
Value Percent:	10.000
Continuous Index:	
Within 8" of Joint:	YES
Remarks:

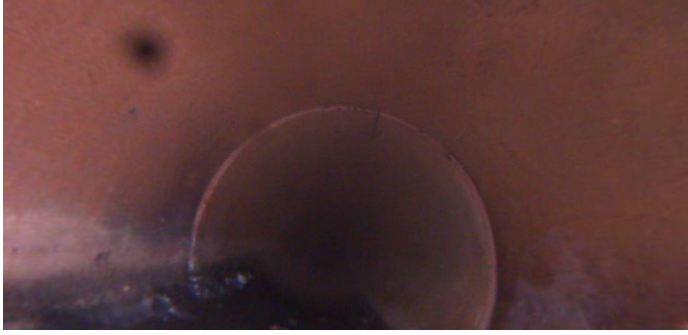
Code:	MSA
Description:	Abandoned Survey
Distance (ft):	12.2
Structural Grade:	0
O&M Grade:	0
Clock Start/From:	
Clock To:	
1st Value:	
2nd Value:	
Value Percent:	
Continuous Index:	
Within 8" of Joint:	NO
Remarks:	dae
