## Profile/Photo Observation Report

Street:	<b>ALLEY BETWEEN W 7TH ST &amp; W 7TH</b>	Flow Control:	<b>Not Controlled</b>
City:	<b>Hobart, IN</b>	Year Renewed:	
Location:	<b>Yard</b>	Tape/Media #:	
Purpose:	<b>Routine Assessment</b>	Dia/Height:	<b>12"</b>
Use:	<b>Sanitary</b>	Material:	<b>VCP</b>
Drain Area:	<b>NA</b>	Lining:	
Category:	<b>NA</b>		
Comment:	<b>False O_C, flow direction is marked wrong.</b>		
Location Details:		Direction of Survey:	<b>Downstream</b>
US MH:	<b>M-606-064</b>	DS MH:	<b>M-606-067</b>
		Total Length Surveyed (ft):	<b>7.8</b>

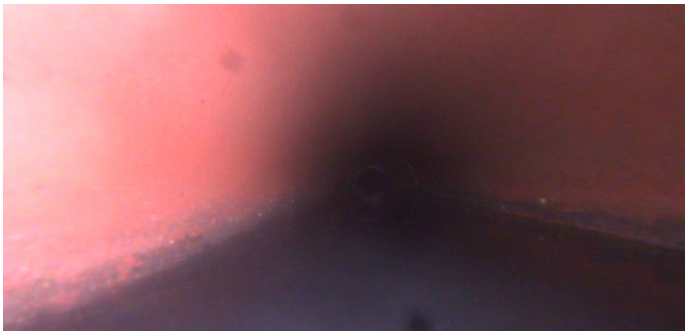
Code: **AMH**  
Description: **Manhole**

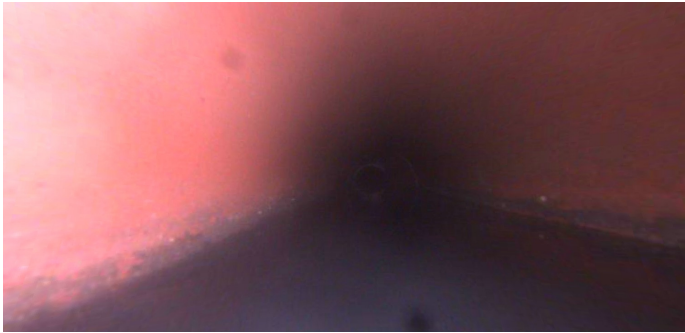
Code:	<b>MWL</b>
Description:	<b>Water Level</b>

Distance (ft):	<b>.0</b>
Structural Grade:	<b>0</b>
O&M Grade:	<b>0</b>
Clock Start/From:	
Clock To:	
1st Value:	
2nd Value:	
Value Percent:	<b>40.000</b>
Continuous Index:	
Within 8" of Joint:	<b>NO</b>
Remarks:

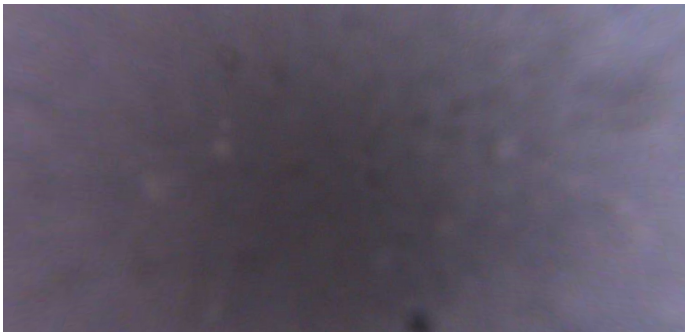
Code:	<b>MWL</b>
Description:	<b>Water Level</b>

Distance (ft):	<b>3.2</b>
Structural Grade:	<b>0</b>
O&M Grade:	<b>0</b>
Clock Start/From:	
Clock To:	
1st Value:	
2nd Value:	
Value Percent:	<b>100.000</b>
Continuous Index:	
Within 8" of Joint:	<b>NO</b>
Remarks:

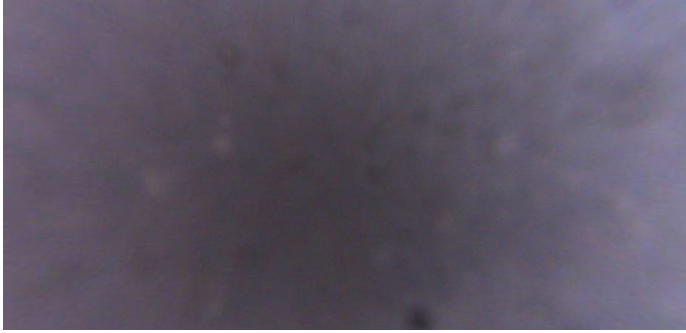
Code: **MCU**  
Description: **Camera Underwater**

Distance (ft): **3.2**  
Structural Grade: **0**  
O&M Grade: **4**  
Clock Start/From:  
Clock To:  
1st Value:  
2nd Value:  
Value Percent:  
Continuous Index:  
Within 8" of Joint: **NO**  
Remarks:

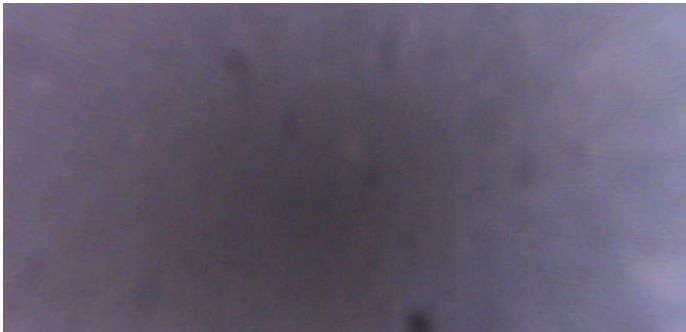
Code: **MSA**  
Description: **Abandoned Survey**

Distance (ft): **7.8**  
Structural Grade: **0**  
O&M Grade: **0**  
Clock Start/From:  
Clock To:  
1st Value:  
2nd Value:  
Value Percent:  
Continuous Index:  
Within 8" of Joint: **NO**  
Remarks: **MCU**
