Profile/Photo Observation Report

Date:	02/28/2024	Weather:		Coding:	PACP 7.0
Pipe Length (ft):	170.0	Owner:	City of Hobart	Pre Clean:	Heavy Cleaning
P.O.#:		Surveyor:	S. Bucklin	PSR:	P-606-067-064
Customer:	City of Hobart	Clean Date:	12/09/2023	Shape:	C

Street:	W 7TH ST	Flow Control:	Not Controlled
City:	Hobart, IN	Year Renewed:	
Location:	Easement/Right of Way	Tape/Media #:	
Purpose:	Sewer System Evaluation Survey (SS	Dia/Height:	12"
Use:	Sanitary Sewage Pipe	Material:	VCP
Drain Area:		Lining:	None
Category:	NA		
Comment:			
Location Details:		Direction of Survey:	Downstream
US MH:	M-606-064	DS MH:	M-606-067
		Total Length Surveyed (ft):	170.0

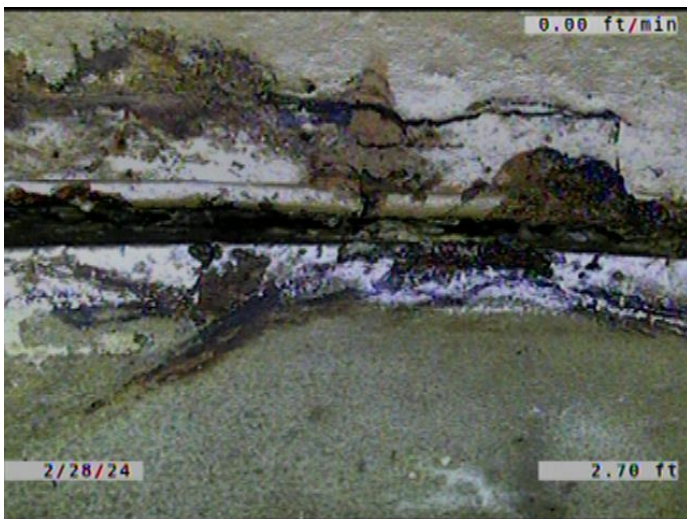
Code: **DAE**
Description: **Deposits Attached Encrustation**

Distance (ft): **2.7**
Structural Grade: **0**
O&M Grade: **2**
Clock Start/From: **7**
Clock To: **5**
1st Value:
2nd Value:
Value Percent: **5.000**
Continuous Index: **S01**
Within 8" of Joint: **YES**
Remarks:

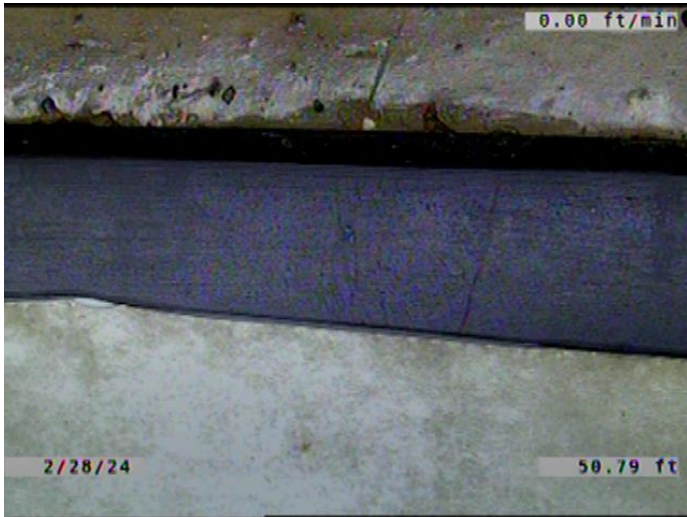
Code: **RPR**
Description: **Point Repair Replacement**

Distance (ft): **50.8**
Structural Grade: **0**
O&M Grade: **0**
Clock Start/From:
Clock To:
1st Value:
2nd Value:
Value Percent:
Continuous Index: **S02**
Within 8" of Joint: **YES**
Remarks: **REPLACED WITH PVC.**

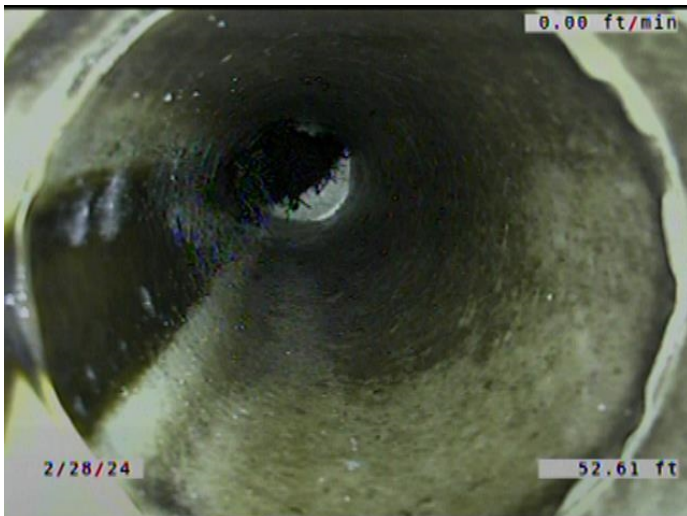
Code: **TF**
Description: **Tap Factory**

Distance (ft): **52.6**
Structural Grade: **0**
O&M Grade: **0**
Clock Start/From: **11**
Clock To:
1st Value: **6.000**
2nd Value:
Value Percent:
Continuous Index:
Within 8" of Joint: **YES**
Remarks: **ROOTS GROWING IN THE JOINTS.**

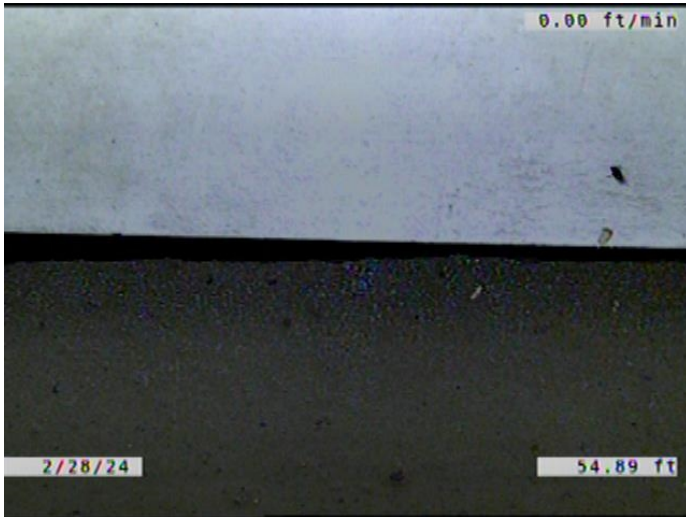
Code: **RPR**
Description: **Point Repair Replacement**

Distance (ft): **54.9**
Structural Grade: **0**
O&M Grade: **0**
Clock Start/From:
Clock To:
1st Value:
2nd Value:
Value Percent:
Continuous Index: **F02**
Within 8" of Joint: **YES**
Remarks: **REPLACED WITH PVC.**

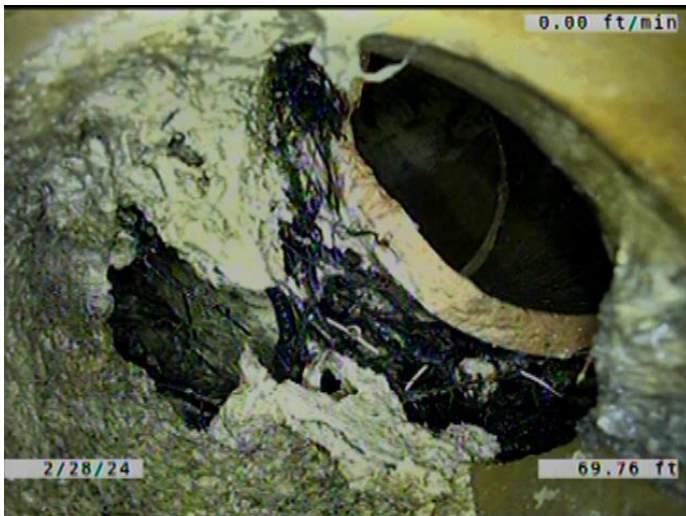
Code: **TFD**
Description: **Tap Factory Defective**

Distance (ft): **69.8**
Structural Grade: **0**
O&M Grade: **3**
Clock Start/From: **1**
Clock To:
1st Value: **6.000**
2nd Value:
Value Percent:
Continuous Index:
Within 8" of Joint: **YES**
Remarks: **SERVICE HAS DROPPED. SOIL AND VOID VISIBLE. ROOTS AND ENCRUST**

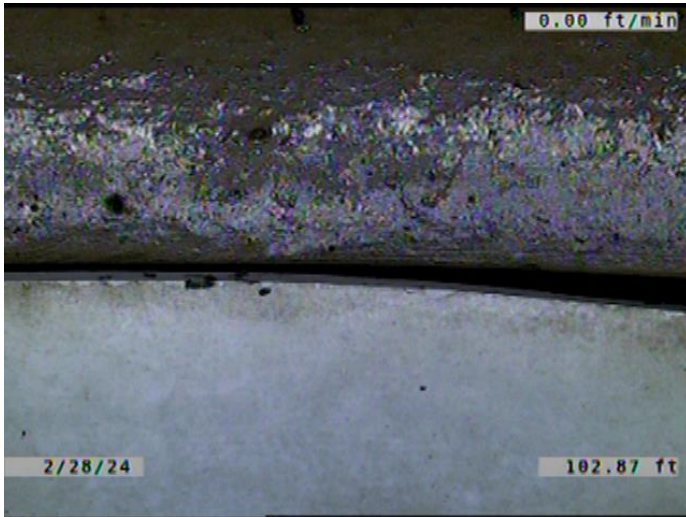
Code: **RPR**
Description: **Point Repair Replacement**

Distance (ft): **102.9**
Structural Grade: **0**
O&M Grade: **0**
Clock Start/From:
Clock To:
1st Value:
2nd Value:
Value Percent:
Continuous Index: **S03**
Within 8" of Joint: **YES**
Remarks: **REPLACED WITH PVC.**

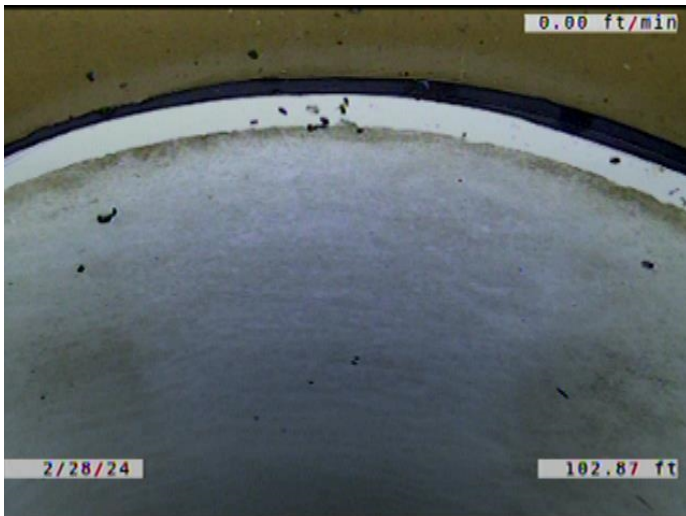
Code: **JOM**
Description: **Joint Offset Medium**

Distance (ft): **102.9**
Structural Grade: **3**
O&M Grade: **0**
Clock Start/From:
Clock To:
1st Value:
2nd Value:
Value Percent:
Continuous Index:
Within 8" of Joint: **NO**
Remarks:

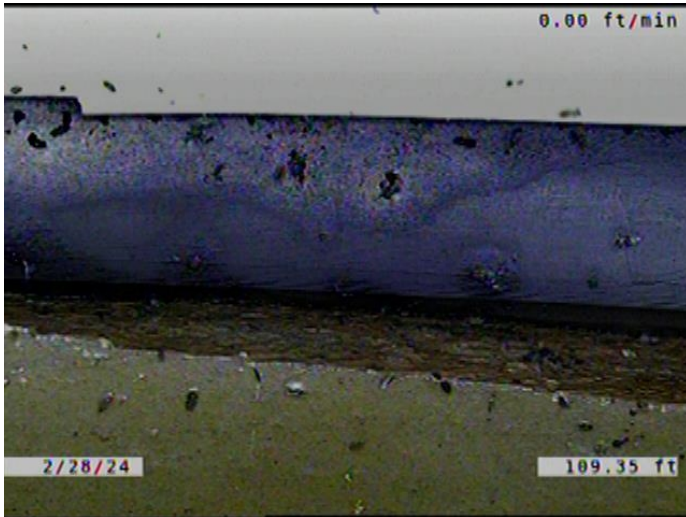
Code: **RPR**
Description: **Point Repair Replacement**

Distance (ft): **109.3**
Structural Grade: **0**
O&M Grade: **0**
Clock Start/From:
Clock To:
1st Value:
2nd Value:
Value Percent:
Continuous Index: **F03**
Within 8" of Joint: **YES**
Remarks: **REPLACED WITH PVC.**

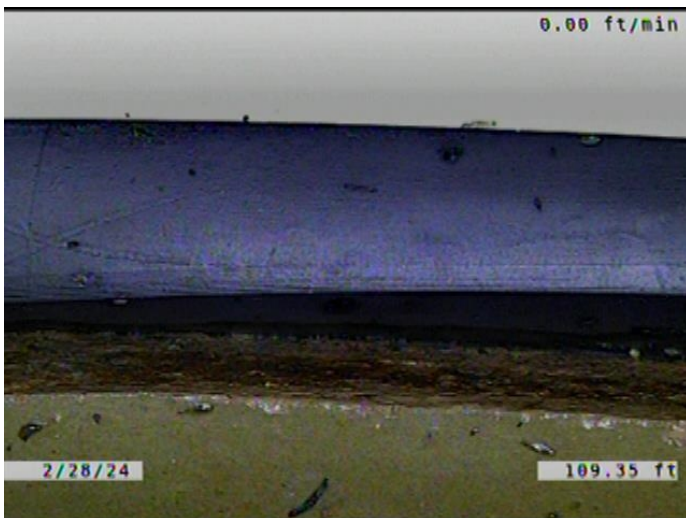
Code: **JAM**
Description: **Joint Angular Medium**

Distance (ft): **109.4**
Structural Grade: **3**
O&M Grade: **0**
Clock Start/From:
Clock To:
1st Value:
2nd Value:
Value Percent:
Continuous Index:
Within 8" of Joint: **NO**
Remarks:

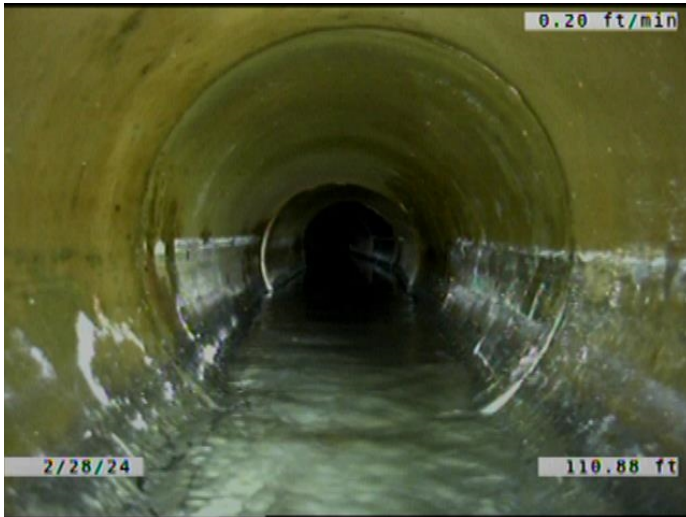
Code: **MWLS**
Description: **Miscellaneous Water Level Sag**

Distance (ft): **110.9**
Structural Grade: **2**
O&M Grade: **0**
Clock Start/From:
Clock To:
1st Value:
2nd Value:
Value Percent: **25.000**
Continuous Index: **S04**
Within 8" of Joint: **NO**
Remarks:

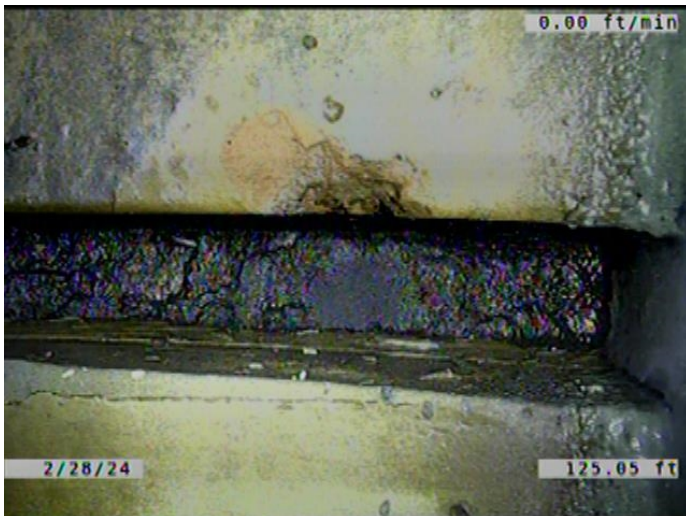
Code: **JAM**
Description: **Joint Angular Medium**

Distance (ft): **125.0**
Structural Grade: **3**
O&M Grade: **0**
Clock Start/From:
Clock To:
1st Value:
2nd Value:
Value Percent:
Continuous Index:
Within 8" of Joint: **NO**
Remarks:

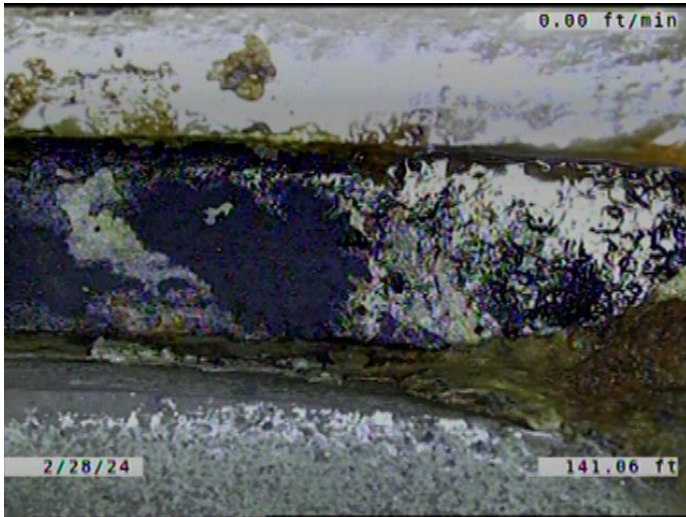
Code: **JAM**
 Description: **Joint Angular Medium**

Distance (ft): **141.1**
 Structural Grade: **3**
 O&M Grade: **0**
 Clock Start/From:
 Clock To:
 1st Value:
 2nd Value:
 Value Percent:
 Continuous Index:
 Within 8" of Joint: **NO**
 Remarks:

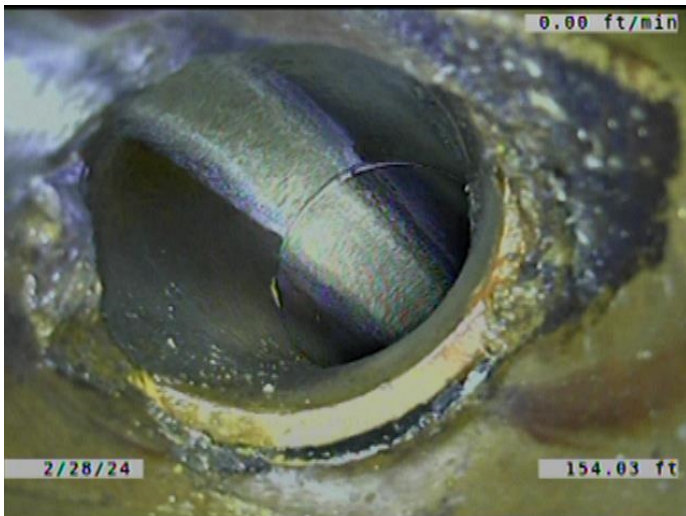
Code: **TFD**
 Description: **Tap Factory Defective**

Distance (ft): **154.0**
 Structural Grade: **0**
 O&M Grade: **3**
 Clock Start/From: **11**
 Clock To:
 1st Value: **6.000**
 2nd Value:
 Value Percent:
 Continuous Index:
 Within 8" of Joint: **YES**
 Remarks: **SERVICE OFFSET. ENCRUSTATION
 COMING FROM THE SERVICE TO MA**

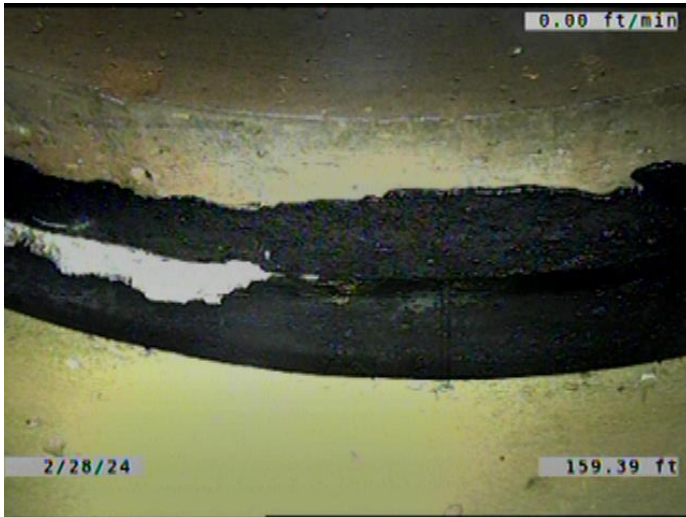
Code: **JOMD**
Description: **Joint Offset Medium Defective**

Distance (ft): **159.4**
Structural Grade: **3**
O&M Grade: **0**
Clock Start/From:
Clock To:
1st Value:
2nd Value:
Value Percent:
Continuous Index:
Within 8" of Joint: **NO**
Remarks:

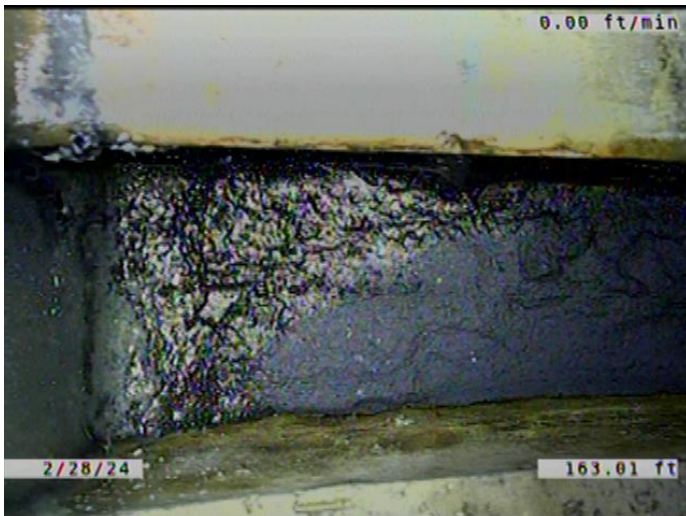
Code: **JAM**
Description: **Joint Angular Medium**

Distance (ft): **163.0**
Structural Grade: **3**
O&M Grade: **0**
Clock Start/From:
Clock To:
1st Value:
2nd Value:
Value Percent:
Continuous Index:
Within 8" of Joint: **NO**
Remarks:

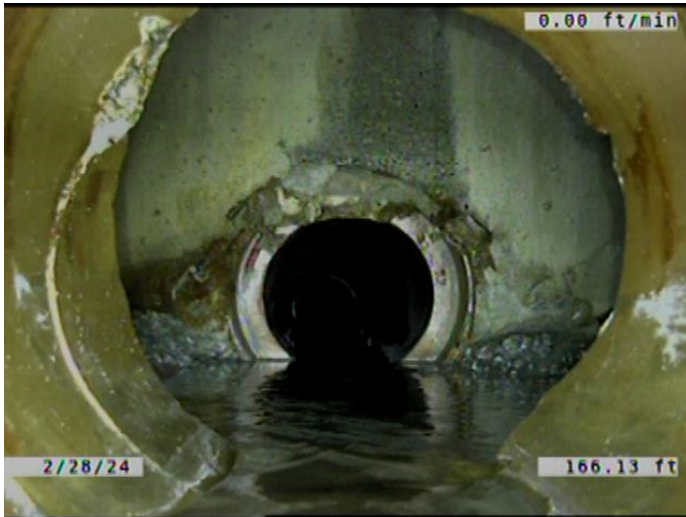
Code: **MWLS**
 Description: **Miscellaneous Water Level Sag**

Distance (ft): **166.1**
 Structural Grade: **2**
 O&M Grade: **0**
 Clock Start/From:
 Clock To:
 1st Value:
 2nd Value:
 Value Percent: **25.000**
 Continuous Index: **F04**
 Within 8" of Joint: **NO**
 Remarks:

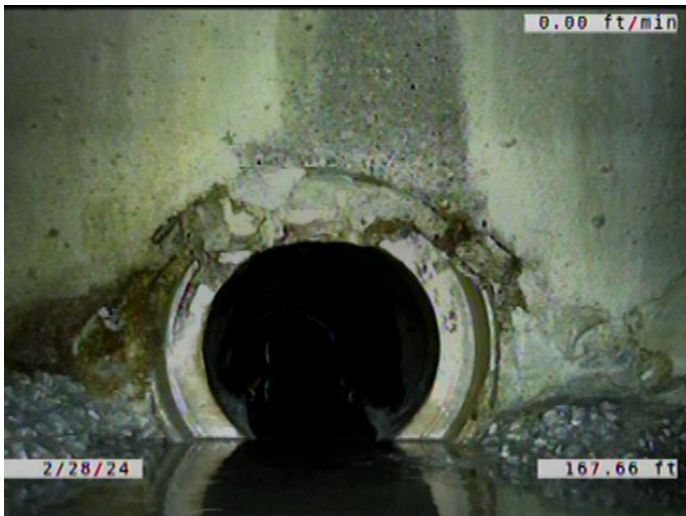
Code: **DAE**
 Description: **Deposits Attached Encrustation**

Distance (ft): **167.6**
 Structural Grade: **0**
 O&M Grade: **2**
 Clock Start/From: **7**
 Clock To: **5**
 1st Value:
 2nd Value:
 Value Percent: **5.000**
 Continuous Index: **F01**
 Within 8" of Joint: **YES**
 Remarks:

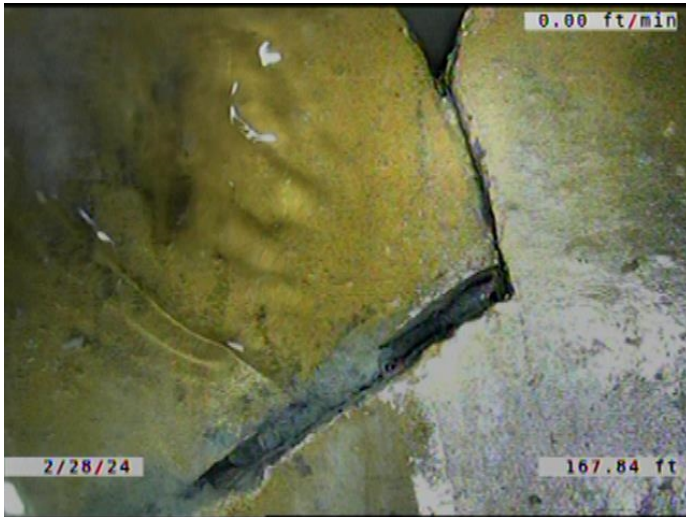
Code: **B**
 Description: **Broken**

Distance (ft): **167.8**
 Structural Grade: **4**
 O&M Grade: **0**
 Clock Start/From: **4**
 Clock To: **10**
 1st Value:
 2nd Value:
 Value Percent:
 Continuous Index:
 Within 8" of Joint: **YES**
 Remarks:
