Profile/Photo Observation Report

| Street: | ALLEY BETWEEN W 7TH ST & W 7TH | Flow Control: | Not Controlled |
| City: | Hobart, IN | Year Renewed: | |
| US MH: | M-606-065 | DS MH: | M-606-066 |

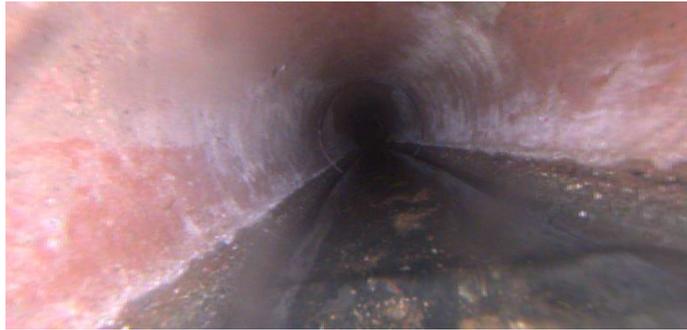
Code: **AMH**
Description: **Manhole**
Distance (ft): **.0**
Structural Grade: **0**
O&M Grade: **0**
Clock Start/From:
Clock To:
1st Value:
2nd Value:
Value Percent:
Continuous Index:
Within 8" of Joint: **NO**
Remarks: **M-606-065**

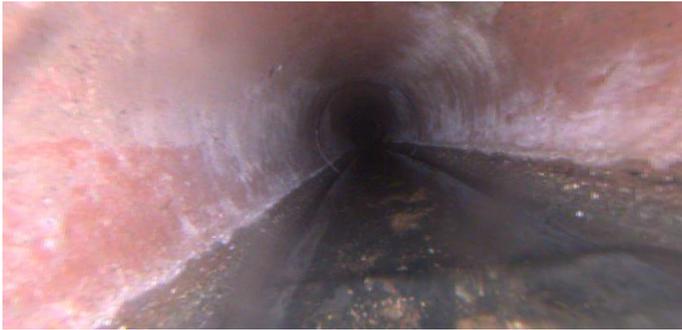
Code: **MWL**
Description: **Water Level**

Distance (ft): **.0**
Structural Grade: **0**
O&M Grade: **0**
Clock Start/From:
Clock To:
1st Value:
2nd Value:
Value Percent: **5.000**
Continuous Index:
Within 8" of Joint: **NO**
Remarks:

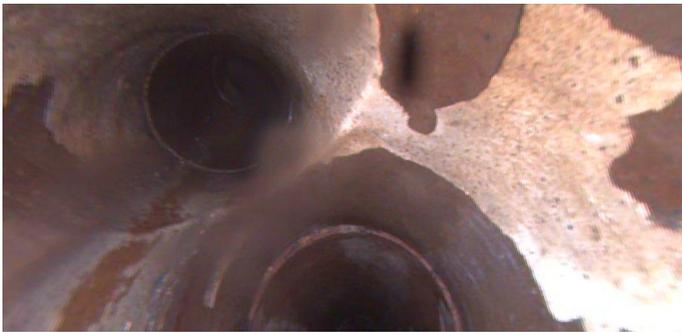
Code: **TF**
Description: **Tap Factory**

Distance (ft): **7.4**
Structural Grade: **0**
O&M Grade: **0**
Clock Start/From: **11**
Clock To:
1st Value: **4.000**
2nd Value:
Value Percent:
Continuous Index:
Within 8" of Joint: **YES**
Remarks:

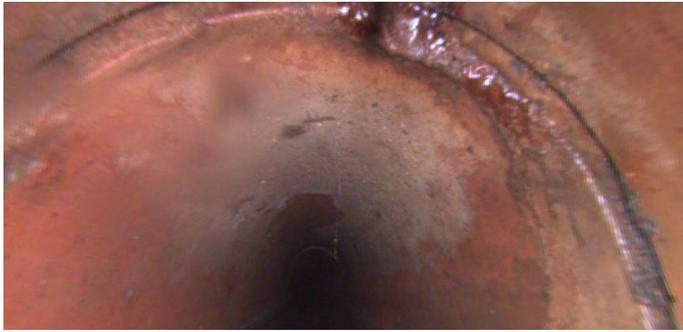
| Position | Code | Observation | Video (sec) | Grade |
|---|---|---|---|---|
| 23.3 | DAE | Deposits Attached Encrustation | 91 | M 2 |

Code: **DAE**
Description: **Deposits Attached Encrustation**

Distance (ft): **23.3**
Structural Grade: **0**
O&M Grade: **2**
Clock Start/From: **1**
Clock To:
1st Value:
2nd Value:
Value Percent: **5.000**
Continuous Index:
Within 8" of Joint: **YES**
Remarks:

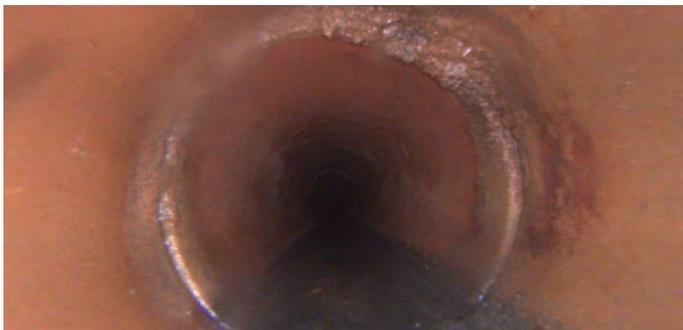
| Position | Code | Observation | Video (sec) | Grade |
|---|---|---|---|---|
| 27.0 | DAE | Deposits Attached Encrustation | 110 | M 2 |

Code: **DAE**
Description: **Deposits Attached Encrustation**

Distance (ft): **27.0**
Structural Grade: **0**
O&M Grade: **2**
Clock Start/From: **12**
Clock To: **2**
1st Value:
2nd Value:
Value Percent: **5.000**
Continuous Index:
Within 8" of Joint: **YES**
Remarks:

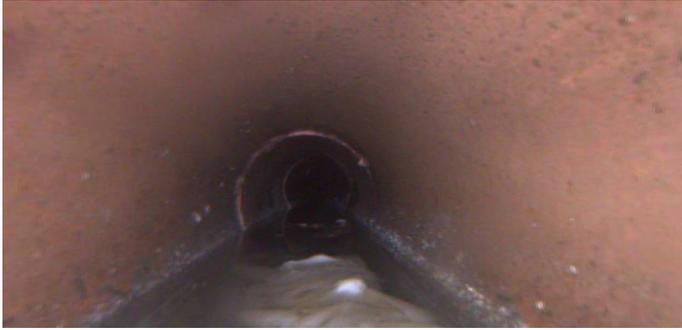
| Position | Code | Observation | Video (sec) | Grade |
|---|---|---|---|---|
| 41.9 | DSZ | Deposits Settled Other | 152 | M 2 |

Code: **DSZ**
Description: **Deposits Settled Other**

Distance (ft): **41.9**
Structural Grade: **0**
O&M Grade: **2**
Clock Start/From: **6**
Clock To:
1st Value:
2nd Value:
Value Percent: **5.000**
Continuous Index:
Within 8" of Joint: **NO**
Remarks: **debris**

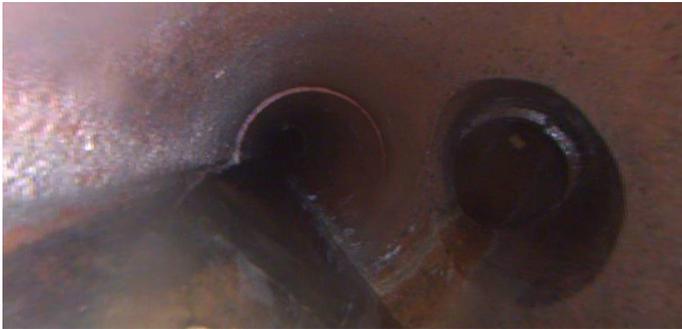
Code: **TF**
Description: **Tap Factory**

Distance (ft): **44.2**
Structural Grade: **0**
O&M Grade: **0**
Clock Start/From: **2**
Clock To:
1st Value: **4.000**
2nd Value:
Value Percent:
Continuous Index:
Within 8" of Joint:
Remarks:

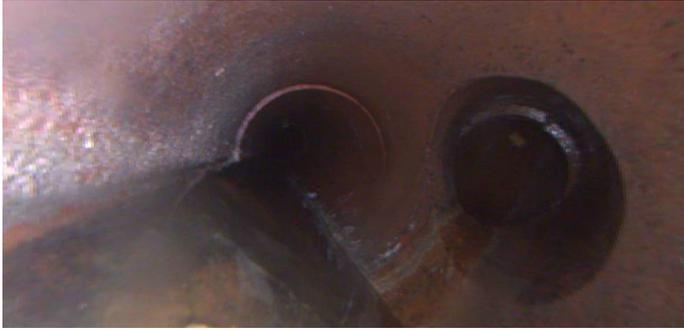
Code: **MSA**
Description: **Abandoned Survey**

Distance (ft): **44.2**
Structural Grade: **0**
O&M Grade: **0**
Clock Start/From:
Clock To:
1st Value:
2nd Value:
Value Percent:
Continuous Index:
Within 8" of Joint: **NO**
Remarks: **camera flipped**
