Profile/Photo Observation Report

Date:	04/08/2018	Weather:		Coding:	PACP 6.0
Pipe Length (ft):	169.7	Owner:	NA	Pre Clean:	No Pre-Cleaning
P.O.#:		Surveyor:	Byrd Fitzgerald	PSR:	P-606-066-065
Customer:		Clean Date:	01/01/1900	Shape:	C

Street:	FOXCROFT STREET	Flow Control:	Not Controlled
City:	Hobart, IN	Year Renewed:	
Location:	Yard	Tape/Media #:	
Purpose:	Routine Assessment	Dia/Height:	10"
Use:	Sanitary	Material:	VCP
Drain Area:	NA	Lining:	
Category:	NA		
Comment:	Flow direction is wrong.		
Location Details:		Direction of Survey:	Downstream
US MH:	M-606-065	DS MH:	M-606-066
		Total Length Surveyed (ft):	44.2

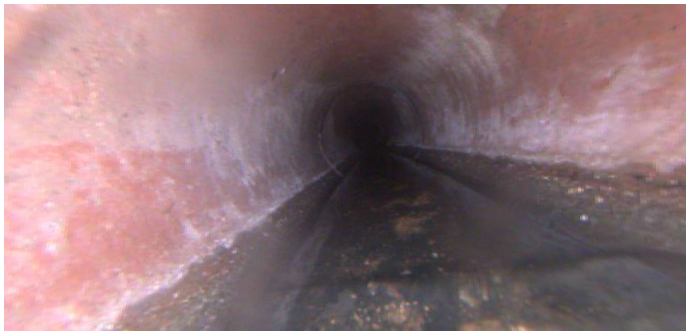
Code: **AMH**
Description: **Manhole**

Distance (ft): **.0**
Structural Grade: **0**
O&M Grade: **0**
Clock Start/From:
Clock To:
1st Value:
2nd Value:
Value Percent:
Continuous Index:
Within 8" of Joint: **NO**
Remarks: **M-606-065**

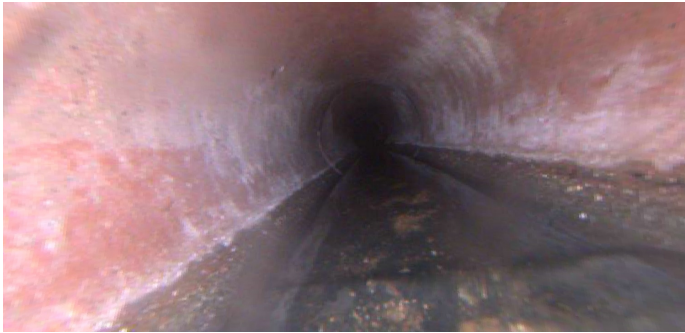
Code:	MWL
Description:	Water Level

Distance (ft):	.0
Structural Grade:	0
O&M Grade:	0
Clock Start/From:	
Clock To:	
1st Value:	
2nd Value:	
Value Percent:	5.000
Continuous Index:	
Within 8" of Joint:	NO
Remarks:

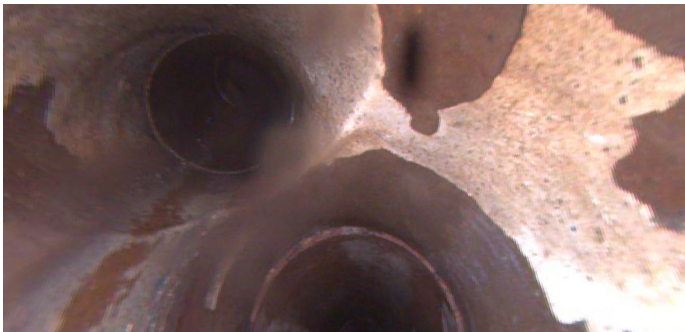
Code:	TF
Description:	Tap Factory

Distance (ft):	7.4
Structural Grade:	0
O&M Grade:	0
Clock Start/From:	11
Clock To:	
1st Value:	4.000
2nd Value:	
Value Percent:	
Continuous Index:	
Within 8" of Joint:	YES
Remarks:

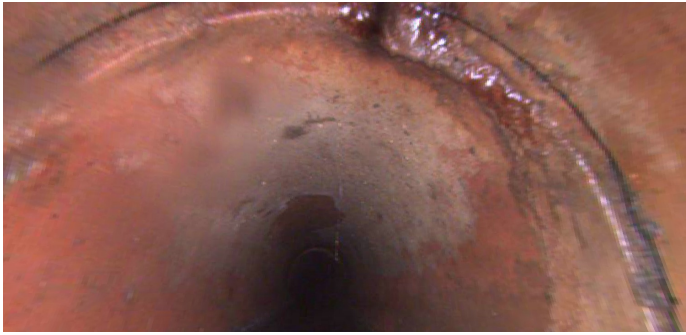
Code: **DAE**
Description: **Deposits Attached Encrustation**

Distance (ft): **23.3**
Structural Grade: **0**
O&M Grade: **2**
Clock Start/From: **1**
Clock To:
1st Value:
2nd Value:
Value Percent: **5.000**
Continuous Index:
Within 8" of Joint: **YES**
Remarks:

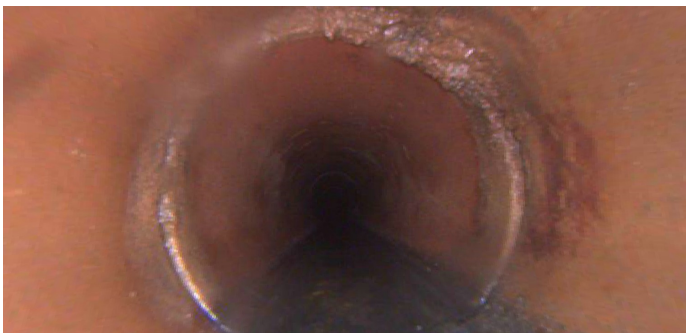
Code: **DAE**
Description: **Deposits Attached Encrustation**

Distance (ft): **27.0**
Structural Grade: **0**
O&M Grade: **2**
Clock Start/From: **12**
Clock To: **2**
1st Value:
2nd Value:
Value Percent: **5.000**
Continuous Index:
Within 8" of Joint: **YES**
Remarks:

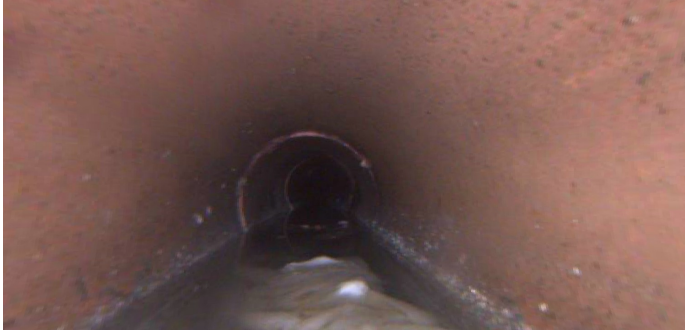
Code: **DSZ**
Description: **Deposits Settled Other**

Distance (ft): **41.9**
Structural Grade: **0**
O&M Grade: **2**
Clock Start/From: **6**
Clock To:
1st Value:
2nd Value:
Value Percent: **5.000**
Continuous Index:
Within 8" of Joint: **NO**
Remarks: **debris**

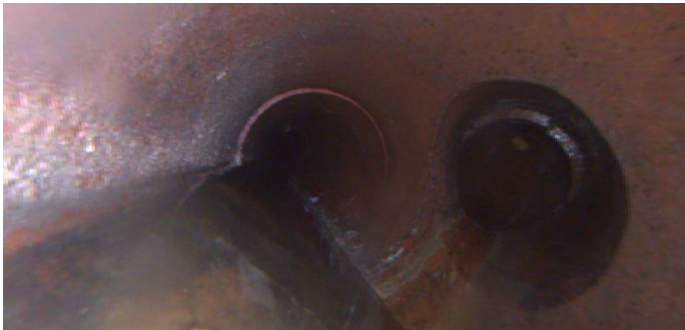
Code: **TF**
Description: **Tap Factory**

Distance (ft): **44.2**
Structural Grade: **0**
O&M Grade: **0**
Clock Start/From: **2**
Clock To:
1st Value: **4.000**
2nd Value:
Value Percent:
Continuous Index:
Within 8" of Joint:
Remarks:

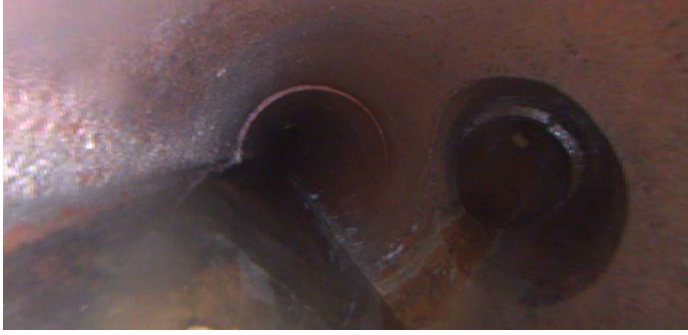
Code:	MSA
Description:	Abandoned Survey
Distance (ft):	44.2
Structural Grade:	0
O&M Grade:	0
Clock Start/From:	
Clock To:	
1st Value:	
2nd Value:	
Value Percent:	
Continuous Index:	
Within 8" of Joint:	NO
Remarks:	camera flipped
