# Profile/Photo Observation Report

Date:	02/16/2024	Weather:		Coding:	PACP 7.0
Pipe Length (ft):	170.0	Owner:	City of Hobart	Pre Clean:	Heavy Cleaning
P.O.#:	YES502259	Surveyor:	S. Bucklin	PSR:	P-606-066-065
Customer:	City of Hobart	Clean Date:	12/08/2023	Shape:	C

Street:	S PENNSLYVANIA ST	Flow Control:	Not Controlled
City:	Hobart, IN	Year Renewed:	
Location:	Other	Tape/Media #:	
Purpose:	Routine Assessment	Dia/Height:	10"
Use:	Sanitary Sewage Pipe	Material:	VCP
Drain Area:		Lining:	None
Category:	NA		
Comment:			
Location Details:	DRIVE WAY	Direction of Survey:	Downstream
US MH:	M-606-065	DS MH:	M-606-066
		Total Length Surveyed (ft):	168.0

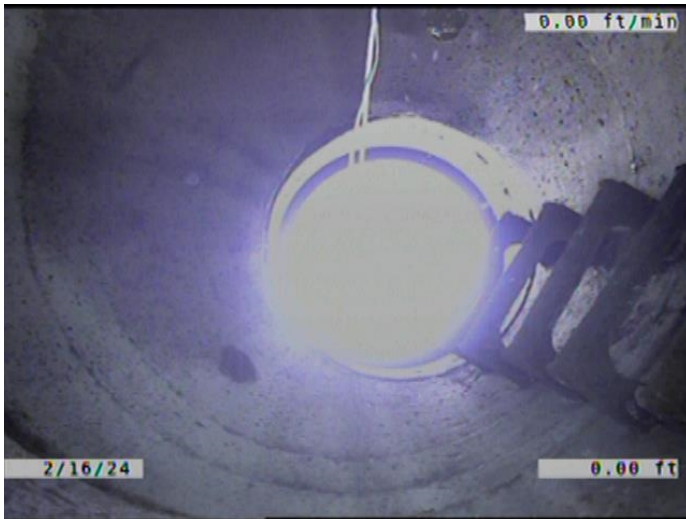
Code: **AMH**  
Description: **Manhole**

Distance (ft): **.0**  
Structural Grade: **0**  
O&M Grade: **0**  
Clock Start/From:  
Clock To:  
1st Value:  
2nd Value:  
Value Percent:  
Continuous Index:  
Within 8" of Joint: **NO**  
Remarks: **M-606-065**

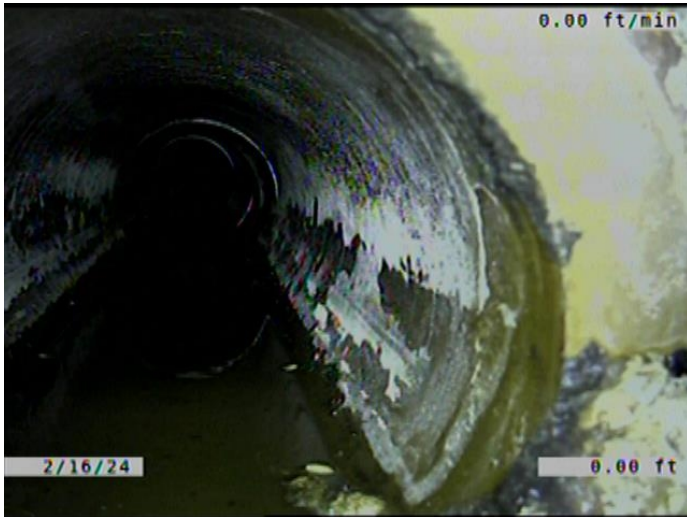
Code: **MWL**  
Description: **Miscellaneous Water Level**

Distance (ft): **.0**  
Structural Grade: **0**  
O&M Grade: **0**  
Clock Start/From:  
Clock To:  
1st Value:  
2nd Value:  
Value Percent: **5.000**  
Continuous Index:  
Within 8" of Joint: **NO**  
Remarks:

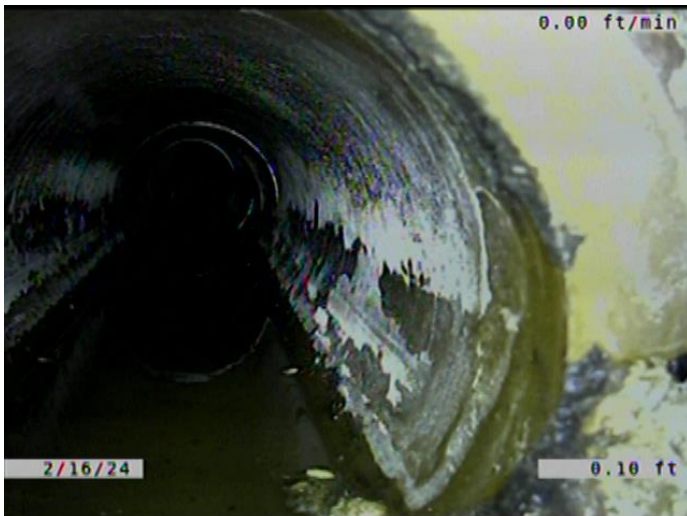
Code: **MWLS**  
Description: **Miscellaneous Water Level Sag**

Distance (ft): **.1**  
Structural Grade: **2**  
O&M Grade: **0**  
Clock Start/From:  
Clock To:  
1st Value:  
2nd Value:  
Value Percent: **10.000**  
Continuous Index: **S01**  
Within 8" of Joint: **NO**  
Remarks:

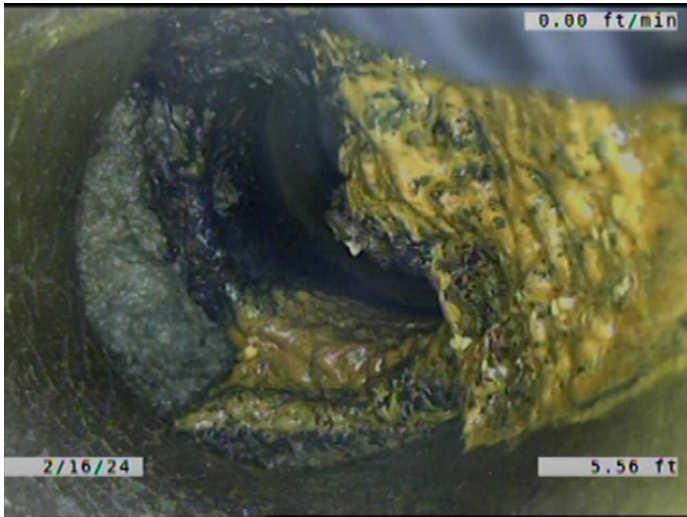
Code: **IRL**  
Description: **Infiltration Runner Lateral**

Distance (ft): **5.6**  
Structural Grade: **0**  
O&M Grade: **4**  
Clock Start/From: **2**  
Clock To:  
1st Value:  
2nd Value:  
Value Percent:  
Continuous Index:  
Within 8" of Joint: **YES**  
Remarks: **SERVICE HAS DROPPED.  
INFILTRATION COMING IN FROM TH**

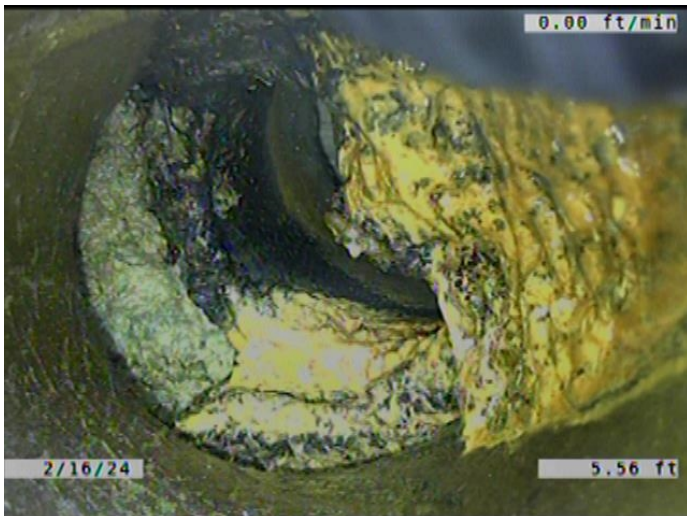
Code: **TFD**  
Description: **Tap Factory Defective**

Distance (ft): **5.6**  
Structural Grade: **0**  
O&M Grade: **3**  
Clock Start/From: **2**  
Clock To:  
1st Value: **6.000**  
2nd Value:  
Value Percent:  
Continuous Index:  
Within 8" of Joint: **YES**  
Remarks: **SERVICE HAS  
DROPPED. ENCRUSTATION COMING**

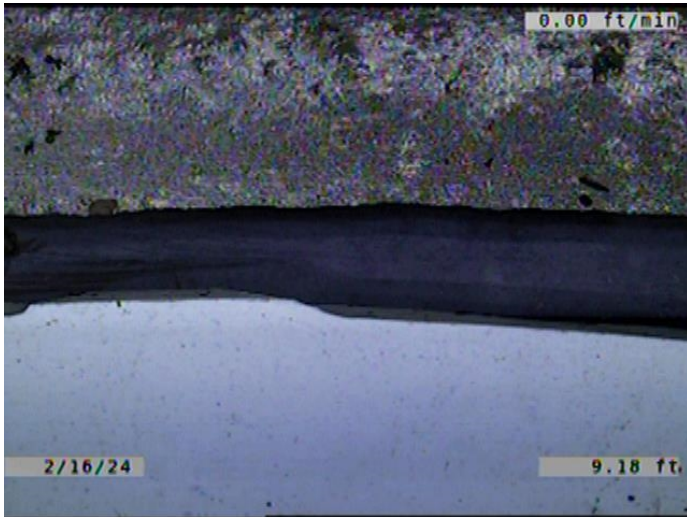
Code: **RPR**  
Description: **Point Repair Replacement**

Distance (ft): **9.2**  
Structural Grade: **0**  
O&M Grade: **0**  
Clock Start/From:  
Clock To:  
1st Value:  
2nd Value:  
Value Percent:  
Continuous Index: **S02**  
Within 8" of Joint: **YES**  
Remarks: **REPLACED WITH PVC.**

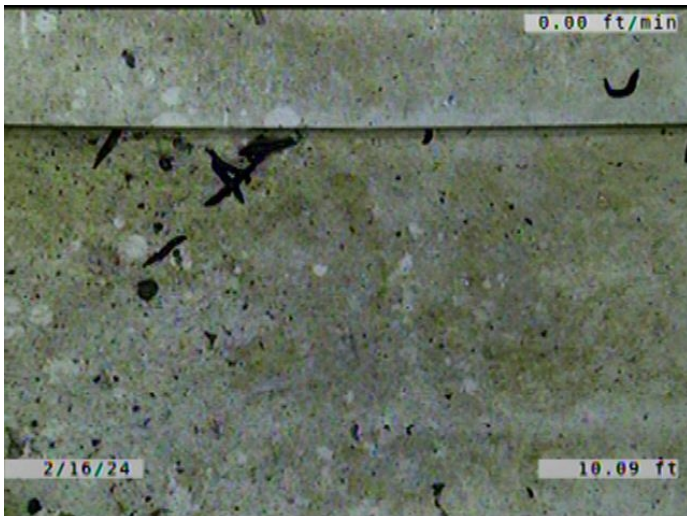
Code: **MGO**  
Description: **Miscellaneous General Observation**

Distance (ft): **10.1**  
Structural Grade: **0**  
O&M Grade: **0**  
Clock Start/From:  
Clock To:  
1st Value:  
2nd Value:  
Value Percent:  
Continuous Index:  
Within 8" of Joint: **NO**  
Remarks: **JOINT/ PIPES NOT PUSHED ALL THE WAY TOGETHER WHEN INSTALLED**

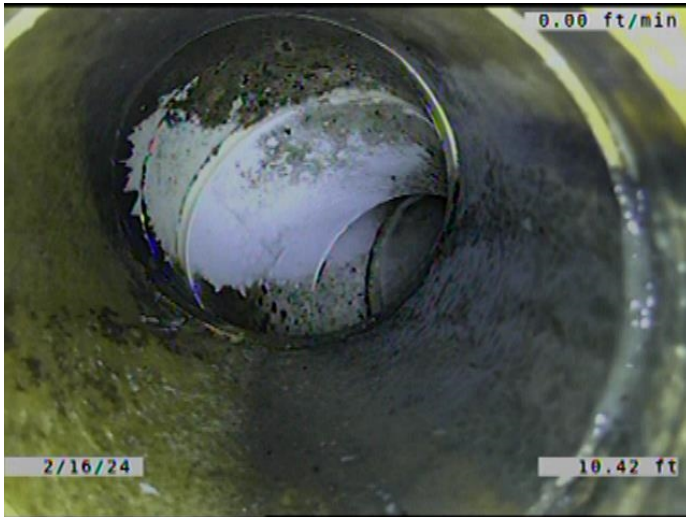
Code: **TF**  
Description: **Tap Factory**

Distance (ft): **10.4**  
Structural Grade: **0**  
O&M Grade: **0**  
Clock Start/From: **1**  
Clock To:  
1st Value: **6.000**  
2nd Value:  
Value Percent:  
Continuous Index:  
Within 8" of Joint: **YES**  
Remarks:

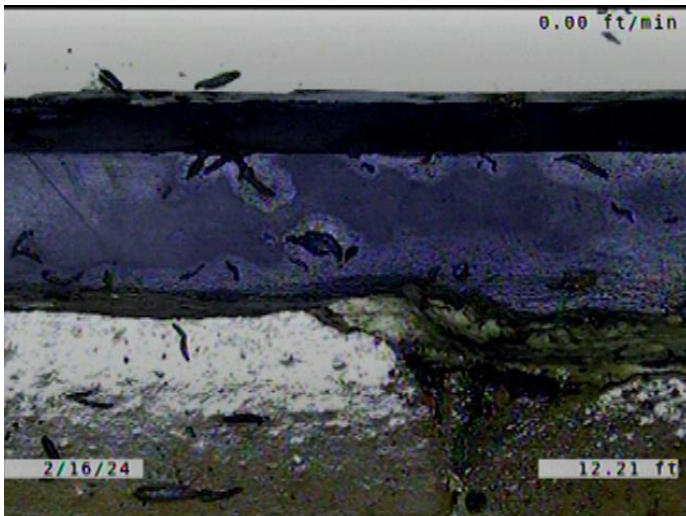
Code: **RPR**  
Description: **Point Repair Replacement**

Distance (ft): **12.2**  
Structural Grade: **0**  
O&M Grade: **0**  
Clock Start/From:  
Clock To:  
1st Value:  
2nd Value:  
Value Percent:  
Continuous Index: **F02**  
Within 8" of Joint: **YES**  
Remarks: **REPLACED WITH PVC.**

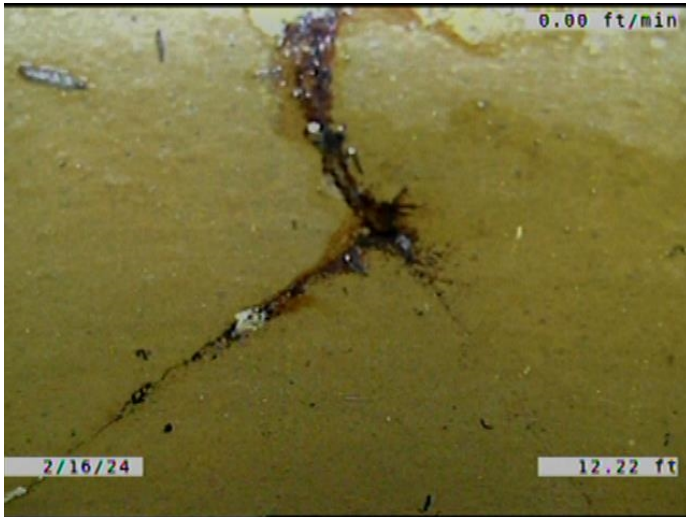
Code: **CM**  
Description: **Crack Multiple**

Distance (ft): **12.2**  
Structural Grade: **3**  
O&M Grade: **0**  
Clock Start/From: **11**  
Clock To: **2**  
1st Value:  
2nd Value:  
Value Percent:  
Continuous Index:  
Within 8" of Joint: **YES**  
Remarks:

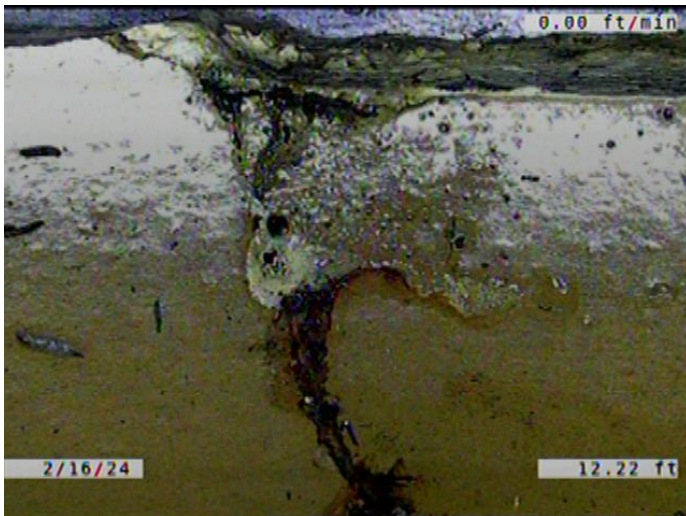
Code: **DAE**  
Description: **Deposits Attached Encrustation**

Distance (ft): **12.2**  
Structural Grade: **0**  
O&M Grade: **2**  
Clock Start/From: **10**  
Clock To: **2**  
1st Value:  
2nd Value:  
Value Percent: **5.000**  
Continuous Index:  
Within 8" of Joint: **YES**  
Remarks:

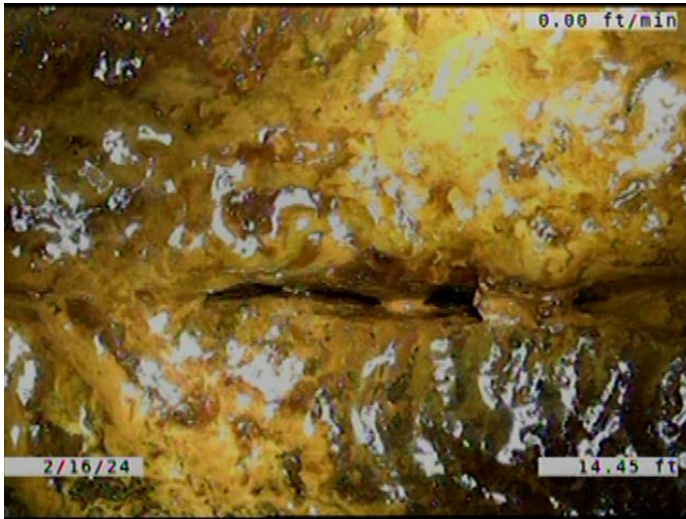
Code: **IWJ**  
Description: **Infiltration Weeper Joint**

Distance (ft): **14.4**  
Structural Grade: **0**  
O&M Grade: **2**  
Clock Start/From: **2**  
Clock To: **3**  
1st Value:  
2nd Value:  
Value Percent:  
Continuous Index:  
Within 8" of Joint: **YES**  
Remarks:

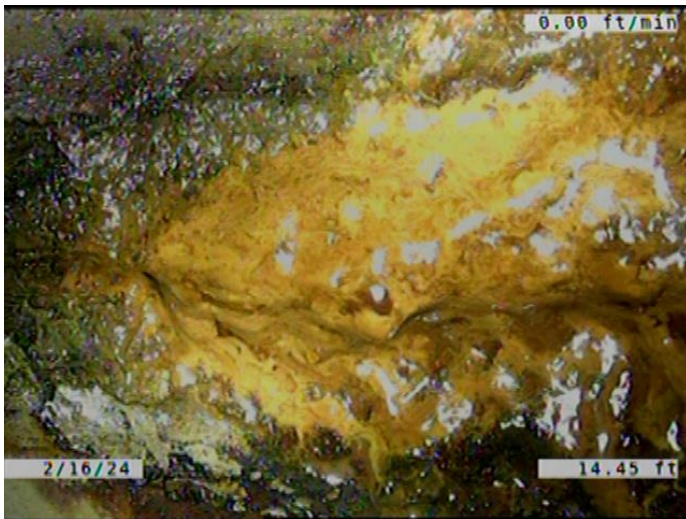
Code: **DAE**  
Description: **Deposits Attached Encrustation**

Distance (ft): **14.4**  
Structural Grade: **0**  
O&M Grade: **2**  
Clock Start/From: **7**  
Clock To: **5**  
1st Value:  
2nd Value:  
Value Percent: **5.000**  
Continuous Index:  
Within 8" of Joint: **YES**  
Remarks:

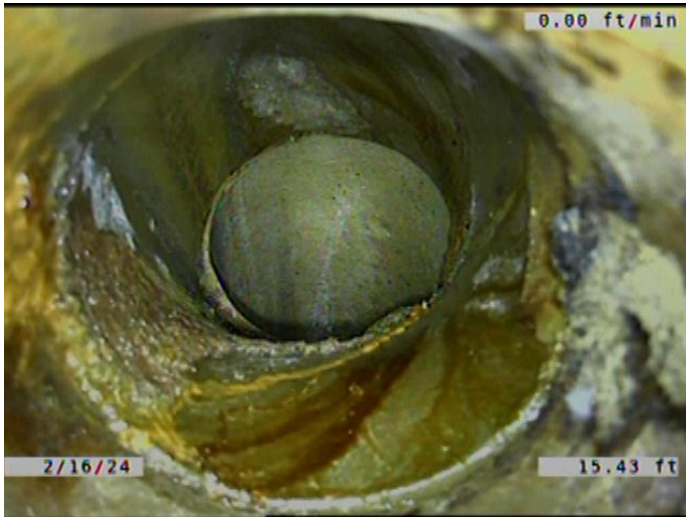
Code:	<b>TFD</b>
Description:	<b>Tap Factory Defective</b>
Distance (ft):	<b>15.4</b>
Structural Grade:	<b>0</b>
O&M Grade:	<b>3</b>
Clock Start/From:	<b>11</b>
Clock To:	
1st Value:	<b>6.000</b>
2nd Value:	
Value Percent:	
Continuous Index:	
Within 8" of Joint:	<b>YES</b>
Remarks:	<b>ENCrustATION COMING FROM THE SERVICE TO MAIN CONNECTION INT</b>

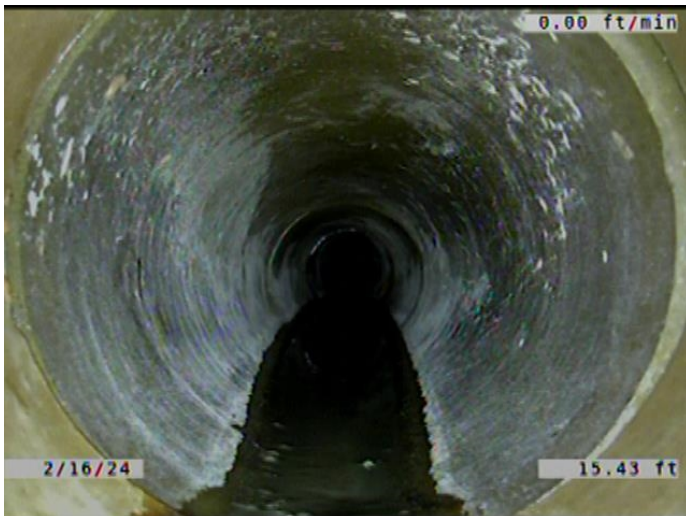
Code:	<b>MWLS</b>
Description:	<b>Miscellaneous Water Level Sag</b>
Distance (ft):	<b>15.4</b>
Structural Grade:	<b>2</b>
O&M Grade:	<b>0</b>
Clock Start/From:	
Clock To:	
1st Value:	
2nd Value:	
Value Percent:	<b>10.000</b>
Continuous Index:	<b>F01</b>
Within 8" of Joint:	<b>NO</b>
Remarks:

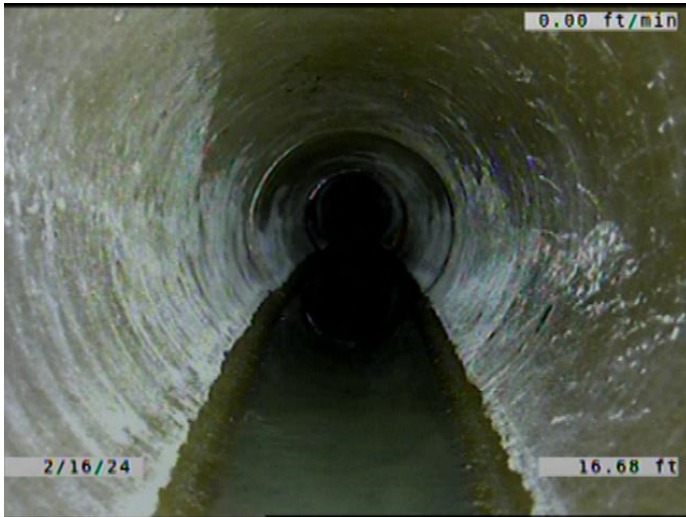
Code: **MWLS**  
Description: **Miscellaneous Water Level Sag**

Distance (ft): **16.7**  
Structural Grade: **2**  
O&M Grade: **0**  
Clock Start/From:  
Clock To:  
1st Value:  
2nd Value:  
Value Percent: **5.000**  
Continuous Index: **S03**  
Within 8" of Joint: **NO**  
Remarks:

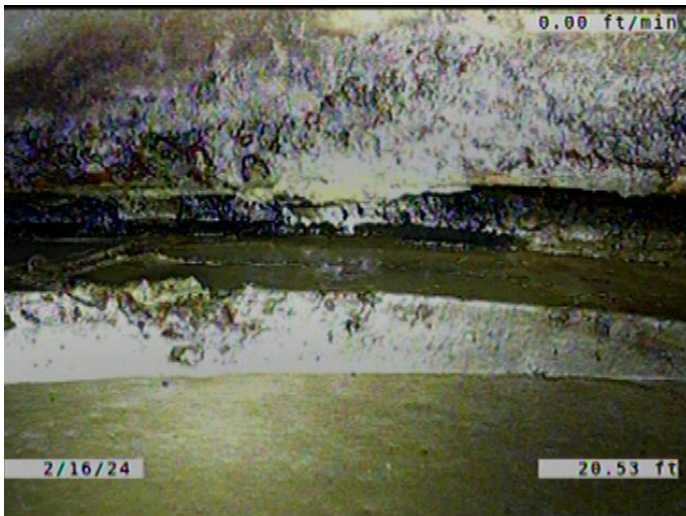
Code: **DAE**  
Description: **Deposits Attached Encrustation**

Distance (ft): **20.5**  
Structural Grade: **0**  
O&M Grade: **2**  
Clock Start/From: **7**  
Clock To: **5**  
1st Value:  
2nd Value:  
Value Percent: **5.000**  
Continuous Index: **S04**  
Within 8" of Joint: **YES**  
Remarks:

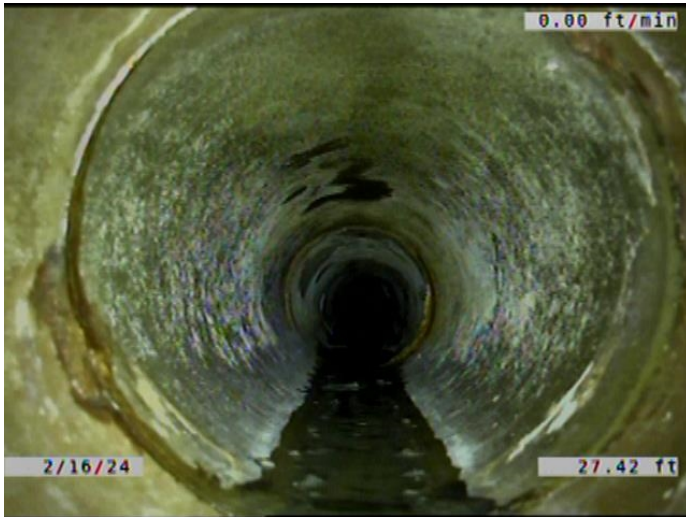
Code: **MWLS**  
Description: **Miscellaneous Water Level Sag**

Distance (ft): **27.4**  
Structural Grade: **2**  
O&M Grade: **0**  
Clock Start/From:  
Clock To:  
1st Value:  
2nd Value:  
Value Percent: **5.000**  
Continuous Index: **F03**  
Within 8" of Joint: **NO**  
Remarks:

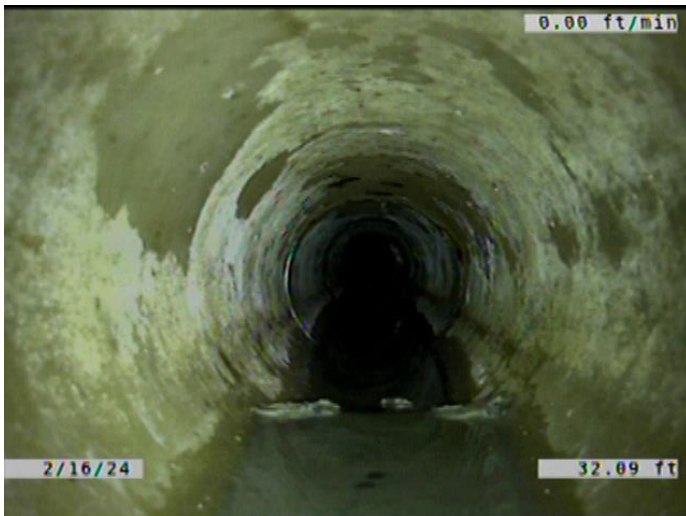
Code: **MWLS**  
Description: **Miscellaneous Water Level Sag**

Distance (ft): **32.1**  
Structural Grade: **2**  
O&M Grade: **0**  
Clock Start/From:  
Clock To:  
1st Value:  
2nd Value:  
Value Percent: **10.000**  
Continuous Index: **S05**  
Within 8" of Joint: **NO**  
Remarks:

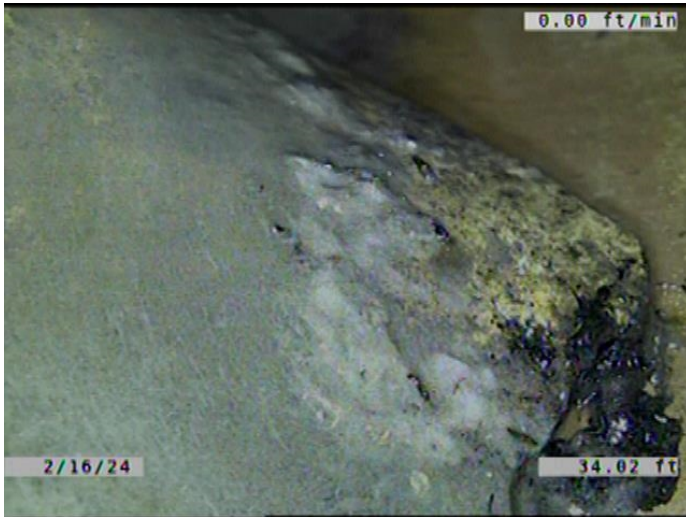
Code:	<b>OBM</b>
Description:	<b>Obstruction Pipe Material in Invert</b>
Distance (ft):	<b>34.0</b>
Structural Grade:	<b>0</b>
O&M Grade:	<b>2</b>
Clock Start/From:	<b>5</b>
Clock To:	<b>7</b>
1st Value:	
2nd Value:	
Value Percent:	<b>5.000</b>
Continuous Index:	
Within 8" of Joint:	<b>YES</b>
Remarks:

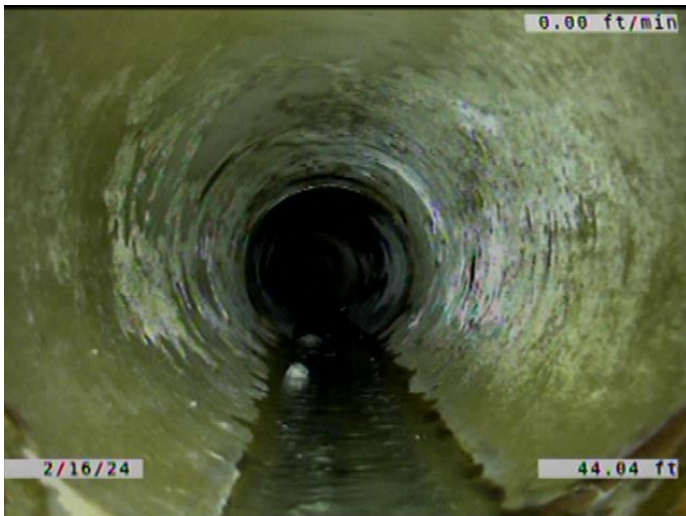
Code:	<b>MWLS</b>
Description:	<b>Miscellaneous Water Level Sag</b>
Distance (ft):	<b>44.0</b>
Structural Grade:	<b>2</b>
O&M Grade:	<b>0</b>
Clock Start/From:	
Clock To:	
1st Value:	
2nd Value:	
Value Percent:	<b>10.000</b>
Continuous Index:	<b>F05</b>
Within 8" of Joint:	<b>NO</b>
Remarks:

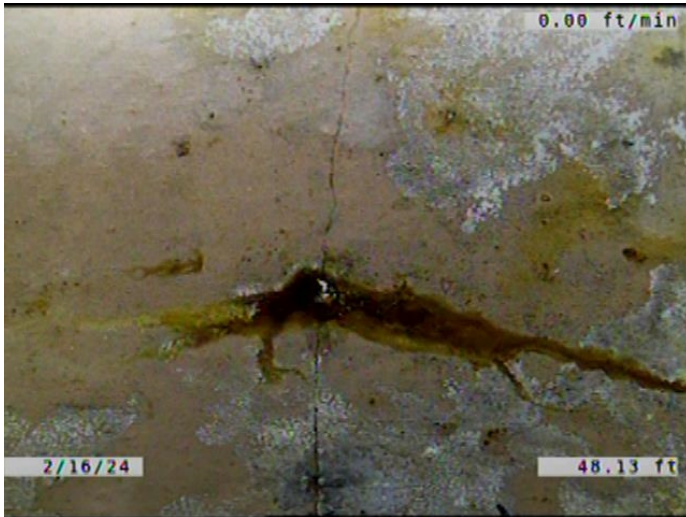
Code: **CL**  
Description: **Crack Longitudinal**

Distance (ft): **48.1**  
Structural Grade: **2**  
O&M Grade: **0**  
Clock Start/From: **1**  
Clock To:  
1st Value:  
2nd Value:  
Value Percent:  
Continuous Index:  
Within 8" of Joint: **YES**  
Remarks:

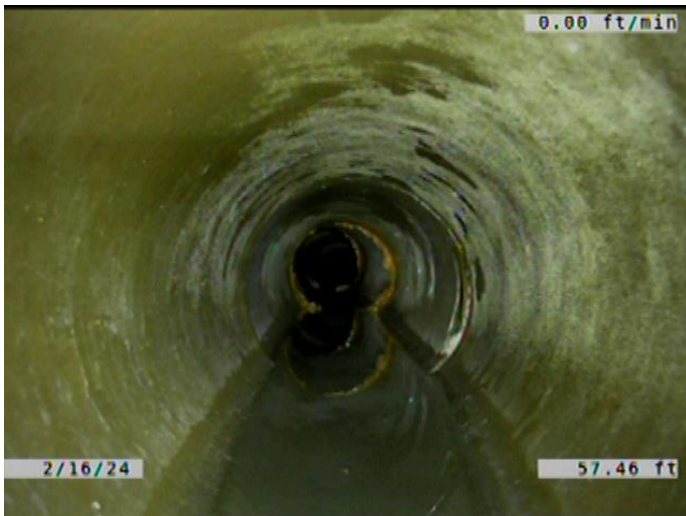
Code: **MWLS**  
Description: **Miscellaneous Water Level Sag**

Distance (ft): **57.5**  
Structural Grade: **2**  
O&M Grade: **0**  
Clock Start/From:  
Clock To:  
1st Value:  
2nd Value:  
Value Percent: **10.000**  
Continuous Index: **S06**  
Within 8" of Joint: **NO**  
Remarks:

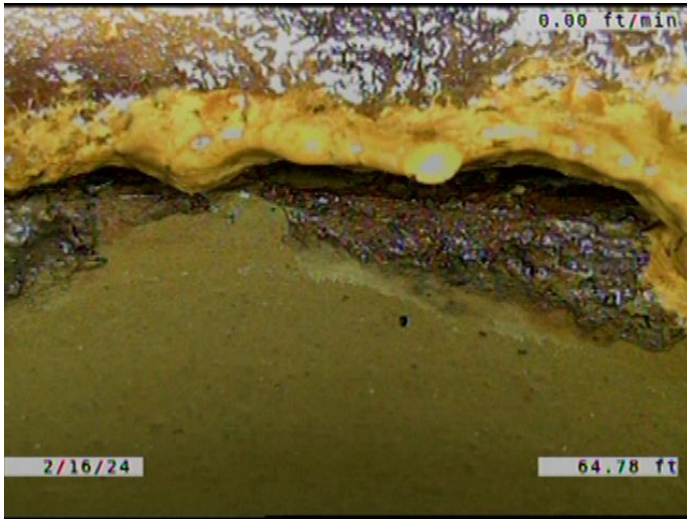
Code: **IDJ**  
Description: **Infiltration Dripper Joint**

Distance (ft): **64.8**  
Structural Grade: **0**  
O&M Grade: **3**  
Clock Start/From: **12**  
Clock To:  
1st Value:  
2nd Value:  
Value Percent:  
Continuous Index:  
Within 8" of Joint: **YES**  
Remarks:

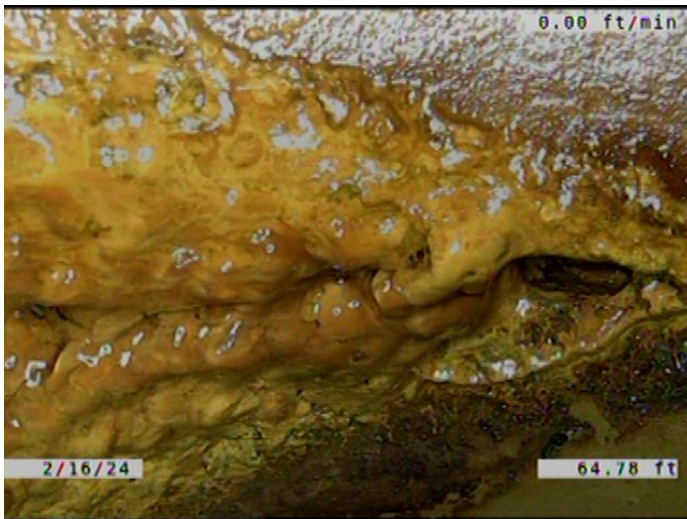
Code: **IRJ**  
Description: **Infiltration Runner Joint**

Distance (ft): **64.8**  
Structural Grade: **0**  
O&M Grade: **4**  
Clock Start/From: **10**  
Clock To:  
1st Value:  
2nd Value:  
Value Percent:  
Continuous Index:  
Within 8" of Joint: **YES**  
Remarks:

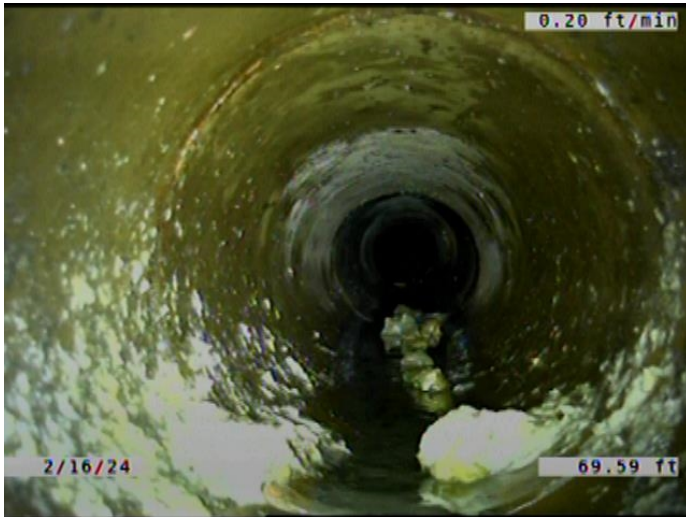
Code: **MWLS**  
Description: **Miscellaneous Water Level Sag**

Distance (ft): **69.6**  
Structural Grade: **2**  
O&M Grade: **0**  
Clock Start/From:  
Clock To:  
1st Value:  
2nd Value:  
Value Percent: **10.000**  
Continuous Index: **F06**  
Within 8" of Joint: **NO**  
Remarks:

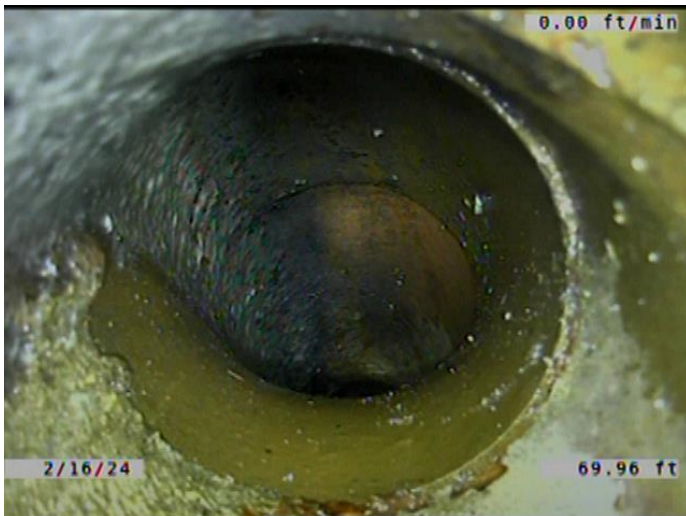
Code: **TFD**  
Description: **Tap Factory Defective**

Distance (ft): **70.0**  
Structural Grade: **0**  
O&M Grade: **3**  
Clock Start/From: **11**  
Clock To:  
1st Value: **6.000**  
2nd Value:  
Value Percent:  
Continuous Index:  
Within 8" of Joint: **YES**  
Remarks: **ENCrustation COMING FROM THE SERVICE TO MAIN CONNECTION AN**

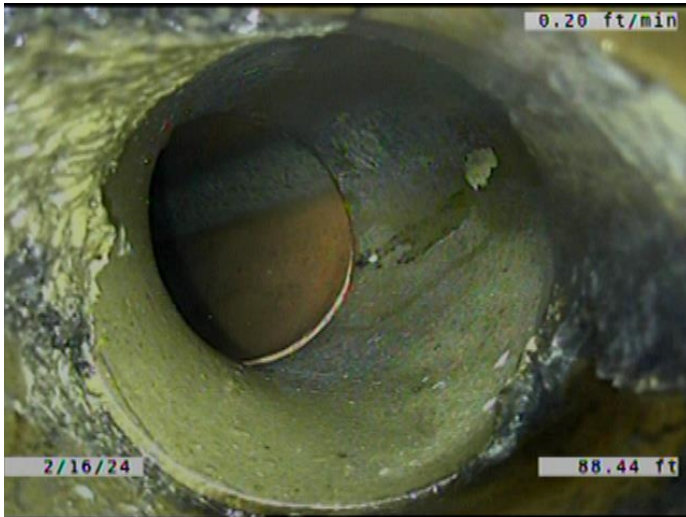
Code:	<b>TFD</b>
Description:	<b>Tap Factory Defective</b>
Distance (ft):	<b>88.4</b>
Structural Grade:	<b>0</b>
O&M Grade:	<b>3</b>
Clock Start/From:	<b>1</b>
Clock To:	
1st Value:	<b>6.000</b>
2nd Value:	
Value Percent:	
Continuous Index:	
Within 8" of Joint:	<b>YES</b>
Remarks:	<b>ENCrustATION COMING FROM THE SERVICE TO MAIN CONNECTION INT</b>

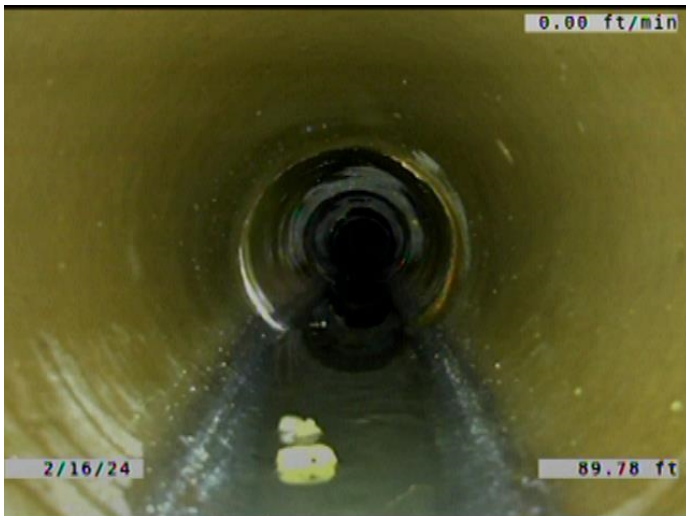
Code:	<b>MWLS</b>
Description:	<b>Miscellaneous Water Level Sag</b>
Distance (ft):	<b>89.8</b>
Structural Grade:	<b>2</b>
O&M Grade:	<b>0</b>
Clock Start/From:	
Clock To:	
1st Value:	
2nd Value:	
Value Percent:	<b>5.000</b>
Continuous Index:	<b>S07</b>
Within 8" of Joint:	<b>NO</b>
Remarks:

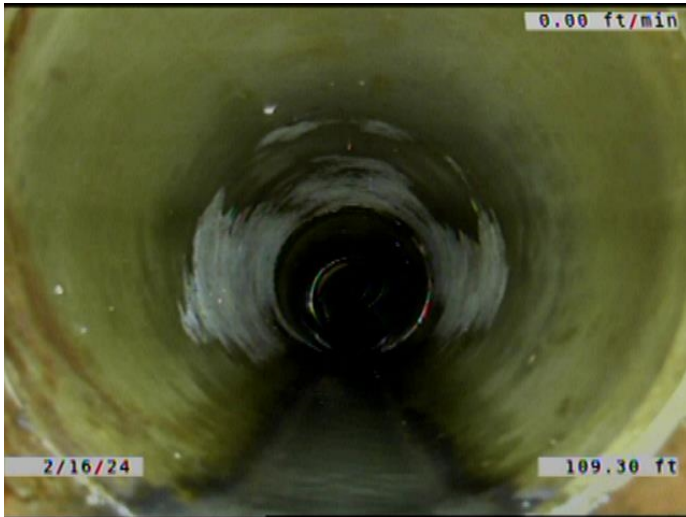
Code: **MWLS**  
Description: **Miscellaneous Water Level Sag**

Distance (ft): **109.3**  
Structural Grade: **2**  
O&M Grade: **0**  
Clock Start/From:  
Clock To:  
1st Value:  
2nd Value:  
Value Percent: **5.000**  
Continuous Index: **F07**  
Within 8" of Joint: **NO**  
Remarks:

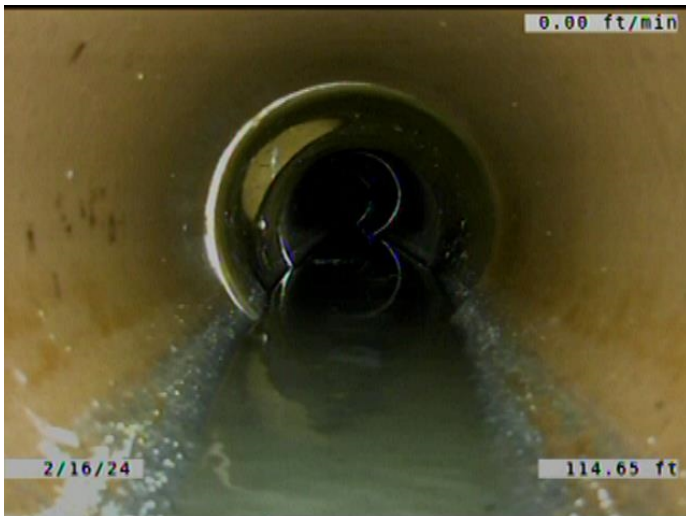
Code: **MWLS**  
Description: **Miscellaneous Water Level Sag**

Distance (ft): **114.6**  
Structural Grade: **2**  
O&M Grade: **0**  
Clock Start/From:  
Clock To:  
1st Value:  
2nd Value:  
Value Percent: **10.000**  
Continuous Index: **S08**  
Within 8" of Joint: **NO**  
Remarks:

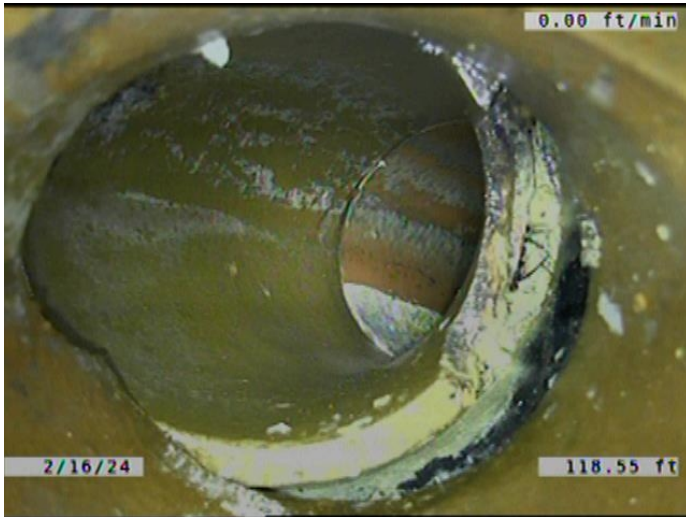
Code: **TFD**  
Description: **Tap Factory Defective**

Distance (ft): **118.5**  
Structural Grade: **0**  
O&M Grade: **3**  
Clock Start/From: **11**  
Clock To:  
1st Value: **6.000**  
2nd Value:  
Value Percent:  
Continuous Index:  
Within 8" of Joint: **YES**  
Remarks: **TAP BROKEN. SERVICE HAS DROPPED. SOIL VISIBLE. CONSTANTL**

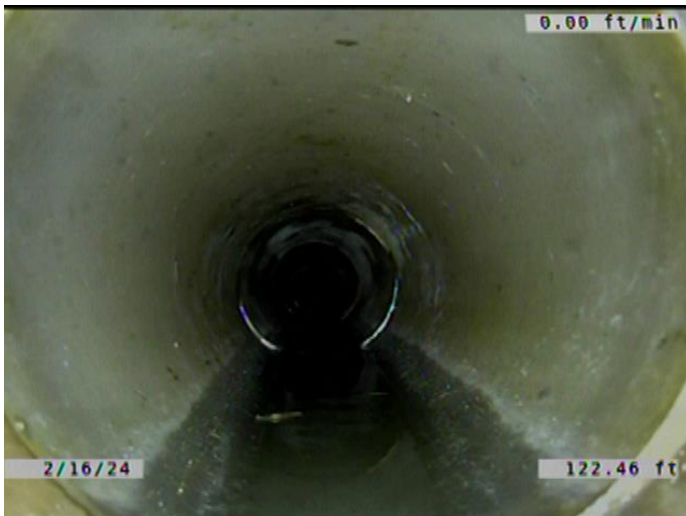
Code: **MWLS**  
Description: **Miscellaneous Water Level Sag**

Distance (ft): **122.5**  
Structural Grade: **2**  
O&M Grade: **0**  
Clock Start/From:  
Clock To:  
1st Value:  
2nd Value:  
Value Percent: **10.000**  
Continuous Index: **F08**  
Within 8" of Joint: **NO**  
Remarks:

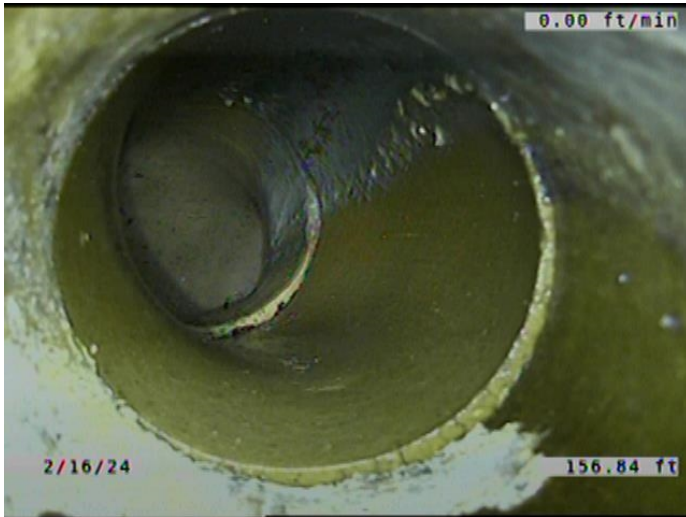
Code:	TFD
Description:	Tap Factory Defective
Distance (ft):	156.8
Structural Grade:	0
O&M Grade:	3
Clock Start/From:	1
Clock To:	
1st Value:	6.000
2nd Value:	
Value Percent:	
Continuous Index:	
Within 8" of Joint:	YES
Remarks:	ENCrustATION COMING FROM THE SERVICE TO MAIN CONNECTION INT

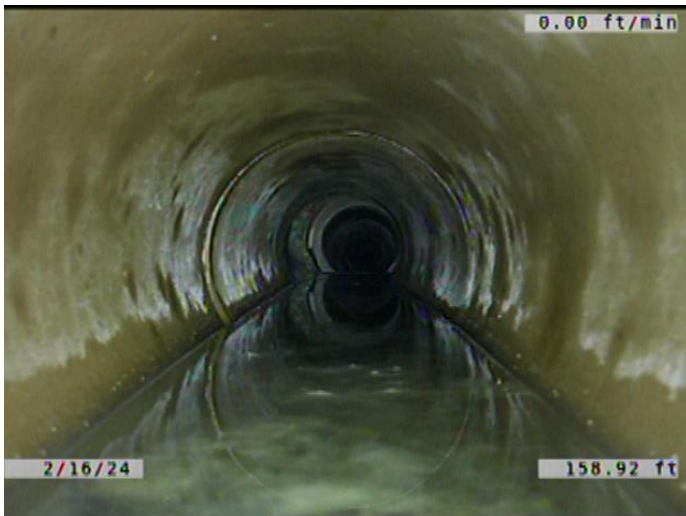
Code:	MWLS
Description:	Miscellaneous Water Level Sag
Distance (ft):	158.9
Structural Grade:	2
O&M Grade:	0
Clock Start/From:	
Clock To:	
1st Value:	
2nd Value:	
Value Percent:	15.000
Continuous Index:	S09
Within 8" of Joint:	NO
Remarks:

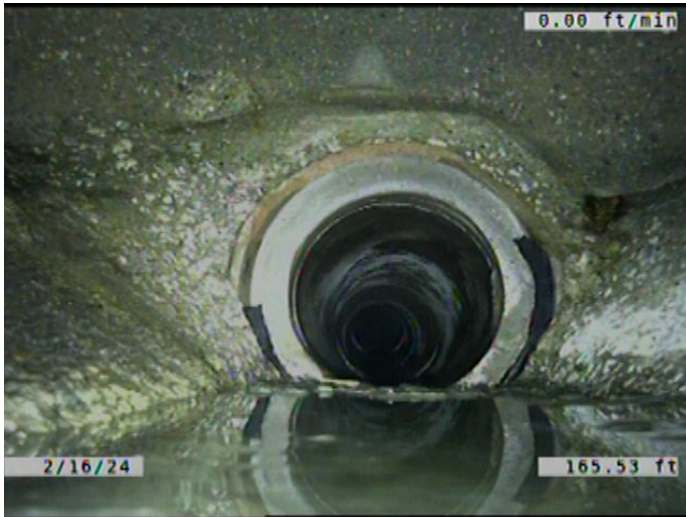
Code: **DAE**  
Description: **Deposits Attached Encrustation**

Distance (ft): **165.5**  
Structural Grade: **0**  
O&M Grade: **2**  
Clock Start/From: **7**  
Clock To: **5**  
1st Value:  
2nd Value:  
Value Percent: **5.000**  
Continuous Index: **F04**  
Within 8" of Joint: **YES**  
Remarks:

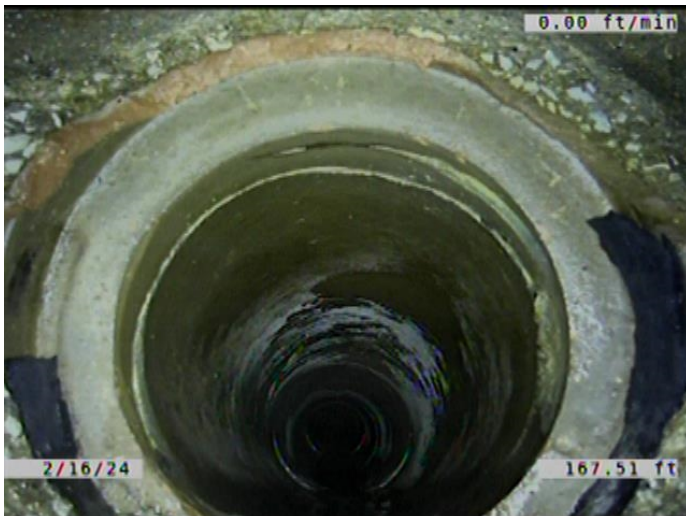
Code: **MWLS**  
Description: **Miscellaneous Water Level Sag**

Distance (ft): **167.5**  
Structural Grade: **2**  
O&M Grade: **0**  
Clock Start/From:  
Clock To:  
1st Value:  
2nd Value:  
Value Percent: **15.000**  
Continuous Index: **F09**  
Within 8" of Joint: **NO**  
Remarks:

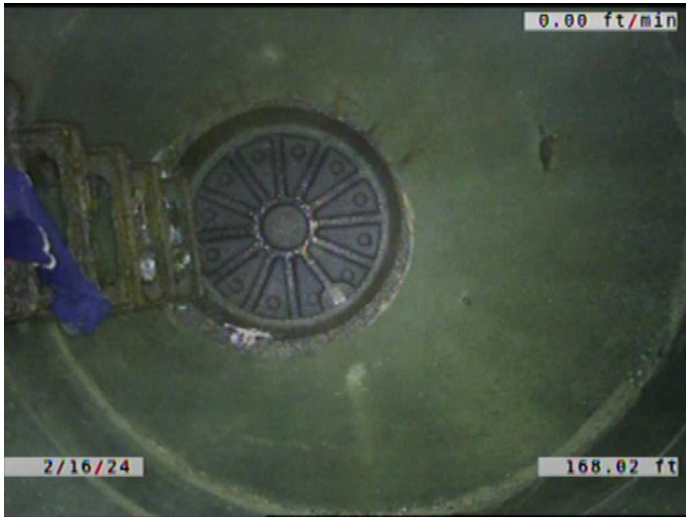
Code:	AMH
Description:	Manhole
Distance (ft):	168.0
Structural Grade:	0
O&M Grade:	0
Clock Start/From:	
Clock To:	
1st Value:	
2nd Value:	
Value Percent:	
Continuous Index:	
Within 8" of Joint:	NO
Remarks:	M-606-066
