## Profile/Photo Observation Report

Street:	<b>FOXCROFT STREET</b>	Flow Control:	<b>Not Controlled</b>
City:	<b>Hobart, IN</b>	Year Renewed:	
Location:	<b>Yard</b>	Tape/Media #:	
Purpose:	<b>Routine Assessment</b>	Dia/Height:	<b>12"</b>
Use:	<b>Sanitary</b>	Material:	<b>VCP</b>
Drain Area:	<b>NA</b>	Lining:	
Category:	<b>NA</b>		
Comment:	<b>Flow direction is marked wrong.</b>		
Location Details:		Direction of Survey:	<b>Upstream</b>
US MH:	<b>M-606-067</b>	DS MH:	<b>M-606-074</b>
		Total Length Surveyed (ft):	<b>22.1</b>

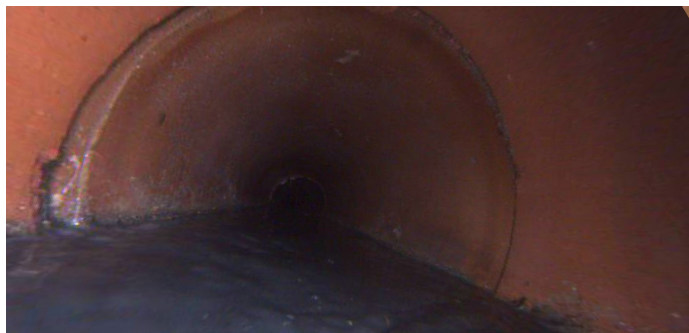
Code: **AMH**  
Description: **Manhole**

Distance (ft): **.0**  
Structural Grade: **0**  
O&M Grade: **0**  
Clock Start/From:  
Clock To:  
1st Value:  
2nd Value:  
Value Percent:  
Continuous Index:  
Within 8" of Joint: **NO**  
Remarks: **M-606-074**

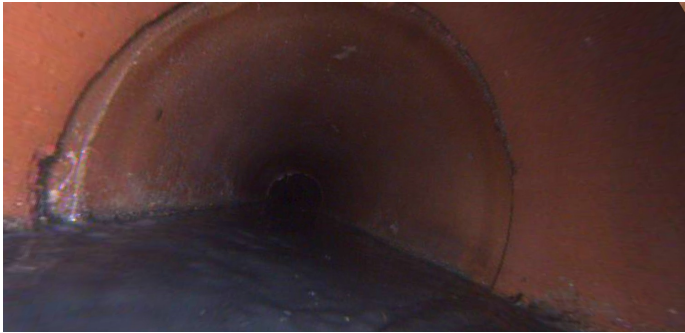
Code:	<b>MWL</b>
Description:	<b>Water Level</b>

Distance (ft):	<b>.0</b>
Structural Grade:	<b>0</b>
O&M Grade:	<b>0</b>
Clock Start/From:	
Clock To:	
1st Value:	
2nd Value:	
Value Percent:	<b>30.000</b>
Continuous Index:	
Within 8" of Joint:	<b>NO</b>
Remarks:

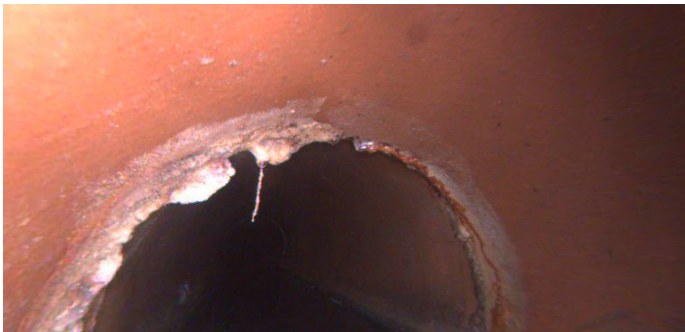
Code:	<b>RFJ</b>
Description:	<b>Roots Fine Joint</b>

Distance (ft):	<b>4.6</b>
Structural Grade:	<b>0</b>
O&M Grade:	<b>1</b>
Clock Start/From:	<b>12</b>
Clock To:	
1st Value:	
2nd Value:	
Value Percent:	
Continuous Index:	
Within 8" of Joint:	<b>YES</b>
Remarks:

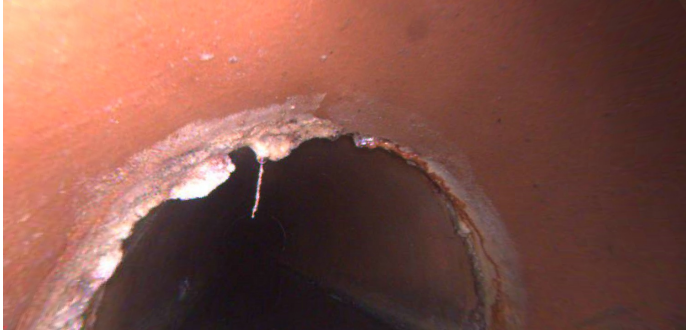
Code: ID  
Description: Infil Dripper

Distance (ft): 4.6  
Structural Grade: 0  
O&M Grade: 3  
Clock Start/From: 12  
Clock To:  
1st Value:  
2nd Value:  
Value Percent:  
Continuous Index:  
Within 8" of Joint: YES  
Remarks:

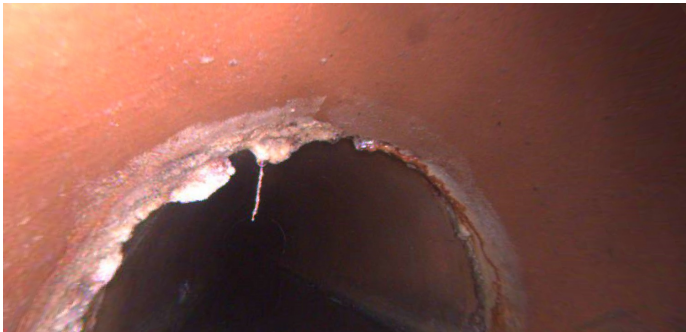
Code: DAE  
Description: Deposits Attached Encrustation

Distance (ft): 4.6  
Structural Grade: 0  
O&M Grade: 2  
Clock Start/From: 8  
Clock To: 4  
1st Value:  
2nd Value:  
Value Percent: 5.000  
Continuous Index:  
Within 8" of Joint: YES  
Remarks:

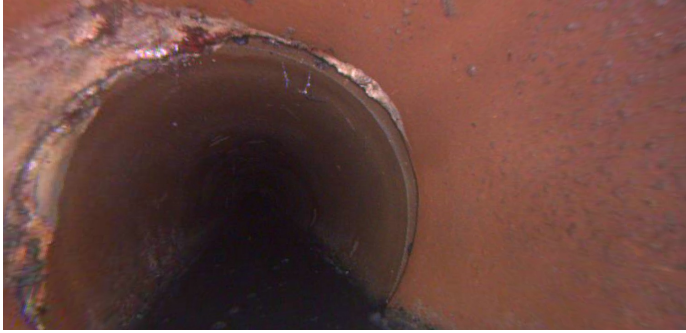
Code: **DAE**  
Description: **Deposits Attached Encrustation**

Distance (ft): **8.4**  
Structural Grade: **0**  
O&M Grade: **2**  
Clock Start/From: **8**  
Clock To: **4**  
1st Value:  
2nd Value:  
Value Percent: **5.000**  
Continuous Index:  
Within 8" of Joint: **YES**  
Remarks:

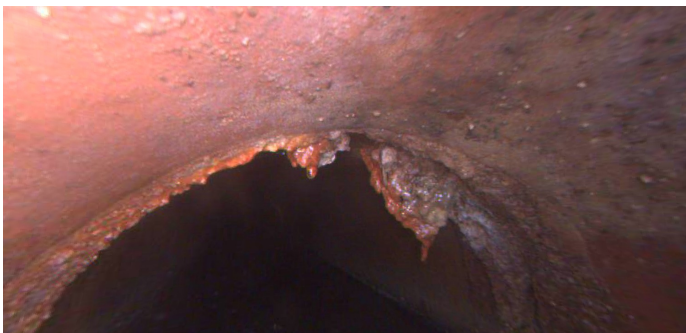
Code: **ID**  
Description: **Infil Dripper**

Distance (ft): **16.6**  
Structural Grade: **0**  
O&M Grade: **3**  
Clock Start/From: **12**  
Clock To: **1**  
1st Value:  
2nd Value:  
Value Percent:  
Continuous Index:  
Within 8" of Joint: **YES**  
Remarks:

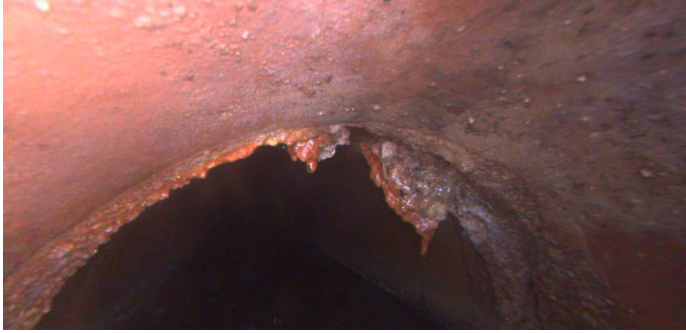
Code: **DAE**  
Description: **Deposits Attached Encrustation**

Distance (ft): **16.6**  
Structural Grade: **0**  
O&M Grade: **2**  
Clock Start/From: **8**  
Clock To: **4**  
1st Value:  
2nd Value:  
Value Percent: **5.000**  
Continuous Index:  
Within 8" of Joint: **YES**  
Remarks:

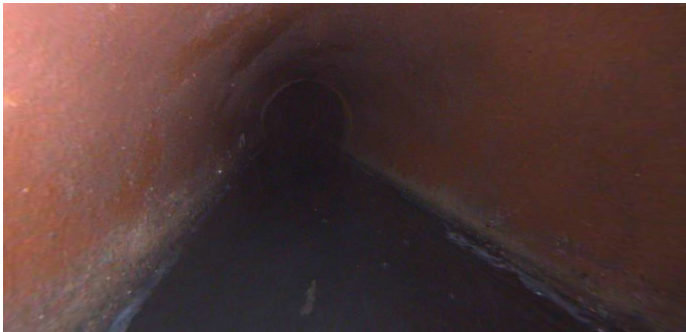
Code: **MSA**  
Description: **Abandoned Survey**

Distance (ft): **22.1**  
Structural Grade: **0**  
O&M Grade: **0**  
Clock Start/From:  
Clock To:  
1st Value:  
2nd Value:  
Value Percent:  
Continuous Index:  
Within 8" of Joint: **NO**  
Remarks: **DEBRIS UNDER WATER**
