Profile/Photo Observation Report

Date:	04/07/2018	Weather:		Coding:	PACP 6.0
Pipe Length (ft):	204.8	Owner:	NA	Pre Clean:	No Pre-Cleaning
P.O.#:		Surveyor:	Byrd Fitzgerald	PSR:	P-606-068-056
Customer:		Clean Date:	01/01/1900	Shape:	C

Street:	W 8TH ST	Flow Control:	Not Controlled
City:	Hobart, IN	Year Renewed:	
Location:	Yard	Tape/Media #:	
Purpose:	Routine Assessment	Dia/Height:	10"
Use:	Sanitary	Material:	VCP
Drain Area:	NA	Lining:	
Category:	NA		
Comment:			
Location Details:		Direction of Survey:	Downstream
US MH:	M-606-068	DS MH:	M-606-056
		Total Length Surveyed (ft):	30.2

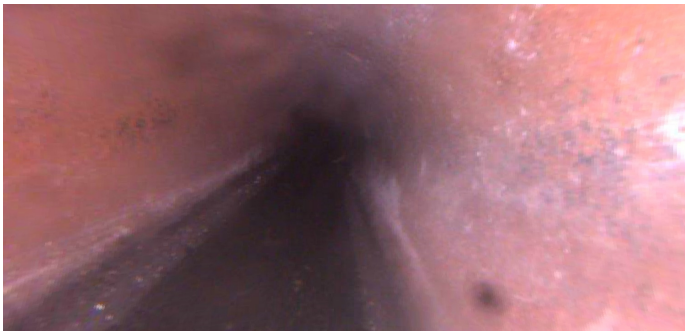
Code: **AMH**
Description: **Manhole**

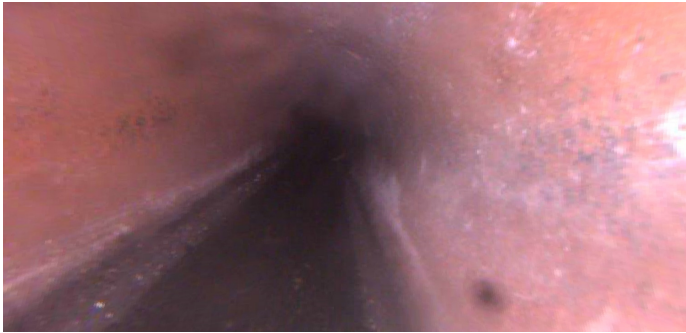
Code:	MWL
Description:	Water Level

Distance (ft):	.0
Structural Grade:	0
O&M Grade:	0
Clock Start/From:	
Clock To:	
1st Value:	
2nd Value:	
Value Percent:	5.000
Continuous Index:	
Within 8" of Joint:	NO
Remarks:

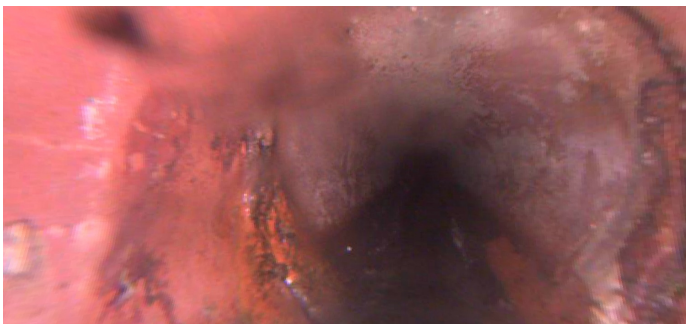
Code:	DAE
Description:	Deposits Attached Encrustation

Distance (ft):	4.2
Structural Grade:	0
O&M Grade:	2
Clock Start/From:	7
Clock To:	5
1st Value:	
2nd Value:	
Value Percent:	5.000
Continuous Index:	
Within 8" of Joint:	YES
Remarks:

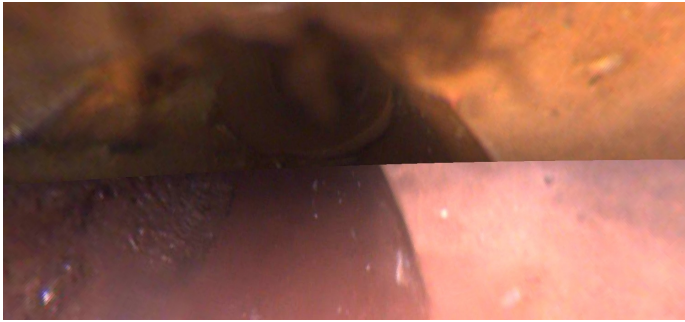
Code: **TF**
Description: **Tap Factory**

Distance (ft): **9.6**
Structural Grade: **0**
O&M Grade: **0**
Clock Start/From: **12**
Clock To:
1st Value: **4.000**
2nd Value:
Value Percent:
Continuous Index:
Within 8" of Joint: **YES**
Remarks:

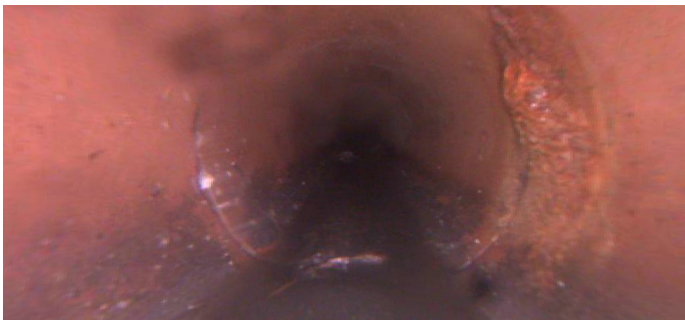
Code: **DAE**
Description: **Deposits Attached Encrustation**

Distance (ft): **10.2**
Structural Grade: **0**
O&M Grade: **2**
Clock Start/From: **1**
Clock To: **5**
1st Value:
2nd Value:
Value Percent: **5.000**
Continuous Index: **S01**
Within 8" of Joint: **YES**
Remarks: **wandering**

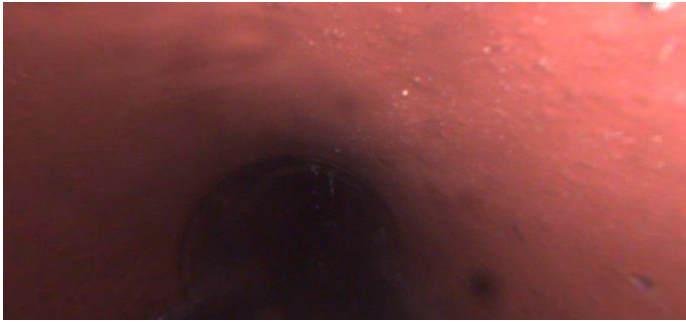
Code: **MSA**
Description: **Abandoned Survey**

Distance (ft): **30.2**
Structural Grade: **0**
O&M Grade: **0**
Clock Start/From:
Clock To:
1st Value:
2nd Value:
Value Percent:
Continuous Index:
Within 8" of Joint: **NO**
Remarks: **no blockage**

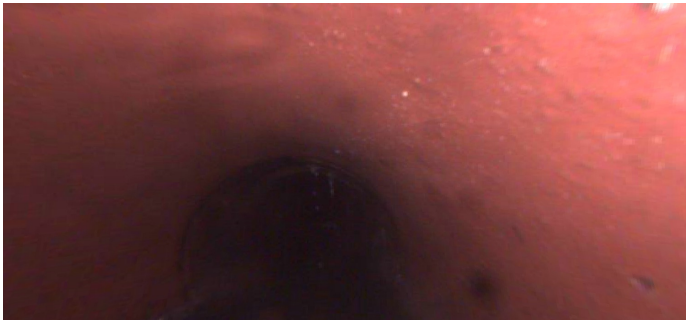
Code: **DAE**
Description: **Deposits Attached Encrustation**

Distance (ft): **30.2**
Structural Grade: **0**
O&M Grade: **2**
Clock Start/From: **1**
Clock To: **5**
1st Value:
2nd Value:
Value Percent: **5.000**
Continuous Index: **F01**
Within 8" of Joint: **YES**
Remarks: **wandering**
