Profile/Photo Observation Report

Date:	04/07/2018	Weather:		Coding:	PACP 6.0
Pipe Length (ft):	204.8	Owner:	NA	Pre Clean:	No Pre-Cleaning
P.O.#:		Surveyor:	Byrd Fitzgerald	PSR:	P-606-068-056
Customer:		Clean Date:	01/01/1900	Shape:	C

Street:	FOXCROFT STREET	Flow Control:	Not Controlled
City:	Hobart, IN	Year Renewed:	
Location:	Yard	Tape/Media #:	
Purpose:	Routine Assessment	Dia/Height:	10"
Use:	Sanitary	Material:	VCP
Drain Area:	NA	Lining:	
Category:	NA		
Comment:

Location Details:		Direction of Survey:	Downstream
US MH:	M-606-068	DS MH:	M-606-056
		Total Length Surveyed (ft):	30.2

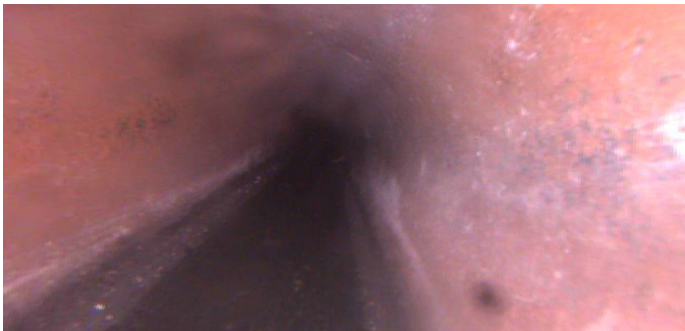
Code: **AMH**
Description: **Manhole**

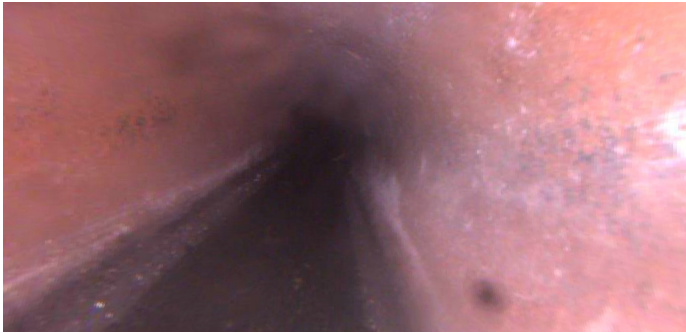
Code:	MWL
Description:	Water Level

Distance (ft):	.0
Structural Grade:	0
O&M Grade:	0
Clock Start/From:	
Clock To:	
1st Value:	
2nd Value:	
Value Percent:	5.000
Continuous Index:	
Within 8" of Joint:	NO
Remarks:

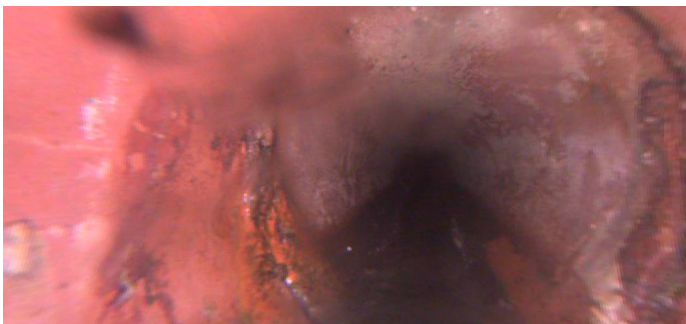
Code:	DAE
Description:	Deposits Attached Encrustation

Distance (ft):	4.2
Structural Grade:	0
O&M Grade:	2
Clock Start/From:	7
Clock To:	5
1st Value:	
2nd Value:	
Value Percent:	5.000
Continuous Index:	
Within 8" of Joint:	YES
Remarks:

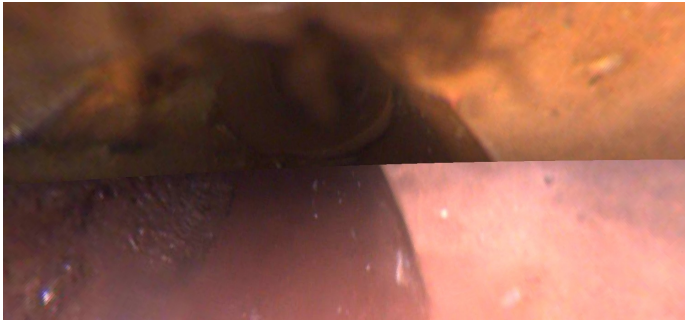
Code: **TF**
Description: **Tap Factory**

Distance (ft): **9.6**
Structural Grade: **0**
O&M Grade: **0**
Clock Start/From: **12**
Clock To:
1st Value: **4.000**
2nd Value:
Value Percent:
Continuous Index:
Within 8" of Joint: **YES**
Remarks:

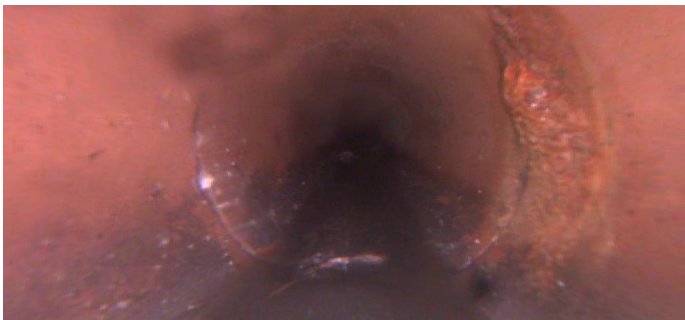
Code: **DAE**
Description: **Deposits Attached Encrustation**

Distance (ft): **10.2**
Structural Grade: **0**
O&M Grade: **2**
Clock Start/From: **1**
Clock To: **5**
1st Value:
2nd Value:
Value Percent: **5.000**
Continuous Index: **S01**
Within 8" of Joint: **YES**
Remarks: **wandering**

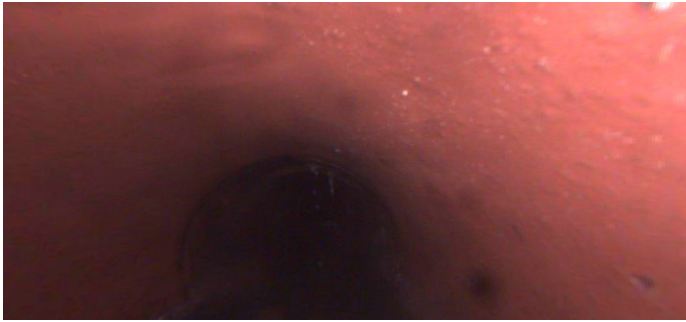
Code: **MSA**
Description: **Abandoned Survey**

Distance (ft): **30.2**
Structural Grade: **0**
O&M Grade: **0**
Clock Start/From:
Clock To:
1st Value:
2nd Value:
Value Percent:
Continuous Index:
Within 8" of Joint: **NO**
Remarks: **no blockage**

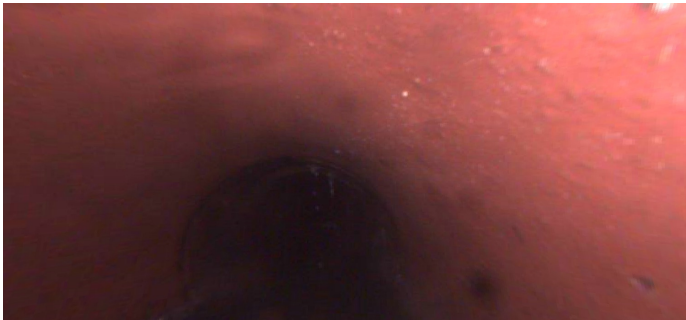
Code: **DAE**
Description: **Deposits Attached Encrustation**

Distance (ft): **30.2**
Structural Grade: **0**
O&M Grade: **2**
Clock Start/From: **1**
Clock To: **5**
1st Value:
2nd Value:
Value Percent: **5.000**
Continuous Index: **F01**
Within 8" of Joint: **YES**
Remarks: **wandering**
