Profile/Photo Observation Report

Street:	FOXCROFT STREET	Flow Control:	Not Controlled
City:	Hobart, IN	Year Renewed:	
Location:	Yard	Tape/Media #:	
Purpose:	Routine Assessment	Dia/Height:	10"
Use:	Sanitary	Material:	VCP
Drain Area:	NA	Lining:	
Category:	NA		
Comment:	Flow direction is marked wrong.

Location Details:		Direction of Survey:	Downstream
US MH:	M-606-068	DS MH:	M-606-069
		Total Length Surveyed (ft):	19.1

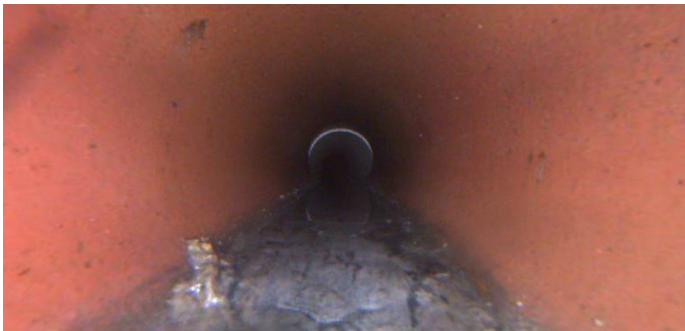
Code: **AMH**
Description: **Manhole**

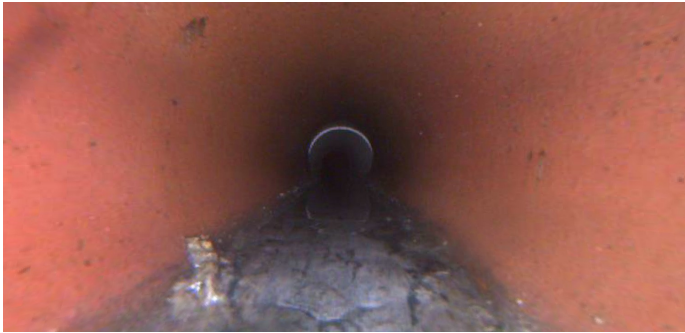
Code:	MWL
Description:	Water Level

Distance (ft):	.0
Structural Grade:	0
O&M Grade:	0
Clock Start/From:	
Clock To:	
1st Value:	
2nd Value:	
Value Percent:	10.000
Continuous Index:	
Within 8" of Joint:	NO
Remarks:

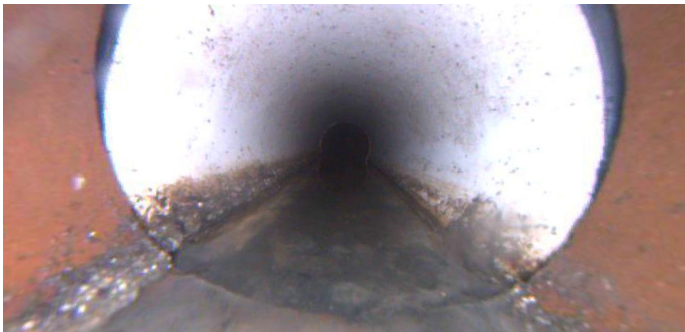
Code:	MMC
Description:	Material Change

Distance (ft):	3.9
Structural Grade:	0
O&M Grade:	0
Clock Start/From:	
Clock To:	
1st Value:	
2nd Value:	
Value Percent:	
Continuous Index:	
Within 8" of Joint:	NO
Remarks:	pvc

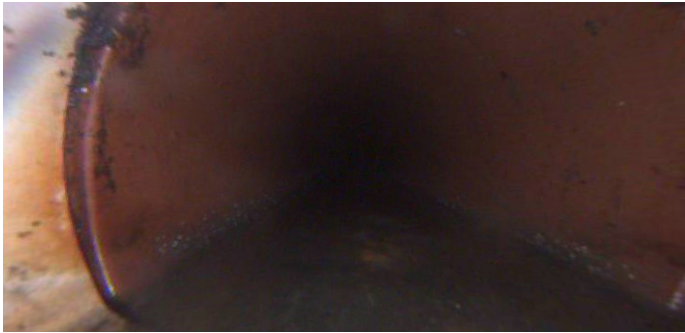
Code: **MMC**
Description: **Material Change**

Distance (ft): **8.2**
Structural Grade: **0**
O&M Grade: **0**
Clock Start/From:
Clock To:
1st Value:
2nd Value:
Value Percent:
Continuous Index:
Within 8" of Joint: **NO**
Remarks: **vcp**

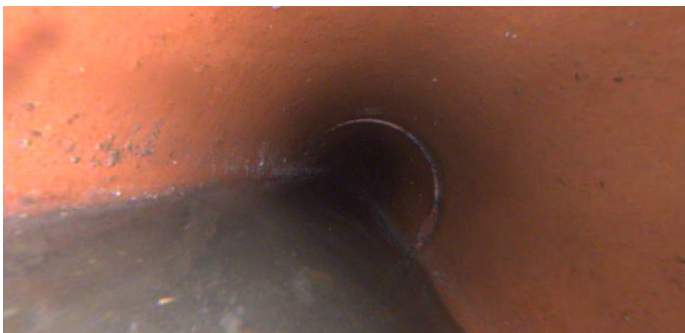
Code: **MSA**
Description: **Abandoned Survey**

Distance (ft): **19.1**
Structural Grade: **0**
O&M Grade: **0**
Clock Start/From:
Clock To:
1st Value:
2nd Value:
Value Percent:
Continuous Index:
Within 8" of Joint: **NO**
Remarks: **overturned**
