Profile/Photo Observation Report

Date:	04/07/2018	Weather:		Coding:	PACP 6.0
Pipe Length (ft):	182.0	Owner:	NA	Pre Clean:	No Pre-Cleaning
P.O.#:		Surveyor:	Mark Ruby	PSR:	P-606-073-072
Customer:		Clean Date:	01/01/1900	Shape:	C

Street:	ALLEY BETWEEN S WISCONSIN ST &	Flow Control:	Not Controlled
City:	Hobart, IN	Year Renewed:	
Location:	Yard	Tape/Media #:	
Purpose:	Routine Assessment	Dia/Height:	10"
Use:	Sanitary	Material:	VCP
Drain Area:	NA	Lining:	
Category:	NA		
Comment:	P_C blockage, flow direction is marked wrong.		
Location Details:		Direction of Survey:	Upstream
US MH:	M-606-072	DS MH:	M-606-073
		Total Length Surveyed (ft):	81.3

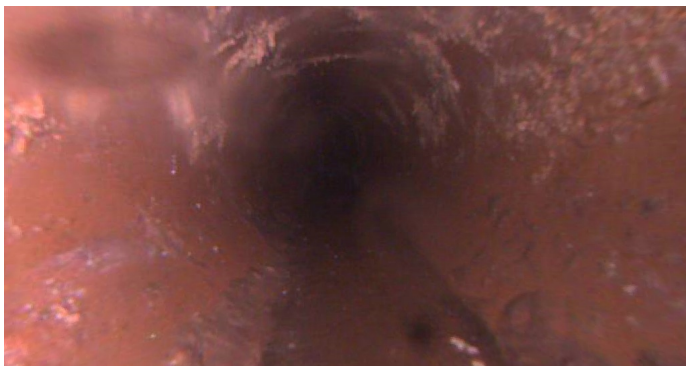
Code: **AMH**
Description: **Manhole**

Distance (ft): **.0**
Structural Grade: **0**
O&M Grade: **0**
Clock Start/From:
Clock To:
1st Value:
2nd Value:
Value Percent:
Continuous Index:
Within 8" of Joint: **NO**
Remarks: **M-606-073**

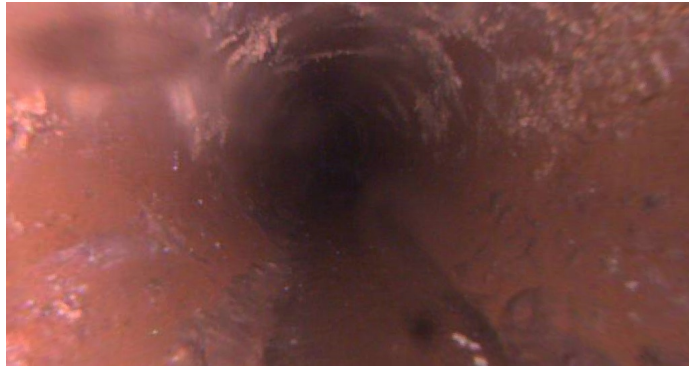
Code:	MWL
Description:	Water Level
Distance (ft):	.0
Structural Grade:	0
O&M Grade:	0
Clock Start/From:	
Clock To:	
1st Value:	
2nd Value:	
Value Percent:	10.000
Continuous Index:	
Within 8" of Joint:	NO
Remarks:

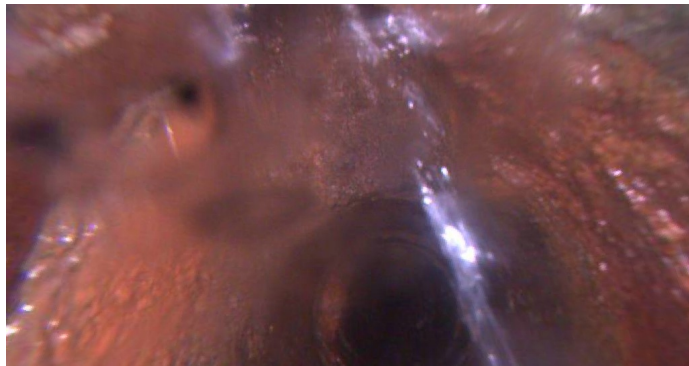
Code:	IR
Description:	Infil Runner
Distance (ft):	4.8
Structural Grade:	0
O&M Grade:	4
Clock Start/From:	12
Clock To:	
1st Value:	
2nd Value:	
Value Percent:	
Continuous Index:	
Within 8" of Joint:	YES
Remarks:

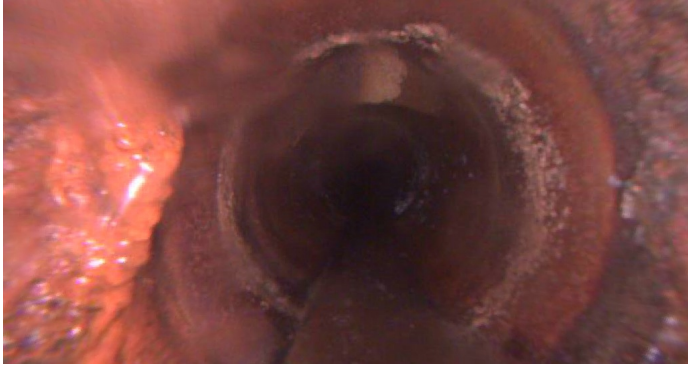
Code: **DAE**
Description: **Deposits Attached Encrustation**

Distance (ft): **6.2**
Structural Grade: **0**
O&M Grade: **2**
Clock Start/From: **7**
Clock To: **12**
1st Value:
2nd Value:
Value Percent: **10.000**
Continuous Index:
Within 8" of Joint: **NO**
Remarks:

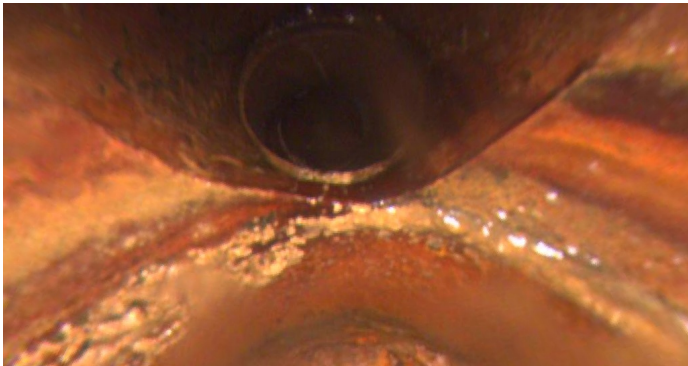
Code: **TF**
Description: **Tap Factory**

Distance (ft): **7.4**
Structural Grade: **0**
O&M Grade: **0**
Clock Start/From: **12**
Clock To:
1st Value: **4.000**
2nd Value:
Value Percent:
Continuous Index:
Within 8" of Joint:
Remarks:

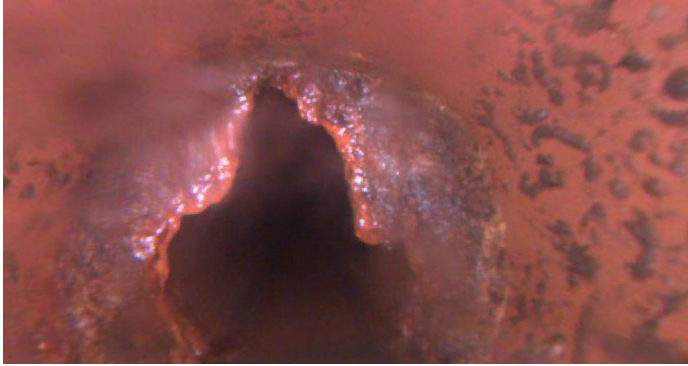
Code:	DAE
Description:	Deposits Attached Encrustation
Distance (ft):	23.8
Structural Grade:	0
O&M Grade:	2
Clock Start/From:	7
Clock To:	5
1st Value:	
2nd Value:	
Value Percent:	10.000
Continuous Index:	
Within 8" of Joint:	YES
Remarks:

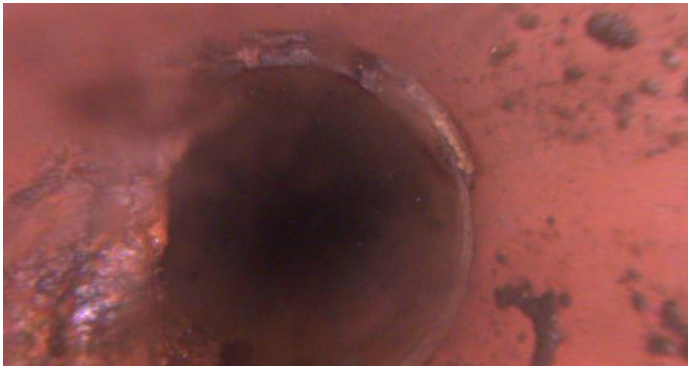
Code:	DAE
Description:	Deposits Attached Encrustation
Distance (ft):	31.9
Structural Grade:	0
O&M Grade:	2
Clock Start/From:	7
Clock To:	2
1st Value:	
2nd Value:	
Value Percent:	10.000
Continuous Index:	
Within 8" of Joint:	YES
Remarks:

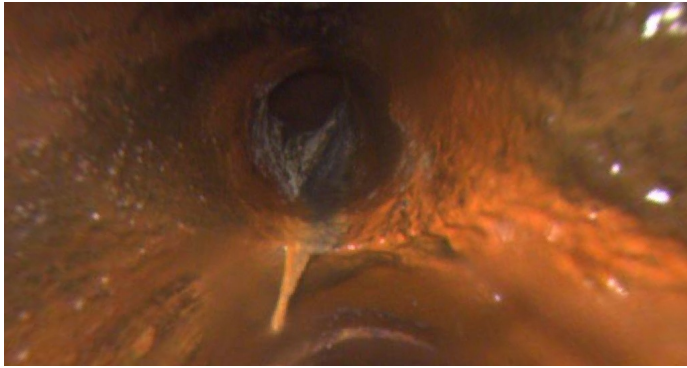
Code: **TF**
Description: **Tap Factory**

Distance (ft): **41.7**
Structural Grade: **0**
O&M Grade: **0**
Clock Start/From: **12**
Clock To:
1st Value: **4.000**
2nd Value:
Value Percent:
Continuous Index:
Within 8" of Joint:
Remarks:

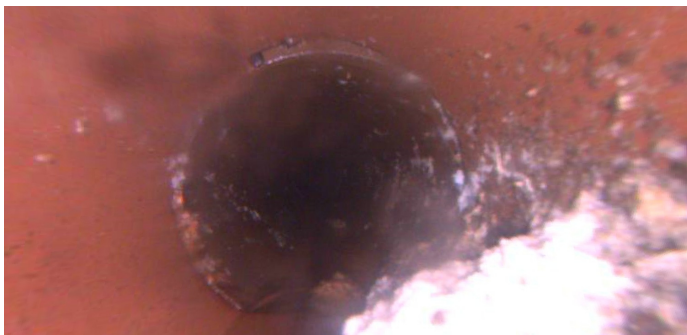
Code: **DAGS**
Description: **Deposits Attached Grease**

Distance (ft): **51.8**
Structural Grade: **0**
O&M Grade: **2**
Clock Start/From: **3**
Clock To: **5**
1st Value:
2nd Value:
Value Percent: **10.000**
Continuous Index:
Within 8" of Joint: **YES**
Remarks:

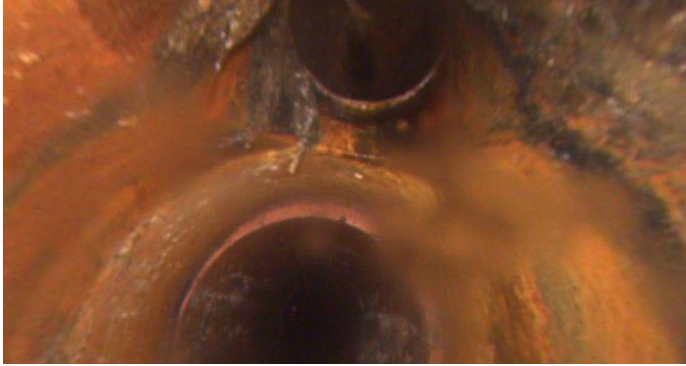
Code: **TF**
Description: **Tap Factory**

Distance (ft): **51.8**
Structural Grade: **0**
O&M Grade: **0**
Clock Start/From: **11**
Clock To:
1st Value: **4.000**
2nd Value:
Value Percent:
Continuous Index:
Within 8" of Joint:
Remarks:

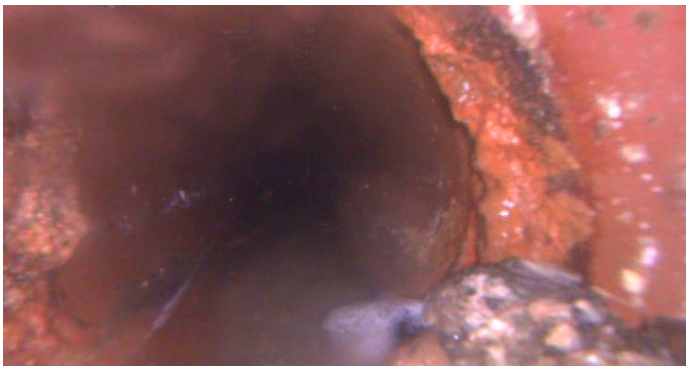
Code: **DAE**
Description: **Deposits Attached Encrustation**

Distance (ft): **60.2**
Structural Grade: **0**
O&M Grade: **2**
Clock Start/From: **7**
Clock To: **5**
1st Value:
2nd Value:
Value Percent: **5.000**
Continuous Index:
Within 8" of Joint: **YES**
Remarks:

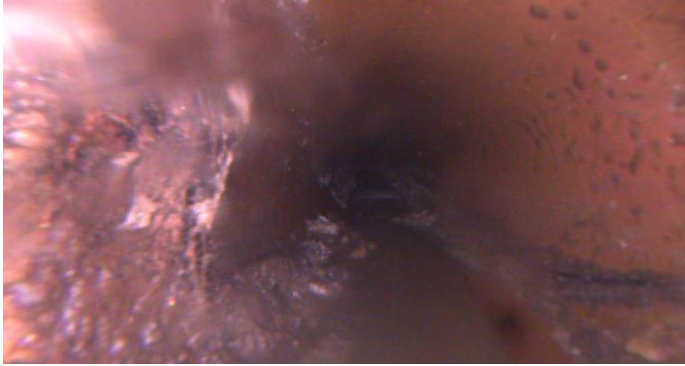
Code: **RMJ**
Description: **Roots Medium Joint**

Distance (ft): **68.3**
Structural Grade: **0**
O&M Grade: **3**
Clock Start/From: **7**
Clock To: **11**
1st Value:
2nd Value:
Value Percent: **10.000**
Continuous Index:
Within 8" of Joint: **YES**
Remarks:

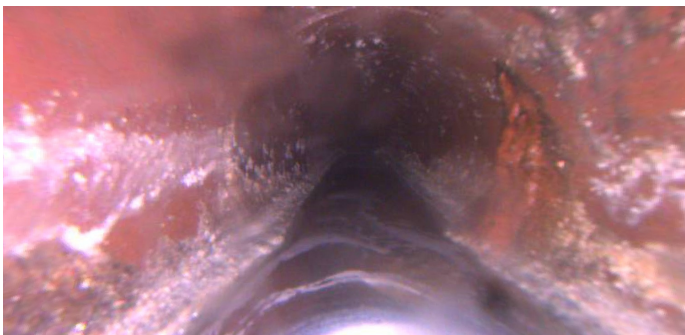
Code: **DAE**
Description: **Deposits Attached Encrustation**

Distance (ft): **71.9**
Structural Grade: **0**
O&M Grade: **2**
Clock Start/From: **1**
Clock To: **4**
1st Value:
2nd Value:
Value Percent: **5.000**
Continuous Index:
Within 8" of Joint: **YES**
Remarks:

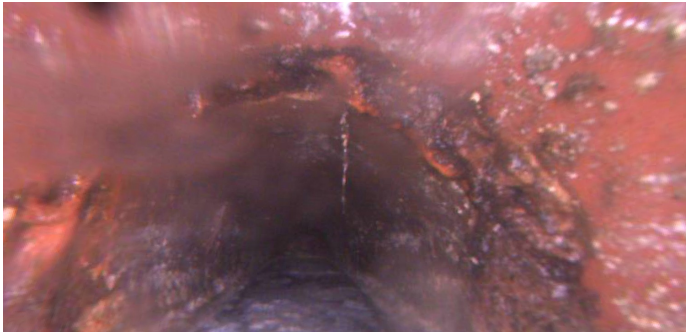
Code: **DAE**
Description: **Deposits Attached Encrustation**

Distance (ft): **76.3**
Structural Grade: **0**
O&M Grade: **2**
Clock Start/From: **8**
Clock To: **4**
1st Value:
2nd Value:
Value Percent: **10.000**
Continuous Index:
Within 8" of Joint: **YES**
Remarks:

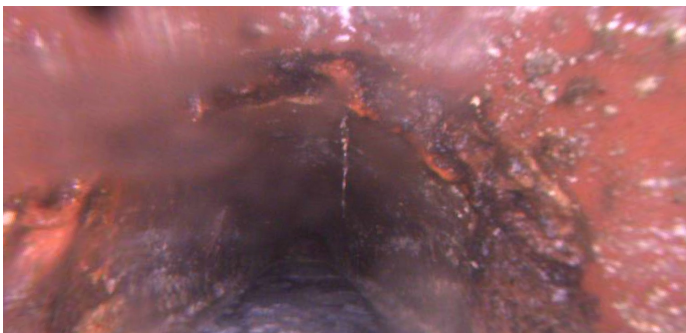
Code: **RFJ**
Description: **Roots Fine Joint**

Distance (ft): **76.3**
Structural Grade: **0**
O&M Grade: **1**
Clock Start/From: **12**
Clock To:
1st Value:
2nd Value:
Value Percent:
Continuous Index:
Within 8" of Joint: **YES**
Remarks:

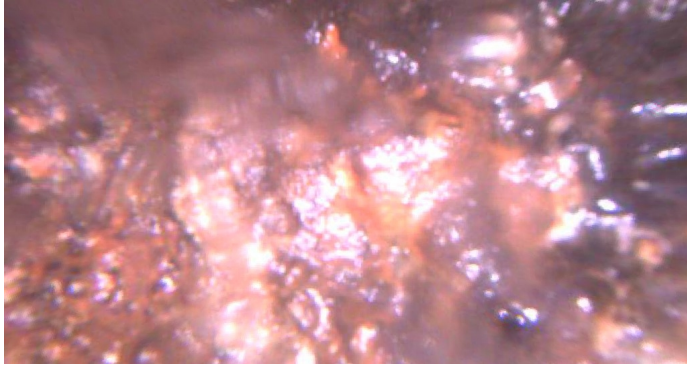
Code:	DAZ
Description:	Deposits Attached Other
Distance (ft):	81.3
Structural Grade:	0
O&M Grade:	5
Clock Start/From:	12
Clock To:	12
1st Value:	
2nd Value:	
Value Percent:	70.000
Continuous Index:	
Within 8" of Joint:	NO
Remarks:

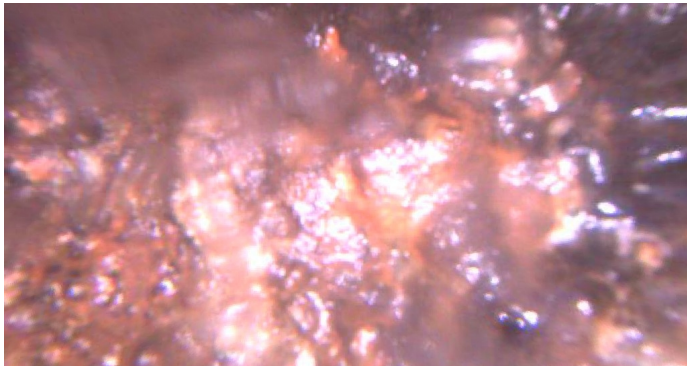
Code:	MSA
Description:	Abandoned Survey
Distance (ft):	81.3
Structural Grade:	0
O&M Grade:	0
Clock Start/From:	
Clock To:	
1st Value:	
2nd Value:	
Value Percent:	
Continuous Index:	
Within 8" of Joint:	NO
Remarks:	DAZ
