Profile/Photo Observation Report

| Street: | South Washington Street | Flow Control: | Not Controlled |
| Use: | Sanitary Sewage Pipe | Material: | VCP |
| US MH: | M-606-072 | DS MH: | M-606-073 |

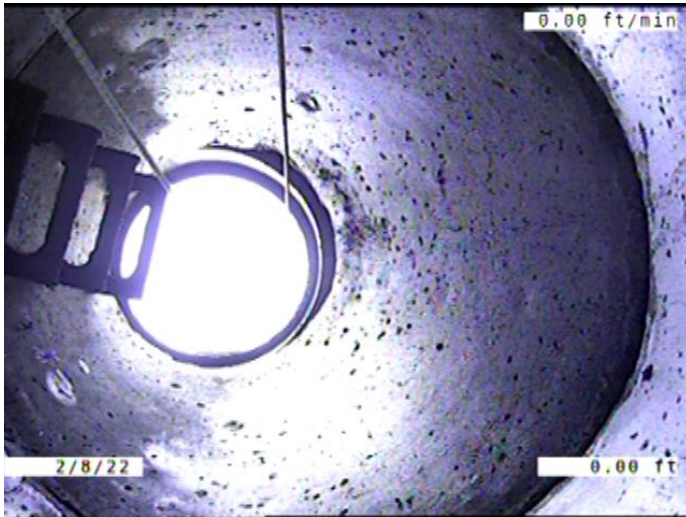
Code: **AMH**
 Description: **Manhole**

Distance (ft): **.0**
 Structural Grade: **0**
 O&M Grade: **0**
 Clock Start/From:
 Clock To:
 1st Value:
 2nd Value:
 Value Percent:
 Continuous Index:
 Within 8" of Joint: **NO**
 Remarks: **M-606-073**

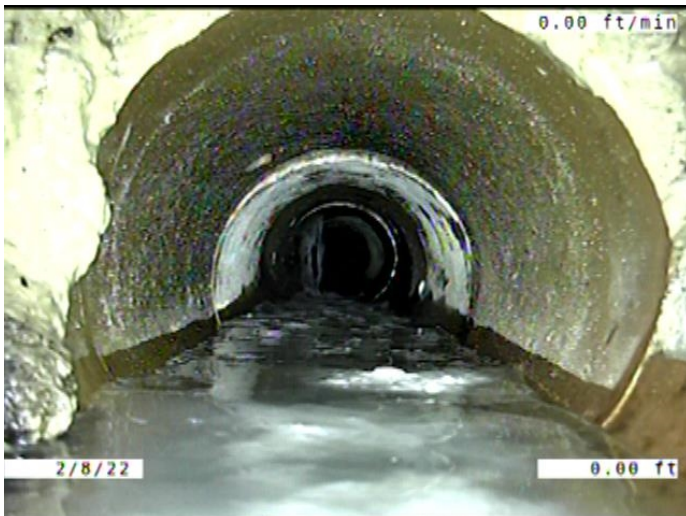
Code: **MWL**
 Description: **Miscellaneous Water Level**

Distance (ft): **.0**
 Structural Grade: **0**
 O&M Grade: **0**
 Clock Start/From:
 Clock To:
 1st Value:
 2nd Value:
 Value Percent: **10.000**
 Continuous Index:
 Within 8" of Joint: **NO**
 Remarks:

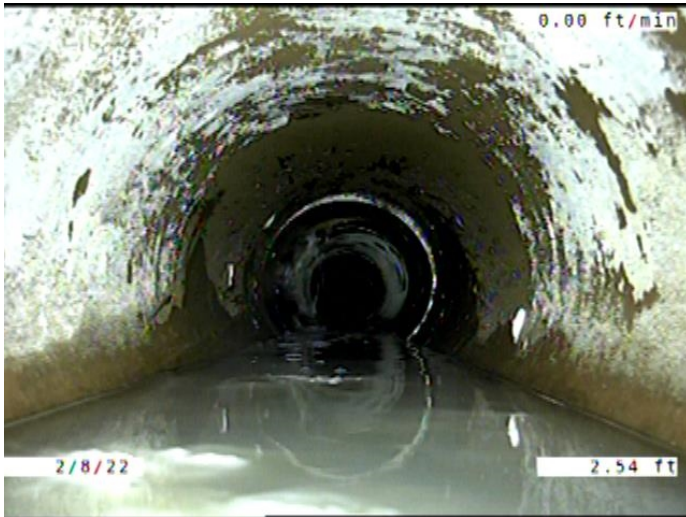
Code: **DAE**
 Description: **Deposits Attached Encrustation**

Distance (ft): **2.5**
 Structural Grade: **0**
 O&M Grade: **2**
 Clock Start/From: **8**
 Clock To: **4**
 1st Value:
 2nd Value:
 Value Percent: **5.000**
 Continuous Index: **S01**
 Within 8" of Joint: **YES**
 Remarks:

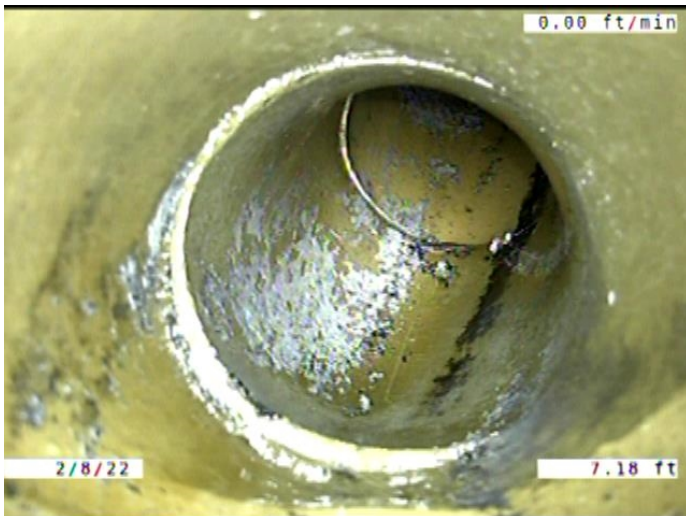
Code: **TFA**
 Description: **Tap Factory Activity**

Distance (ft): **7.2**
 Structural Grade: **0**
 O&M Grade: **0**
 Clock Start/From: **11**
 Clock To:
 1st Value: **6.000**
 2nd Value:
 Value Percent:
 Continuous Index:
 Within 8" of Joint: **YES**
 Remarks:

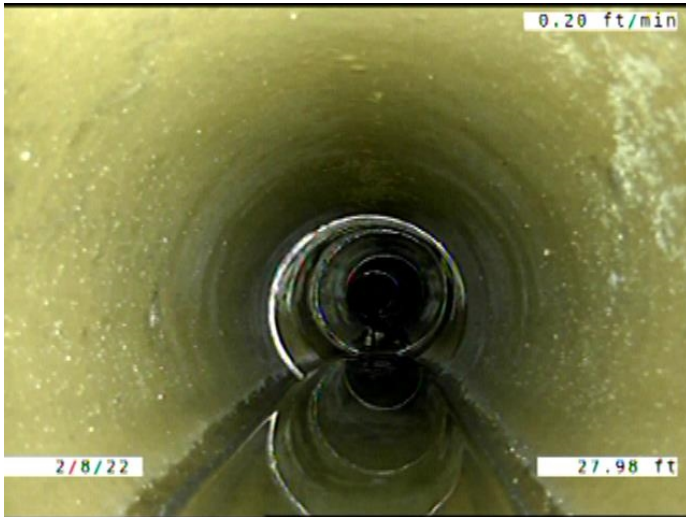
Code: **MWLS**
Description: **Miscellaneous Water Level Sag**

Distance (ft): **28.0**
Structural Grade: **2**
O&M Grade: **0**
Clock Start/From:
Clock To:
1st Value:
2nd Value:
Value Percent: **5.000**
Continuous Index: **S02**
Within 8" of Joint: **NO**
Remarks:

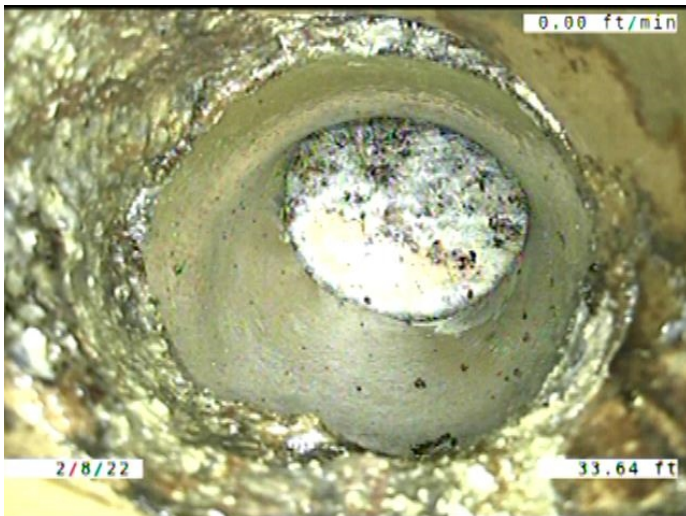
Code: **TFC**
Description: **Tap Factory Capped**

Distance (ft): **33.6**
Structural Grade: **0**
O&M Grade: **0**
Clock Start/From: **12**
Clock To:
1st Value: **6.000**
2nd Value:
Value Percent:
Continuous Index:
Within 8" of Joint: **YES**
Remarks: **ENCrustation COMING FROM THE SERVICE TO MAIN CONNECTION.**

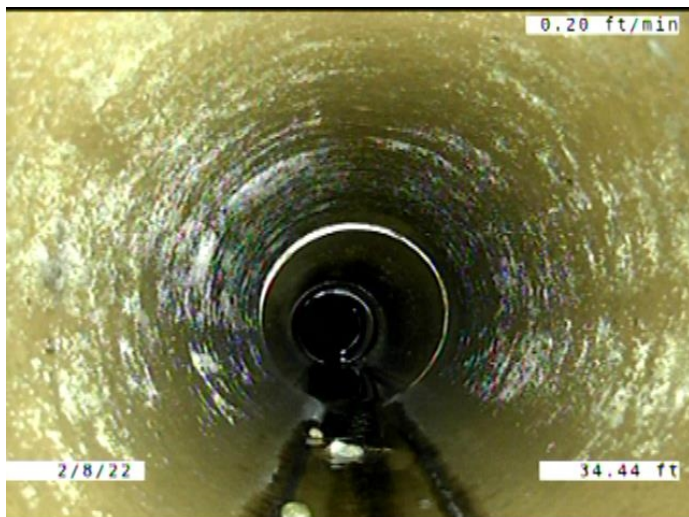
Code: **MWLS**
 Description: **Miscellaneous Water Level Sag**

Distance (ft): **34.4**
 Structural Grade: **2**
 O&M Grade: **0**
 Clock Start/From:
 Clock To:
 1st Value:
 2nd Value:
 Value Percent: **5.000**
 Continuous Index: **F02**
 Within 8" of Joint: **NO**
 Remarks:

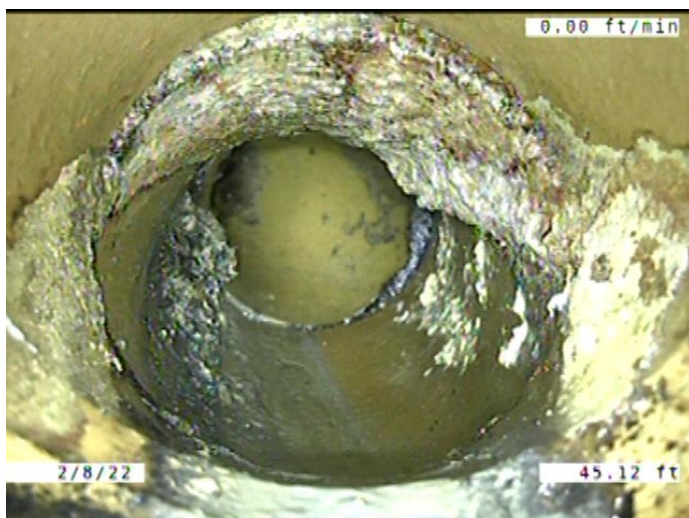
Code: **TF**
 Description: **Tap Factory**

Distance (ft): **45.1**
 Structural Grade: **0**
 O&M Grade: **0**
 Clock Start/From: **12**
 Clock To:
 1st Value: **6.000**
 2nd Value:
 Value Percent:
 Continuous Index:
 Within 8" of Joint: **YES**
 Remarks: **ENCrustATION COMING FROM THE SERVICE TO MAIN CONNECTION.**

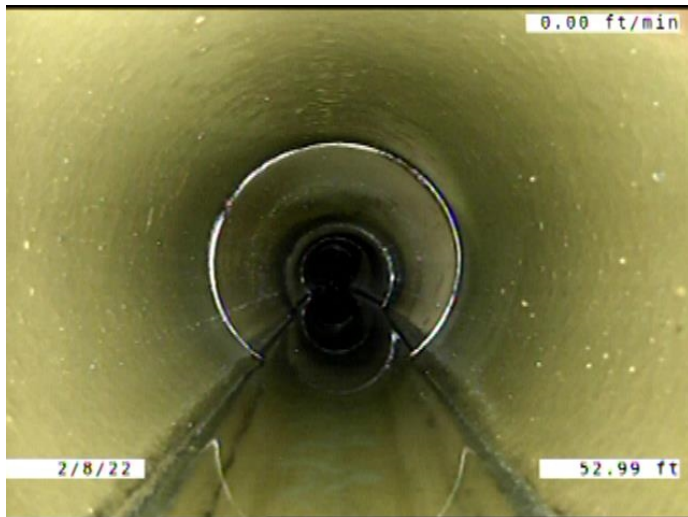
Code: **MWLS**
Description: **Miscellaneous Water Level Sag**

Distance (ft): **53.0**
Structural Grade: **2**
O&M Grade: **0**
Clock Start/From:
Clock To:
1st Value:
2nd Value:
Value Percent: **5.000**
Continuous Index: **S03**
Within 8" of Joint: **NO**
Remarks:

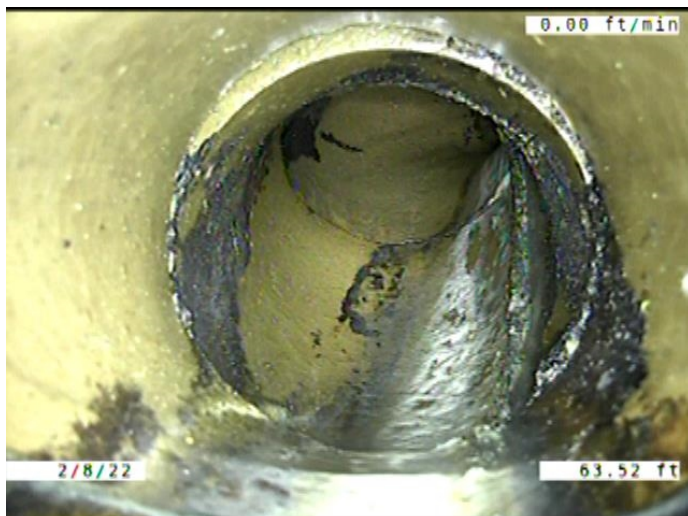
Code: **TF**
Description: **Tap Factory**

Distance (ft): **63.5**
Structural Grade: **0**
O&M Grade: **0**
Clock Start/From: **12**
Clock To:
1st Value: **6.000**
2nd Value:
Value Percent:
Continuous Index:
Within 8" of Joint: **YES**
Remarks: **ENCrustATION COMING FROM THE SERVICE TO MAIN CONNECTION.**

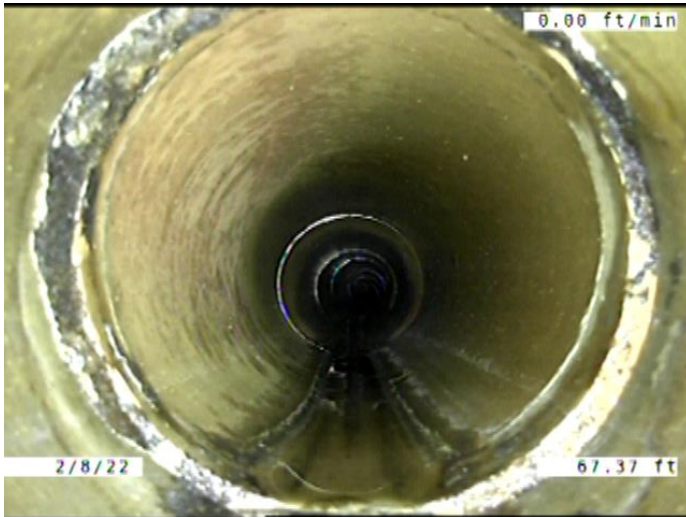
Code: **MWLS**
 Description: **Miscellaneous Water Level Sag**

Distance (ft): **67.4**
 Structural Grade: **2**
 O&M Grade: **0**
 Clock Start/From:
 Clock To:
 1st Value:
 2nd Value:
 Value Percent: **5.000**
 Continuous Index: **F03**
 Within 8" of Joint: **NO**
 Remarks:

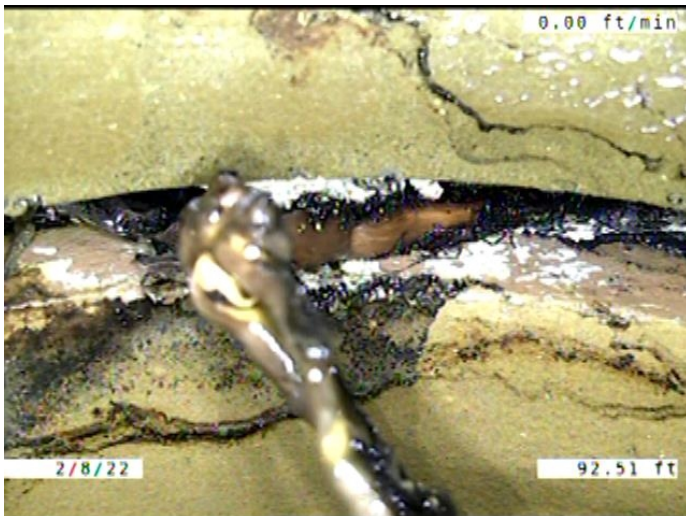
Code: **RTJ**
 Description: **Roots Tap Joint**

Distance (ft): **92.5**
 Structural Grade: **0**
 O&M Grade: **2**
 Clock Start/From: **11**
 Clock To:
 1st Value:
 2nd Value:
 Value Percent: **5.000**
 Continuous Index:
 Within 8" of Joint: **YES**
 Remarks:

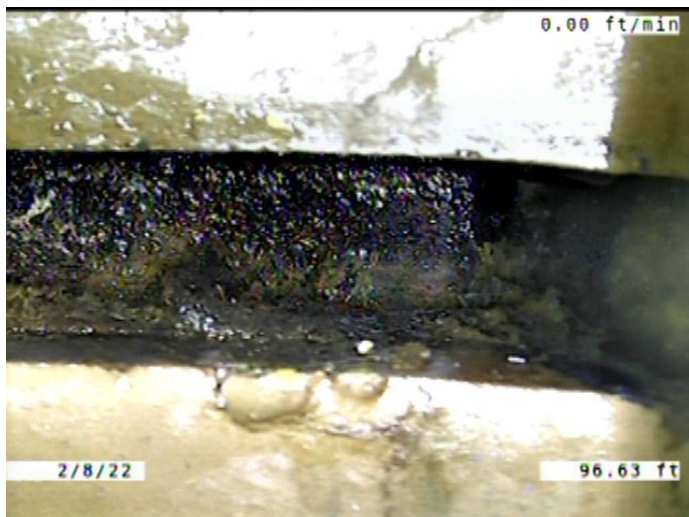
Code: **JAM**
 Description: **Joint Angular Medium**

Distance (ft): **96.6**
 Structural Grade: **3**
 O&M Grade: **0**
 Clock Start/From:
 Clock To:
 1st Value:
 2nd Value:
 Value Percent:
 Continuous Index:
 Within 8" of Joint: **NO**
 Remarks:

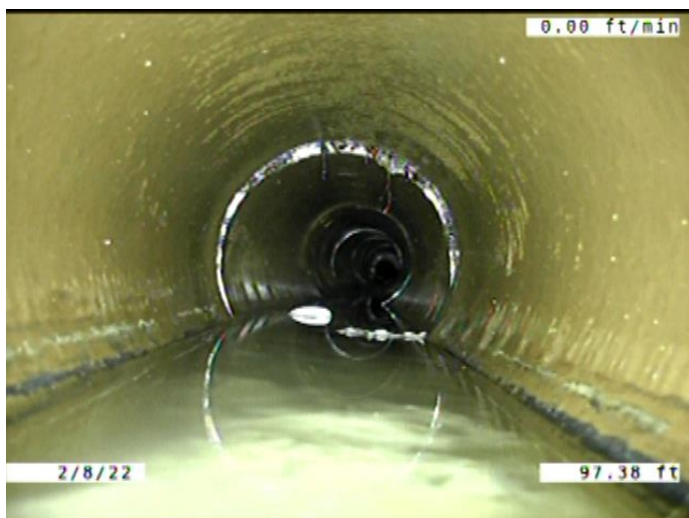
Code: **MWLS**
 Description: **Miscellaneous Water Level Sag**

Distance (ft): **97.4**
 Structural Grade: **2**
 O&M Grade: **0**
 Clock Start/From:
 Clock To:
 1st Value:
 2nd Value:
 Value Percent: **10.000**
 Continuous Index: **S04**
 Within 8" of Joint: **NO**
 Remarks:

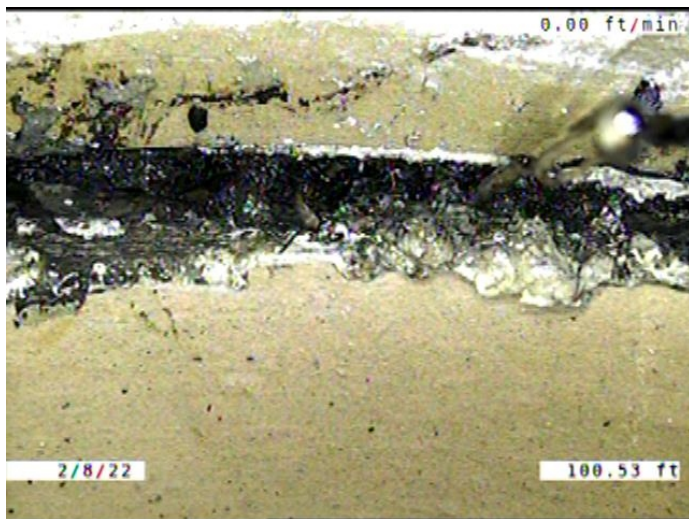
Code: **RFJ**
Description: **Roots Fine Joint**

Distance (ft): **100.5**
Structural Grade: **0**
O&M Grade: **1**
Clock Start/From: **10**
Clock To: **2**
1st Value:
2nd Value:
Value Percent:
Continuous Index:
Within 8" of Joint: **YES**
Remarks:

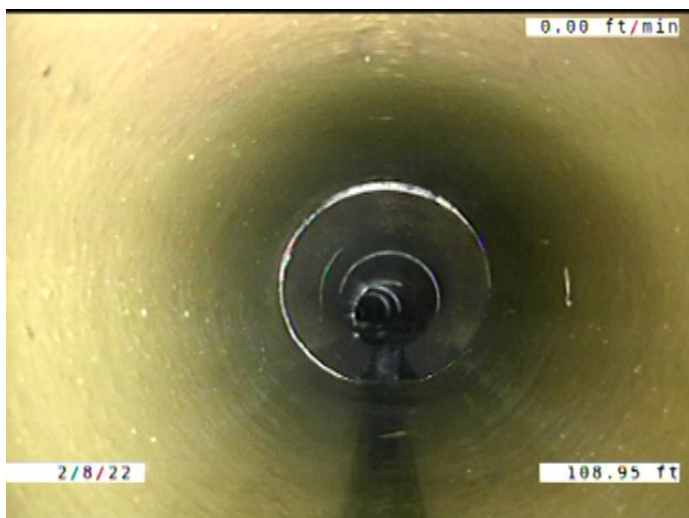
Code: **MWLS**
Description: **Miscellaneous Water Level Sag**

Distance (ft): **109.0**
Structural Grade: **2**
O&M Grade: **0**
Clock Start/From:
Clock To:
1st Value:
2nd Value:
Value Percent: **10.000**
Continuous Index: **F04**
Within 8" of Joint: **NO**
Remarks:

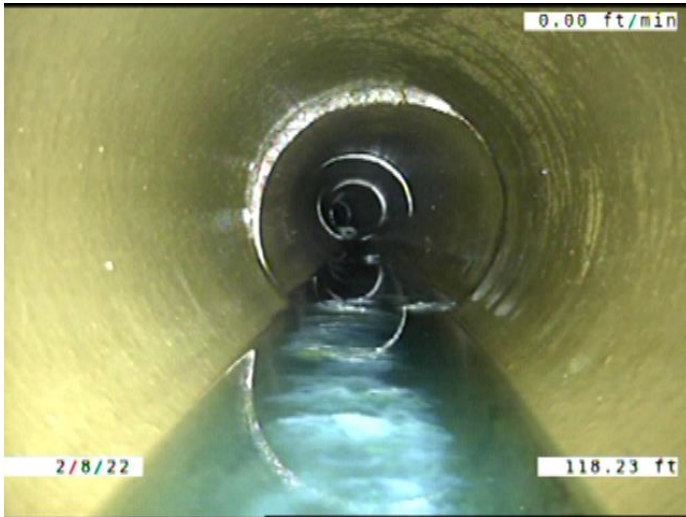
Code: **MWLS**
 Description: **Miscellaneous Water Level Sag**

Distance (ft): **118.2**
 Structural Grade: **2**
 O&M Grade: **0**
 Clock Start/From:
 Clock To:
 1st Value:
 2nd Value:
 Value Percent: **5.000**
 Continuous Index: **S05**
 Within 8" of Joint: **NO**
 Remarks:

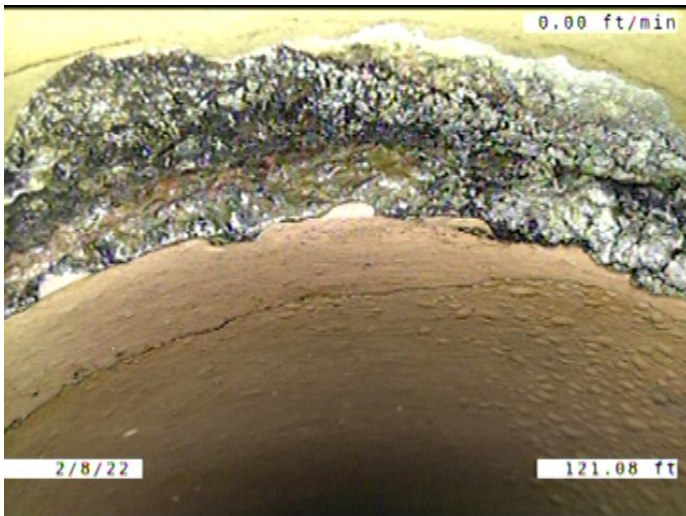
Code: **JOM**
 Description: **Joint Offset Medium**

Distance (ft): **121.1**
 Structural Grade: **3**
 O&M Grade: **0**
 Clock Start/From:
 Clock To:
 1st Value:
 2nd Value:
 Value Percent:
 Continuous Index:
 Within 8" of Joint: **NO**
 Remarks:

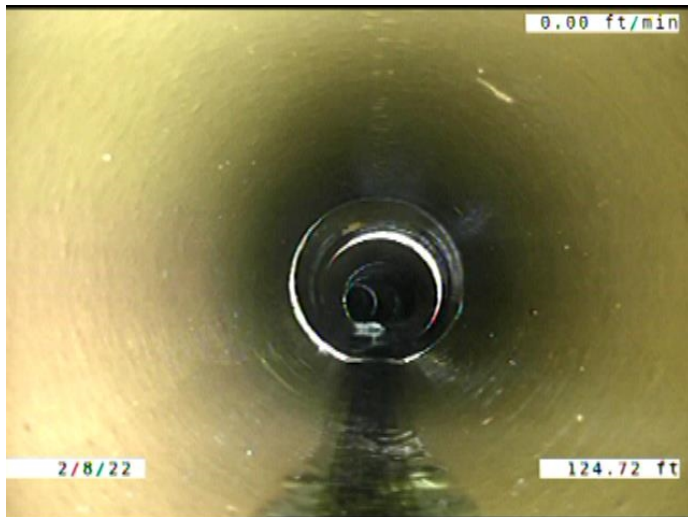
Code: **MWLS**
 Description: **Miscellaneous Water Level Sag**

Distance (ft): **124.7**
 Structural Grade: **2**
 O&M Grade: **0**
 Clock Start/From:
 Clock To:
 1st Value:
 2nd Value:
 Value Percent: **5.000**
 Continuous Index: **F05**
 Within 8" of Joint: **NO**
 Remarks:

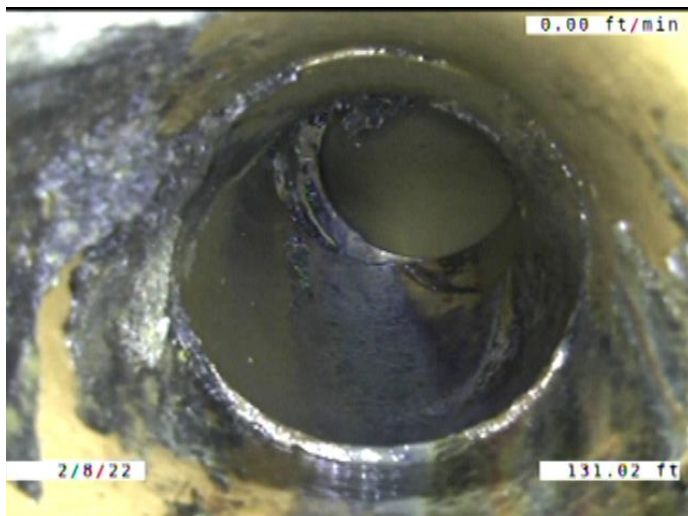
Code: **TF**
 Description: **Tap Factory**

Distance (ft): **131.0**
 Structural Grade: **0**
 O&M Grade: **0**
 Clock Start/From: **12**
 Clock To:
 1st Value: **6.000**
 2nd Value:
 Value Percent:
 Continuous Index:
 Within 8" of Joint: **YES**
 Remarks: **ENCrustation COMING FROM THE SERVICE TO MAIN CONNECTION.**

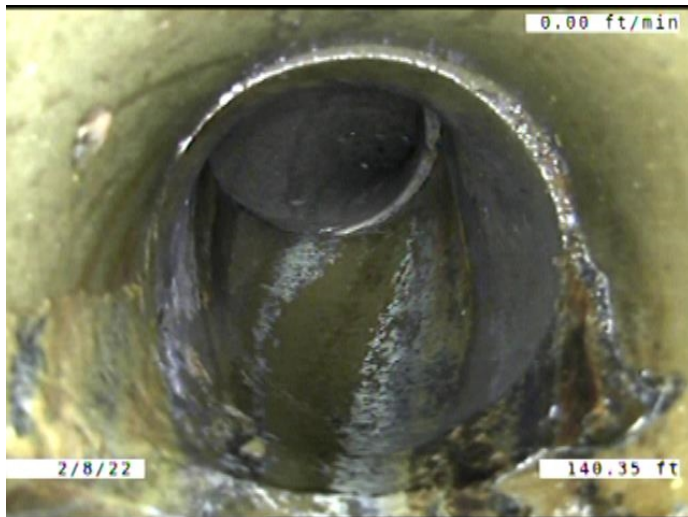
Code: **TF**
 Description: **Tap Factory**

Distance (ft): **140.4**
 Structural Grade: **0**
 O&M Grade: **0**
 Clock Start/From: **12**
 Clock To:
 1st Value: **6.000**
 2nd Value:
 Value Percent:
 Continuous Index:
 Within 8" of Joint: **YES**
 Remarks:

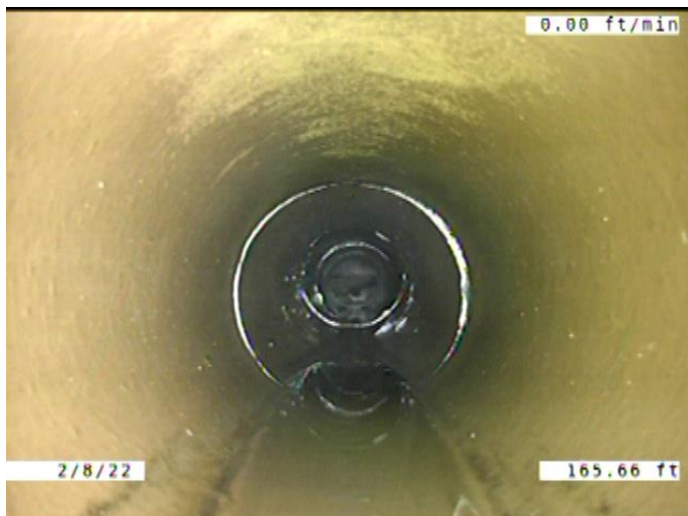
Code: **MWLS**
 Description: **Miscellaneous Water Level Sag**

Distance (ft): **165.6**
 Structural Grade: **2**
 O&M Grade: **0**
 Clock Start/From:
 Clock To:
 1st Value:
 2nd Value:
 Value Percent: **5.000**
 Continuous Index: **S06**
 Within 8" of Joint: **NO**
 Remarks:

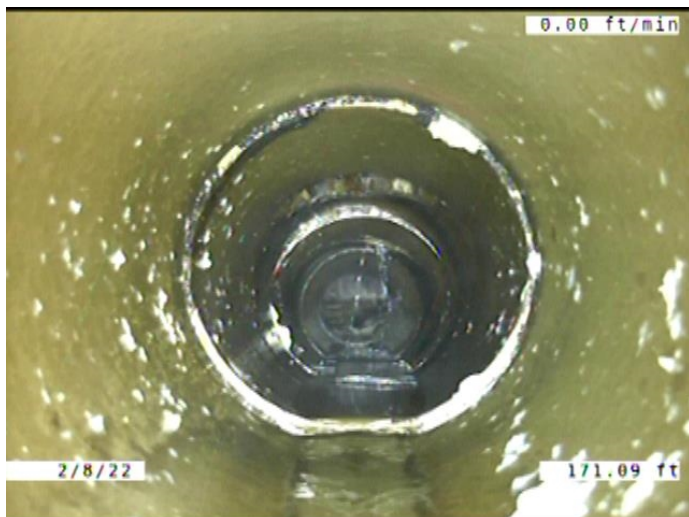
Code: **MWLS**
Description: **Miscellaneous Water Level Sag**

Distance (ft): **171.0**
Structural Grade: **2**
O&M Grade: **0**
Clock Start/From:
Clock To:
1st Value:
2nd Value:
Value Percent: **5.000**
Continuous Index: **F06**
Within 8" of Joint: **NO**
Remarks:

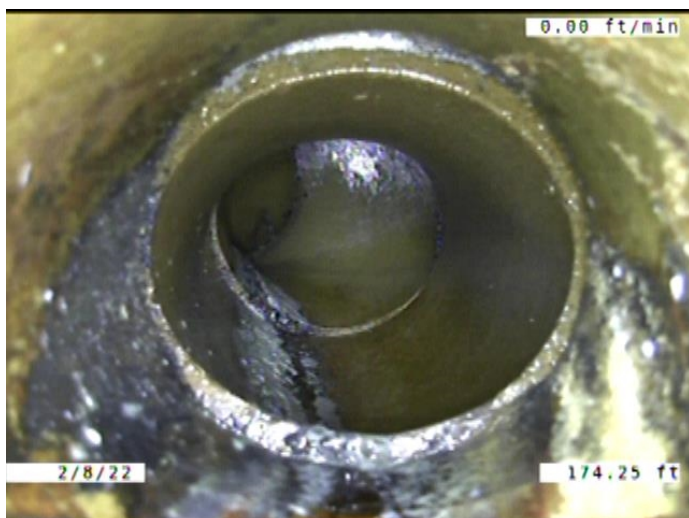
Code: **TF**
Description: **Tap Factory**

Distance (ft): **174.2**
Structural Grade: **0**
O&M Grade: **0**
Clock Start/From: **12**
Clock To:
1st Value: **6.000**
2nd Value:
Value Percent:
Continuous Index:
Within 8" of Joint: **YES**
Remarks: **STAINING COMING FROM THE SERVICE TO MAIN CONNECTION.**

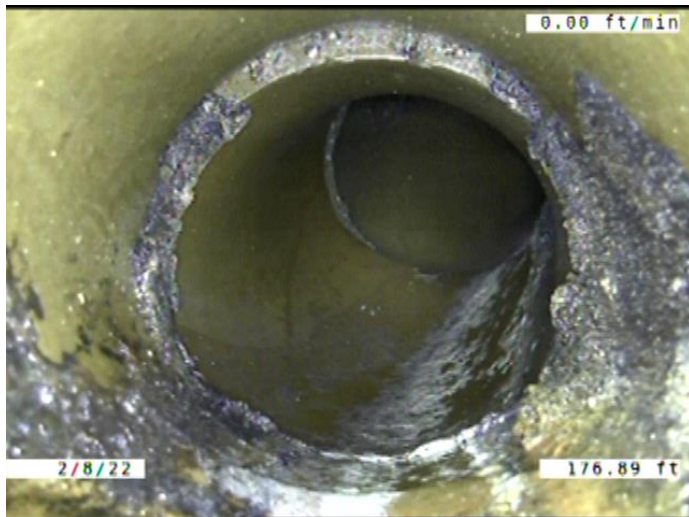
| Description: | Tap Factory Activity |
| Distance (ft): | 176.9 |
| Remarks: | ENCrustATION COMING FROM THE SERVICE TO MAIN CONNECTION. |

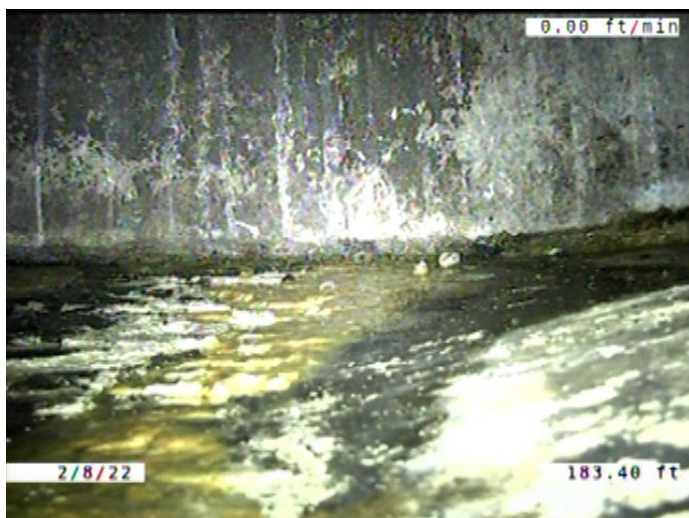
| Description: | Deposits Attached Encrustation |
| Distance (ft): | 183.4 |
| O&M Grade: | 2 |
| Value Percent: | 5.000 |

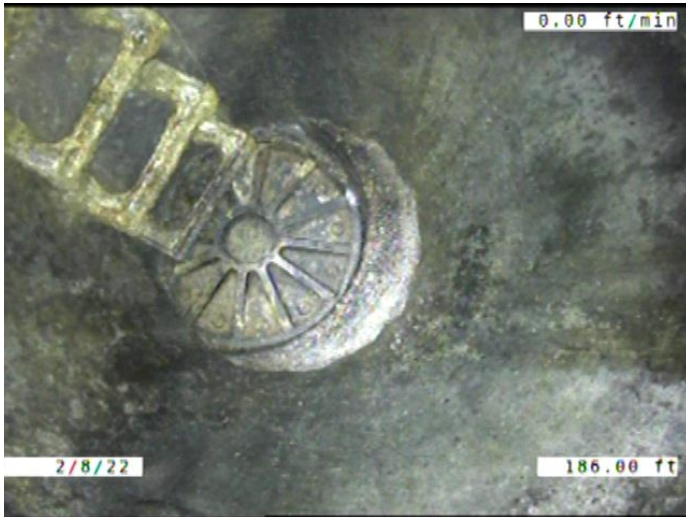
| Description: | Manhole |
| Distance (ft): | 186.0 |
| Remarks: | M-606-072 |
