Profile/Ph	oto Observatio	n Report			RedZon
Date:	04/08/2018	Weather:		Coding:	PACP 6.0
Pipe Length (ft	:): 179.0	Owner:	NA	Pre Clean:	No Pre-Cleaning
P.O.#:		Surveyor:	Jen Costello	PSR:	P-606-075-074
Customer:		Clean Date:	01/01/1900	Shape:	C
Street:	ALLEY BETWEEN	S CONNECTICUT S	T Flow Control:	Not Controlled	ł
City:	Hobart, IN		Year Renewed:		
Location:	Yard		Tape/Media #:		
Purpose:	Routine Assessme	ent	Dia/Height:	12"	
Use:	Sanitary		Material:	VCP	
Drain Area:	NA		Lining:		
Category:	NA				
Comment:					
Location Detai	ls:		Direction of Sur	vey: Upstream	
US MH:	M-606-074	DS MH:	M-606-075	Total Length Surveyed (ft): 6.3
0&M Index:	4.50	O&M Quick:	514	41 O&M Rating:	9.00
tructural Index:	0.00	Structural Q			0.00
Overall Index:	4.50	Overall Quic			9.00

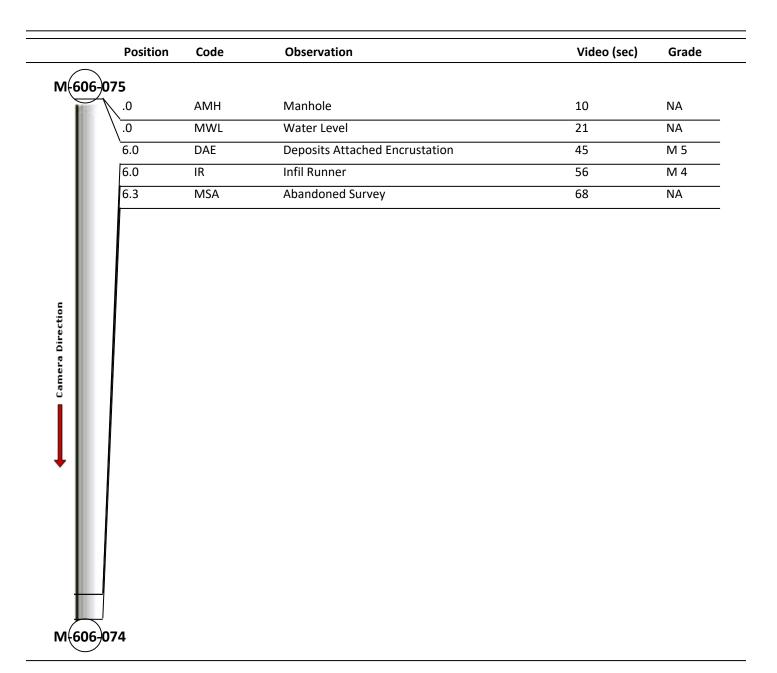
Code:	DAE
Description:	Deposits Attached Encrustation

Distance (ft):	6.0
Structural Grade:	0
O&M Grade:	5
Clock Start/From:	8
Clock To:	4
1st Value:	
2nd Value:	
Value Percent:	40.000
Continuous Index:	
Within 8" of Joint:	YES
Remarks:

Code:	IR
Description:	Infil Runner

Distance (ft):	6.0
Structural Grade:	0
O&M Grade:	4
Clock Start/From:	12
Clock To:	
1st Value:	
2nd Value:	
Value Percent:	
Continuous Index:	
Within 8" of Joint:	YES
Remarks:
