Profile/Photo Observation Report

Date:	02/28/2024	Weather:		Coding:	PACP 7.0
Pipe Length (ft):	179.0	Owner:	City of Hobart	Pre Clean:	Heavy Cleaning
P.O.#:		Surveyor:	S. Bucklin	PSR:	P-606-075-074
Customer:	City of Hobart	Clean Date:	12/02/2023	Shape:	C

Street:	S CONNECTICUT ST	Flow Control:	Not Controlled
City:	Hobart, IN	Year Renewed:	
Location:	Easement/Right of Way	Tape/Media #:	
Purpose:	Sewer System Evaluation Survey (SS)	Dia/Height:	12"
Use:	Sanitary Sewage Pipe	Material:	VCP
Drain Area:		Lining:	None
Category:	NA		
Comment:			
Location Details:		Direction of Survey:	Upstream
US MH:	M-606-074	DS MH:	M-606-075
		Total Length Surveyed (ft):	180.8

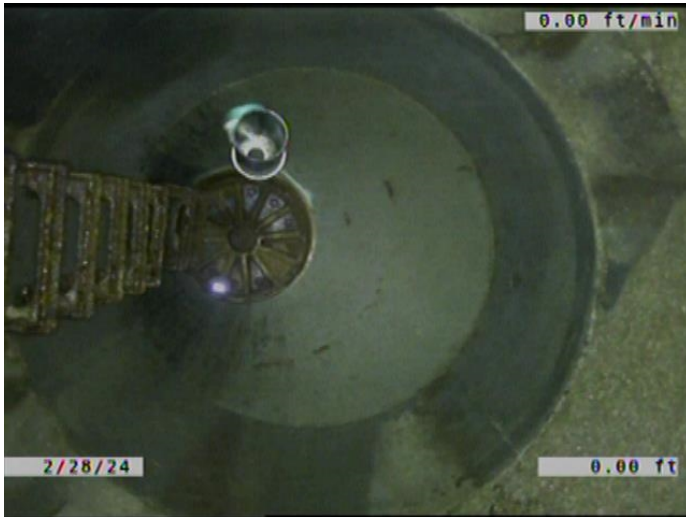
Code: **AMH**
Description: **Manhole**

Distance (ft): **.0**
Structural Grade: **0**
O&M Grade: **0**
Clock Start/From:
Clock To:
1st Value:
2nd Value:
Value Percent:
Continuous Index:
Within 8" of Joint: **NO**
Remarks: **M-606-075**

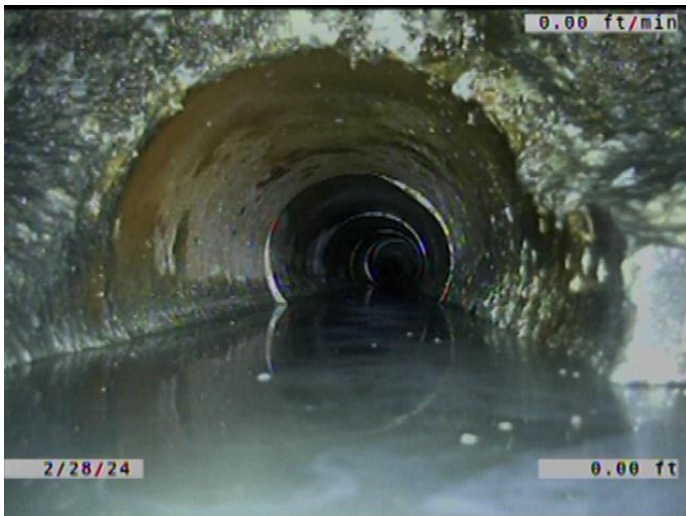
Code: **MWL**
Description: **Miscellaneous Water Level**

Distance (ft): **.0**
Structural Grade: **0**
O&M Grade: **0**
Clock Start/From:
Clock To:
1st Value:
2nd Value:
Value Percent: **10.000**
Continuous Index:
Within 8" of Joint: **NO**
Remarks:

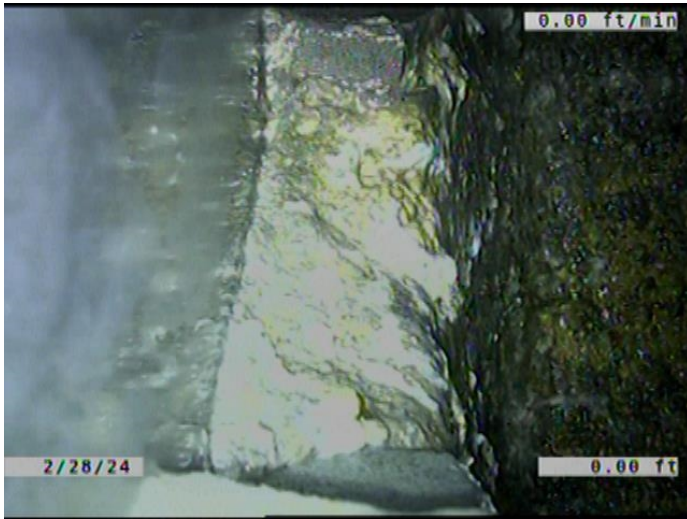
Code: **MGO**
Description: **Miscellaneous General Observation**

Distance (ft): **.0**
Structural Grade: **0**
O&M Grade: **0**
Clock Start/From:
Clock To:
1st Value:
2nd Value:
Value Percent:
Continuous Index:
Within 8" of Joint: **NO**
Remarks: **PIPE MISSING OUT OF THE BOTTOM OF THE CHANNEL.**

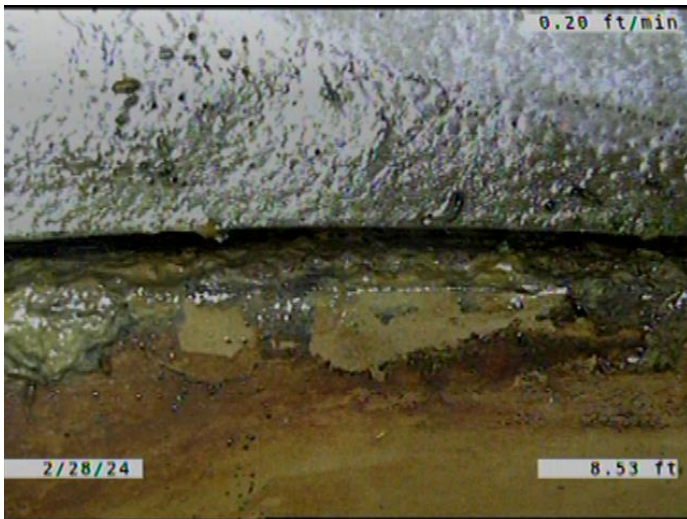
Code: **DAE**
Description: **Deposits Attached Encrustation**

Distance (ft): **8.5**
Structural Grade: **0**
O&M Grade: **2**
Clock Start/From: **7**
Clock To: **5**
1st Value:
2nd Value:
Value Percent: **5.000**
Continuous Index: **S01**
Within 8" of Joint: **YES**
Remarks:

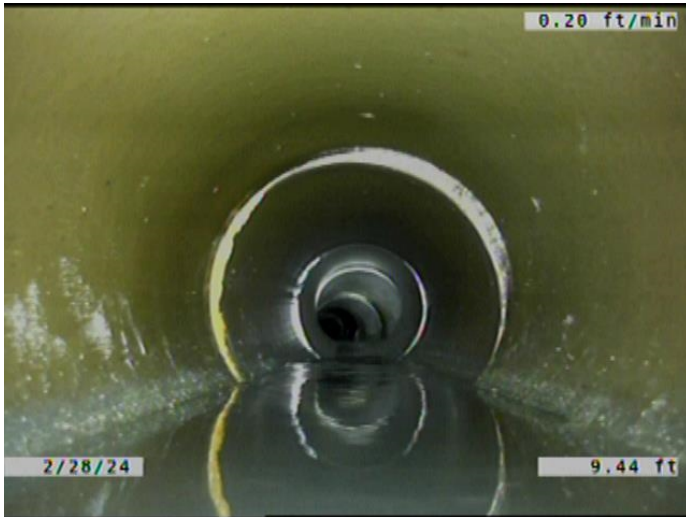
Code: **MWLS**
Description: **Miscellaneous Water Level Sag**

Distance (ft): **9.4**
Structural Grade: **2**
O&M Grade: **0**
Clock Start/From:
Clock To:
1st Value:
2nd Value:
Value Percent: **15.000**
Continuous Index: **S02**
Within 8" of Joint: **NO**
Remarks:

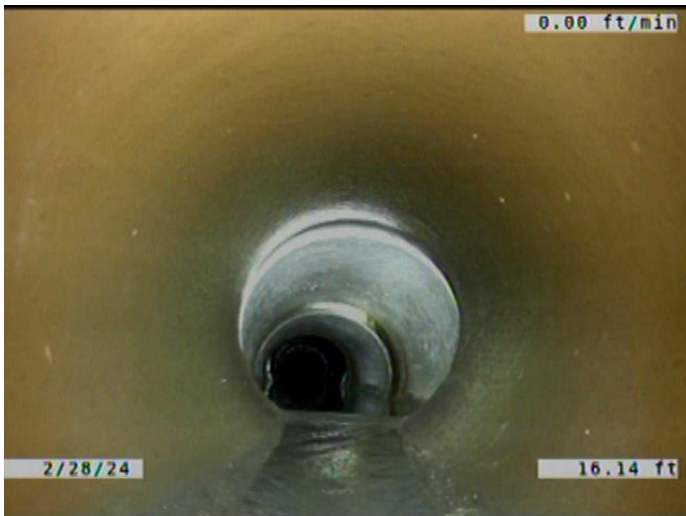
Code: **MWLS**
Description: **Miscellaneous Water Level Sag**

Distance (ft): **16.1**
Structural Grade: **2**
O&M Grade: **0**
Clock Start/From:
Clock To:
1st Value:
2nd Value:
Value Percent: **15.000**
Continuous Index: **F02**
Within 8" of Joint: **NO**
Remarks:

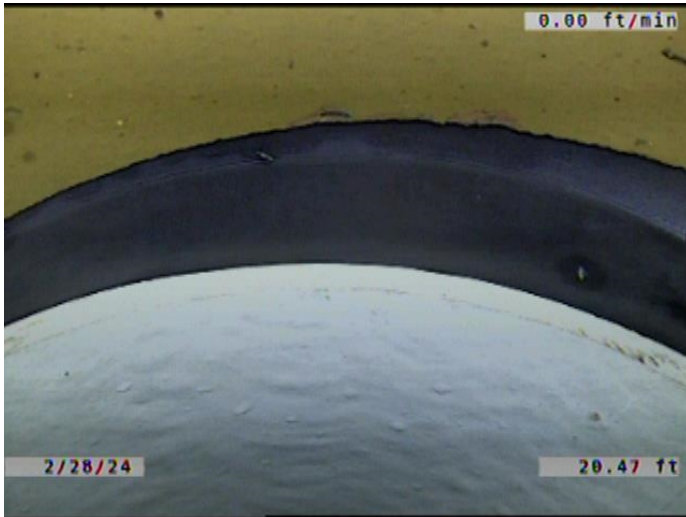
Code: **JOM**
Description: **Joint Offset Medium**

Distance (ft): **20.5**
Structural Grade: **3**
O&M Grade: **0**
Clock Start/From:
Clock To:
1st Value:
2nd Value:
Value Percent:
Continuous Index:
Within 8" of Joint: **NO**
Remarks:

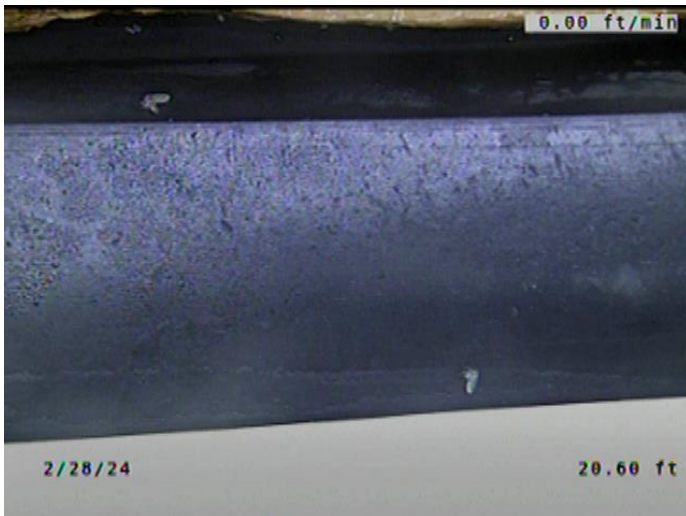
Code: **JAM**
Description: **Joint Angular Medium**

Distance (ft): **20.6**
Structural Grade: **3**
O&M Grade: **0**
Clock Start/From:
Clock To:
1st Value:
2nd Value:
Value Percent:
Continuous Index:
Within 8" of Joint: **NO**
Remarks:

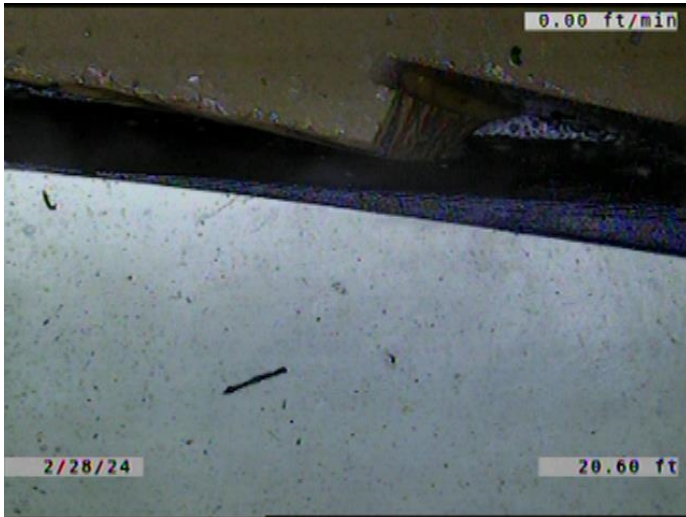
Code: **RPR**
Description: **Point Repair Replacement**

Distance (ft): **20.6**
Structural Grade: **0**
O&M Grade: **0**
Clock Start/From:
Clock To:
1st Value:
2nd Value:
Value Percent:
Continuous Index: **S03**
Within 8" of Joint: **YES**
Remarks: **REPLACED WITH PVC.**

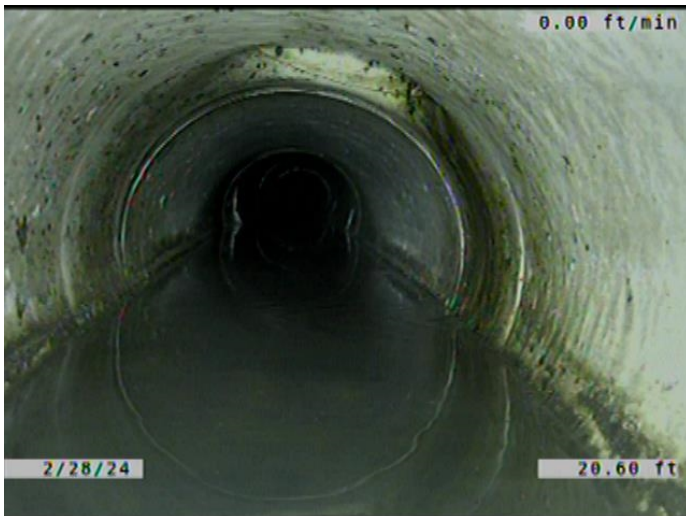
Code: **MWLS**
Description: **Miscellaneous Water Level Sag**

Distance (ft): **20.6**
Structural Grade: **2**
O&M Grade: **0**
Clock Start/From:
Clock To:
1st Value:
2nd Value:
Value Percent: **20.000**
Continuous Index: **S04**
Within 8" of Joint: **NO**
Remarks:

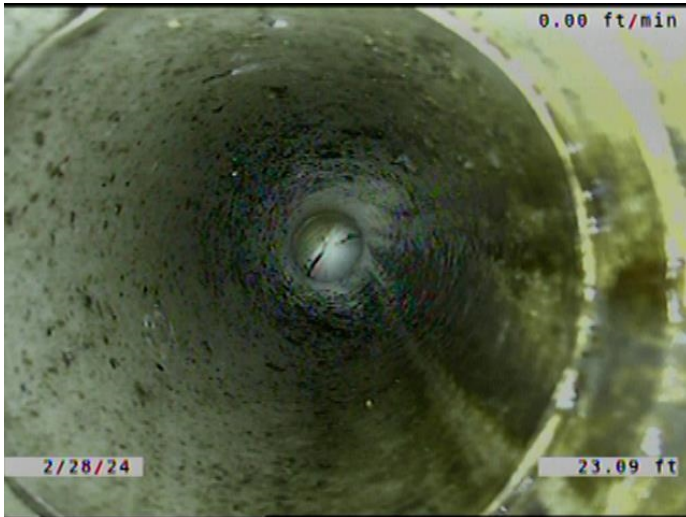
Code: **TF**
Description: **Tap Factory**

Distance (ft): **23.1**
Structural Grade: **0**
O&M Grade: **0**
Clock Start/From: **1**
Clock To:
1st Value: **6.000**
2nd Value:
Value Percent:
Continuous Index:
Within 8" of Joint: **YES**
Remarks: **CONSTANTLY RUNNING WATER.**

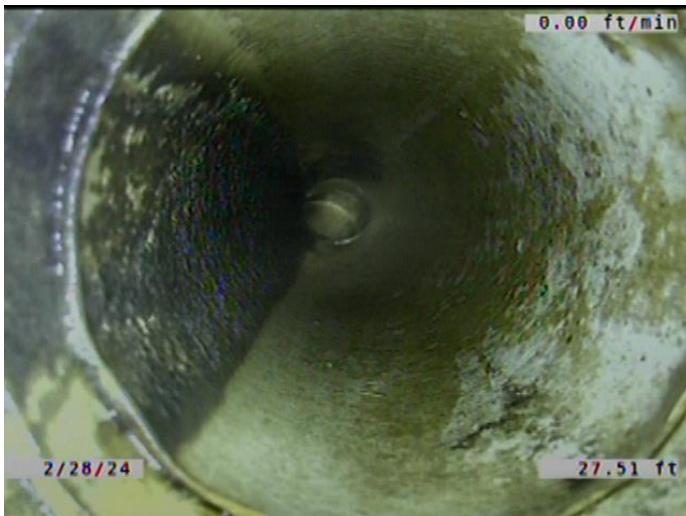
Code: **TF**
Description: **Tap Factory**

Distance (ft): **27.5**
Structural Grade: **0**
O&M Grade: **0**
Clock Start/From: **11**
Clock To:
1st Value: **6.000**
2nd Value:
Value Percent:
Continuous Index:
Within 8" of Joint: **YES**
Remarks:

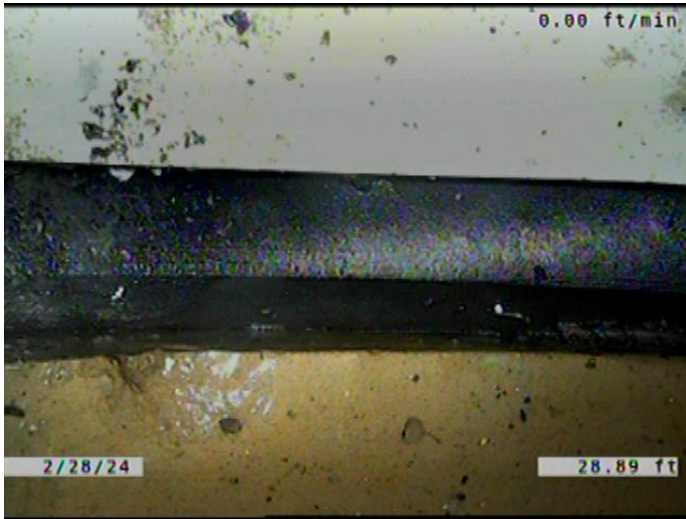
Code: **RPR**
Description: **Point Repair Replacement**

Distance (ft): **28.9**
Structural Grade: **0**
O&M Grade: **0**
Clock Start/From:
Clock To:
1st Value:
2nd Value:
Value Percent:
Continuous Index: **F03**
Within 8" of Joint: **YES**
Remarks: **REPLACED WITH PVC.**

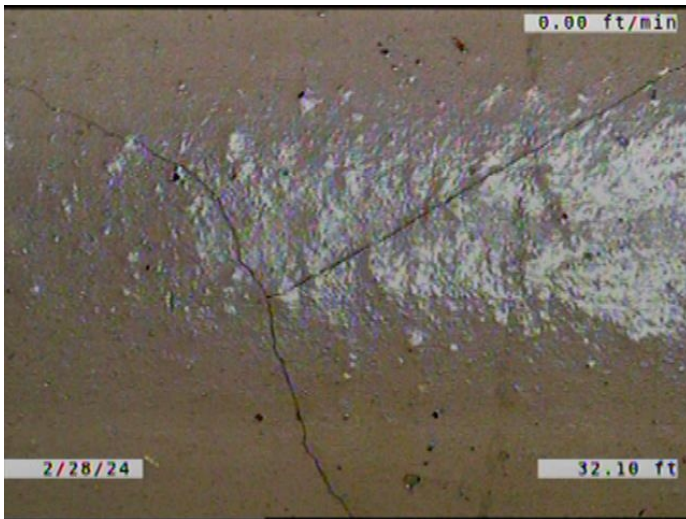
Code: **CM**
Description: **Crack Multiple**

Distance (ft): **32.1**
Structural Grade: **3**
O&M Grade: **0**
Clock Start/From: **1**
Clock To: **4**
1st Value:
2nd Value:
Value Percent:
Continuous Index:
Within 8" of Joint: **YES**
Remarks:

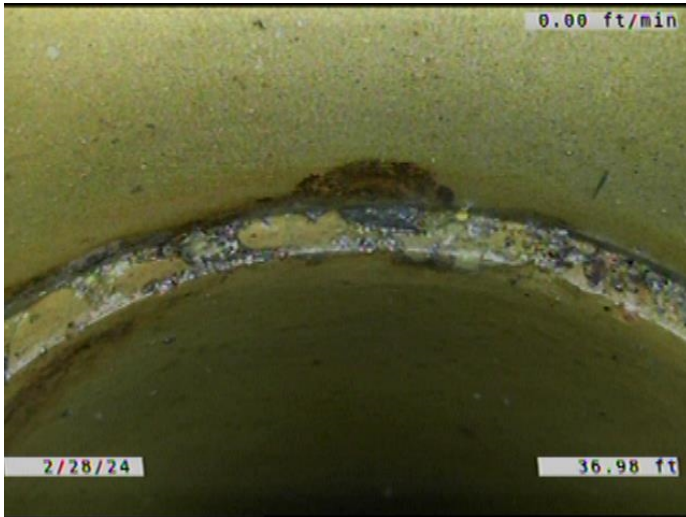
Code: **JOMD**
Description: **Joint Offset Medium Defective**

Distance (ft): **37.0**
Structural Grade: **3**
O&M Grade: **0**
Clock Start/From:
Clock To:
1st Value:
2nd Value:
Value Percent:
Continuous Index:
Within 8" of Joint: **NO**
Remarks:

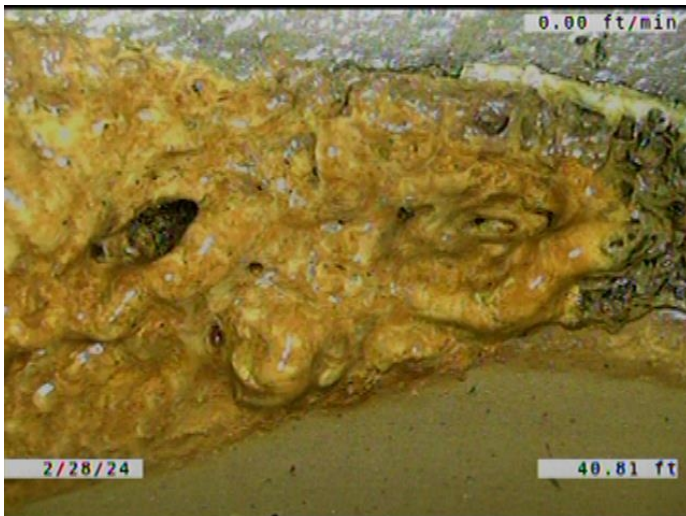
Code: **IRJ**
Description: **Infiltration Runner Joint**

Distance (ft): **40.8**
Structural Grade: **0**
O&M Grade: **4**
Clock Start/From: **11**
Clock To:
1st Value:
2nd Value:
Value Percent:
Continuous Index:
Within 8" of Joint: **YES**
Remarks:

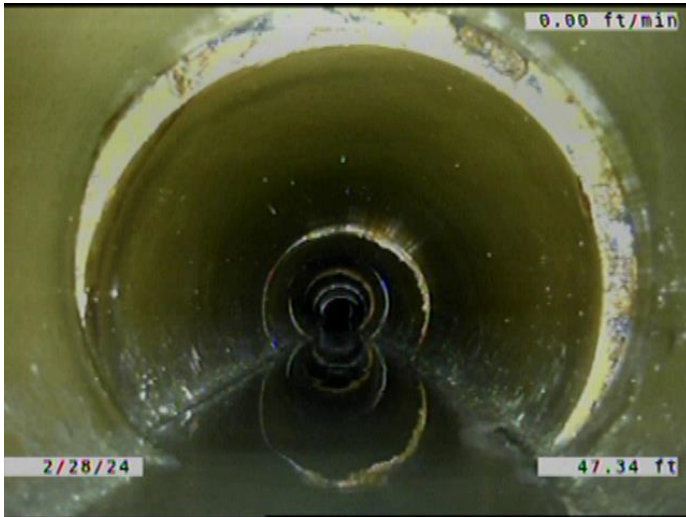
Code: **MWLS**
Description: **Miscellaneous Water Level Sag**

Distance (ft): **47.3**
Structural Grade: **2**
O&M Grade: **0**
Clock Start/From:
Clock To:
1st Value:
2nd Value:
Value Percent: **20.000**
Continuous Index: **F04**
Within 8" of Joint: **NO**
Remarks:

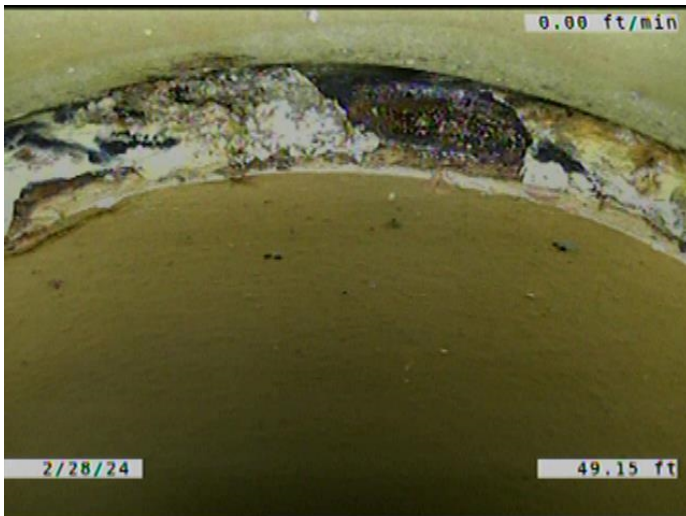
Code: **JOMD**
Description: **Joint Offset Medium Defective**

Distance (ft): **49.2**
Structural Grade: **3**
O&M Grade: **0**
Clock Start/From:
Clock To:
1st Value:
2nd Value:
Value Percent:
Continuous Index:
Within 8" of Joint: **NO**
Remarks:

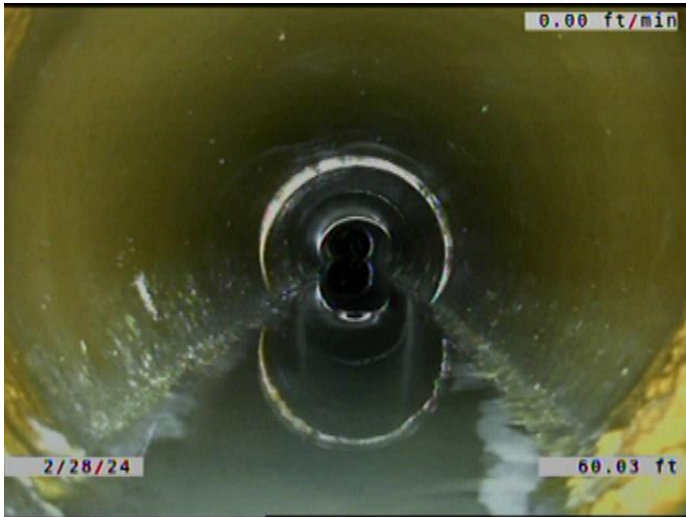
Code: **MWLS**
Description: **Miscellaneous Water Level Sag**

Distance (ft): **60.0**
Structural Grade: **2**
O&M Grade: **0**
Clock Start/From:
Clock To:
1st Value:
2nd Value:
Value Percent: **15.000**
Continuous Index: **S05**
Within 8" of Joint: **NO**
Remarks:

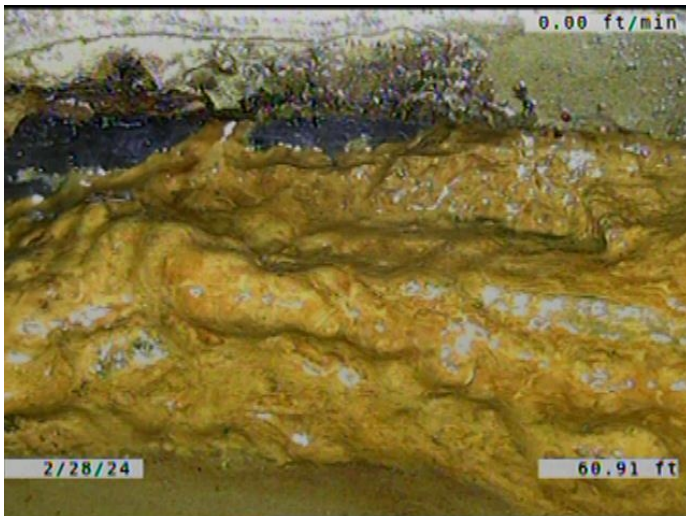
Code: **IDJ**
Description: **Infiltration Dripper Joint**

Distance (ft): **60.9**
Structural Grade: **0**
O&M Grade: **3**
Clock Start/From: **1**
Clock To: **2**
1st Value:
2nd Value:
Value Percent:
Continuous Index:
Within 8" of Joint: **YES**
Remarks:

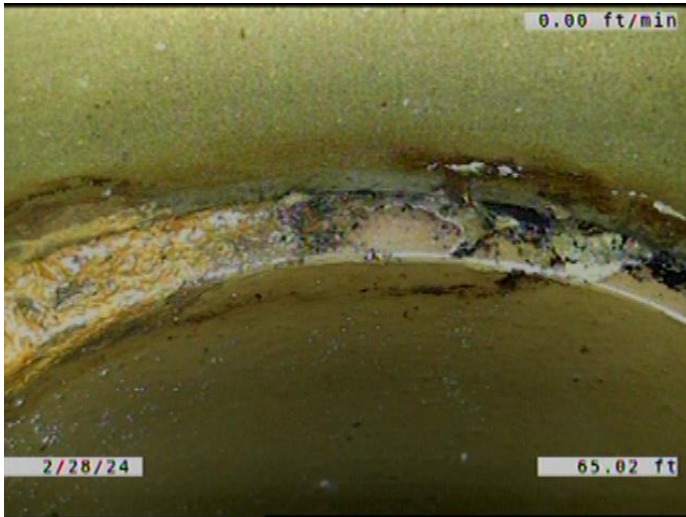
Code: **MWLS**
Description: **Miscellaneous Water Level Sag**

Distance (ft): **65.0**
Structural Grade: **2**
O&M Grade: **0**
Clock Start/From:
Clock To:
1st Value:
2nd Value:
Value Percent: **15.000**
Continuous Index: **F05**
Within 8" of Joint: **NO**
Remarks:

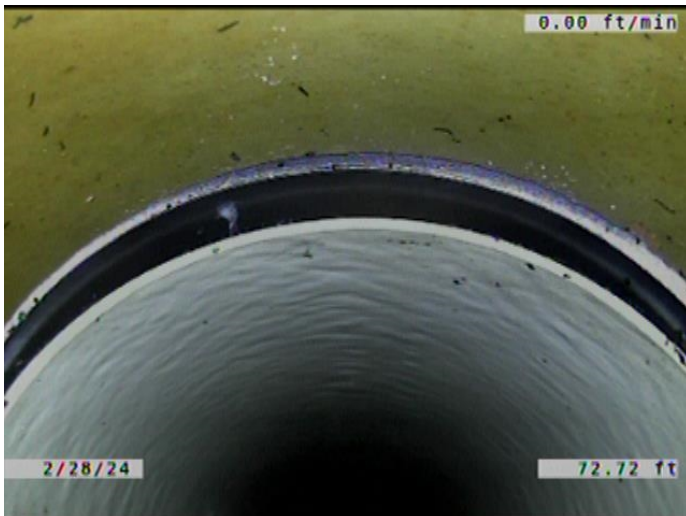
Code: **JOM**
Description: **Joint Offset Medium**

Distance (ft): **72.7**
Structural Grade: **3**
O&M Grade: **0**
Clock Start/From:
Clock To:
1st Value:
2nd Value:
Value Percent:
Continuous Index:
Within 8" of Joint: **NO**
Remarks:

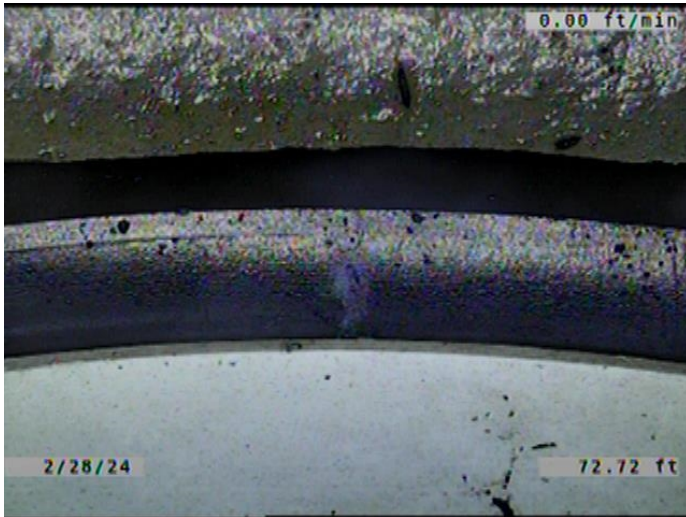
Code: **RPR**
Description: **Point Repair Replacement**

Distance (ft): **72.7**
Structural Grade: **0**
O&M Grade: **0**
Clock Start/From:
Clock To:
1st Value:
2nd Value:
Value Percent:
Continuous Index: **S06**
Within 8" of Joint: **YES**
Remarks: **REPLACED WITH PVC.**

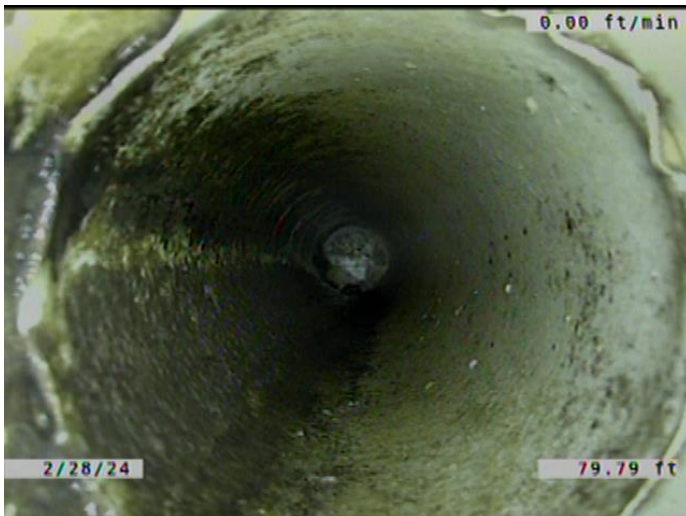
Code: **TF**
Description: **Tap Factory**

Distance (ft): **79.8**
Structural Grade: **0**
O&M Grade: **0**
Clock Start/From: **12**
Clock To:
1st Value: **6.000**
2nd Value:
Value Percent:
Continuous Index:
Within 8" of Joint: **YES**
Remarks:

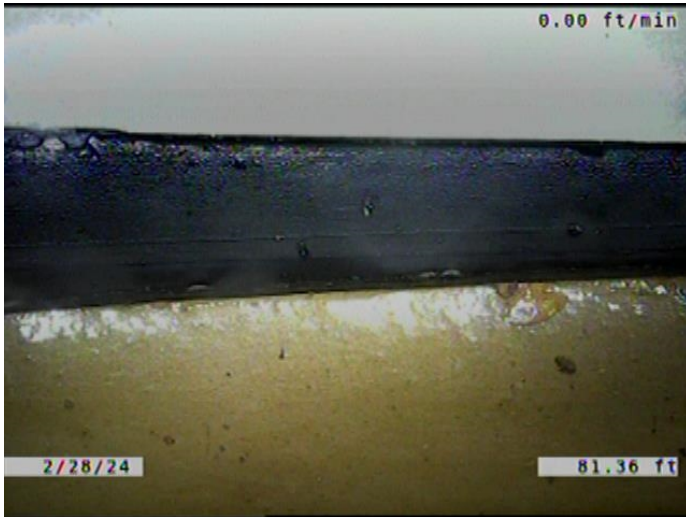
Code: **RPR**
Description: **Point Repair Replacement**

Distance (ft): **81.4**
Structural Grade: **0**
O&M Grade: **0**
Clock Start/From:
Clock To:
1st Value:
2nd Value:
Value Percent:
Continuous Index: **F06**
Within 8" of Joint: **YES**
Remarks: **REPLACED WITH PVC.**

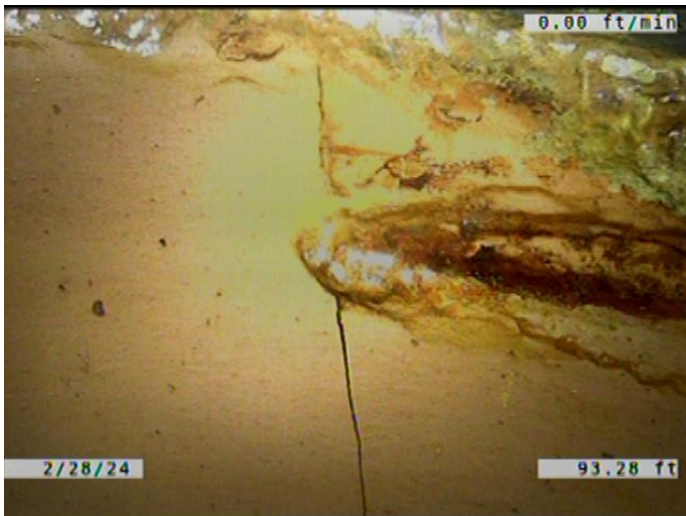
Code: **CM**
Description: **Crack Multiple**

Distance (ft): **93.3**
Structural Grade: **3**
O&M Grade: **0**
Clock Start/From: **1**
Clock To: **2**
1st Value:
2nd Value:
Value Percent:
Continuous Index:
Within 8" of Joint: **YES**
Remarks:

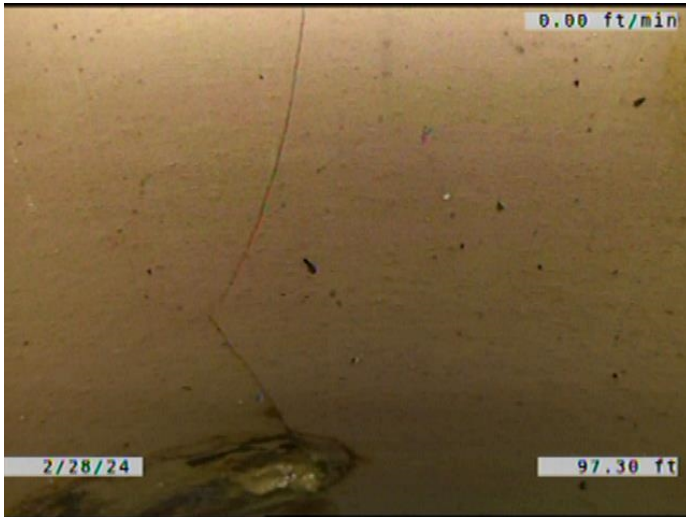
Code: **CM**
Description: **Crack Multiple**

Distance (ft): **97.3**
Structural Grade: **3**
O&M Grade: **0**
Clock Start/From: **11**
Clock To: **12**
1st Value:
2nd Value:
Value Percent:
Continuous Index:
Within 8" of Joint: **YES**
Remarks:

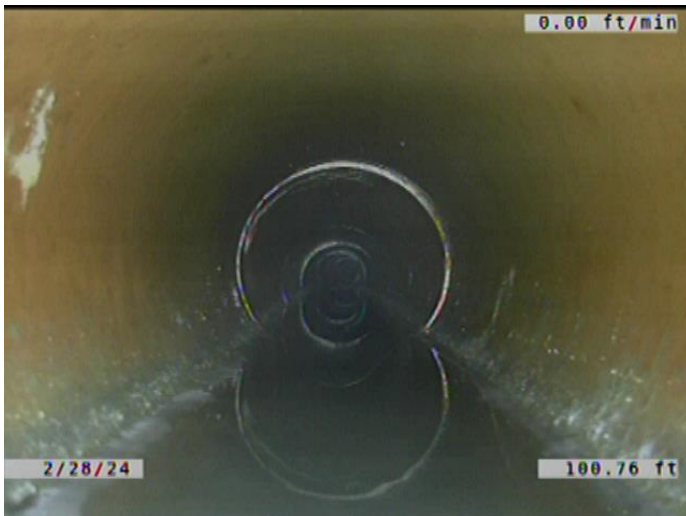
Code: **MWLS**
Description: **Miscellaneous Water Level Sag**

Distance (ft): **100.8**
Structural Grade: **2**
O&M Grade: **0**
Clock Start/From:
Clock To:
1st Value:
2nd Value:
Value Percent: **15.000**
Continuous Index: **S07**
Within 8" of Joint: **NO**
Remarks:

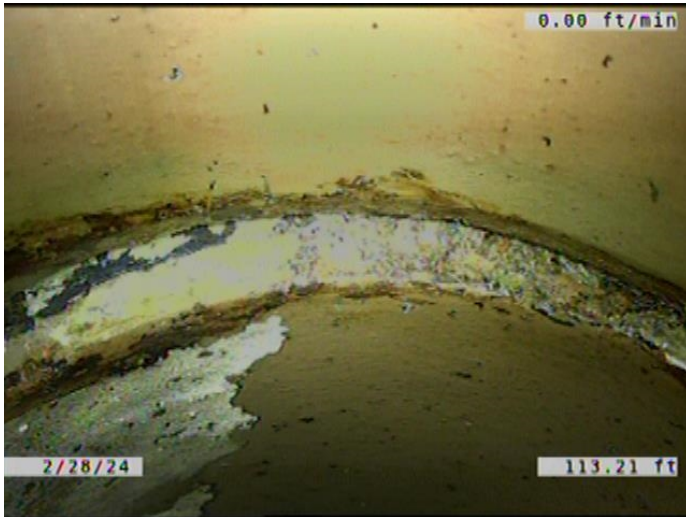
Code: **JOMD**
Description: **Joint Offset Medium Defective**

Distance (ft): **113.2**
Structural Grade: **3**
O&M Grade: **0**
Clock Start/From:
Clock To:
1st Value:
2nd Value:
Value Percent:
Continuous Index:
Within 8" of Joint: **NO**
Remarks:

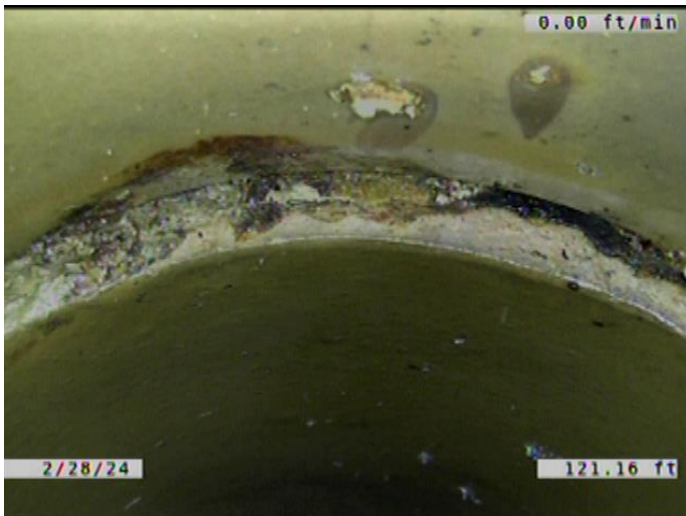
Code: **JOMD**
Description: **Joint Offset Medium Defective**

Distance (ft): **121.2**
Structural Grade: **3**
O&M Grade: **0**
Clock Start/From:
Clock To:
1st Value:
2nd Value:
Value Percent:
Continuous Index:
Within 8" of Joint: **NO**
Remarks:

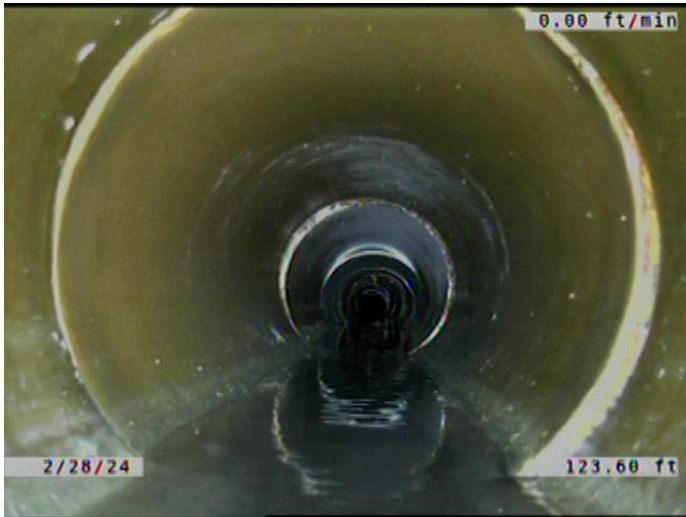
Code: **MWLS**
Description: **Miscellaneous Water Level Sag**

Distance (ft): **123.6**
Structural Grade: **2**
O&M Grade: **0**
Clock Start/From:
Clock To:
1st Value:
2nd Value:
Value Percent: **15.000**
Continuous Index: **F07**
Within 8" of Joint: **NO**
Remarks:

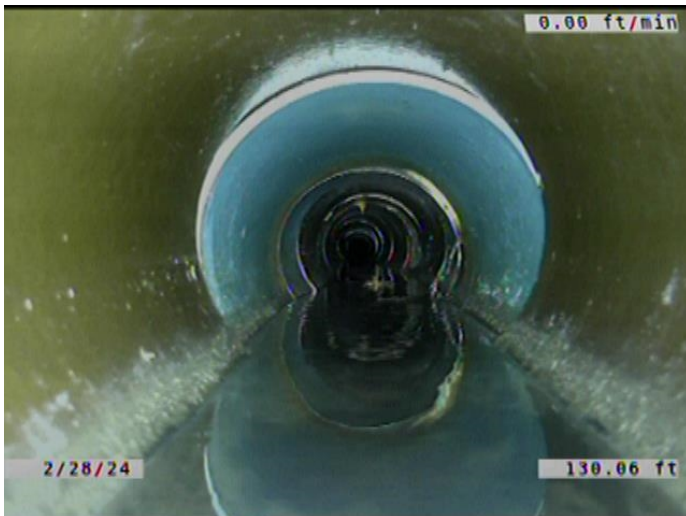
Code: **MWLS**
Description: **Miscellaneous Water Level Sag**

Distance (ft): **130.0**
Structural Grade: **2**
O&M Grade: **0**
Clock Start/From:
Clock To:
1st Value:
2nd Value:
Value Percent: **10.000**
Continuous Index: **S08**
Within 8" of Joint: **NO**
Remarks:

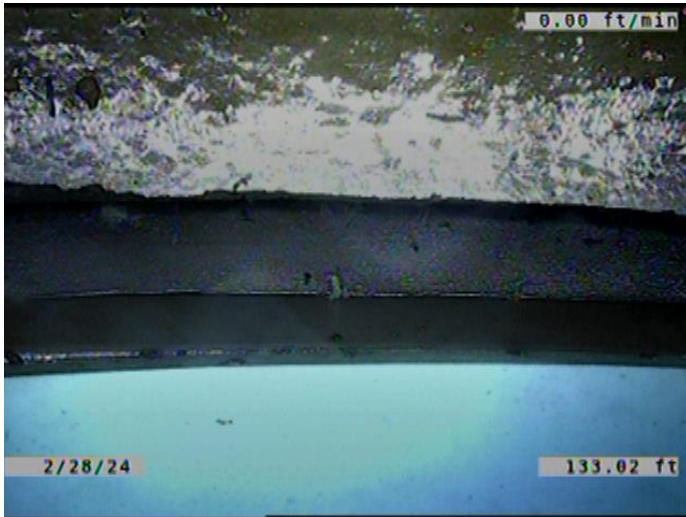
Code: **RPR**
Description: **Point Repair Replacement**

Distance (ft): **133.0**
Structural Grade: **0**
O&M Grade: **0**
Clock Start/From:
Clock To:
1st Value:
2nd Value:
Value Percent:
Continuous Index: **S09**
Within 8" of Joint: **YES**
Remarks: **REPLACED WITH PVC.**

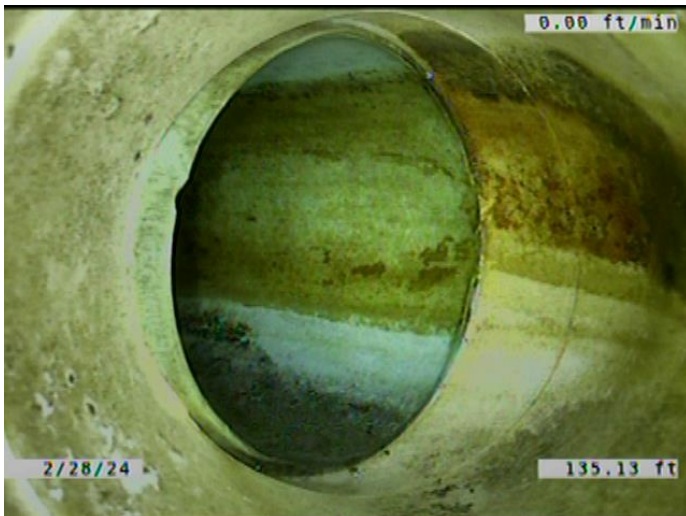
Code: **TF**
Description: **Tap Factory**

Distance (ft): **135.1**
Structural Grade: **0**
O&M Grade: **0**
Clock Start/From: **2**
Clock To:
1st Value: **6.000**
2nd Value:
Value Percent:
Continuous Index:
Within 8" of Joint: **YES**
Remarks: **CONSTANTLY RUNNING WATER.**

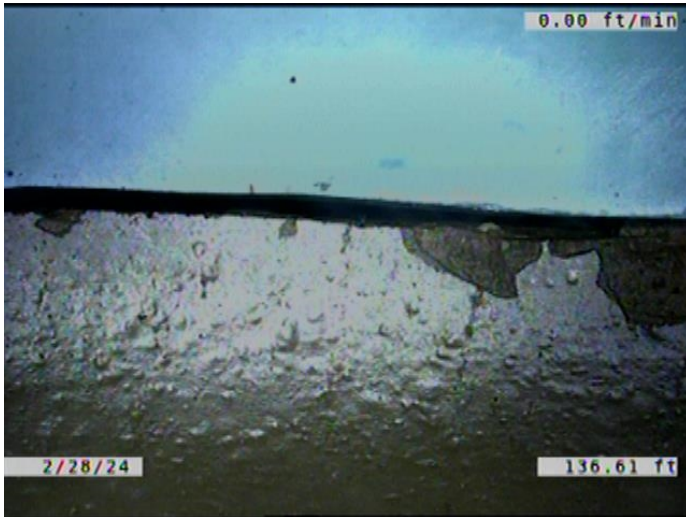
Code: **RPR**
Description: **Point Repair Replacement**

Distance (ft): **136.6**
Structural Grade: **0**
O&M Grade: **0**
Clock Start/From:
Clock To:
1st Value:
2nd Value:
Value Percent:
Continuous Index: **F09**
Within 8" of Joint: **YES**
Remarks: **REPLACED WITH PVC.**

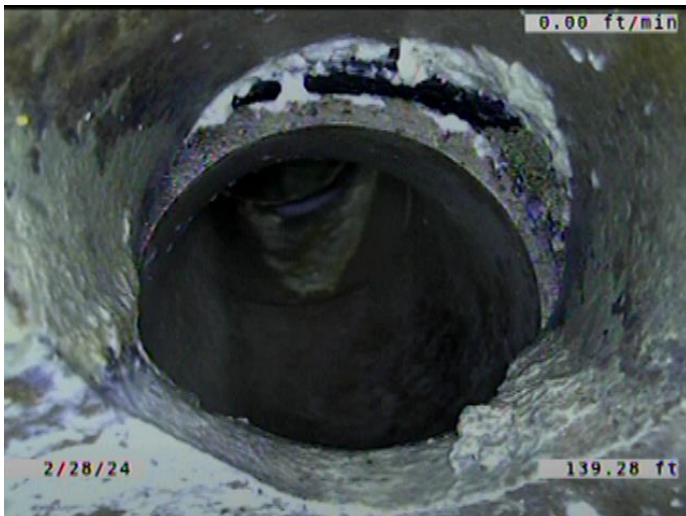
Code: **TFD**
Description: **Tap Factory Defective**

Distance (ft): **139.3**
Structural Grade: **0**
O&M Grade: **3**
Clock Start/From: **11**
Clock To:
1st Value: **6.000**
2nd Value:
Value Percent:
Continuous Index:
Within 8" of Joint: **YES**
Remarks: **SERVICE TO MAIN CONNECTION
LARGE OFFSET. SOIL VISIBLE. SERVIC**

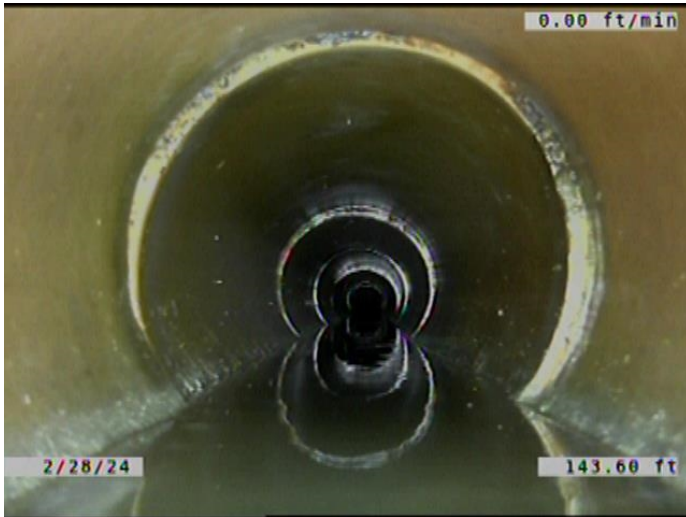
Code: **MWLS**
Description: **Miscellaneous Water Level Sag**

Distance (ft): **143.6**
Structural Grade: **2**
O&M Grade: **0**
Clock Start/From:
Clock To:
1st Value:
2nd Value:
Value Percent: **10.000**
Continuous Index: **F08**
Within 8" of Joint: **NO**
Remarks:

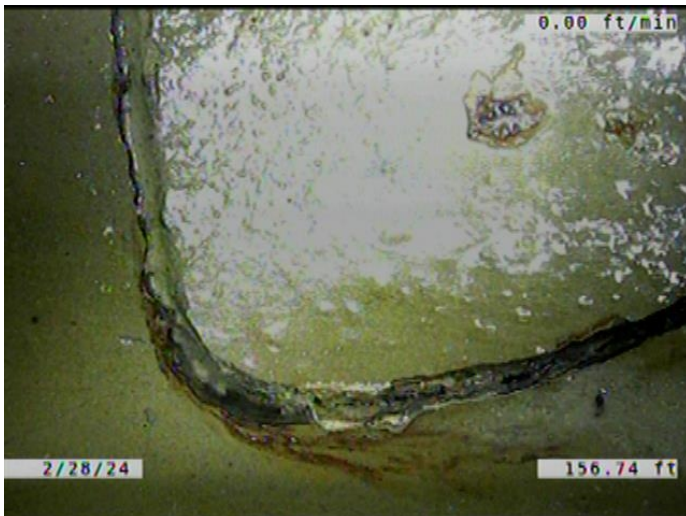
Code: **BSV**
Description: **Broken Soil Visible**

Distance (ft): **156.7**
Structural Grade: **5**
O&M Grade: **0**
Clock Start/From: **4**
Clock To: **9**
1st Value:
2nd Value:
Value Percent:
Continuous Index:
Within 8" of Joint: **YES**
Remarks:

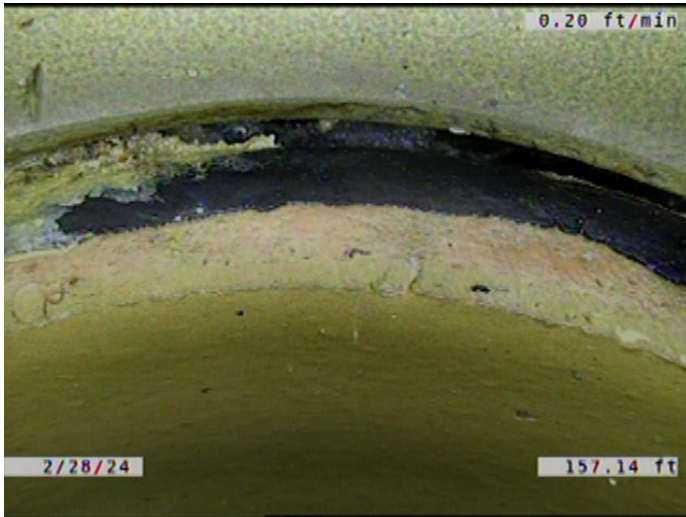
Code: **JOMD**
Description: **Joint Offset Medium Defective**

Distance (ft): **157.1**
Structural Grade: **3**
O&M Grade: **0**
Clock Start/From:
Clock To:
1st Value:
2nd Value:
Value Percent:
Continuous Index:
Within 8" of Joint: **NO**
Remarks:

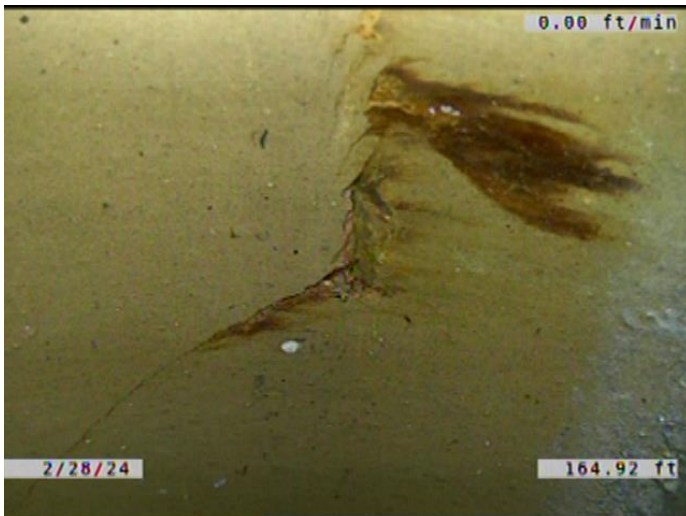
Code: **FM**
Description: **Fracture Multiple**

Distance (ft): **164.9**
Structural Grade: **4**
O&M Grade: **0**
Clock Start/From: **11**
Clock To: **4**
1st Value:
2nd Value:
Value Percent:
Continuous Index:
Within 8" of Joint: **YES**
Remarks:

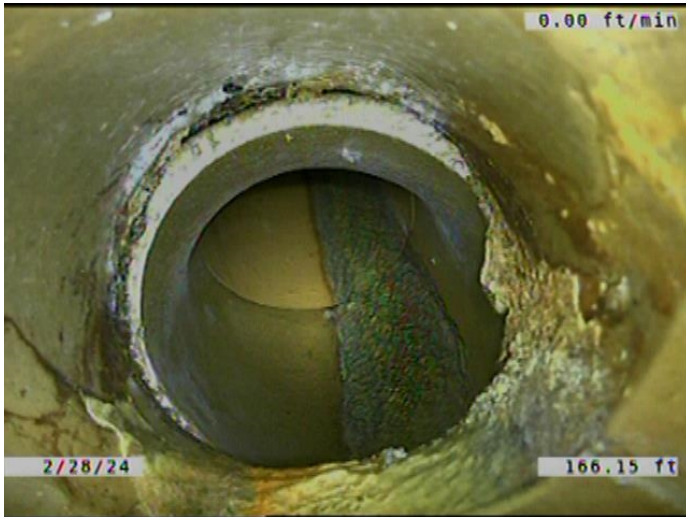
Code:	TFD
Description:	Tap Factory Defective
Distance (ft):	166.2
Structural Grade:	0
O&M Grade:	3
Clock Start/From:	1
Clock To:	
1st Value:	6.000
2nd Value:	
Value Percent:	
Continuous Index:	
Within 8" of Joint:	YES
Remarks:	TAP BROKEN. SERVICE OFFSET. ENCrustation COMING DOWN THE

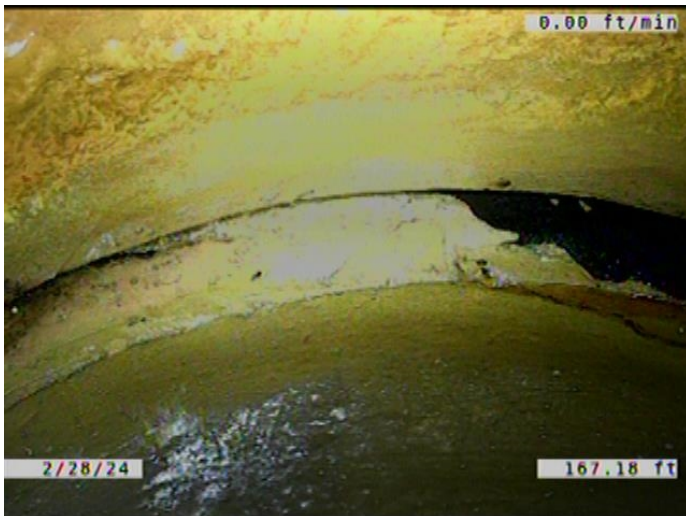
Code:	JOMD
Description:	Joint Offset Medium Defective
Distance (ft):	167.2
Structural Grade:	3
O&M Grade:	0
Clock Start/From:	
Clock To:	
1st Value:	
2nd Value:	
Value Percent:	
Continuous Index:	
Within 8" of Joint:	NO
Remarks:

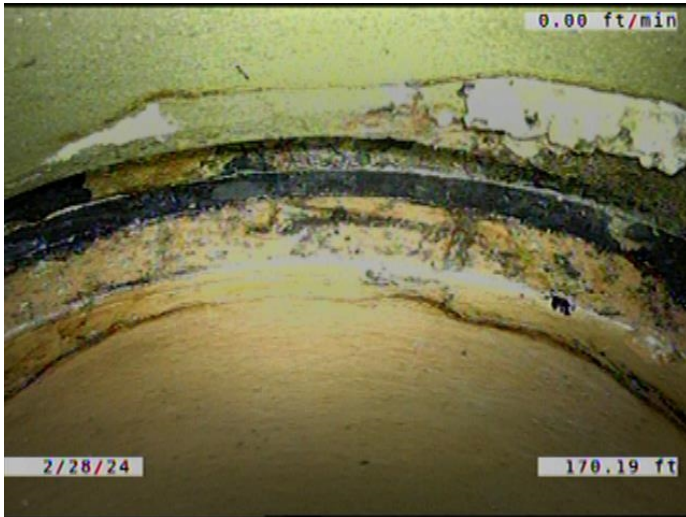
Code: **JOMD**
Description: **Joint Offset Medium Defective**

Distance (ft): **170.2**
Structural Grade: **3**
O&M Grade: **0**
Clock Start/From:
Clock To:
1st Value:
2nd Value:
Value Percent:
Continuous Index:
Within 8" of Joint: **NO**
Remarks:

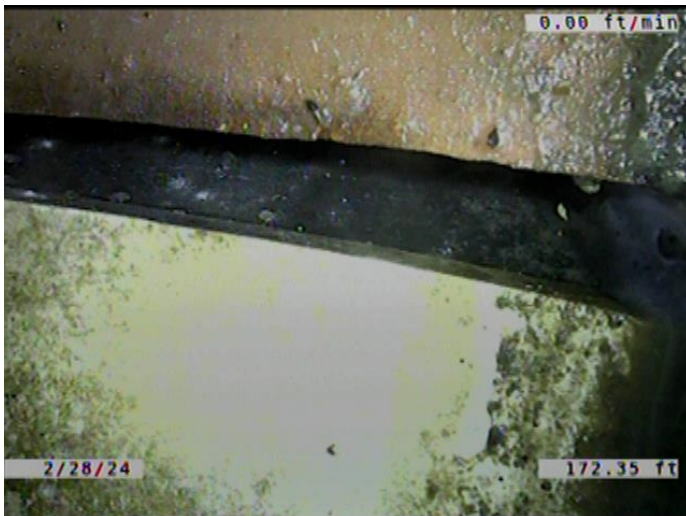
Code: **JAM**
Description: **Joint Angular Medium**

Distance (ft): **172.4**
Structural Grade: **3**
O&M Grade: **0**
Clock Start/From:
Clock To:
1st Value:
2nd Value:
Value Percent:
Continuous Index:
Within 8" of Joint: **NO**
Remarks:

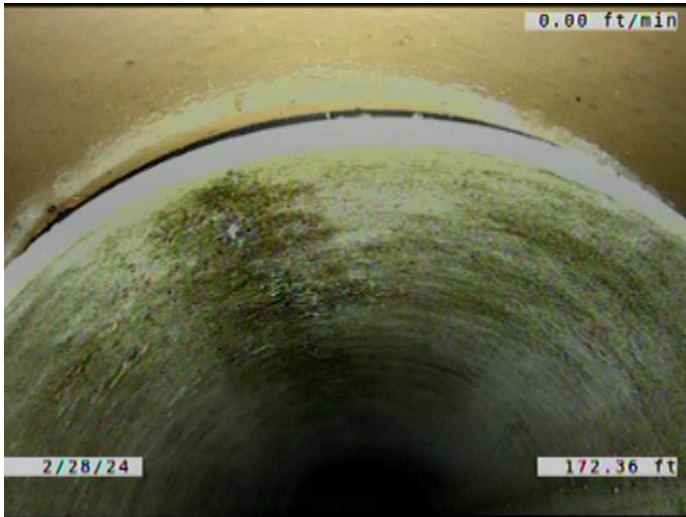
Code: **JOM**
Description: **Joint Offset Medium**

Distance (ft): **172.4**
Structural Grade: **3**
O&M Grade: **0**
Clock Start/From:
Clock To:
1st Value:
2nd Value:
Value Percent:
Continuous Index:
Within 8" of Joint: **NO**
Remarks:

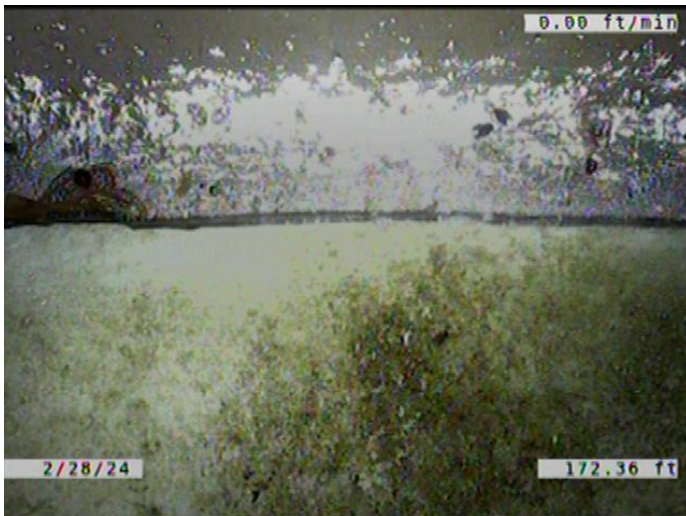
Code: **RPR**
Description: **Point Repair Replacement**

Distance (ft): **172.4**
Structural Grade: **0**
O&M Grade: **0**
Clock Start/From:
Clock To:
1st Value:
2nd Value:
Value Percent:
Continuous Index: **S10**
Within 8" of Joint: **YES**
Remarks: **REPLACED WITH PVC.**

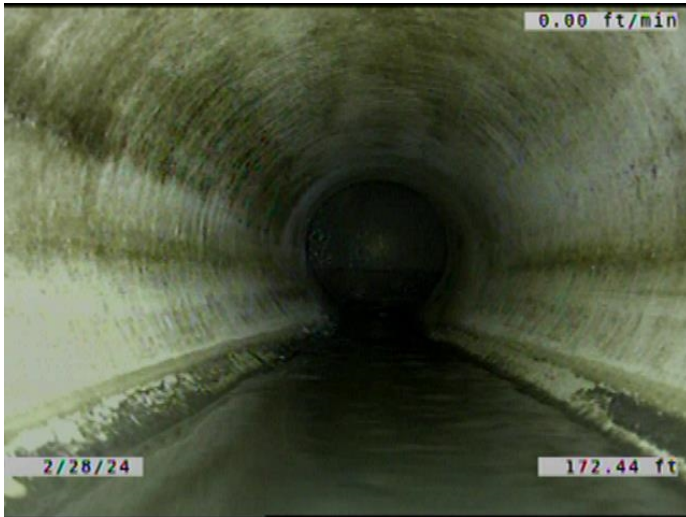
Code: **DAE**
Description: **Deposits Attached Encrustation**

Distance (ft): **172.4**
Structural Grade: **0**
O&M Grade: **2**
Clock Start/From: **7**
Clock To: **5**
1st Value:
2nd Value:
Value Percent: **5.000**
Continuous Index: **F01**
Within 8" of Joint: **YES**
Remarks:

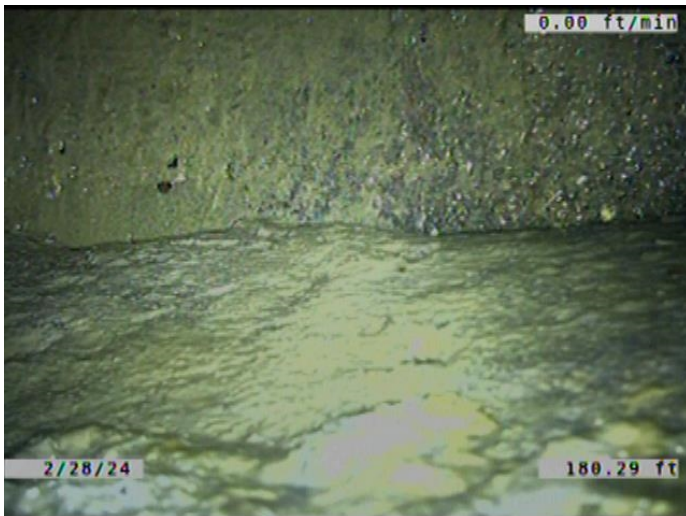
Code: **RPR**
Description: **Point Repair Replacement**

Distance (ft): **180.3**
Structural Grade: **0**
O&M Grade: **0**
Clock Start/From:
Clock To:
1st Value:
2nd Value:
Value Percent:
Continuous Index: **F10**
Within 8" of Joint: **YES**
Remarks: **REPLACED WITH PVC.**

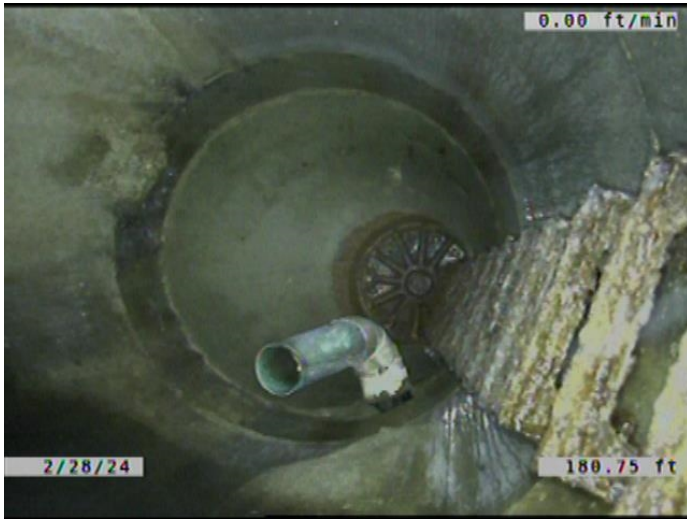
Code:	AMH
Description:	Manhole
Distance (ft):	180.8
Structural Grade:	0
O&M Grade:	0
Clock Start/From:	
Clock To:	
1st Value:	
2nd Value:	
Value Percent:	
Continuous Index:	
Within 8" of Joint:	NO
Remarks:	M-606-074
