Profile/Photo Observation Report

Date:	04/08/2018	Weather:		Coding:	PACP 6.0
Pipe Length (ft):	157.0	Owner:	NA	Pre Clean:	No Pre-Cleaning
P.O.#:		Surveyor:	Byrd Fitzgerald	PSR:	P-606-076-075
Customer:		Clean Date:	01/01/1900	Shape:	C

Street:	S CONNECTICUT ST	Flow Control:	Not Controlled
City:	Hobart, IN	Year Renewed:	
Location:	Yard	Tape/Media #:	
Purpose:	Routine Assessment	Dia/Height:	12"
Use:	Sanitary	Material:	VCP
Drain Area:	NA	Lining:	
Category:	NA		
Comment:	Flow direction is marked wrong.		
Location Details:		Direction of Survey:	Downstream
US MH:	M-606-075	DS MH:	M-606-076
		Total Length Surveyed (ft):	46.8

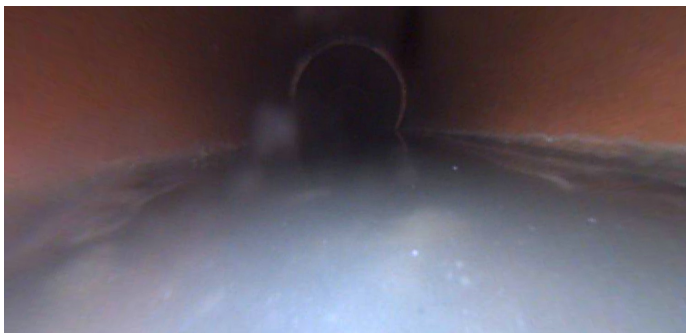
Code: **AMH**
Description: **Manhole**

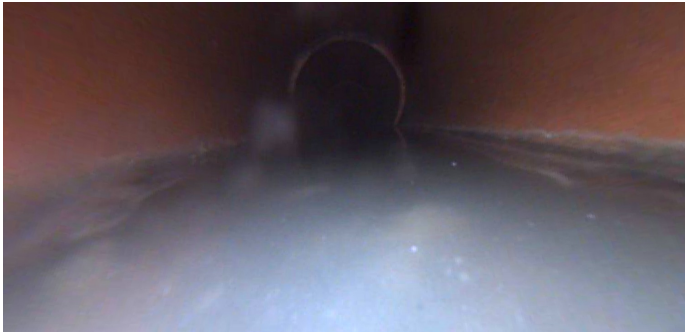
Code:	MWL
Description:	Water Level

Distance (ft):	.0
Structural Grade:	0
O&M Grade:	0
Clock Start/From:	
Clock To:	
1st Value:	
2nd Value:	
Value Percent:	5.000
Continuous Index:	
Within 8" of Joint:	NO
Remarks:

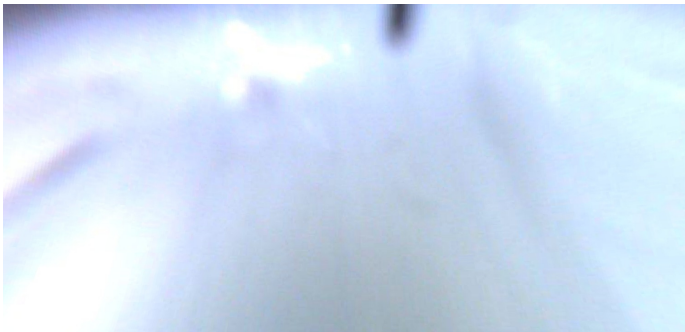
Code:	MCU
Description:	Camera Underwater

Distance (ft):	1.0
Structural Grade:	0
O&M Grade:	4
Clock Start/From:	
Clock To:	
1st Value:	
2nd Value:	
Value Percent:	
Continuous Index:	
Within 8" of Joint:	NO
Remarks:

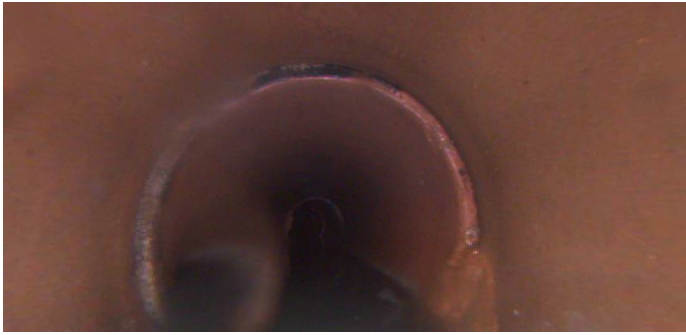
Code: **DAE**
Description: **Deposits Attached Encrustation**

Distance (ft): **9.9**
Structural Grade: **0**
O&M Grade: **2**
Clock Start/From: **5**
Clock To:
1st Value:
2nd Value:
Value Percent: **5.000**
Continuous Index: **S01**
Within 8" of Joint: **YES**
Remarks: **wandering**

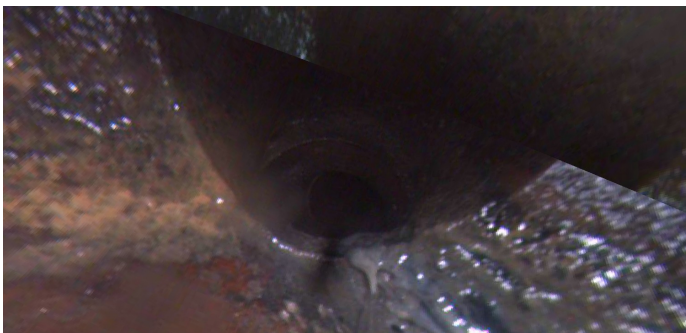
Code: **TF**
Description: **Tap Factory**

Distance (ft): **43.3**
Structural Grade: **0**
O&M Grade: **0**
Clock Start/From: **1**
Clock To:
1st Value: **4.000**
2nd Value:
Value Percent:
Continuous Index:
Within 8" of Joint: **YES**
Remarks:

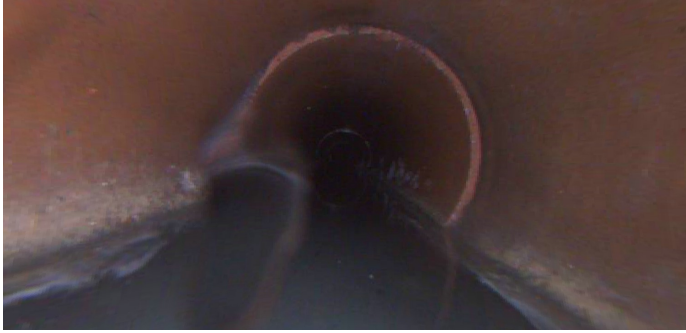
Code: **MSA**
Description: **Abandoned Survey**

Distance (ft): **46.8**
Structural Grade: **0**
O&M Grade: **0**
Clock Start/From:
Clock To:
1st Value:
2nd Value:
Value Percent:
Continuous Index:
Within 8" of Joint: **NO**
Remarks: **debris under water**

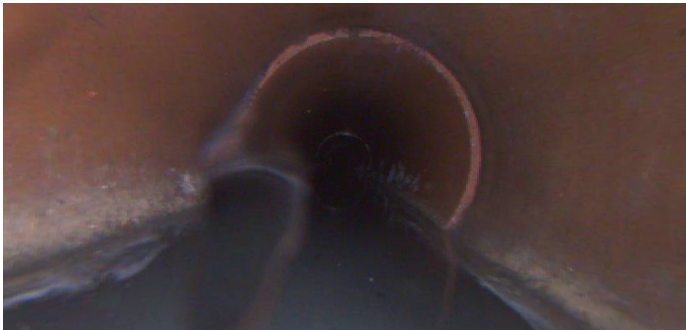
Code: **DAE**
Description: **Deposits Attached Encrustation**

Distance (ft): **46.8**
Structural Grade: **0**
O&M Grade: **2**
Clock Start/From: **5**
Clock To:
1st Value:
2nd Value:
Value Percent: **5.000**
Continuous Index: **F01**
Within 8" of Joint: **YES**
Remarks: **wandering**
