Profile/Photo Observation Report

Street:	FOXCROFT STREET	Flow Control:	Not Controlled
City:	Hobart, IN	Year Renewed:	
Location:	Yard	Tape/Media #:	
Purpose:	Routine Assessment	Dia/Height:	12"
Use:	Sanitary	Material:	VCP
Drain Area:	NA	Lining:	
Category:	NA		
Comment:	Flow direction is marked wrong.		
Location Details:		Direction of Survey:	Downstream
US MH:	M-606-075	DS MH:	M-606-076
		Total Length Surveyed (ft):	46.8

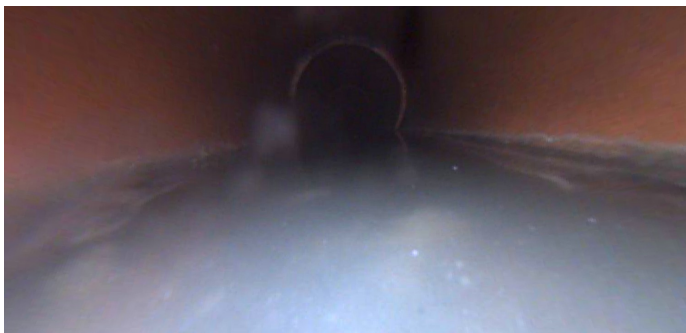
Code: **AMH**
Description: **Manhole**

Distance (ft): **.0**
Structural Grade: **0**
O&M Grade: **0**
Clock Start/From:
Clock To:
1st Value:
2nd Value:
Value Percent:
Continuous Index:
Within 8" of Joint: **NO**
Remarks: **M-606-075**

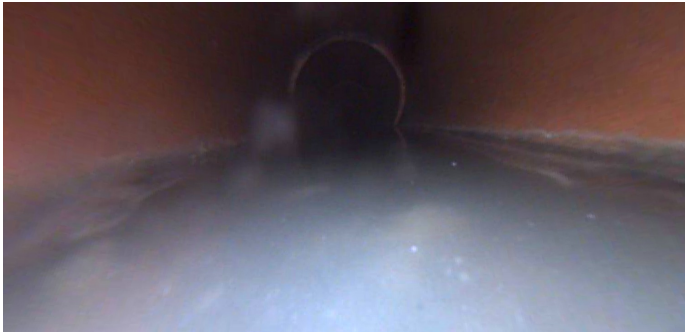
Code:	MWL
Description:	Water Level

Distance (ft):	.0
Structural Grade:	0
O&M Grade:	0
Clock Start/From:	
Clock To:	
1st Value:	
2nd Value:	
Value Percent:	5.000
Continuous Index:	
Within 8" of Joint:	NO
Remarks:

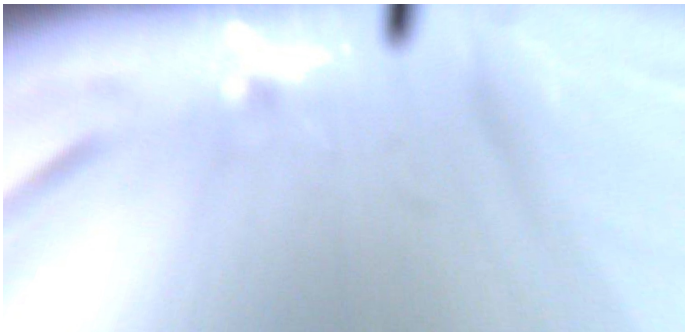
Code:	MCU
Description:	Camera Underwater

Distance (ft):	1.0
Structural Grade:	0
O&M Grade:	4
Clock Start/From:	
Clock To:	
1st Value:	
2nd Value:	
Value Percent:	
Continuous Index:	
Within 8" of Joint:	NO
Remarks:

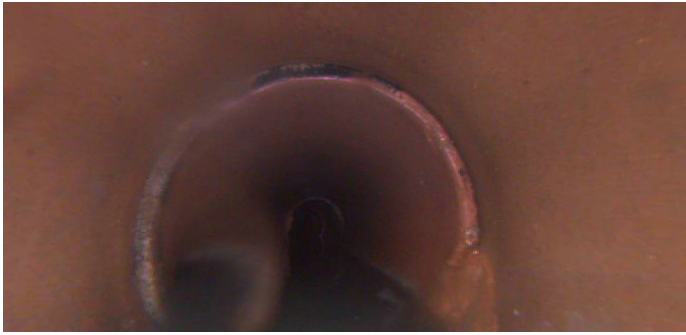
Code: **DAE**
Description: **Deposits Attached Encrustation**

Distance (ft): **9.9**
Structural Grade: **0**
O&M Grade: **2**
Clock Start/From: **5**
Clock To:
1st Value:
2nd Value:
Value Percent: **5.000**
Continuous Index: **S01**
Within 8" of Joint: **YES**
Remarks: **wandering**

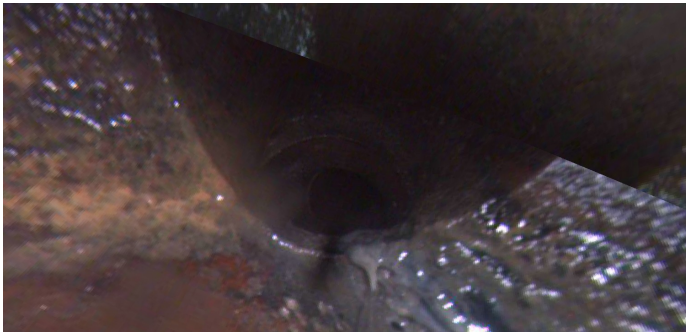
Code: **TF**
Description: **Tap Factory**

Distance (ft): **43.3**
Structural Grade: **0**
O&M Grade: **0**
Clock Start/From: **1**
Clock To:
1st Value: **4.000**
2nd Value:
Value Percent:
Continuous Index:
Within 8" of Joint: **YES**
Remarks:

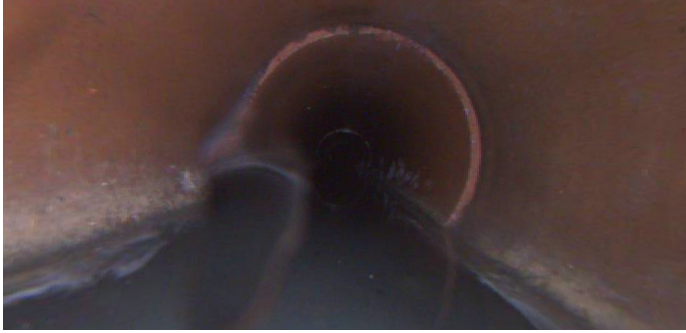
Code: **MSA**
Description: **Abandoned Survey**

Distance (ft): **46.8**
Structural Grade: **0**
O&M Grade: **0**
Clock Start/From:
Clock To:
1st Value:
2nd Value:
Value Percent:
Continuous Index:
Within 8" of Joint: **NO**
Remarks: **debris under water**

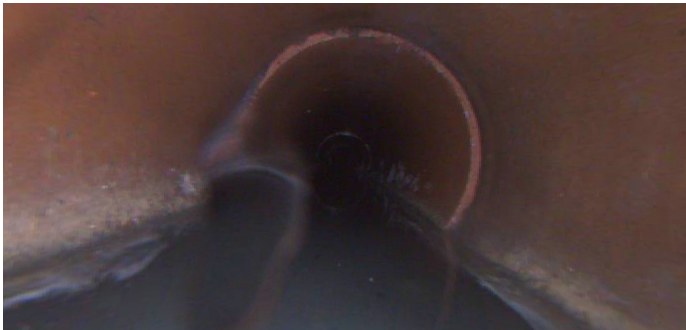
Code: **DAE**
Description: **Deposits Attached Encrustation**

Distance (ft): **46.8**
Structural Grade: **0**
O&M Grade: **2**
Clock Start/From: **5**
Clock To:
1st Value:
2nd Value:
Value Percent: **5.000**
Continuous Index: **F01**
Within 8" of Joint: **YES**
Remarks: **wandering**
