## Profile/Photo Observation Report

Date:	<b>02/05/2022</b>	Weather:		Coding:	<b>PACP 7.0</b>
Pipe Length (ft):	<b>154.7</b>	Owner:	<b>City of Hobart</b>	Pre Clean:	<b>Heavy Cleaning</b>
P.O.#:	<b>YES502259</b>	Surveyor:	<b>S. Bucklin</b>	PSR:	<b>P-606-076-075</b>
Customer:	<b>City of Hobart</b>	Clean Date:	<b>02/01/2022</b>	Shape:	<b>C</b>

Street:	<b>South Connection Street</b>	Flow Control:	<b>Not Controlled</b>
City:	<b>Hobart, IN</b>	Year Renewed:	
Location:	<b>Easement/Right of Way</b>	Tape/Media #:	
Purpose:	<b>Routine Assessment</b>	Dia/Height:	<b>12"</b>
Use:	<b>Sanitary Sewage Pipe</b>	Material:	<b>VCP</b>
Drain Area:		Lining:	<b>None</b>
Category:	<b>NA</b>

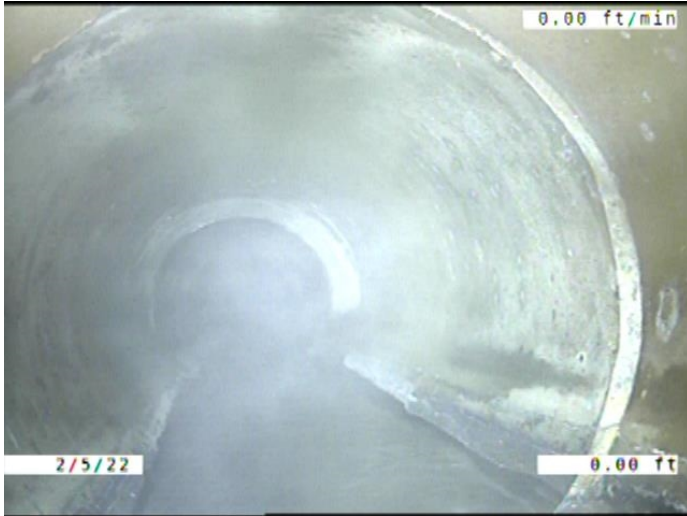
Code: **MWL**  
Description: **Miscellaneous Water Level**

Distance (ft): **.0**  
Structural Grade: **0**  
O&M Grade: **0**  
Clock Start/From:  
Clock To:  
1st Value:  
2nd Value:  
Value Percent: **5.000**  
Continuous Index:  
Within 8" of Joint: **NO**  
Remarks:

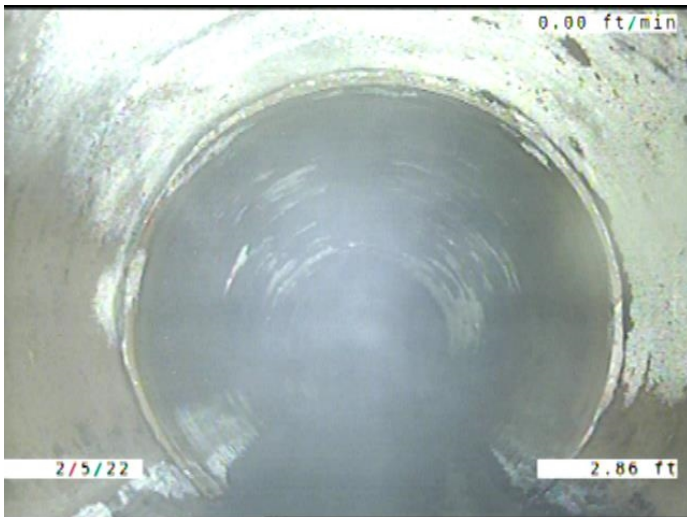
Code: **DAE**  
Description: **Deposits Attached Encrustation**

Distance (ft): **2.9**  
Structural Grade: **0**  
O&M Grade: **2**  
Clock Start/From: **7**  
Clock To: **5**  
1st Value:  
2nd Value:  
Value Percent: **5.000**  
Continuous Index: **S01**  
Within 8" of Joint: **YES**  
Remarks:

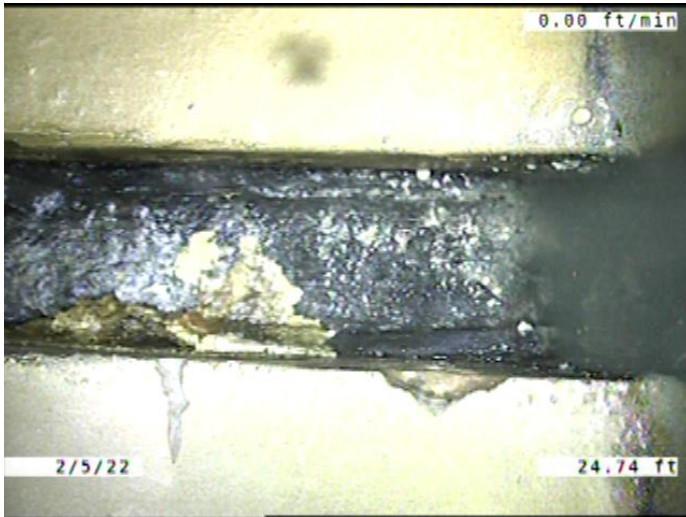
Code: **JAM**  
Description: **Joint Angular Medium**

Distance (ft): **24.7**  
Structural Grade: **3**  
O&M Grade: **0**  
Clock Start/From:  
Clock To:  
1st Value:  
2nd Value:  
Value Percent:  
Continuous Index:  
Within 8" of Joint: **NO**  
Remarks:

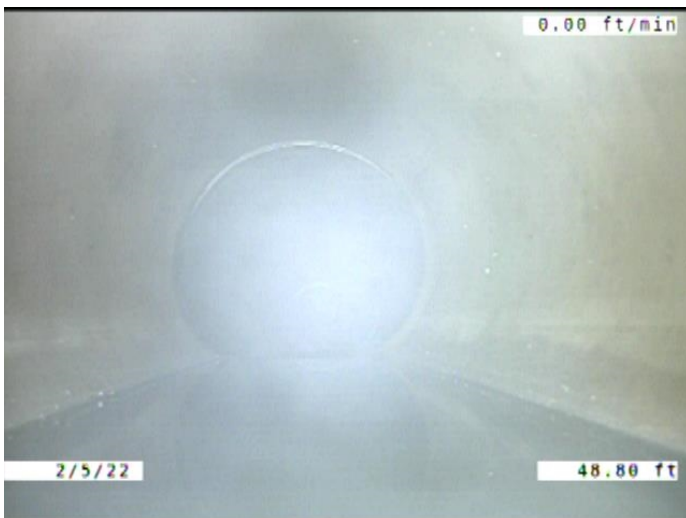
Code: **MWLS**  
Description: **Miscellaneous Water Level Sag**

Distance (ft): **48.8**  
Structural Grade: **2**  
O&M Grade: **0**  
Clock Start/From:  
Clock To:  
1st Value:  
2nd Value:  
Value Percent: **10.000**  
Continuous Index:  
Within 8" of Joint: **NO**  
Remarks:

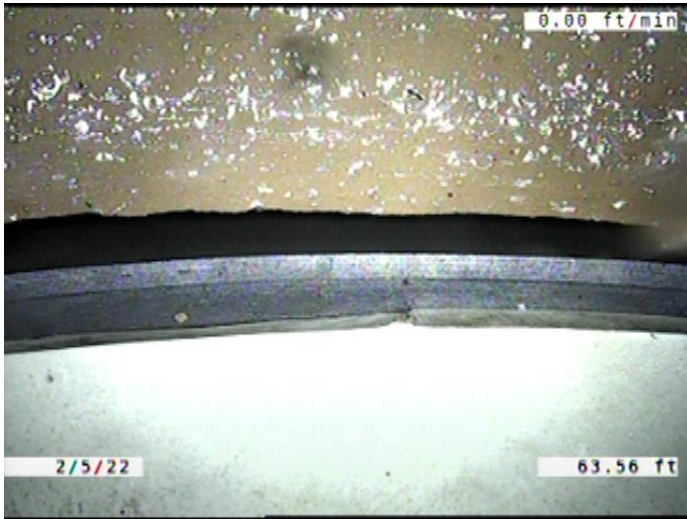
Code:	<b>MMC</b>
Description:	<b>Miscellaneous Material Change</b>
Distance (ft):	<b>63.6</b>
Structural Grade:	<b>0</b>
O&M Grade:	<b>0</b>
Clock Start/From:	
Clock To:	
1st Value:	
2nd Value:	
Value Percent:	
Continuous Index:	
Within 8" of Joint:	<b>NO</b>
Remarks:	<b>VCP TO PVC</b>

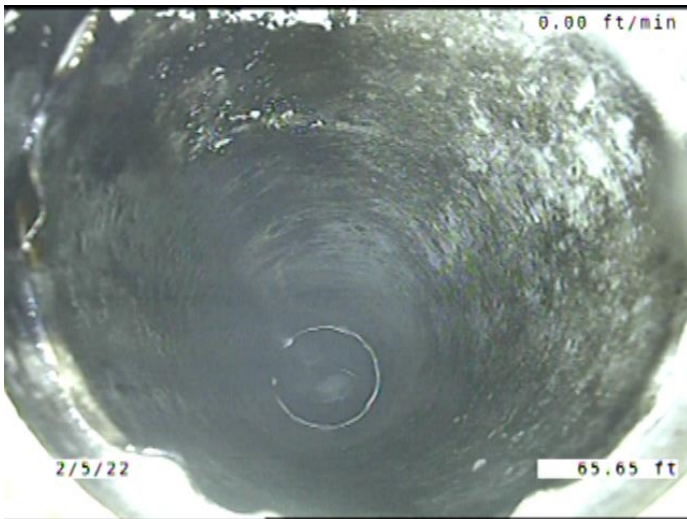
Code:	<b>TF</b>
Description:	<b>Tap Factory</b>
Distance (ft):	<b>65.6</b>
Structural Grade:	<b>0</b>
O&M Grade:	<b>0</b>
Clock Start/From:	<b>12</b>
Clock To:	
1st Value:	<b>6.000</b>
2nd Value:	
Value Percent:	
Continuous Index:	
Within 8" of Joint:	<b>YES</b>
Remarks:

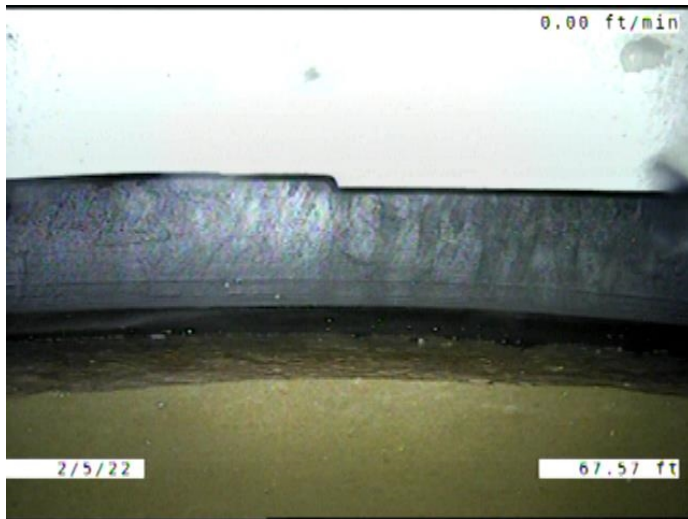
Code: **MMC**  
Description: **Miscellaneous Material Change**

Distance (ft): **67.6**  
Structural Grade: **0**  
O&M Grade: **0**  
Clock Start/From:  
Clock To:  
1st Value:  
2nd Value:  
Value Percent:  
Continuous Index:  
Within 8" of Joint: **NO**  
Remarks: **PVC TO VCP**

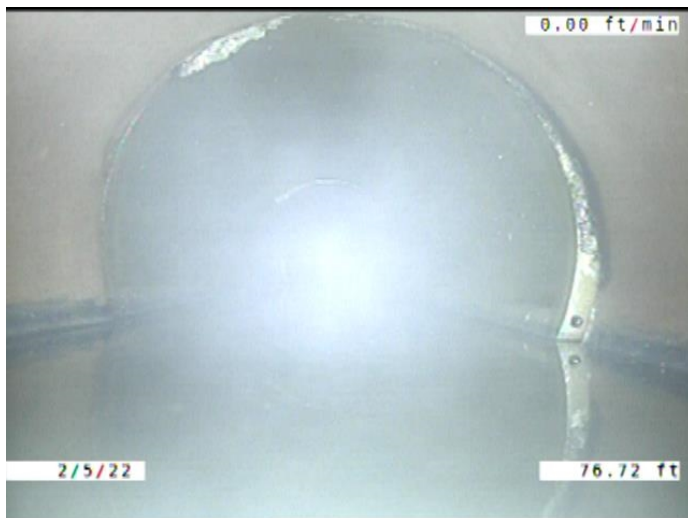
Code: **MWL**  
Description: **Miscellaneous Water Level**

Distance (ft): **76.7**  
Structural Grade: **0**  
O&M Grade: **0**  
Clock Start/From:  
Clock To:  
1st Value:  
2nd Value:  
Value Percent: **15.000**  
Continuous Index:  
Within 8" of Joint: **NO**  
Remarks:

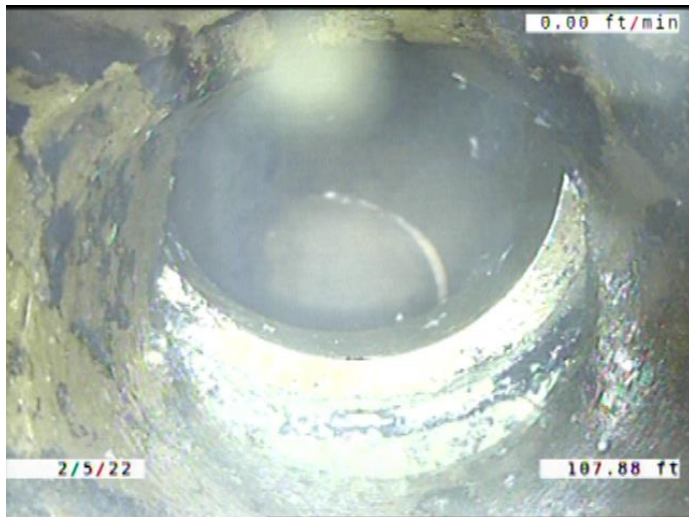
Code: **TF**  
 Description: **Tap Factory**

Distance (ft): **107.9**  
 Structural Grade: **0**  
 O&M Grade: **0**  
 Clock Start/From: **12**  
 Clock To:  
 1st Value: **6.000**  
 2nd Value:  
 Value Percent:  
 Continuous Index:  
 Within 8" of Joint: **YES**  
 Remarks: **LARGE OFFSET JOINT ON THE SERVICE, SOIL VISABLE, I&I STAINING**

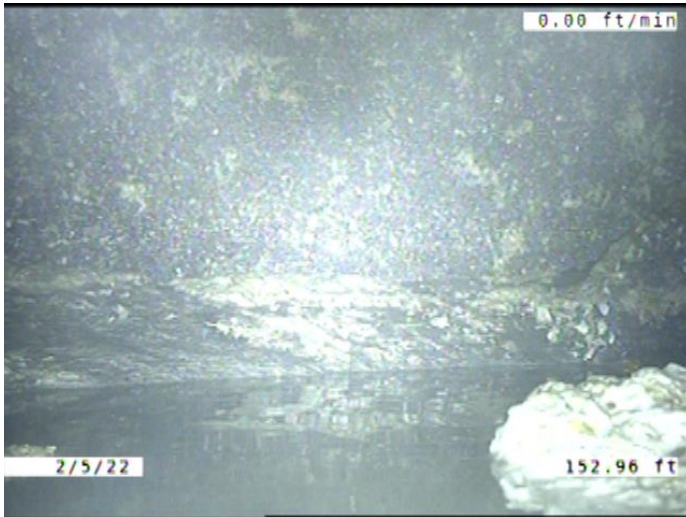
Code:	<b>DAE</b>
Description:	<b>Deposits Attached Encrustation</b>
Distance (ft):	<b>153.0</b>
Structural Grade:	<b>0</b>
O&M Grade:	<b>2</b>
Clock Start/From:	<b>7</b>
Clock To:	<b>5</b>
1st Value:	
2nd Value:	
Value Percent:	<b>5.000</b>
Continuous Index:	<b>F01</b>
Within 8" of Joint:	<b>YES</b>
Remarks:
