## Profile/Photo Observation Report

Date:	<b>02/24/2024</b>	Weather:		Coding:	<b>PACP 7.0</b>
Pipe Length (ft):	<b>42.0</b>	Owner:	<b>City of Hobart</b>	Pre Clean:	<b>Heavy Cleaning</b>
P.O.#:	<b>YES502259</b>	Surveyor:	<b>S. Bucklin</b>	PSR:	<b>P-606-077-076</b>
Customer:	<b>City of Hobart</b>	Clean Date:	<b>02/19/2024</b>	Shape:	<b>C</b>

Street:	<b>S CONNECTICUT ST</b>	Flow Control:	<b>Not Controlled</b>
City:	<b>Hobart, IN</b>	Year Renewed:	
Location:	<b>Local rural streets with light traffic, t</b>	Tape/Media #:	
Purpose:	<b>Sewer System Evaluation Survey (SS</b>	Dia/Height:	<b>10"</b>
Use:	<b>Sanitary Sewage Pipe</b>	Material:	<b>VCP</b>
Drain Area:		Lining:	<b>None</b>
Category:	<b>NA</b>		
Comment:			
Location Details:		Direction of Survey:	<b>Downstream</b>
US MH:	<b>M-606-076</b>	DS MH:	<b>M-606-077</b>
		Total Length Surveyed (ft):	<b>31.0</b>

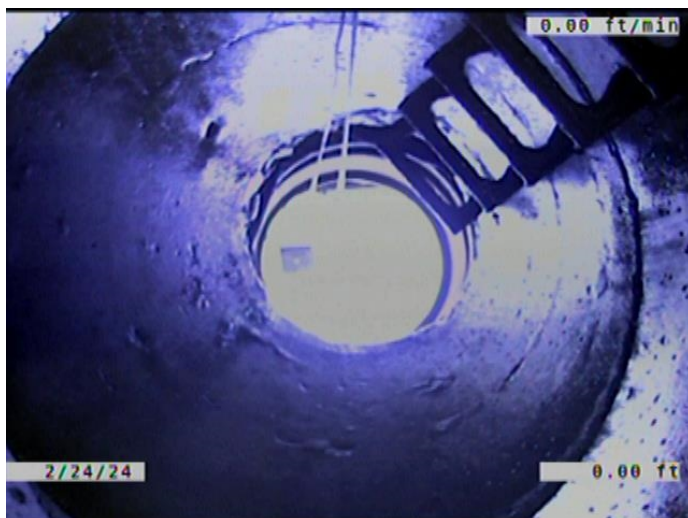
Code: **AMH**  
Description: **Manhole**

Distance (ft): **.0**  
Structural Grade: **0**  
O&M Grade: **0**  
Clock Start/From:  
Clock To:  
1st Value:  
2nd Value:  
Value Percent:  
Continuous Index:  
Within 8" of Joint: **NO**  
Remarks: **M-606-076**

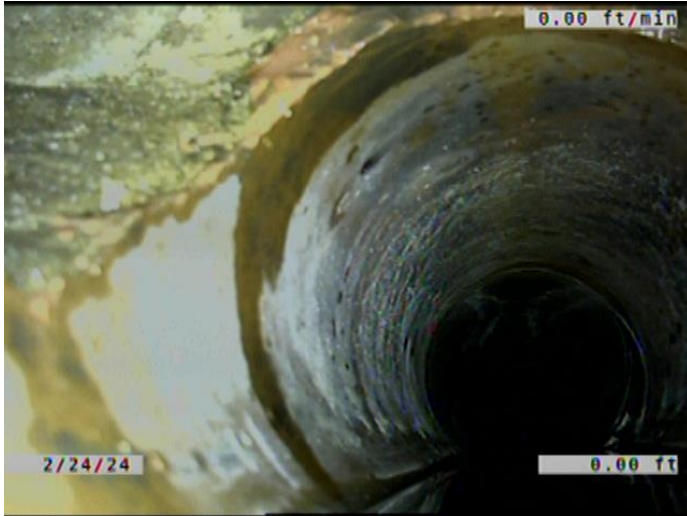
Code: **MWL**  
Description: **Miscellaneous Water Level**

Distance (ft): **.0**  
Structural Grade: **0**  
O&M Grade: **0**  
Clock Start/From:  
Clock To:  
1st Value:  
2nd Value:  
Value Percent: **5.000**  
Continuous Index:  
Within 8" of Joint: **NO**  
Remarks:

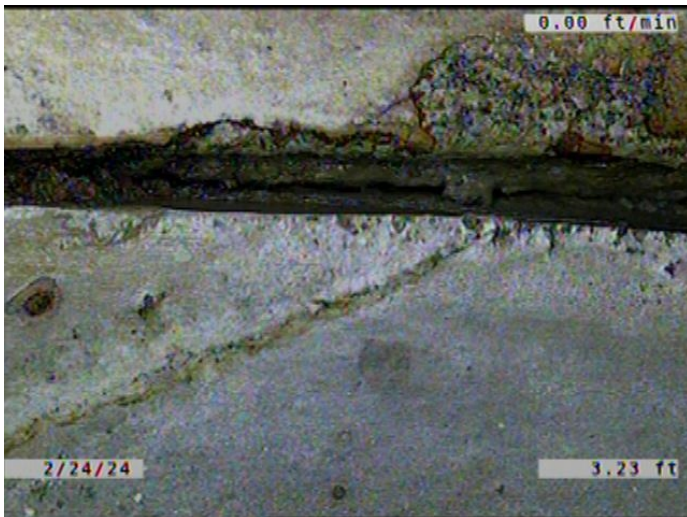
Code: **DAE**  
Description: **Deposits Attached Encrustation**

Distance (ft): **3.2**  
Structural Grade: **0**  
O&M Grade: **2**  
Clock Start/From: **7**  
Clock To: **5**  
1st Value:  
2nd Value:  
Value Percent: **5.000**  
Continuous Index: **S01**  
Within 8" of Joint: **YES**  
Remarks:

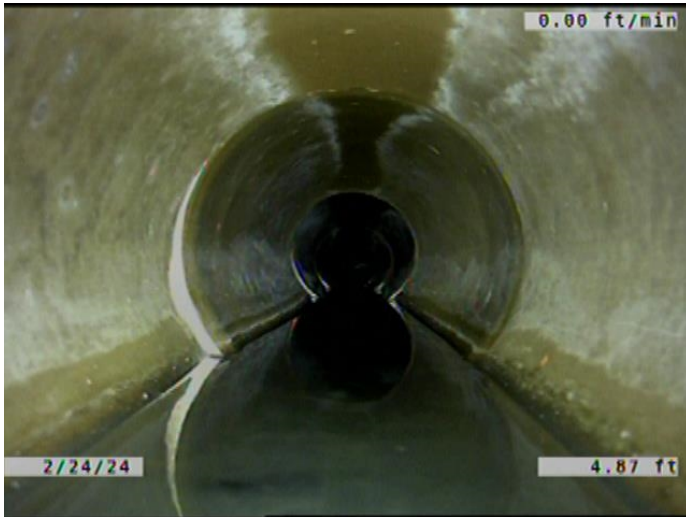
Code: **MWLS**  
Description: **Miscellaneous Water Level Sag**

Distance (ft): **4.9**  
Structural Grade: **2**  
O&M Grade: **0**  
Clock Start/From:  
Clock To:  
1st Value:  
2nd Value:  
Value Percent: **10.000**  
Continuous Index: **S02**  
Within 8" of Joint: **NO**  
Remarks:

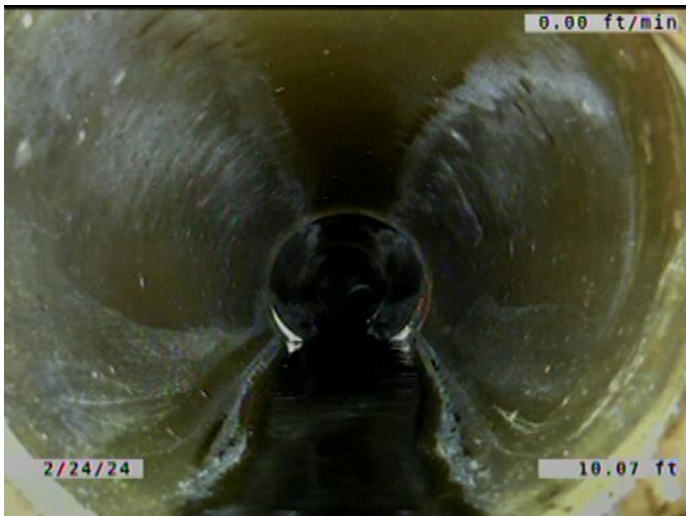
Code: **MWLS**  
Description: **Miscellaneous Water Level Sag**

Distance (ft): **10.1**  
Structural Grade: **2**  
O&M Grade: **0**  
Clock Start/From:  
Clock To:  
1st Value:  
2nd Value:  
Value Percent: **10.000**  
Continuous Index: **F02**  
Within 8" of Joint: **NO**  
Remarks:

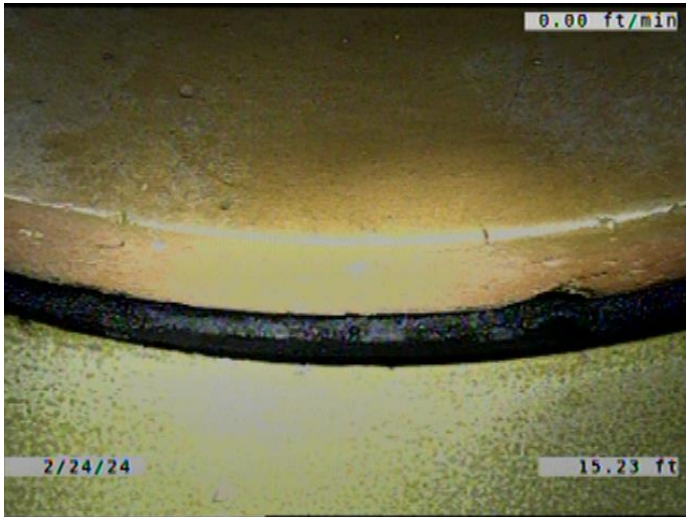
Code: **JOMD**  
Description: **Joint Offset Medium Defective**

Distance (ft): **15.2**  
Structural Grade: **3**  
O&M Grade: **0**  
Clock Start/From:  
Clock To:  
1st Value:  
2nd Value:  
Value Percent:  
Continuous Index:  
Within 8" of Joint: **NO**  
Remarks:

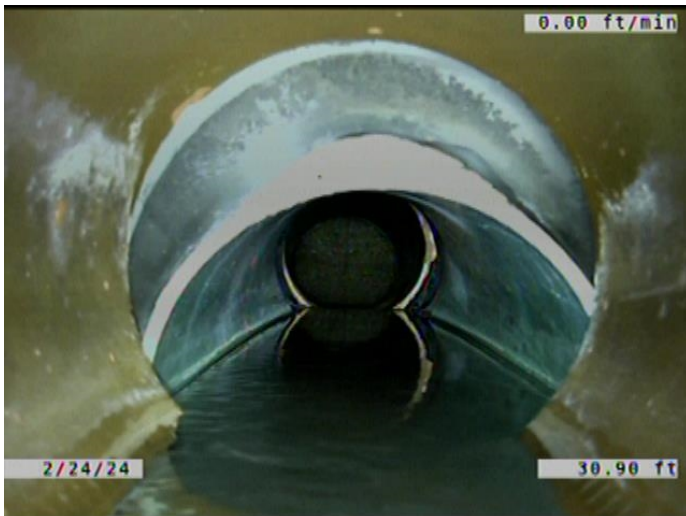
Code: **RPRD**  
Description: **Point Repair Replacement Defective**

Distance (ft): **30.9**  
Structural Grade: **4**  
O&M Grade: **0**  
Clock Start/From:  
Clock To:  
1st Value:  
2nd Value:  
Value Percent:  
Continuous Index:  
Within 8" of Joint: **YES**  
Remarks: **REPLACED WITH PVC. JOINT HAS DROPPED. GRAVEL VISIBLE. BAND C**

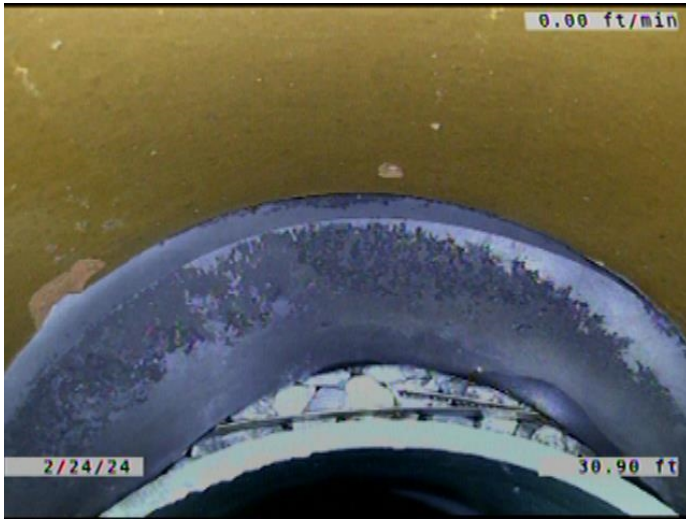
Code: **JOLD**  
Description: **Joint Offset Large Defective**

Distance (ft): **30.9**  
Structural Grade: **4**  
O&M Grade: **0**  
Clock Start/From:  
Clock To:  
1st Value:  
2nd Value:  
Value Percent:  
Continuous Index:  
Within 8" of Joint: **NO**  
Remarks: **JOINT HAS DROPPED. GRAVEL  
VISIBLE. BAND CLAMP VISIBLE.**

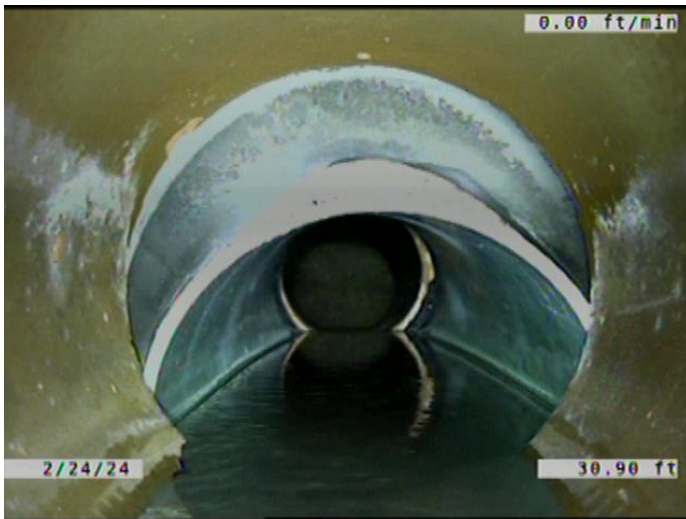
Code: **MWL**  
Description: **Miscellaneous Water Level**

Distance (ft): **30.9**  
Structural Grade: **0**  
O&M Grade: **0**  
Clock Start/From:  
Clock To:  
1st Value:  
2nd Value:  
Value Percent: **45.000**  
Continuous Index:  
Within 8" of Joint: **NO**  
Remarks:

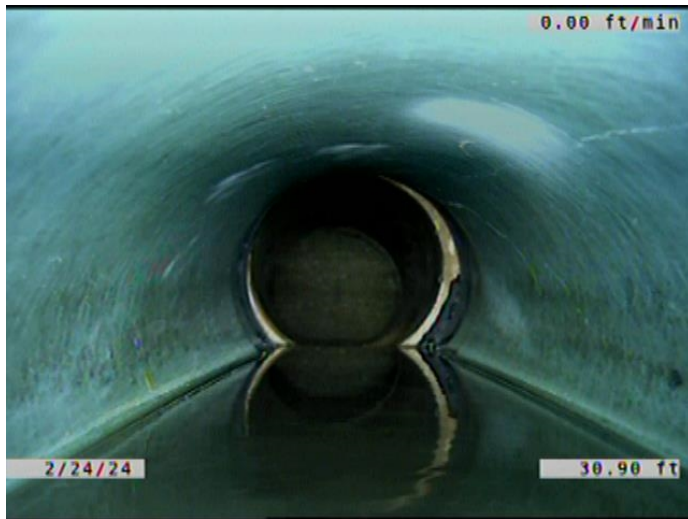
Code:	<b>DAE</b>
Description:	<b>Deposits Attached Encrustation</b>
Distance (ft):	<b>30.9</b>
Structural Grade:	<b>0</b>
O&M Grade:	<b>2</b>
Clock Start/From:	<b>7</b>
Clock To:	<b>5</b>
1st Value:	
2nd Value:	
Value Percent:	<b>5.000</b>
Continuous Index:	<b>F01</b>
Within 8" of Joint:	<b>YES</b>
Remarks:

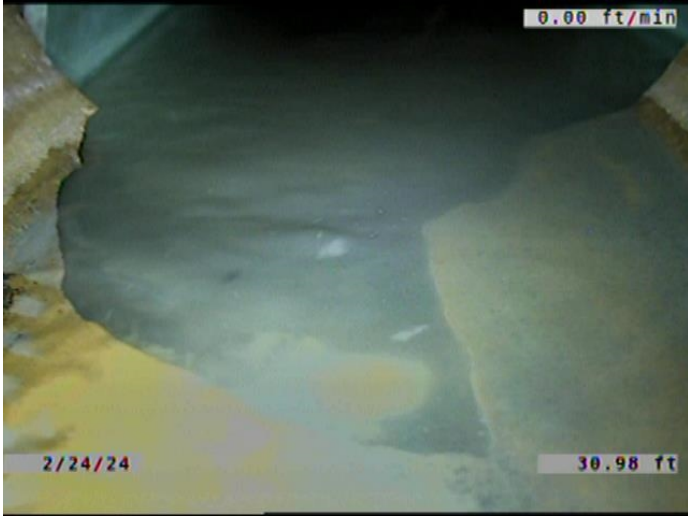
Code:	MSA
Description:	Miscellaneous Survey Abandoned
Distance (ft):	31.0
Structural Grade:	0
O&M Grade:	0
Clock Start/From:	
Clock To:	
1st Value:	
2nd Value:	
Value Percent:	
Continuous Index:	
Within 8" of Joint:	NO
Remarks:	CAMERA CANT MAKE IT PAST PIPE WALL MISSING. SOIL AND GRAVEL V
