Profile/Photo Observation Report

Date:	02/08/2022	Weather:		Coding:	PACP 7.0
Pipe Length (ft):	134.0	Owner:	City of Hobart	Pre Clean:	Heavy Cleaning
P.O.#:	YES502259	Surveyor:	S. Bucklin	PSR:	P-606-085-076
Customer:	City of Hobart	Clean Date:	02/01/2022	Shape:	C

Street:	South Connecticut Street	Flow Control:	Not Controlled
City:	Hobart, IN	Year Renewed:	
Location:	Local rural streets with light traffic, t	Tape/Media #:	
Purpose:	Routine Assessment	Dia/Height:	12"
Use:	Sanitary Sewage Pipe	Material:	VCP
Drain Area:		Lining:	None
Category:	NA		
Comment:			
Location Details:		Direction of Survey:	Downstream
US MH:	M-606-076	DS MH:	M-606-085
		Total Length Surveyed (ft):	131.5

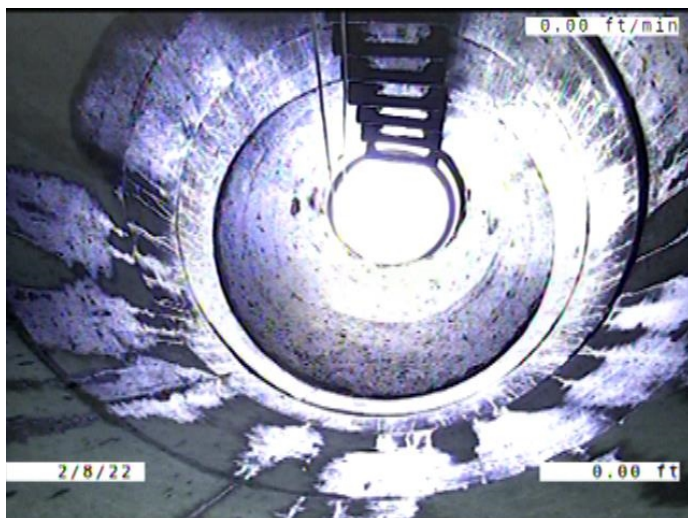
Code: **AMH**
 Description: **Manhole**

Distance (ft): **.0**
 Structural Grade: **0**
 O&M Grade: **0**
 Clock Start/From:
 Clock To:
 1st Value:
 2nd Value:
 Value Percent:
 Continuous Index:
 Within 8" of Joint: **NO**
 Remarks: **M-606-076**

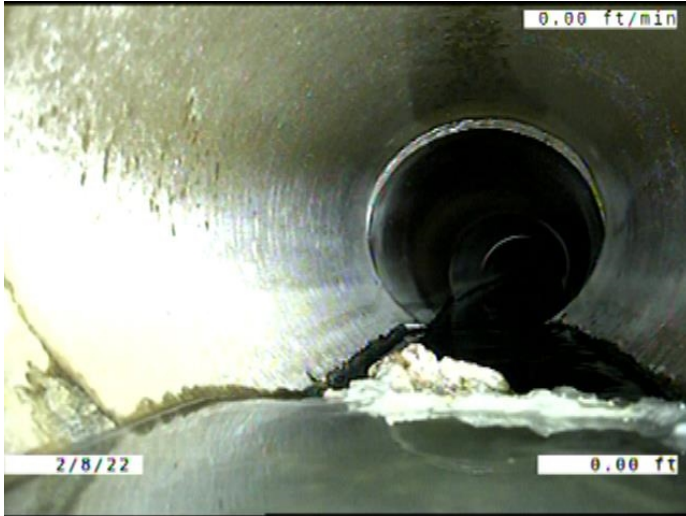
Code: **MWL**
Description: **Miscellaneous Water Level**

Distance (ft): **.0**
Structural Grade: **0**
O&M Grade: **0**
Clock Start/From:
Clock To:
1st Value:
2nd Value:
Value Percent: **5.000**
Continuous Index:
Within 8" of Joint: **NO**
Remarks:

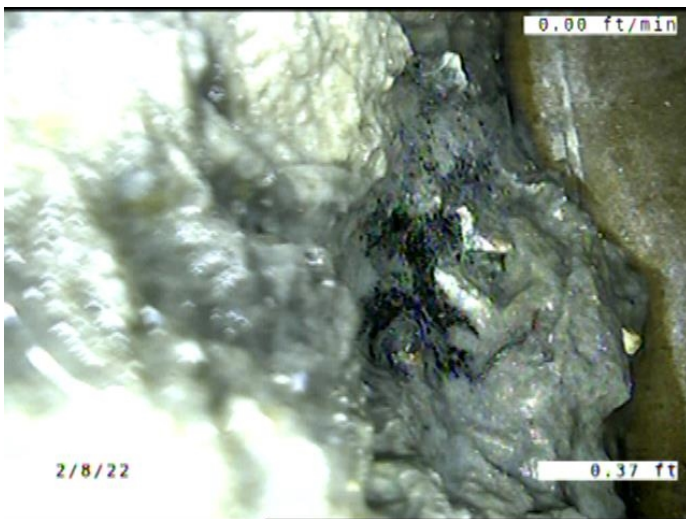
Code: **DSC**
Description: **Deposits Settled Hard/Compacted**

Distance (ft): **.4**
Structural Grade: **0**
O&M Grade: **2**
Clock Start/From: **5**
Clock To: **7**
1st Value:
2nd Value:
Value Percent: **5.000**
Continuous Index:
Within 8" of Joint: **YES**
Remarks:

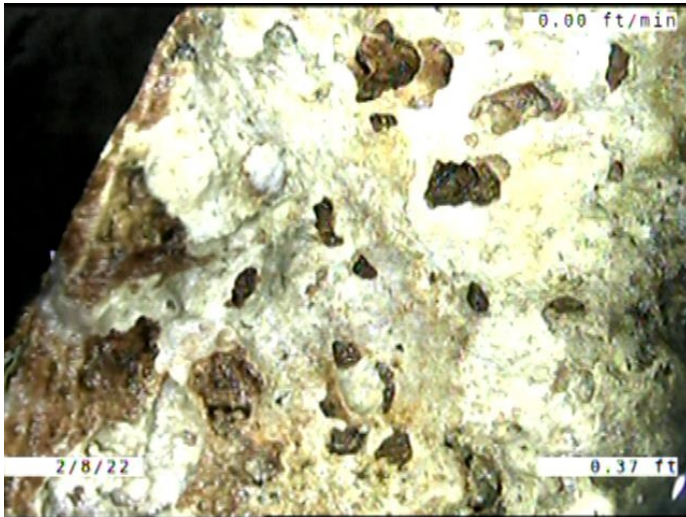
Code:	OBZ
Description:	Obstruction Other
Distance (ft):	.4
Structural Grade:	0
O&M Grade:	2
Clock Start/From:	6
Clock To:	7
1st Value:	
2nd Value:	
Value Percent:	5.000
Continuous Index:	
Within 8" of Joint:	YES
Remarks:	ENCRUSTATION THAT HAS BEEN CUT OFF THE PIPE WALL

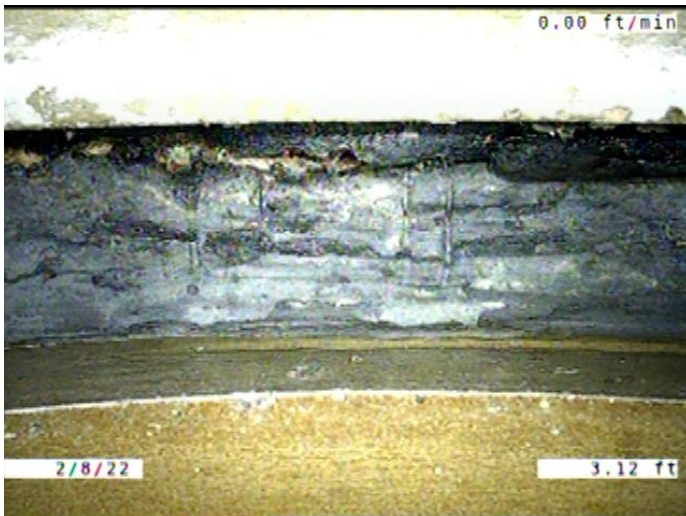
Code:	JAM
Description:	Joint Angular Medium
Distance (ft):	3.1
Structural Grade:	3
O&M Grade:	0
Clock Start/From:	
Clock To:	
1st Value:	
2nd Value:	
Value Percent:	
Continuous Index:	
Within 8" of Joint:	NO
Remarks:

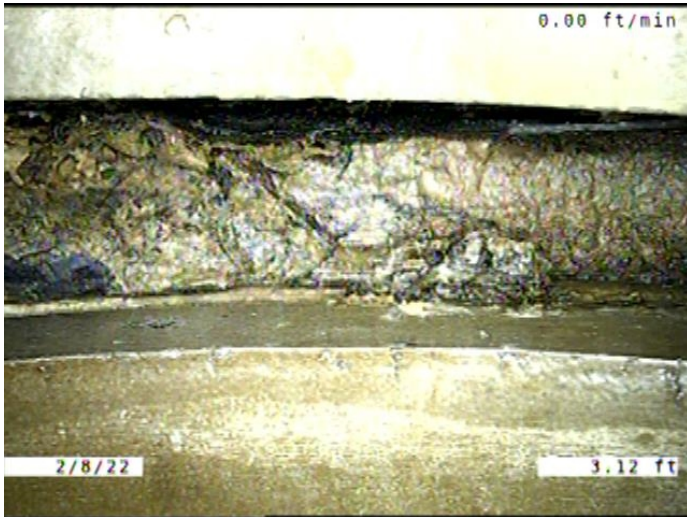
Code: **DAE**
Description: **Deposits Attached Encrustation**

Distance (ft): **3.1**
Structural Grade: **0**
O&M Grade: **2**
Clock Start/From: **8**
Clock To: **4**
1st Value:
2nd Value:
Value Percent: **5.000**
Continuous Index:
Within 8" of Joint: **YES**
Remarks:

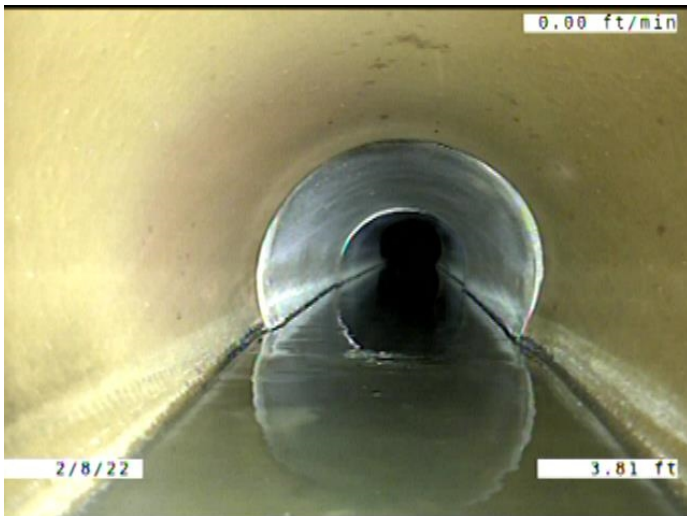
Code: **MWLS**
Description: **Miscellaneous Water Level Sag**

Distance (ft): **3.8**
Structural Grade: **2**
O&M Grade: **0**
Clock Start/From:
Clock To:
1st Value:
2nd Value:
Value Percent: **15.000**
Continuous Index: **S01**
Within 8" of Joint: **NO**
Remarks:

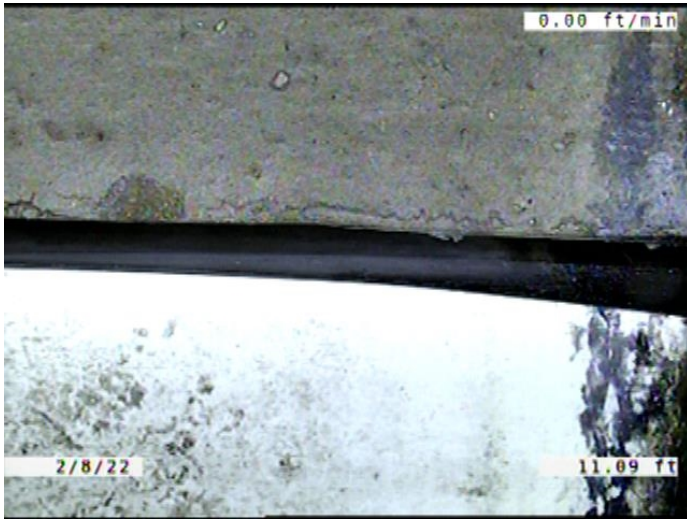
Code: **MMC**
Description: **Miscellaneous Material Change**

Distance (ft): **11.1**
Structural Grade: **0**
O&M Grade: **0**
Clock Start/From:
Clock To:
1st Value:
2nd Value:
Value Percent:
Continuous Index:
Within 8" of Joint: **NO**
Remarks: **VCP TO PVC**

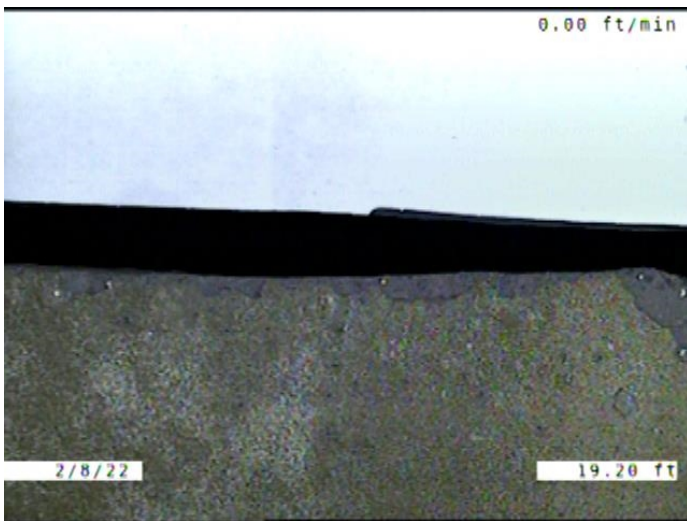
Code: **MMC**
Description: **Miscellaneous Material Change**

Distance (ft): **19.2**
Structural Grade: **0**
O&M Grade: **0**
Clock Start/From:
Clock To:
1st Value:
2nd Value:
Value Percent:
Continuous Index:
Within 8" of Joint: **NO**
Remarks: **PVC TO VCP**

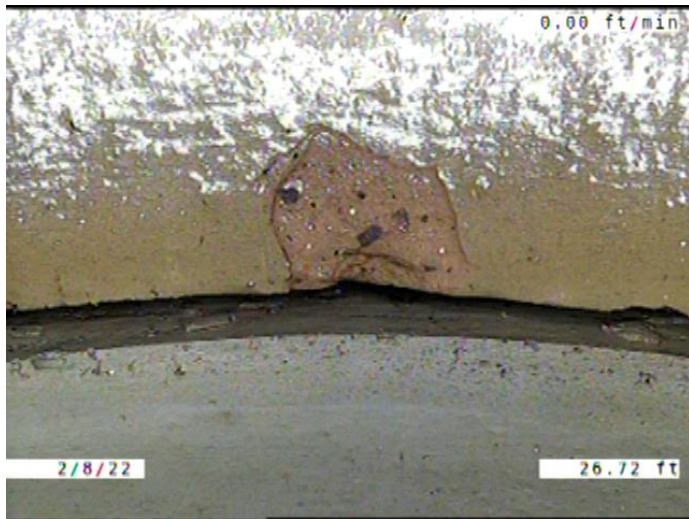
Code: **SZ**
 Description: **Surface Damage Other**

Distance (ft): **26.7**
 Structural Grade: **0**
 O&M Grade: **0**
 Clock Start/From: **12**
 Clock To:
 1st Value:
 2nd Value:
 Value Percent:
 Continuous Index:
 Within 8" of Joint: **YES**
 Remarks: **A PIECE CHIPPED AWAY FROM THE JOINT**

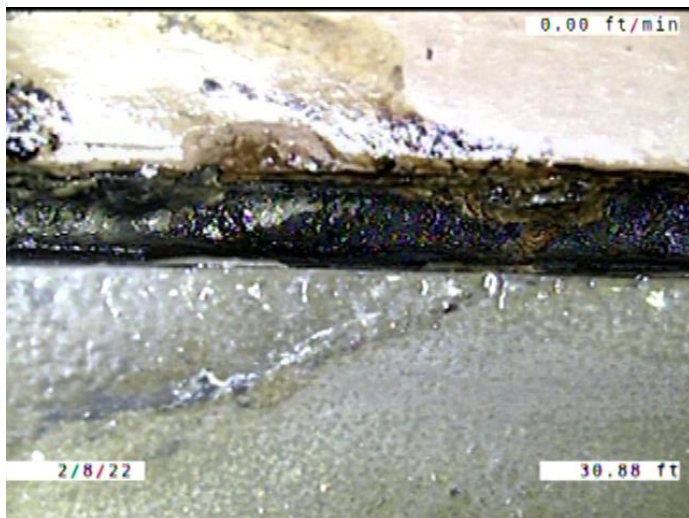
Code: **DAE**
 Description: **Deposits Attached Encrustation**

Distance (ft): **30.9**
 Structural Grade: **0**
 O&M Grade: **2**
 Clock Start/From: **8**
 Clock To: **4**
 1st Value:
 2nd Value:
 Value Percent: **5.000**
 Continuous Index:
 Within 8" of Joint: **YES**
 Remarks:

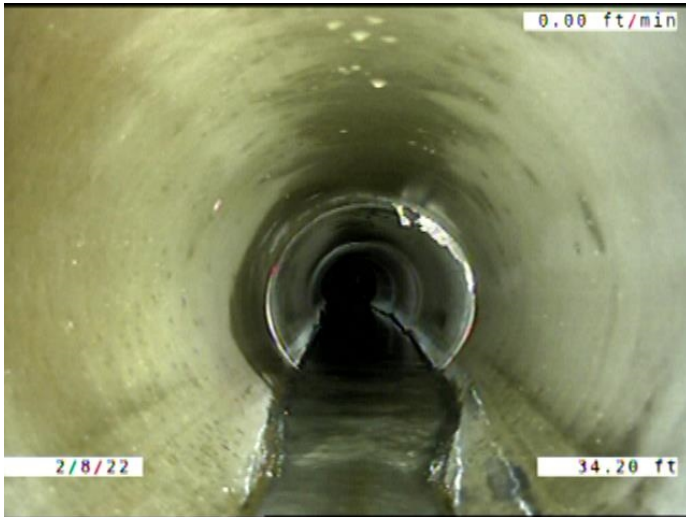
Code: **MWLS**
 Description: **Miscellaneous Water Level Sag**

Distance (ft): **34.2**
 Structural Grade: **2**
 O&M Grade: **0**
 Clock Start/From:
 Clock To:
 1st Value:
 2nd Value:
 Value Percent: **15.000**
 Continuous Index: **F01**
 Within 8" of Joint: **NO**
 Remarks:

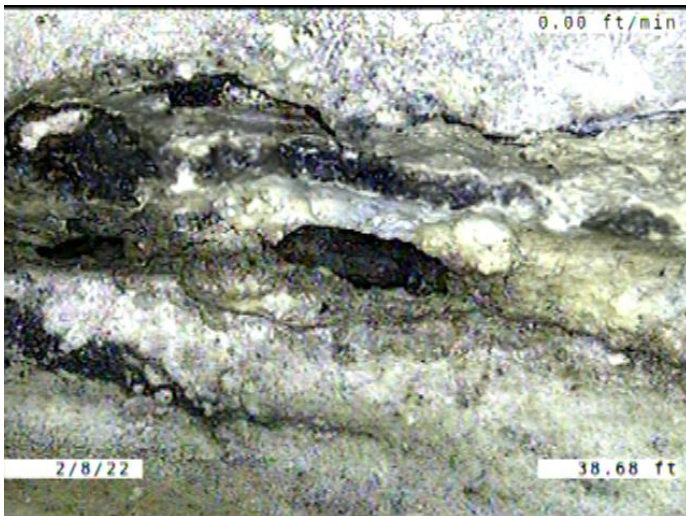
Code: **DAE**
 Description: **Deposits Attached Encrustation**

Distance (ft): **38.7**
 Structural Grade: **0**
 O&M Grade: **2**
 Clock Start/From: **8**
 Clock To: **4**
 1st Value:
 2nd Value:
 Value Percent: **5.000**
 Continuous Index:
 Within 8" of Joint: **YES**
 Remarks:

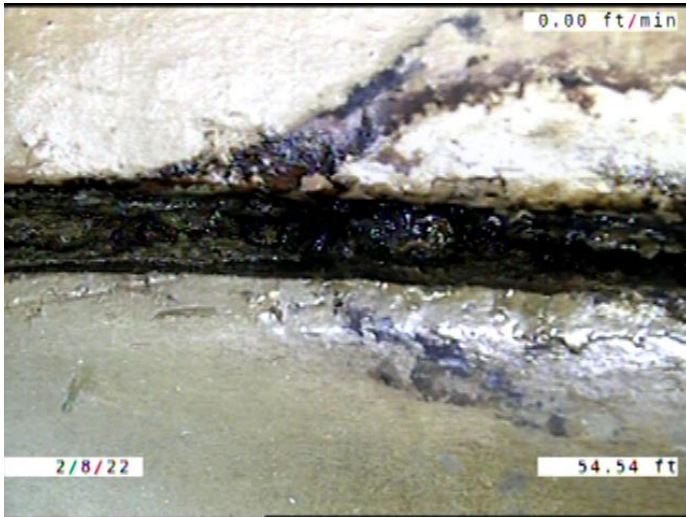
Code: **DAE**
Description: **Deposits Attached Encrustation**

Distance (ft): **54.5**
Structural Grade: **0**
O&M Grade: **2**
Clock Start/From: **8**
Clock To: **4**
1st Value:
2nd Value:
Value Percent: **5.000**
Continuous Index: **S02**
Within 8" of Joint: **YES**
Remarks:

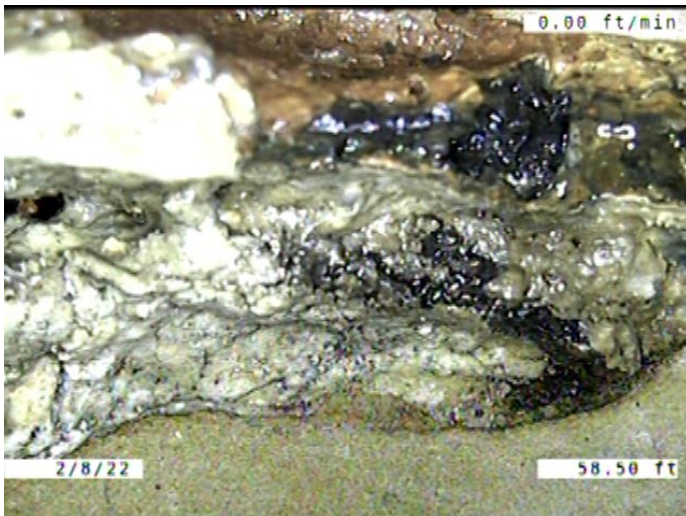
Code: **DAE**
Description: **Deposits Attached Encrustation**

Distance (ft): **58.5**
Structural Grade: **0**
O&M Grade: **3**
Clock Start/From: **8**
Clock To: **4**
1st Value:
2nd Value:
Value Percent: **15.000**
Continuous Index:
Within 8" of Joint: **YES**
Remarks:

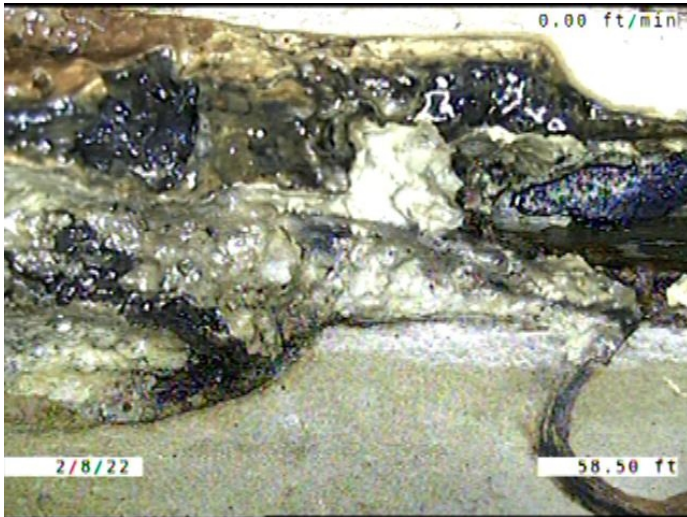
Code: **IRJ**
 Description: **Infiltration Runner Joint**

Distance (ft): **58.5**
 Structural Grade: **0**
 O&M Grade: **4**
 Clock Start/From: **11**
 Clock To: **1**
 1st Value:
 2nd Value:
 Value Percent:
 Continuous Index:
 Within 8" of Joint: **YES**
 Remarks:

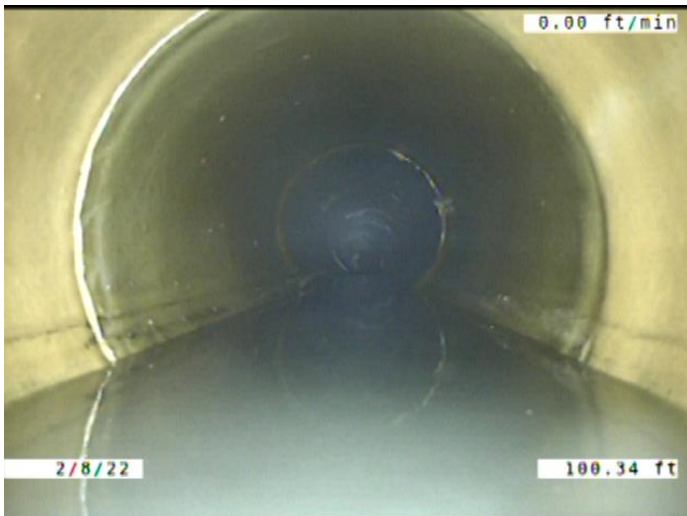
Code: **MWLS**
 Description: **Miscellaneous Water Level Sag**

Distance (ft): **100.3**
 Structural Grade: **2**
 O&M Grade: **0**
 Clock Start/From:
 Clock To:
 1st Value:
 2nd Value:
 Value Percent: **10.000**
 Continuous Index: **S03**
 Within 8" of Joint: **NO**
 Remarks:

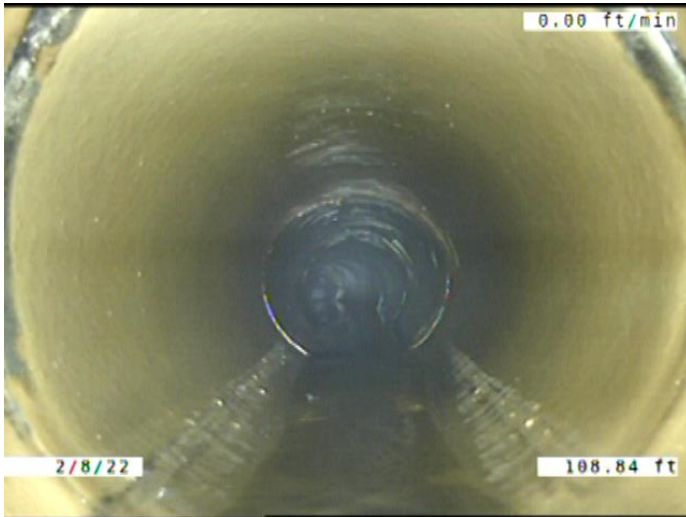
Code: **MWLS**
 Description: **Miscellaneous Water Level Sag**

Distance (ft): **108.8**
 Structural Grade: **2**
 O&M Grade: **0**
 Clock Start/From:
 Clock To:
 1st Value:
 2nd Value:
 Value Percent: **10.000**
 Continuous Index: **F03**
 Within 8" of Joint: **NO**
 Remarks:

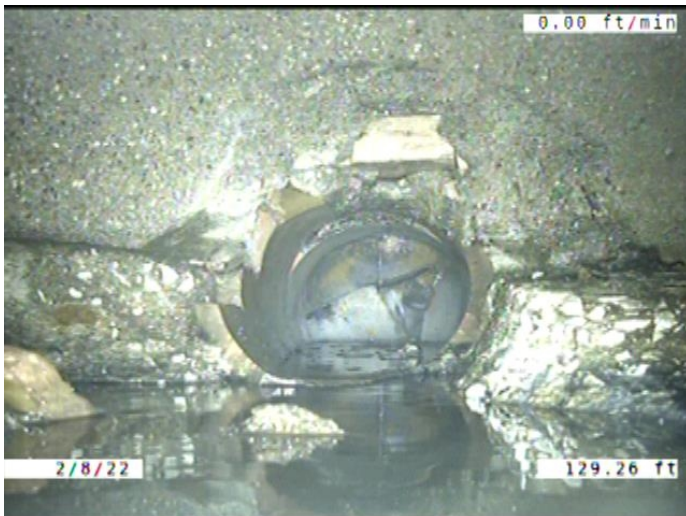
Code: **DAE**
 Description: **Deposits Attached Encrustation**

Distance (ft): **129.3**
 Structural Grade: **0**
 O&M Grade: **2**
 Clock Start/From: **8**
 Clock To: **4**
 1st Value:
 2nd Value:
 Value Percent: **5.000**
 Continuous Index: **F02**
 Within 8" of Joint: **YES**
 Remarks:

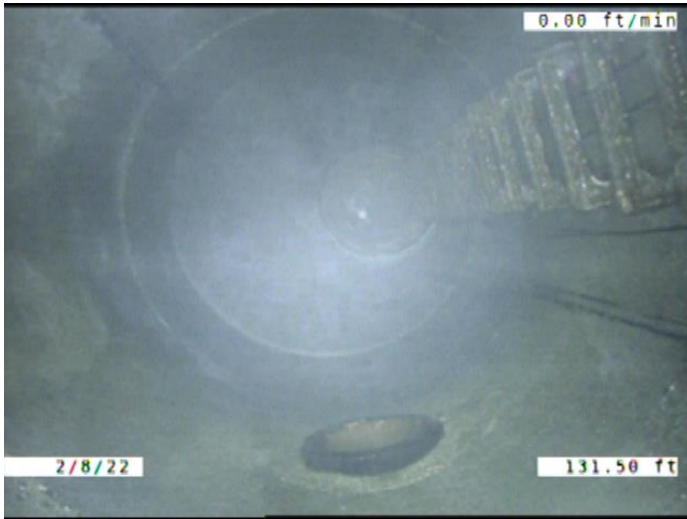
Code:	AMH
Description:	Manhole
Distance (ft):	131.5
Structural Grade:	0
O&M Grade:	0
Clock Start/From:	
Clock To:	
1st Value:	
2nd Value:	
Value Percent:	
Continuous Index:	
Within 8" of Joint:	NO
Remarks:	M-606-085
