Profile/Photo Observation Report

Street:	S CONNECTICUT ST	Flow Control:	Not Controlled
City:	Hobart, IN	Year Renewed:	
Location:	Yard	Tape/Media #:	
Purpose:	Routine Assessment	Dia/Height:	10"
Use:	Sanitary	Material:	VCP
Drain Area:	NA	Lining:	
Category:	NA		
Comment:			
Location Details:		Direction of Survey:	Downstream
US MH:	M-606-077	DS MH:	M-606-078
		Total Length Surveyed (ft):	10.4

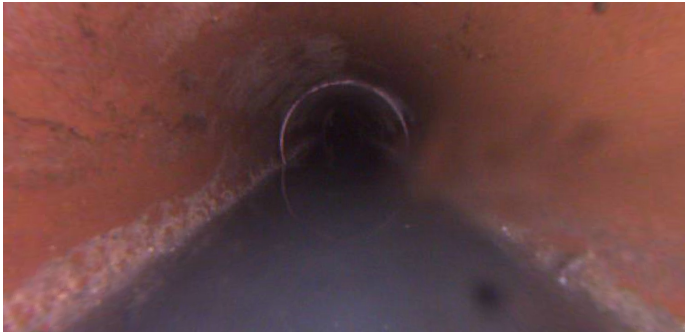
Code:	MWL
Description:	Water Level

Distance (ft):	.0
Structural Grade:	0
O&M Grade:	0
Clock Start/From:	
Clock To:	
1st Value:	
2nd Value:	
Value Percent:	20.000
Continuous Index:	
Within 8" of Joint:	NO
Remarks:

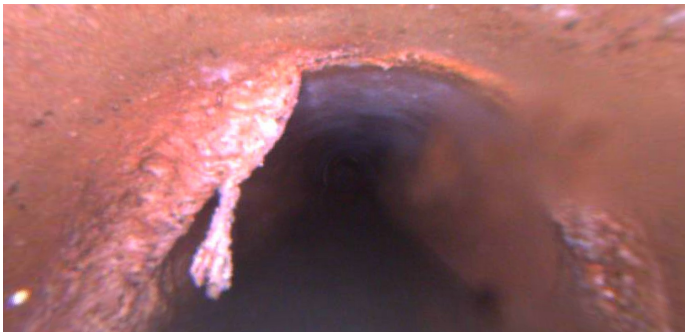
Code:	DAE
Description:	Deposits Attached Encrustation

Distance (ft):	5.8
Structural Grade:	0
O&M Grade:	2
Clock Start/From:	8
Clock To:	4
1st Value:	
2nd Value:	
Value Percent:	10.000
Continuous Index:	
Within 8" of Joint:	YES
Remarks:

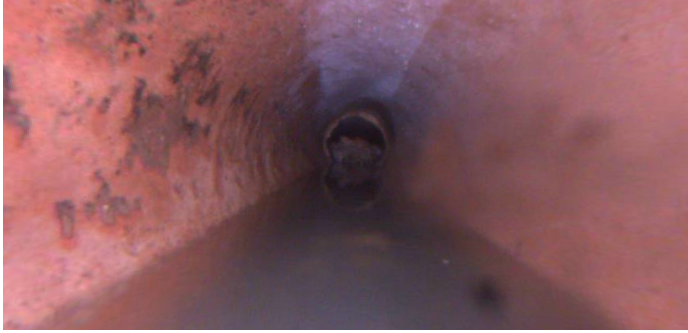
Code:	MSA
Description:	Abandoned Survey
Distance (ft):	10.4
Structural Grade:	0
O&M Grade:	0
Clock Start/From:	
Clock To:	
1st Value:	
2nd Value:	
Value Percent:	
Continuous Index:	
Within 8" of Joint:	NO
Remarks:	debris under water
