Profile/Photo Observation Report

Street:	FOXCROFT STREET	Flow Control:	Not Controlled
City:	Hobart, IN	Year Renewed:	
Location:	Yard	Tape/Media #:	
Purpose:	Routine Assessment	Dia/Height:	10"
Use:	Sanitary	Material:	VCP
Drain Area:	NA	Lining:	
Category:	NA		
Comment:

Location Details:		Direction of Survey:	Downstream
US MH:	M-606-077	DS MH:	M-606-078
		Total Length Surveyed (ft):	10.4

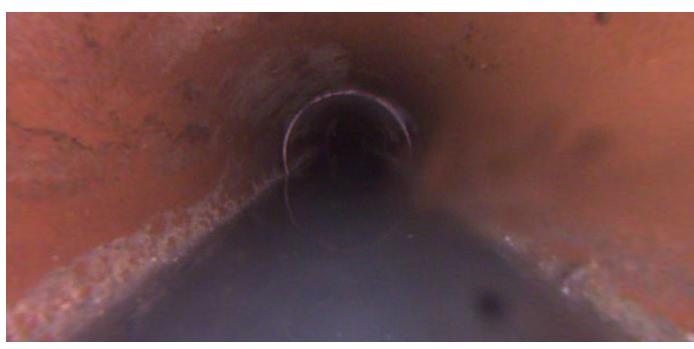
Code: **AMH**
Description: **Manhole**

Distance (ft): **.0**
Structural Grade: **0**
O&M Grade: **0**
Clock Start/From:
Clock To:
1st Value:
2nd Value:
Value Percent:
Continuous Index:
Within 8" of Joint: **NO**
Remarks: **M-606-077**

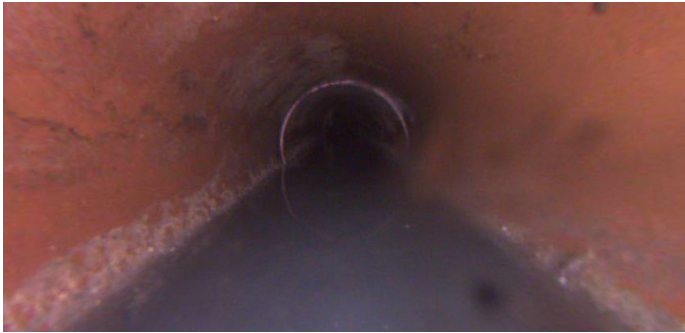
Code:	MWL
Description:	Water Level

Distance (ft):	.0
Structural Grade:	0
O&M Grade:	0
Clock Start/From:	
Clock To:	
1st Value:	
2nd Value:	
Value Percent:	20.000
Continuous Index:	
Within 8" of Joint:	NO
Remarks:

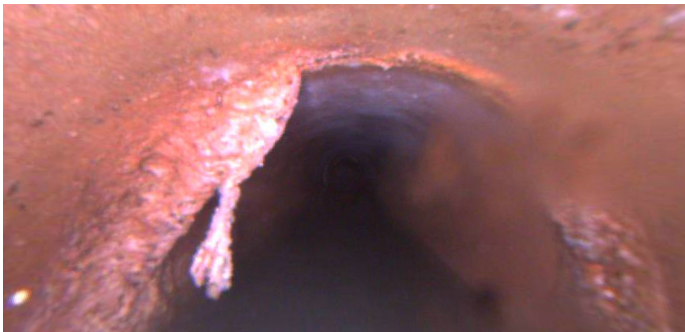
Code:	DAE
Description:	Deposits Attached Encrustation

Distance (ft):	5.8
Structural Grade:	0
O&M Grade:	2
Clock Start/From:	8
Clock To:	4
1st Value:	
2nd Value:	
Value Percent:	10.000
Continuous Index:	
Within 8" of Joint:	YES
Remarks:

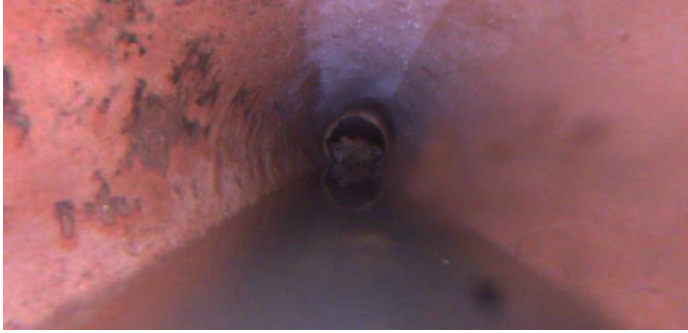
Code:	MSA
Description:	Abandoned Survey
Distance (ft):	10.4
Structural Grade:	0
O&M Grade:	0
Clock Start/From:	
Clock To:	
1st Value:	
2nd Value:	
Value Percent:	
Continuous Index:	
Within 8" of Joint:	NO
Remarks:	debris under water
