## Profile/Photo Observation Report

Date:	<b>02/24/2024</b>	Weather:		Coding:	<b>PACP 7.0</b>
Pipe Length (ft):	<b>169.0</b>	Owner:	<b>City of Hobart</b>	Pre Clean:	<b>Heavy Cleaning</b>
P.O.#:	<b>YES502259</b>	Surveyor:	<b>S. Bucklin</b>	PSR:	<b>P-606-078-077</b>
Customer:	<b>City of Hobart</b>	Clean Date:	<b>12/04/2023</b>	Shape:	<b>C</b>

Street:	<b>S CONNECTICUT ST</b>	Flow Control:	<b>Not Controlled</b>
City:	<b>Hobart, IN</b>	Year Renewed:	
Location:	<b>Easement/Right of Way</b>	Tape/Media #:	
Purpose:	<b>Sewer System Evaluation Survey (SS</b>	Dia/Height:	<b>10"</b>
Use:	<b>Sanitary Sewage Pipe</b>	Material:	<b>VCP</b>
Drain Area:		Lining:	<b>None</b>
Category:	<b>NA</b>		
Comment:			
Location Details:		Direction of Survey:	<b>Upstream</b>
US MH:	<b>M-606-077</b>	DS MH:	<b>M-606-078</b>
		Total Length Surveyed (ft):	<b>126.9</b>

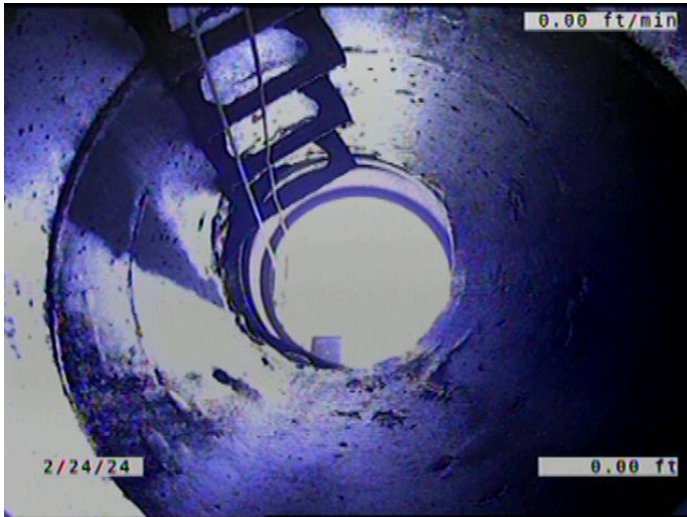
Code: **AMH**  
Description: **Manhole**

Distance (ft): **.0**  
Structural Grade: **0**  
O&M Grade: **0**  
Clock Start/From:  
Clock To:  
1st Value:  
2nd Value:  
Value Percent:  
Continuous Index:  
Within 8" of Joint: **NO**  
Remarks: **M-606-078**

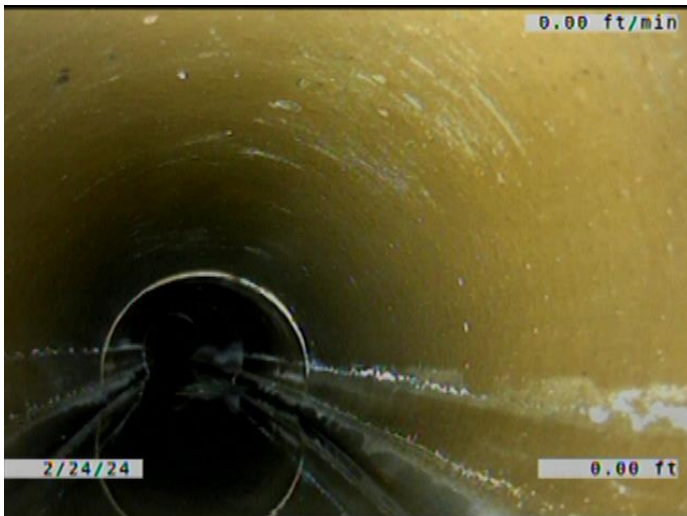
Code: **MWL**  
Description: **Miscellaneous Water Level**

Distance (ft): **.0**  
Structural Grade: **0**  
O&M Grade: **0**  
Clock Start/From:  
Clock To:  
1st Value:  
2nd Value:  
Value Percent: **15.000**  
Continuous Index:  
Within 8" of Joint: **NO**  
Remarks:

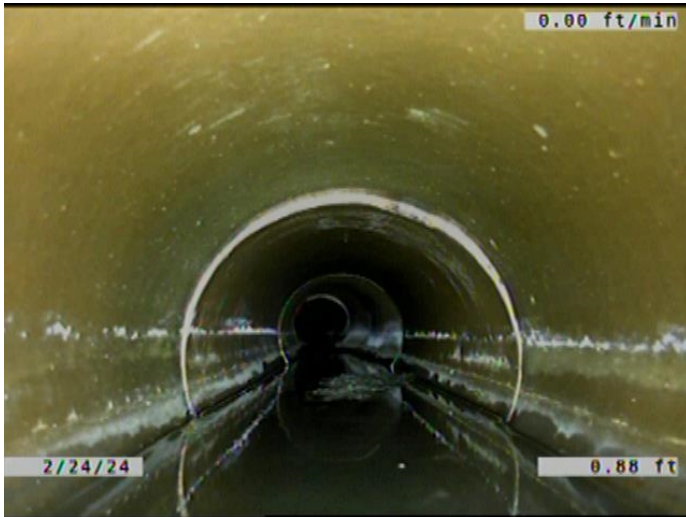
Code: **MWLS**  
Description: **Miscellaneous Water Level Sag**

Distance (ft): **.9**  
Structural Grade: **2**  
O&M Grade: **0**  
Clock Start/From:  
Clock To:  
1st Value:  
2nd Value:  
Value Percent: **15.000**  
Continuous Index: **S01**  
Within 8" of Joint: **NO**  
Remarks:

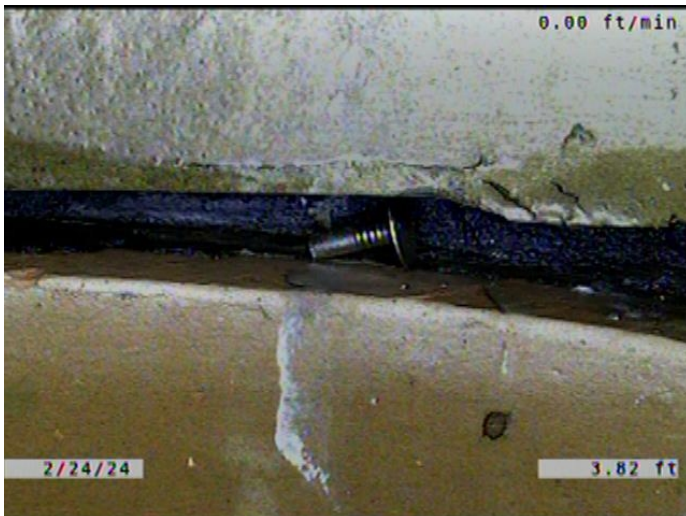
Code: **OBJ**  
Description: **Obstruction Wedged In The Joint**

Distance (ft): **3.8**  
Structural Grade: **0**  
O&M Grade: **2**  
Clock Start/From: **2**  
Clock To: **3**  
1st Value:  
2nd Value:  
Value Percent: **5.000**  
Continuous Index:  
Within 8" of Joint: **YES**  
Remarks: **BOLT**

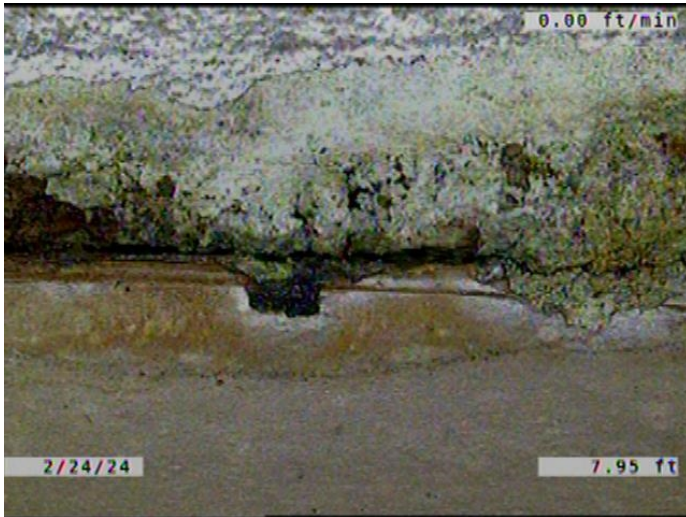
Code: **DAE**  
Description: **Deposits Attached Encrustation**

Distance (ft): **7.9**  
Structural Grade: **0**  
O&M Grade: **2**  
Clock Start/From: **7**  
Clock To: **5**  
1st Value:  
2nd Value:  
Value Percent: **5.000**  
Continuous Index: **S02**  
Within 8" of Joint: **YES**  
Remarks:

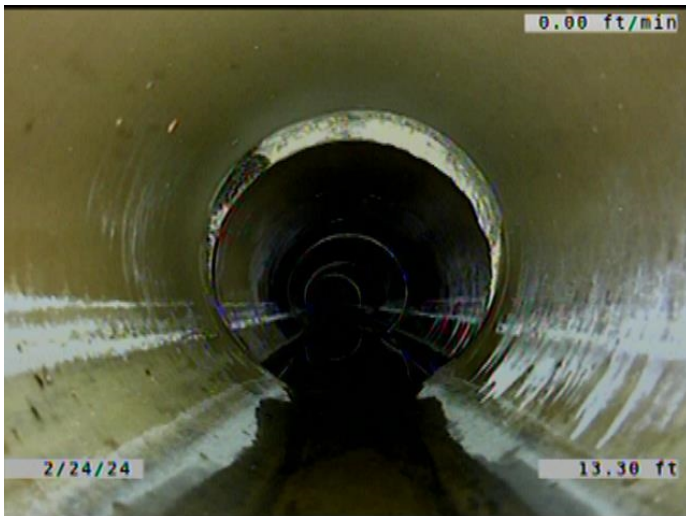
Code: **MWLS**  
Description: **Miscellaneous Water Level Sag**

Distance (ft): **13.3**  
Structural Grade: **2**  
O&M Grade: **0**  
Clock Start/From:  
Clock To:  
1st Value:  
2nd Value:  
Value Percent: **15.000**  
Continuous Index: **F01**  
Within 8" of Joint: **NO**  
Remarks:

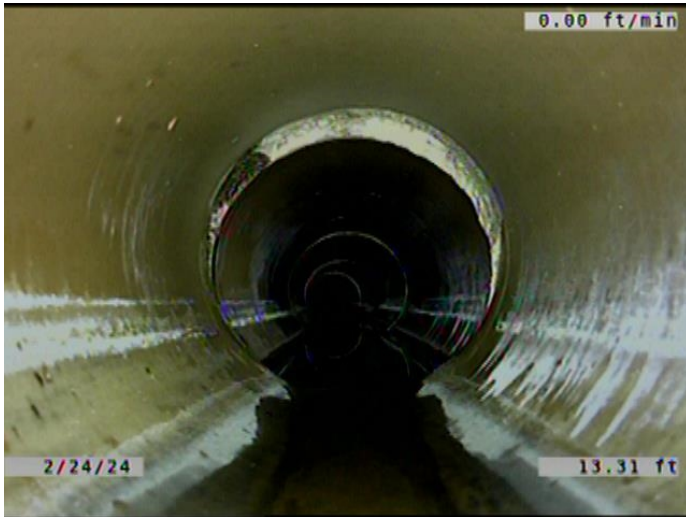
Code: **MWL**  
Description: **Miscellaneous Water Level**

Distance (ft): **13.3**  
Structural Grade: **0**  
O&M Grade: **0**  
Clock Start/From:  
Clock To:  
1st Value:  
2nd Value:  
Value Percent: **5.000**  
Continuous Index:  
Within 8" of Joint: **NO**  
Remarks:

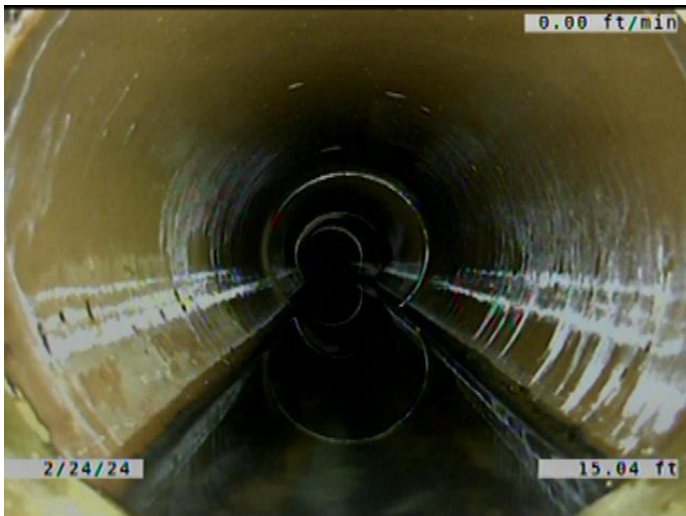
Code: **MWLS**  
Description: **Miscellaneous Water Level Sag**

Distance (ft): **15.0**  
Structural Grade: **2**  
O&M Grade: **0**  
Clock Start/From:  
Clock To:  
1st Value:  
2nd Value:  
Value Percent: **15.000**  
Continuous Index: **S03**  
Within 8" of Joint: **NO**  
Remarks:

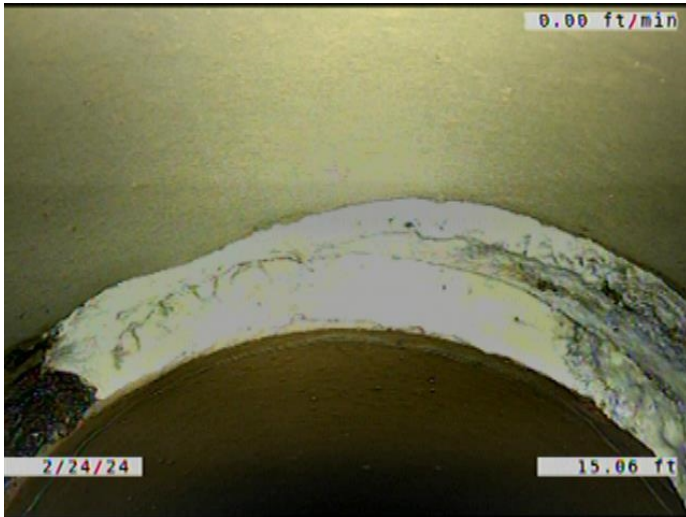
Code: **JOMD**  
Description: **Joint Offset Medium Defective**

Distance (ft): **15.1**  
Structural Grade: **3**  
O&M Grade: **0**  
Clock Start/From:  
Clock To:  
1st Value:  
2nd Value:  
Value Percent:  
Continuous Index:  
Within 8" of Joint: **NO**  
Remarks:

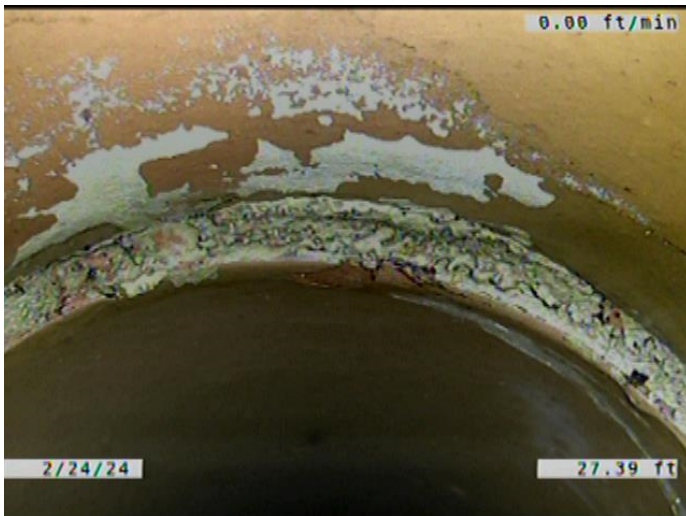
Code: **JOMD**  
Description: **Joint Offset Medium Defective**

Distance (ft): **27.4**  
Structural Grade: **3**  
O&M Grade: **0**  
Clock Start/From:  
Clock To:  
1st Value:  
2nd Value:  
Value Percent:  
Continuous Index:  
Within 8" of Joint: **NO**  
Remarks:

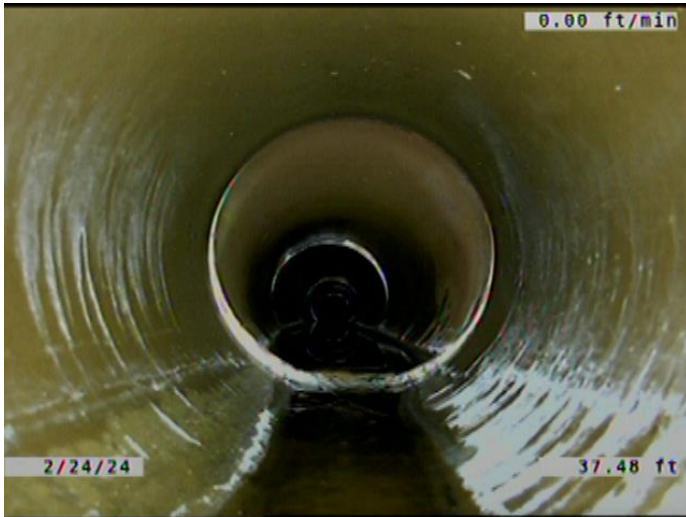
Code: **MWLS**  
Description: **Miscellaneous Water Level Sag**

Distance (ft): **37.5**  
Structural Grade: **2**  
O&M Grade: **0**  
Clock Start/From:  
Clock To:  
1st Value:  
2nd Value:  
Value Percent: **15.000**  
Continuous Index: **F03**  
Within 8" of Joint: **NO**  
Remarks:

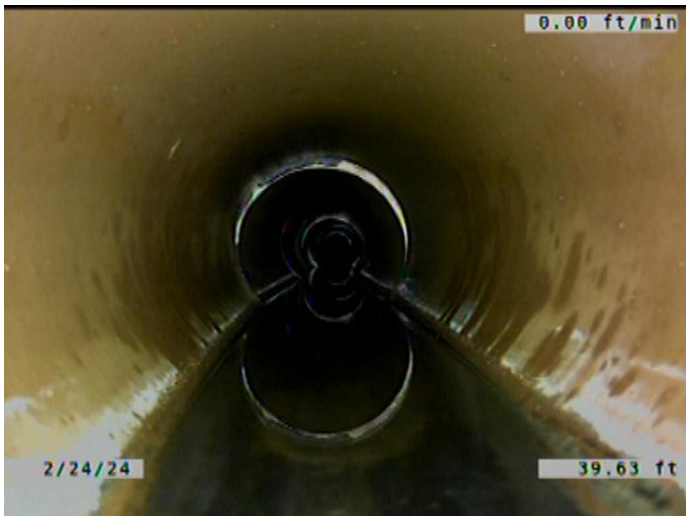
Code: **MWLS**  
Description: **Miscellaneous Water Level Sag**

Distance (ft): **39.6**  
Structural Grade: **2**  
O&M Grade: **0**  
Clock Start/From:  
Clock To:  
1st Value:  
2nd Value:  
Value Percent: **10.000**  
Continuous Index: **S04**  
Within 8" of Joint: **NO**  
Remarks:

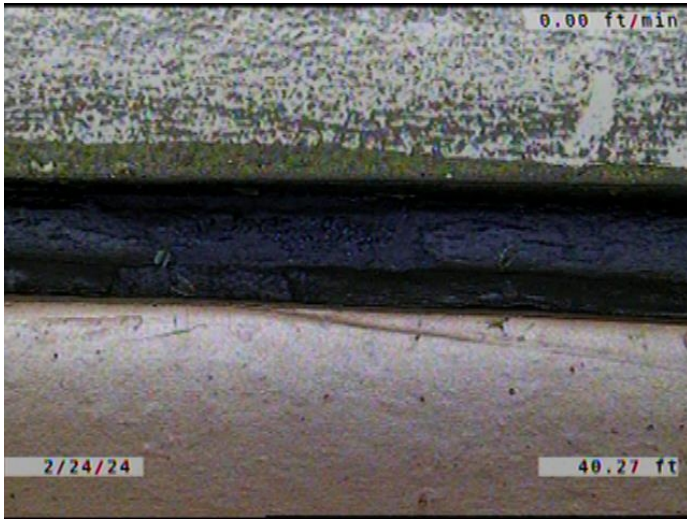
Code: **JAM**  
Description: **Joint Angular Medium**

Distance (ft): **40.3**  
Structural Grade: **3**  
O&M Grade: **0**  
Clock Start/From:  
Clock To:  
1st Value:  
2nd Value:  
Value Percent:  
Continuous Index:  
Within 8" of Joint: **NO**  
Remarks:

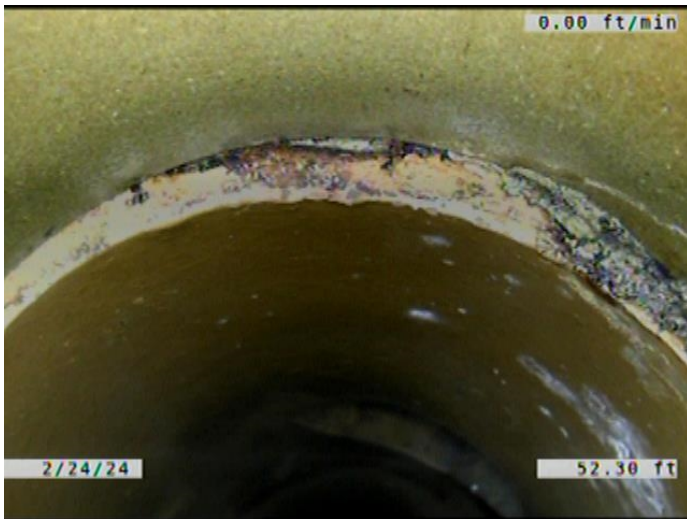
Code: **JOMD**  
Description: **Joint Offset Medium Defective**

Distance (ft): **52.3**  
Structural Grade: **3**  
O&M Grade: **0**  
Clock Start/From:  
Clock To:  
1st Value:  
2nd Value:  
Value Percent:  
Continuous Index:  
Within 8" of Joint: **NO**  
Remarks:

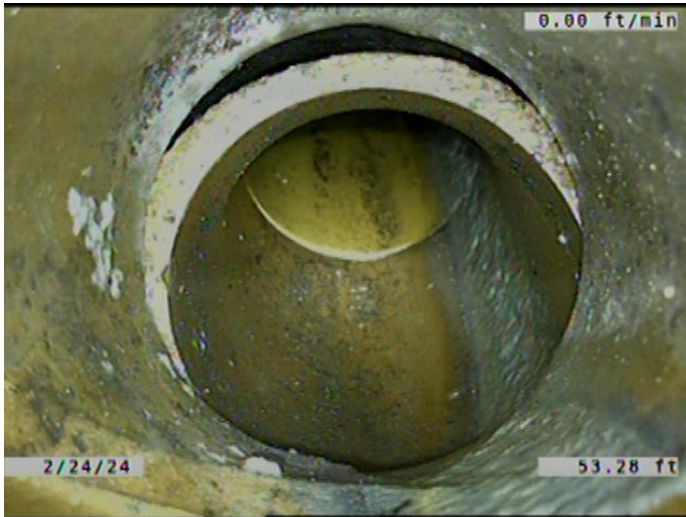
Code: **TFD**  
Description: **Tap Factory Defective**

Distance (ft): **53.3**  
Structural Grade: **0**  
O&M Grade: **3**  
Clock Start/From: **1**  
Clock To:  
1st Value: **6.000**  
2nd Value:  
Value Percent:  
Continuous Index:  
Within 8" of Joint: **YES**  
Remarks: **SERVICE OFFSET.**

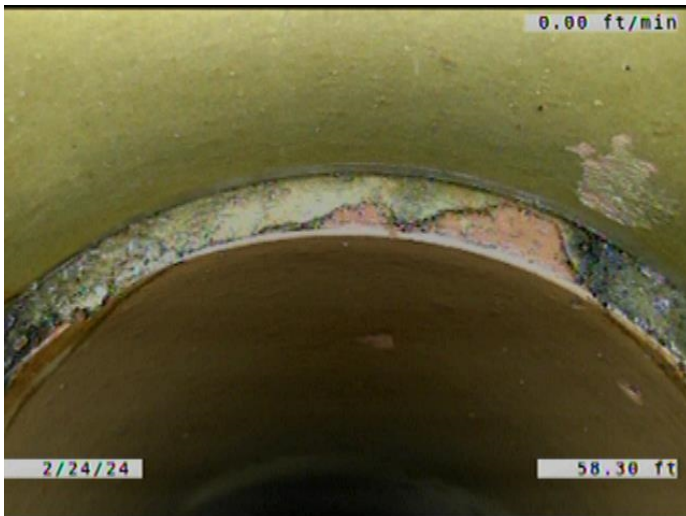
Code: **JOMD**  
Description: **Joint Offset Medium Defective**

Distance (ft): **58.3**  
Structural Grade: **3**  
O&M Grade: **0**  
Clock Start/From:  
Clock To:  
1st Value:  
2nd Value:  
Value Percent:  
Continuous Index:  
Within 8" of Joint: **NO**  
Remarks:

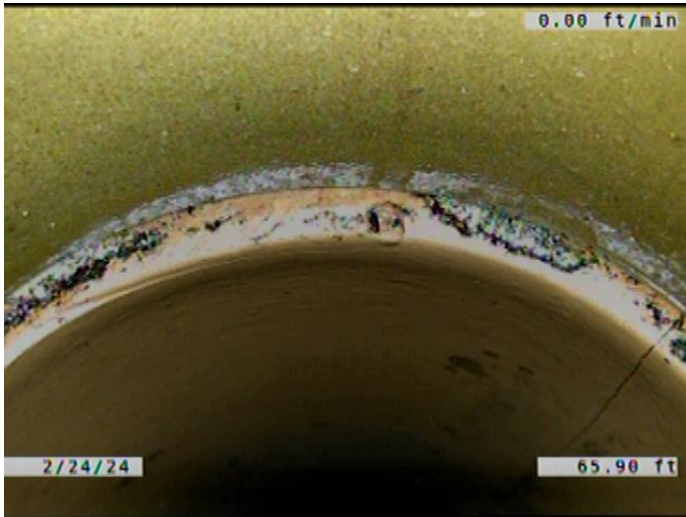
Code: **JOMD**  
Description: **Joint Offset Medium Defective**

Distance (ft): **65.9**  
Structural Grade: **3**  
O&M Grade: **0**  
Clock Start/From:  
Clock To:  
1st Value:  
2nd Value:  
Value Percent:  
Continuous Index:  
Within 8" of Joint: **NO**  
Remarks:

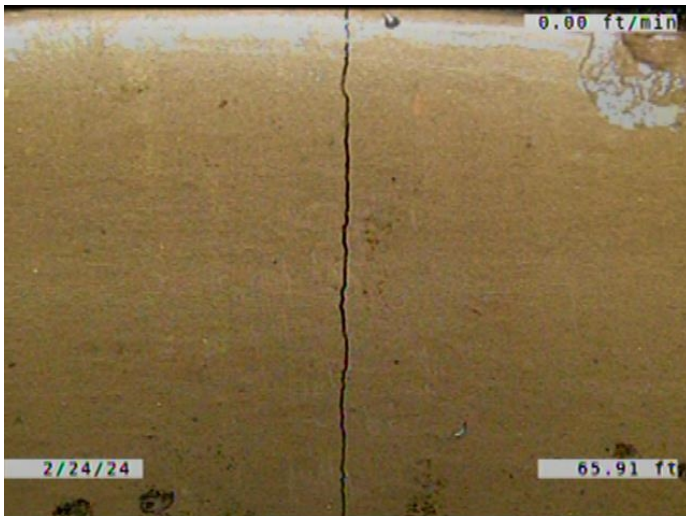
Code: **CS**  
Description: **Crack Spiral**

Distance (ft): **65.9**  
Structural Grade: **2**  
O&M Grade: **0**  
Clock Start/From: **12**  
Clock To: **1**  
1st Value:  
2nd Value:  
Value Percent:  
Continuous Index:  
Within 8" of Joint: **YES**  
Remarks:

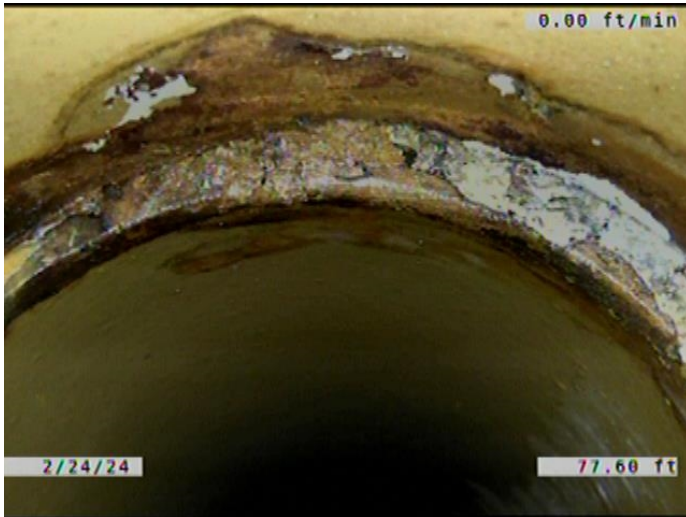
Code: **JOMD**  
Description: **Joint Offset Medium Defective**

Distance (ft): **77.6**  
Structural Grade: **3**  
O&M Grade: **0**  
Clock Start/From:  
Clock To:  
1st Value:  
2nd Value:  
Value Percent:  
Continuous Index: **S05**  
Within 8" of Joint: **NO**  
Remarks:

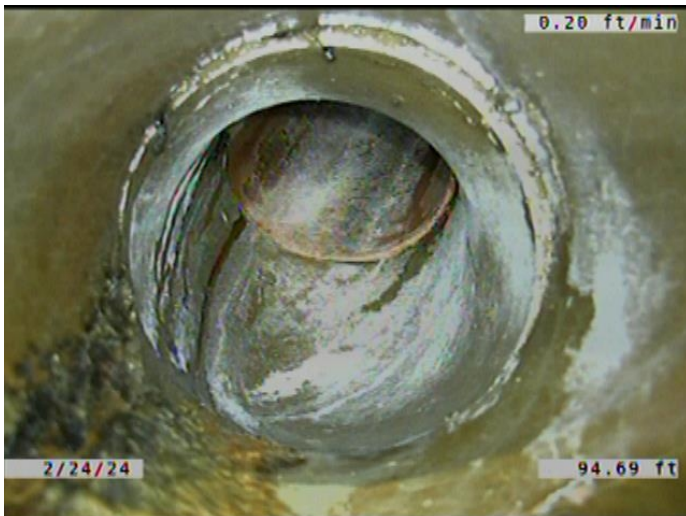
Code: **TFD**  
Description: **Tap Factory Defective**

Distance (ft): **94.7**  
Structural Grade: **0**  
O&M Grade: **3**  
Clock Start/From: **11**  
Clock To:  
1st Value: **6.000**  
2nd Value:  
Value Percent:  
Continuous Index:  
Within 8" of Joint: **YES**  
Remarks: **INFILTRATION AND ENCRUSTATION  
COMING FROM THE SERVICE TO MA**

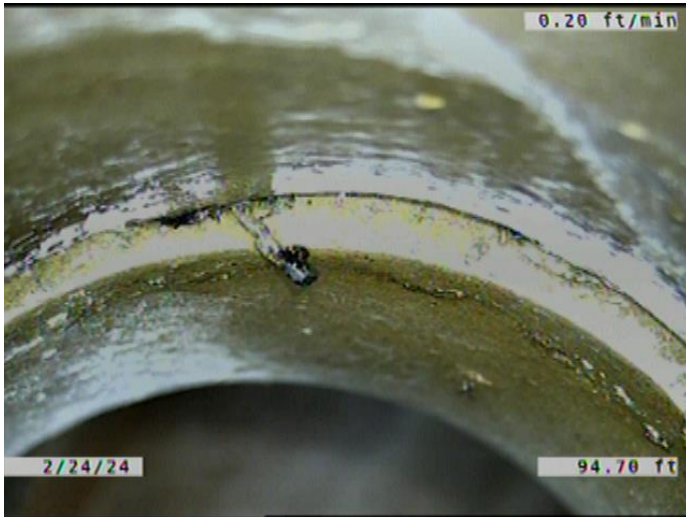
Code:	<b>IDC</b>
Description:	<b>Infiltration Dripper Connection</b>
Distance (ft):	<b>94.7</b>
Structural Grade:	<b>0</b>
O&M Grade:	<b>3</b>
Clock Start/From:	<b>11</b>
Clock To:	
1st Value:	
2nd Value:	
Value Percent:	
Continuous Index:	
Within 8" of Joint:	<b>YES</b>
Remarks:

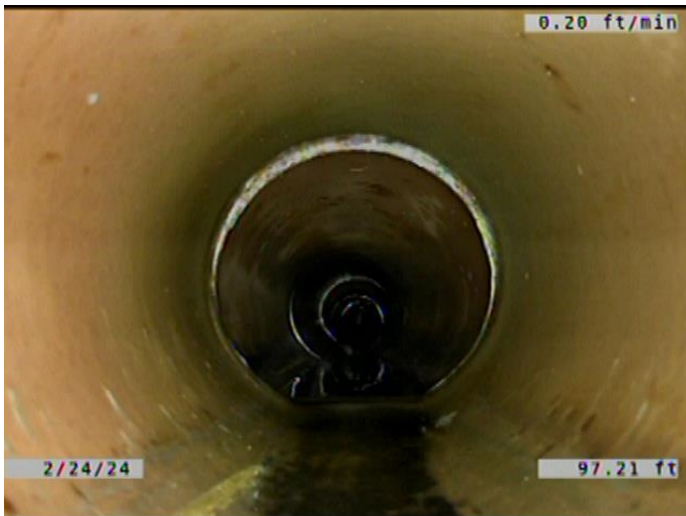
Code:	<b>MWLS</b>
Description:	<b>Miscellaneous Water Level Sag</b>
Distance (ft):	<b>97.2</b>
Structural Grade:	<b>2</b>
O&M Grade:	<b>0</b>
Clock Start/From:	
Clock To:	
1st Value:	
2nd Value:	
Value Percent:	<b>10.000</b>
Continuous Index:	<b>F04</b>
Within 8" of Joint:	<b>NO</b>
Remarks:

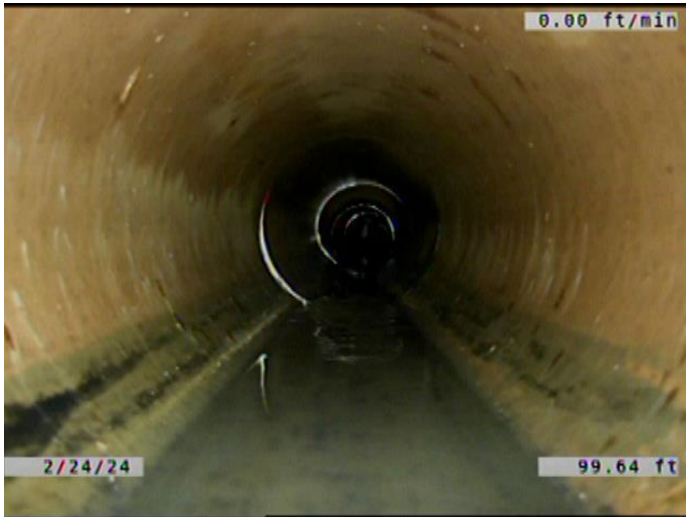
Code: **MWLS**  
Description: **Miscellaneous Water Level Sag**

Distance (ft): **99.6**  
Structural Grade: **2**  
O&M Grade: **0**  
Clock Start/From:  
Clock To:  
1st Value:  
2nd Value:  
Value Percent: **10.000**  
Continuous Index: **S06**  
Within 8" of Joint: **NO**  
Remarks:

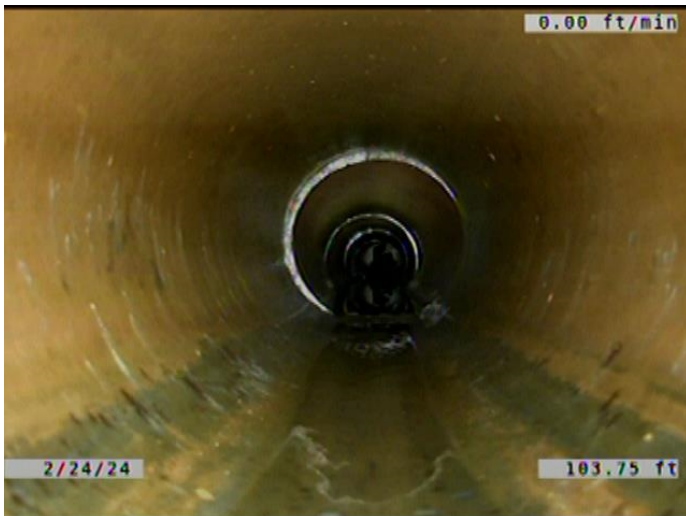
Code: **MWLS**  
Description: **Miscellaneous Water Level Sag**

Distance (ft): **103.8**  
Structural Grade: **2**  
O&M Grade: **0**  
Clock Start/From:  
Clock To:  
1st Value:  
2nd Value:  
Value Percent: **10.000**  
Continuous Index: **F06**  
Within 8" of Joint: **NO**  
Remarks:

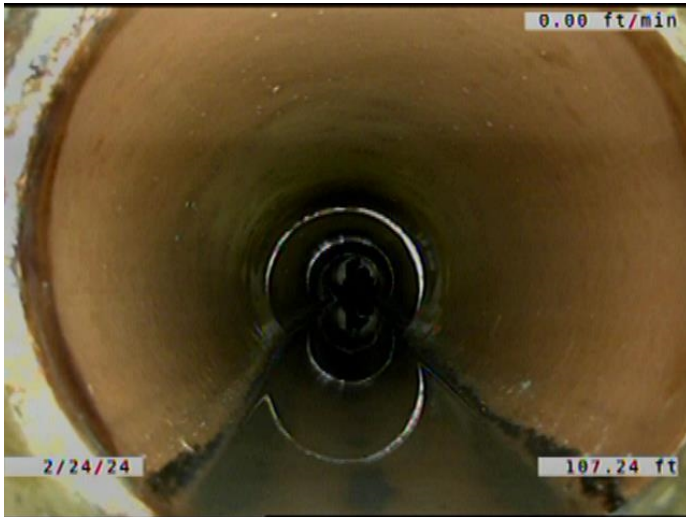
Code: **MWLS**  
Description: **Miscellaneous Water Level Sag**

Distance (ft): **107.2**  
Structural Grade: **2**  
O&M Grade: **0**  
Clock Start/From:  
Clock To:  
1st Value:  
2nd Value:  
Value Percent: **10.000**  
Continuous Index: **S07**  
Within 8" of Joint: **NO**  
Remarks:

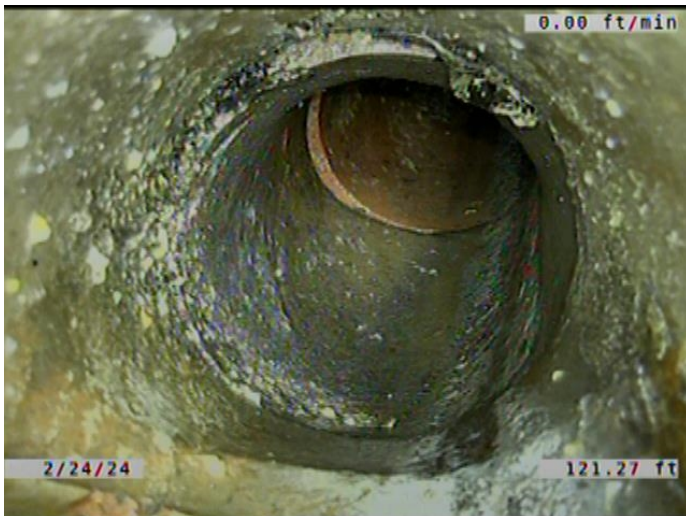
Code: **TFD**  
Description: **Tap Factory Defective**

Distance (ft): **121.3**  
Structural Grade: **0**  
O&M Grade: **3**  
Clock Start/From: **1**  
Clock To:  
1st Value: **6.000**  
2nd Value:  
Value Percent:  
Continuous Index:  
Within 8" of Joint: **YES**  
Remarks: **INFILTRATION ROOTS AND ENCRUSTATION COMING FROM THE**

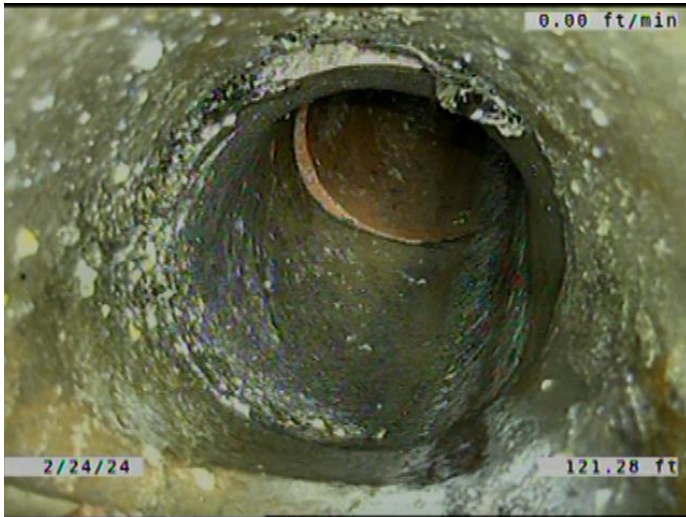
Code: **IDC**  
Description: **Infiltration Dripper Connection**

Distance (ft): **121.3**  
Structural Grade: **0**  
O&M Grade: **3**  
Clock Start/From: **1**  
Clock To:  
1st Value:  
2nd Value:  
Value Percent:  
Continuous Index:  
Within 8" of Joint: **YES**  
Remarks:

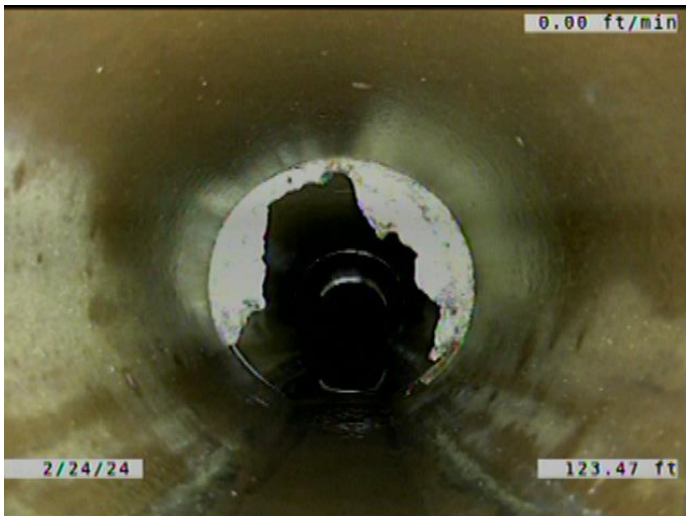
Code: **MWLS**  
Description: **Miscellaneous Water Level Sag**

Distance (ft): **123.5**  
Structural Grade: **2**  
O&M Grade: **0**  
Clock Start/From:  
Clock To:  
1st Value:  
2nd Value:  
Value Percent: **10.000**  
Continuous Index: **F07**  
Within 8" of Joint: **NO**  
Remarks:

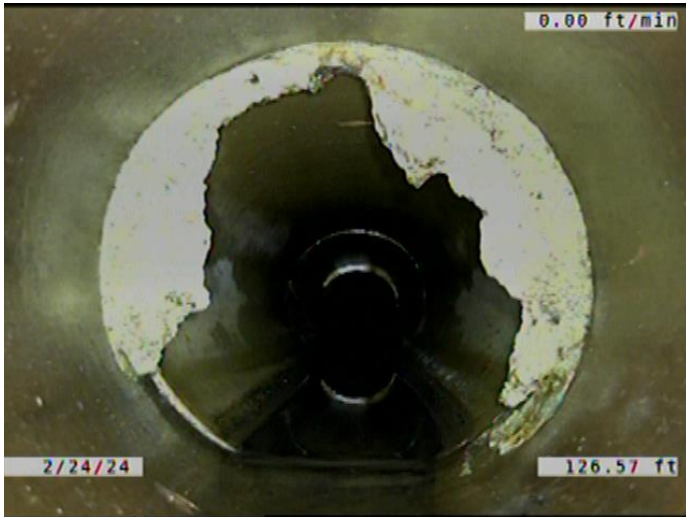
Code: **DAE**  
Description: **Deposits Attached Encrustation**

Distance (ft): **126.6**  
Structural Grade: **0**  
O&M Grade: **3**  
Clock Start/From: **8**  
Clock To: **5**  
1st Value:  
2nd Value:  
Value Percent: **20.000**  
Continuous Index:  
Within 8" of Joint: **YES**  
Remarks:

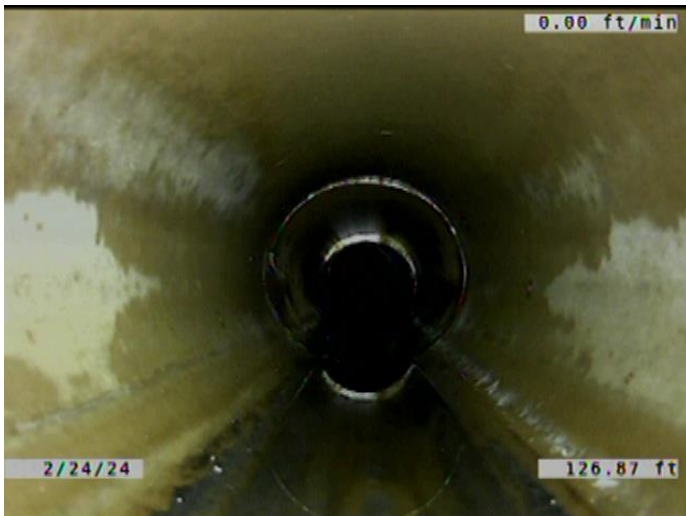
Code: **DAE**  
Description: **Deposits Attached Encrustation**

Distance (ft): **126.9**  
Structural Grade: **0**  
O&M Grade: **2**  
Clock Start/From: **7**  
Clock To: **5**  
1st Value:  
2nd Value:  
Value Percent: **5.000**  
Continuous Index: **F02**  
Within 8" of Joint: **YES**  
Remarks:

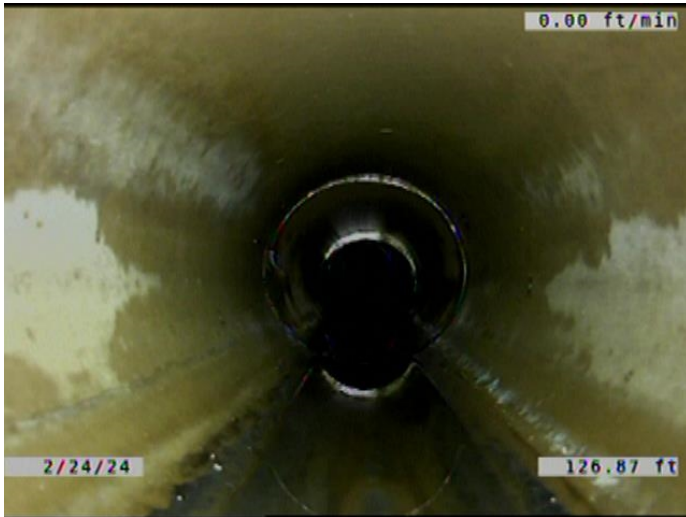
Code: **JOMD**  
 Description: **Joint Offset Medium Defective**

Distance (ft): **126.9**  
 Structural Grade: **3**  
 O&M Grade: **0**  
 Clock Start/From:  
 Clock To:  
 1st Value:  
 2nd Value:  
 Value Percent:  
 Continuous Index: **F05**  
 Within 8" of Joint: **NO**  
 Remarks:

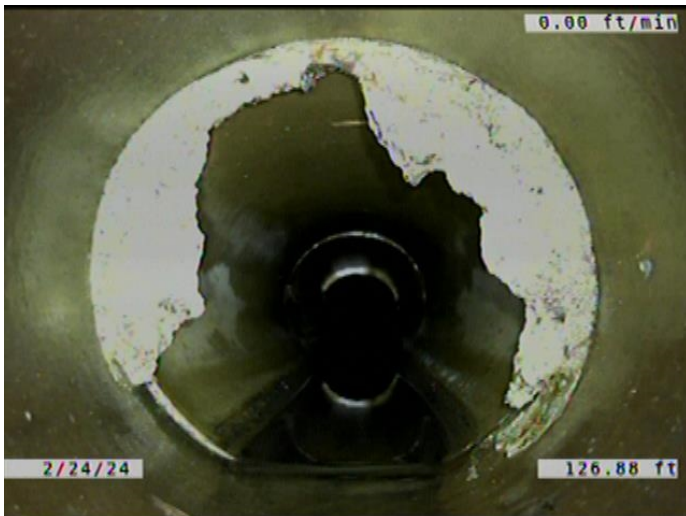
Code: **MSA**  
 Description: **Miscellaneous Survey Abandoned**

Distance (ft): **126.9**  
 Structural Grade: **0**  
 O&M Grade: **0**  
 Clock Start/From:  
 Clock To:  
 1st Value:  
 2nd Value:  
 Value Percent:  
 Continuous Index:  
 Within 8" of Joint: **NO**  
 Remarks: **CAMERA CANT MAKE IT PAST ENCRUSTATION.**
