Profile/Photo Observation Report

Date:	02/29/2024	Weather:		Coding:	PACP 7.0
Pipe Length (ft):	169.0	Owner:	City of Hobart	Pre Clean:	Heavy Cleaning
P.O.#:		Surveyor:	S. Bucklin	PSR:	P-606-078-077
Customer:	City of Hobart	Clean Date:	12/04/2023	Shape:	C

Street:	S CONNECTICUT ST	Flow Control:	Not Controlled
City:	Hobart, IN	Year Renewed:	
Location:	Easement/Right of Way	Tape/Media #:	
Purpose:	Sewer System Evaluation Survey (SS)	Dia/Height:	10"
Use:	Sanitary Sewage Pipe	Material:	VCP
Drain Area:		Lining:	None
Category:	NA		
Comment:			
Location Details:		Direction of Survey:	Downstream
US MH:	M-606-077	DS MH:	M-606-078
		Total Length Surveyed (ft):	44.4

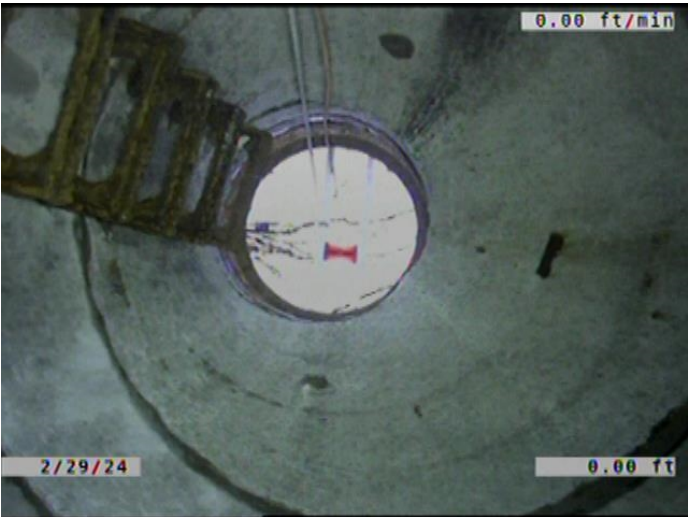
AMH

Manhole

.0

M-606-077

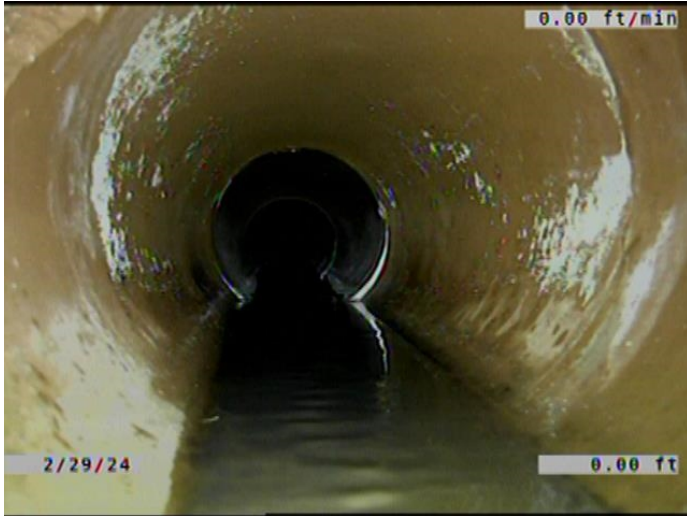
Code: **MWL**
Description: **Miscellaneous Water Level**

Distance (ft): **.0**
Structural Grade: **0**
O&M Grade: **0**
Clock Start/From:
Clock To:
1st Value:
2nd Value:
Value Percent: **10.000**
Continuous Index:
Within 8" of Joint: **NO**
Remarks:

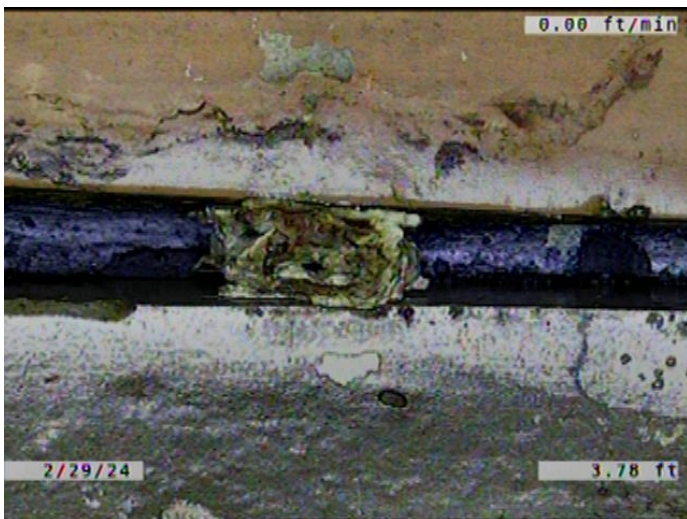
Code: **DAE**
Description: **Deposits Attached Encrustation**

Distance (ft): **3.8**
Structural Grade: **0**
O&M Grade: **2**
Clock Start/From: **7**
Clock To: **5**
1st Value:
2nd Value:
Value Percent: **5.000**
Continuous Index: **S01**
Within 8" of Joint: **YES**
Remarks:

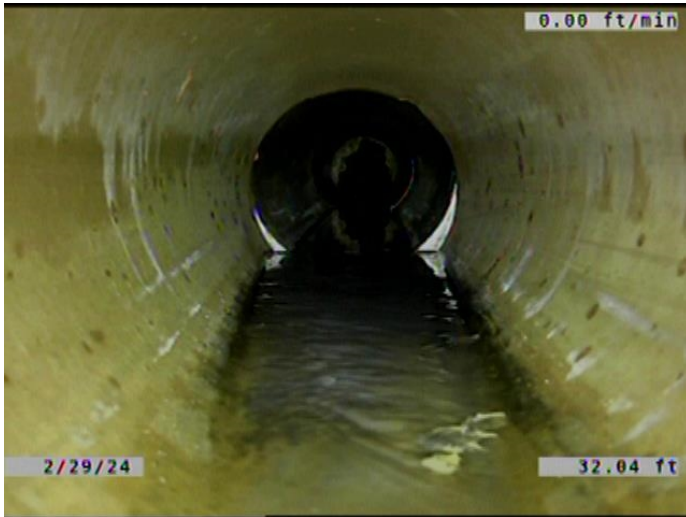
Code: **MWLS**
Description: **Miscellaneous Water Level Sag**

Distance (ft): **32.0**
Structural Grade: **2**
O&M Grade: **0**
Clock Start/From:
Clock To:
1st Value:
2nd Value:
Value Percent: **10.000**
Continuous Index: **S02**
Within 8" of Joint: **NO**
Remarks:

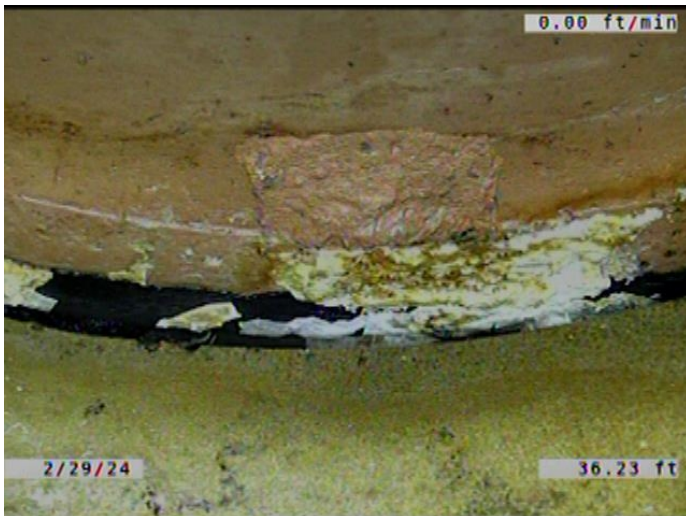
Code: **JOMD**
Description: **Joint Offset Medium Defective**

Distance (ft): **36.2**
Structural Grade: **3**
O&M Grade: **0**
Clock Start/From:
Clock To:
1st Value:
2nd Value:
Value Percent:
Continuous Index:
Within 8" of Joint: **NO**
Remarks:

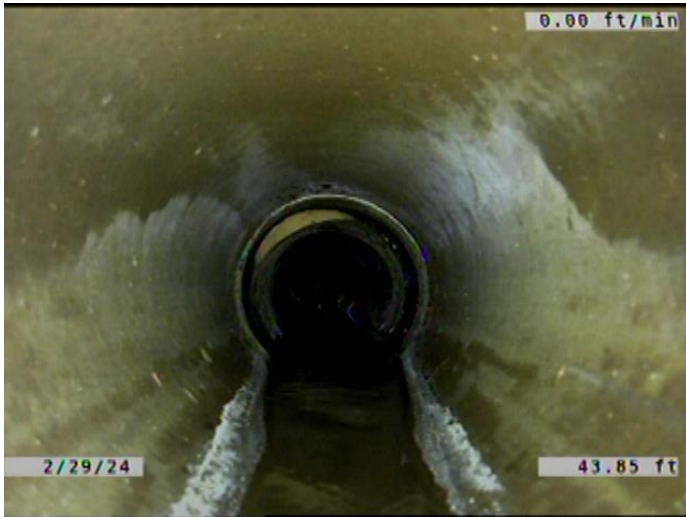
Code: **DAE**
Description: **Deposits Attached Encrustation**

Distance (ft): **43.8**
Structural Grade: **0**
O&M Grade: **2**
Clock Start/From: **7**
Clock To: **5**
1st Value:
2nd Value:
Value Percent: **5.000**
Continuous Index: **F01**
Within 8" of Joint: **YES**
Remarks:

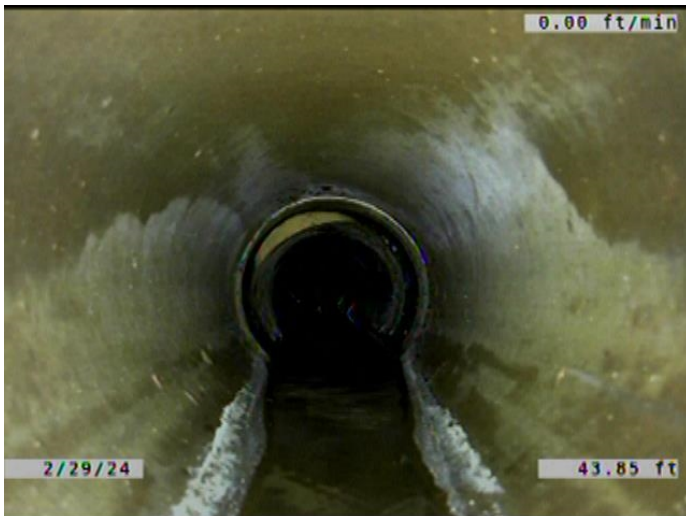
Code: **MWLS**
Description: **Miscellaneous Water Level Sag**

Distance (ft): **43.8**
Structural Grade: **2**
O&M Grade: **0**
Clock Start/From:
Clock To:
1st Value:
2nd Value:
Value Percent: **10.000**
Continuous Index: **F02**
Within 8" of Joint: **NO**
Remarks:

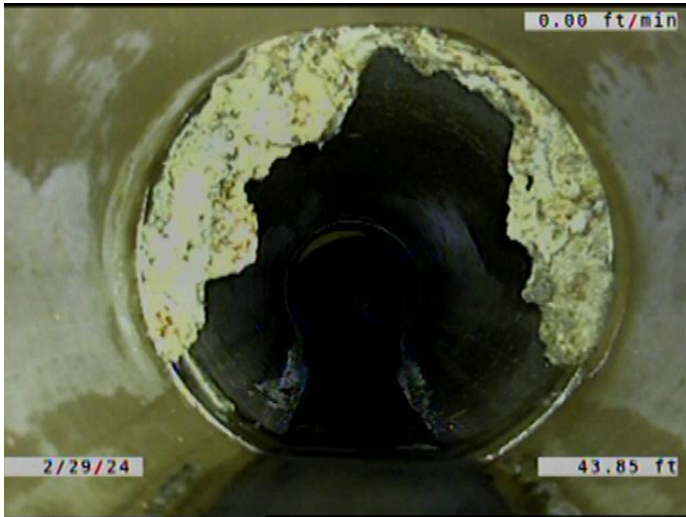
Code: **DAE**
 Description: **Deposits Attached Encrustation**

Distance (ft): **43.8**
 Structural Grade: **0**
 O&M Grade: **3**
 Clock Start/From: **7**
 Clock To: **4**
 1st Value:
 2nd Value:
 Value Percent: **20.000**
 Continuous Index:
 Within 8" of Joint: **YES**
 Remarks:

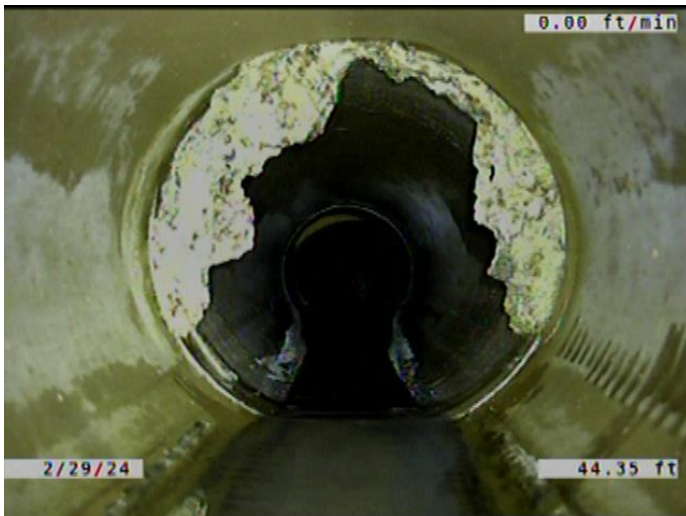
Code: **MSA**
 Description: **Miscellaneous Survey Abandoned**

Distance (ft): **44.4**
 Structural Grade: **0**
 O&M Grade: **0**
 Clock Start/From:
 Clock To:
 1st Value:
 2nd Value:
 Value Percent:
 Continuous Index:
 Within 8" of Joint: **NO**
 Remarks: **CAMERA CANT MAKE IT PAST ENCRUSTATION. MADE IT TO THE P**
