Profile/Photo Observation Report

Street:	S CONNECTICUT ST	Flow Control:	Not Controlled
City:	Hobart, IN	Year Renewed:	
Location:	Yard	Tape/Media #:	
Purpose:	Routine Assessment	Dia/Height:	10"
Use:	Sanitary	Material:	VCP
Drain Area:	NA	Lining:	
Category:	NA		
Comment:

Location Details:		Direction of Survey:	Downstream
US MH:	M-606-078	DS MH:	M-606-079
		Total Length Surveyed (ft):	40.2

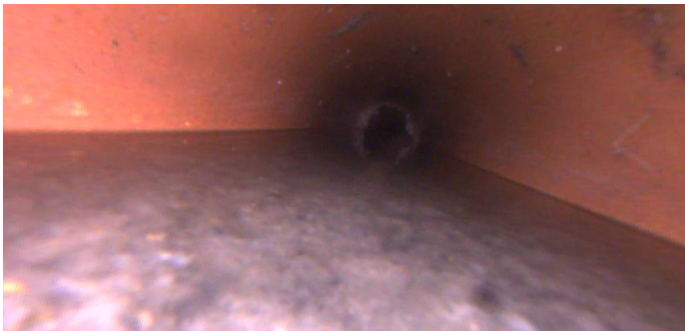
Code: **AMH**
Description: **Manhole**

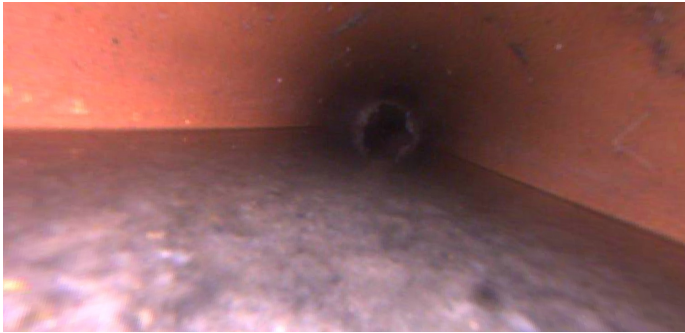
Code:	MWL
Description:	Water Level

Distance (ft):	.0
Structural Grade:	0
O&M Grade:	0
Clock Start/From:	
Clock To:	
1st Value:	
2nd Value:	
Value Percent:	25.000
Continuous Index:	
Within 8" of Joint:	NO
Remarks:

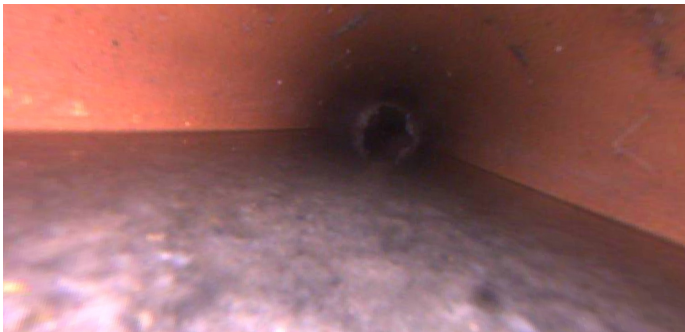
Code:	DSZ
Description:	Deposits Settled Other

Distance (ft):	.0
Structural Grade:	0
O&M Grade:	2
Clock Start/From:	6
Clock To:	
1st Value:	
2nd Value:	
Value Percent:	5.000
Continuous Index:	S01
Within 8" of Joint:	NO
Remarks:	debris/sediments

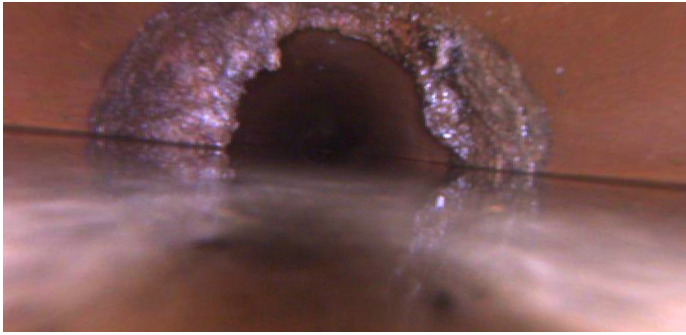
Code: **DAE**
Description: **Deposits Attached Encrustation**

Distance (ft): **3.9**
Structural Grade: **0**
O&M Grade: **2**
Clock Start/From: **9**
Clock To: **3**
1st Value:
2nd Value:
Value Percent: **10.000**
Continuous Index: **S02**
Within 8" of Joint: **YES**
Remarks: **wandering in %**

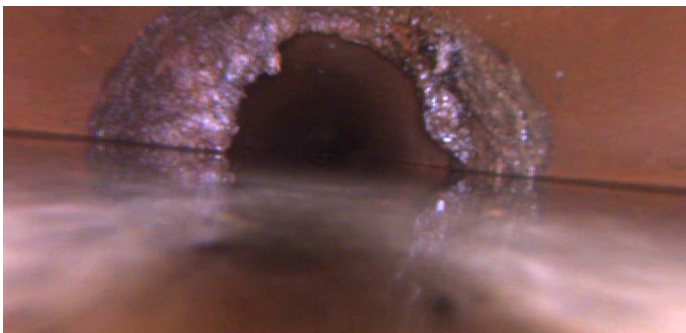
Code: **MWL**
Description: **Water Level**

Distance (ft): **3.9**
Structural Grade: **0**
O&M Grade: **0**
Clock Start/From:
Clock To:
1st Value:
2nd Value:
Value Percent: **50.000**
Continuous Index:
Within 8" of Joint: **NO**
Remarks:

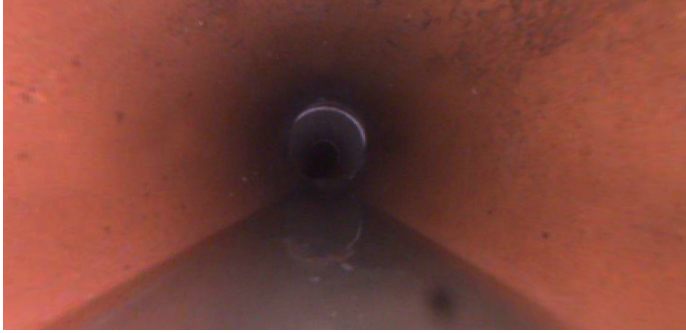
Code: **MWL**
Description: **Water Level**

Distance (ft): **17.3**
Structural Grade: **0**
O&M Grade: **0**
Clock Start/From:
Clock To:
1st Value:
2nd Value:
Value Percent: **5.000**
Continuous Index:
Within 8" of Joint: **NO**
Remarks:

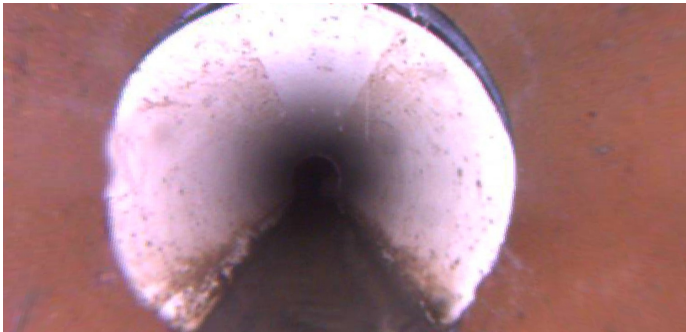
Code: **RPR**
Description: **Repair Point Pipe Replaced**

Distance (ft): **19.7**
Structural Grade: **0**
O&M Grade: **0**
Clock Start/From:
Clock To:
1st Value:
2nd Value:
Value Percent:
Continuous Index:
Within 8" of Joint: **NO**
Remarks: **pvc**

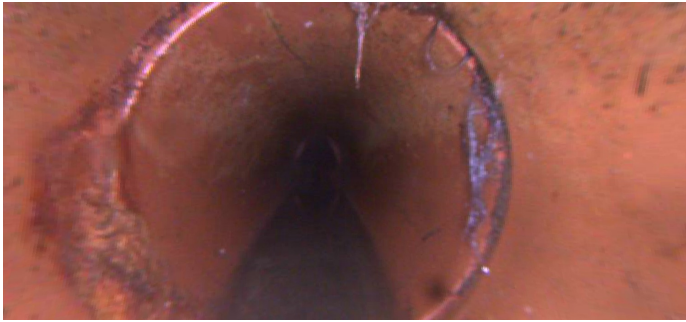
Code: **RFJ**
Description: **Roots Fine Joint**

Distance (ft): **27.9**
Structural Grade: **0**
O&M Grade: **1**
Clock Start/From: **12**
Clock To: **3**
1st Value:
2nd Value:
Value Percent:
Continuous Index:
Within 8" of Joint: **YES**
Remarks:

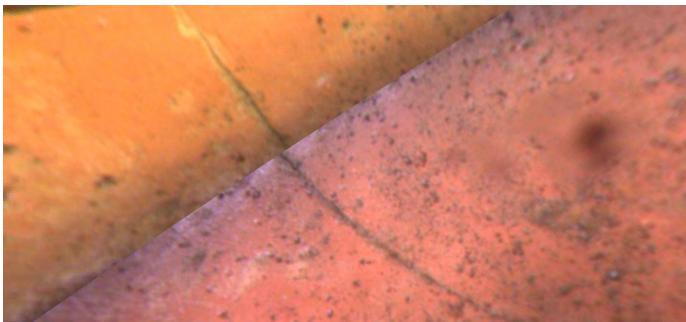
Code: **SZ**
Description: **Surface Other**

Distance (ft): **28.7**
Structural Grade: **0**
O&M Grade: **0**
Clock Start/From: **12**
Clock To:
1st Value:
2nd Value:
Value Percent:
Continuous Index:
Within 8" of Joint: **YES**
Remarks: **scratch**

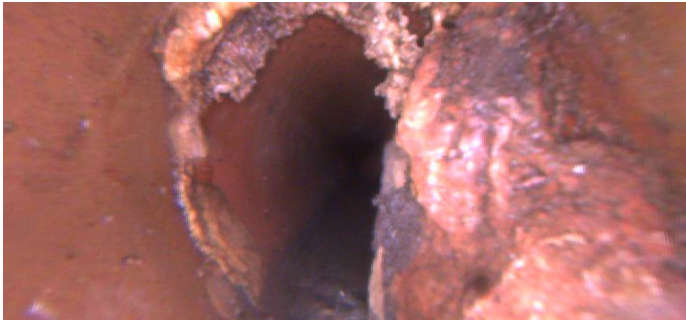
Code: **DAE**
Description: **Deposits Attached Encrustation**

Distance (ft): **40.0**
Structural Grade: **0**
O&M Grade: **5**
Clock Start/From: **11**
Clock To: **6**
1st Value:
2nd Value:
Value Percent: **50.000**
Continuous Index:
Within 8" of Joint: **YES**
Remarks:

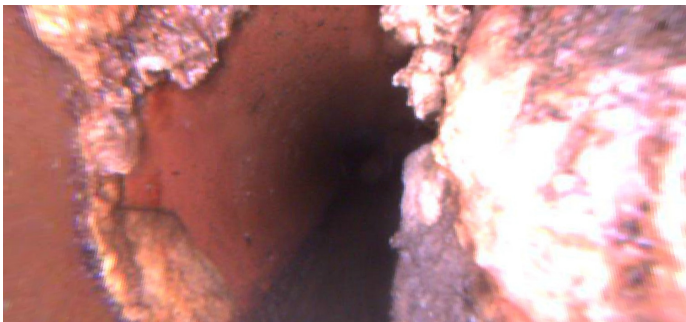
Code: **MSA**
Description: **Abandoned Survey**

Distance (ft): **40.2**
Structural Grade: **0**
O&M Grade: **0**
Clock Start/From:
Clock To:
1st Value:
2nd Value:
Value Percent:
Continuous Index:
Within 8" of Joint: **NO**
Remarks: **dae**

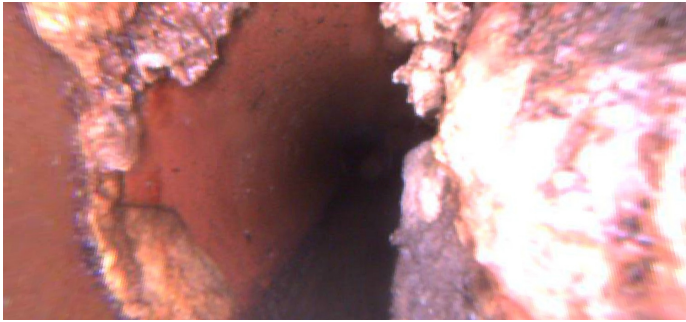
Code: **DAE**
Description: **Deposits Attached Encrustation**

Distance (ft): **40.2**
Structural Grade: **0**
O&M Grade: **2**
Clock Start/From: **9**
Clock To: **3**
1st Value:
2nd Value:
Value Percent: **10.000**
Continuous Index: **F02**
Within 8" of Joint: **YES**
Remarks: **wandering in %**

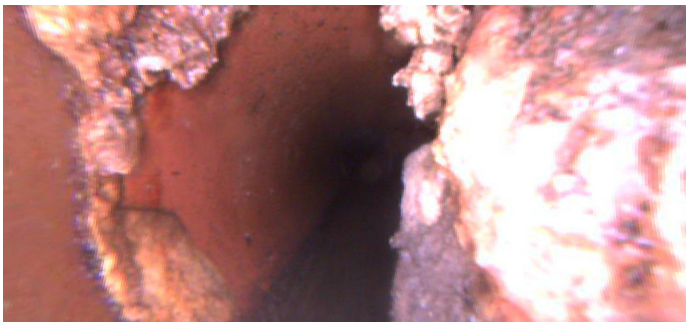
Code: **DSZ**
Description: **Deposits Settled Other**

Distance (ft): **40.2**
Structural Grade: **0**
O&M Grade: **2**
Clock Start/From: **6**
Clock To:
1st Value:
2nd Value:
Value Percent: **5.000**
Continuous Index: **F01**
Within 8" of Joint: **NO**
Remarks: **debris/sediments**
