Profile/Photo Observation Report

Street:	FOXCROFT STREET	Flow Control:	Not Controlled
City:	Hobart, IN	Year Renewed:	
Location:	Yard	Tape/Media #:	
Purpose:	Routine Assessment	Dia/Height:	10"
Use:	Sanitary	Material:	VCP
Drain Area:	NA	Lining:	
Category:	NA		
Comment:

Location Details:		Direction of Survey:	Downstream
US MH:	M-606-078	DS MH:	M-606-079
		Total Length Surveyed (ft):	40.2

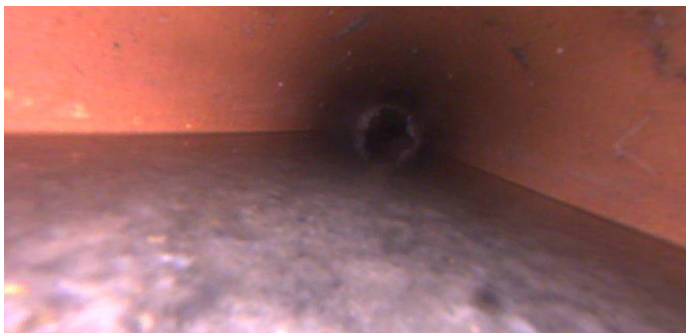
Code: **AMH**
Description: **Manhole**

Distance (ft): **.0**
Structural Grade: **0**
O&M Grade: **0**
Clock Start/From:
Clock To:
1st Value:
2nd Value:
Value Percent:
Continuous Index:
Within 8" of Joint: **NO**
Remarks: **M-606-078**

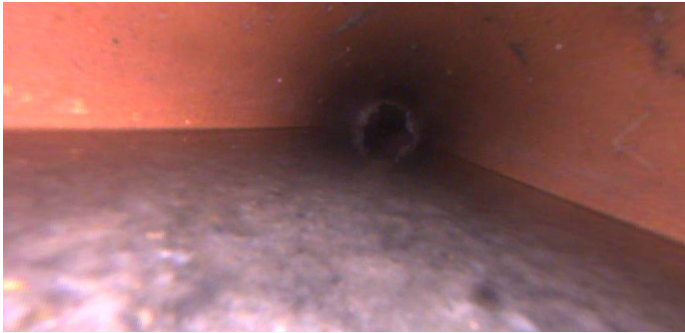
Code:	MWL
Description:	Water Level

Distance (ft):	.0
Structural Grade:	0
O&M Grade:	0
Clock Start/From:	
Clock To:	
1st Value:	
2nd Value:	
Value Percent:	25.000
Continuous Index:	
Within 8" of Joint:	NO
Remarks:

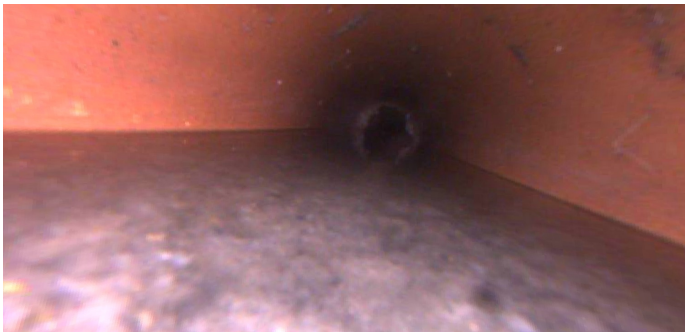
Code:	DSZ
Description:	Deposits Settled Other

Distance (ft):	.0
Structural Grade:	0
O&M Grade:	2
Clock Start/From:	6
Clock To:	
1st Value:	
2nd Value:	
Value Percent:	5.000
Continuous Index:	S01
Within 8" of Joint:	NO
Remarks:	debris/sediments

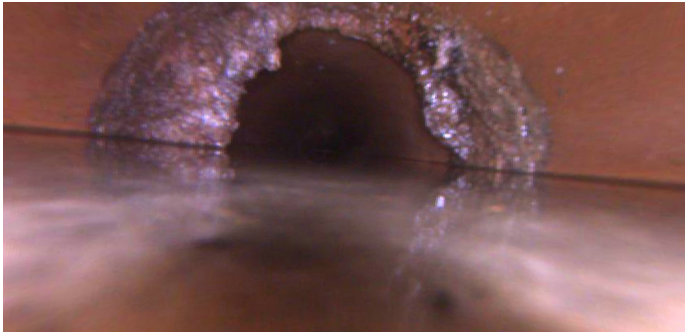
Code: **DAE**
Description: **Deposits Attached Encrustation**

Distance (ft): **3.9**
Structural Grade: **0**
O&M Grade: **2**
Clock Start/From: **9**
Clock To: **3**
1st Value:
2nd Value:
Value Percent: **10.000**
Continuous Index: **S02**
Within 8" of Joint: **YES**
Remarks: **wandering in %**

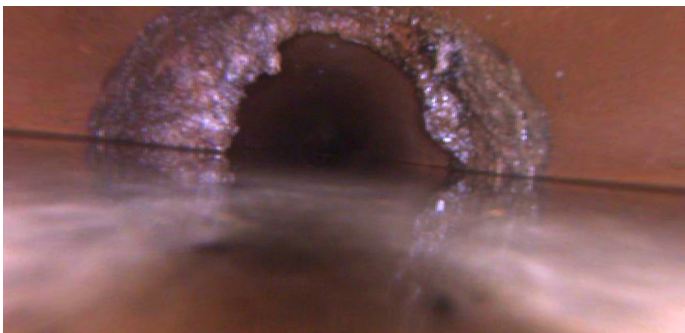
Code: **MWL**
Description: **Water Level**

Distance (ft): **3.9**
Structural Grade: **0**
O&M Grade: **0**
Clock Start/From:
Clock To:
1st Value:
2nd Value:
Value Percent: **50.000**
Continuous Index:
Within 8" of Joint: **NO**
Remarks:

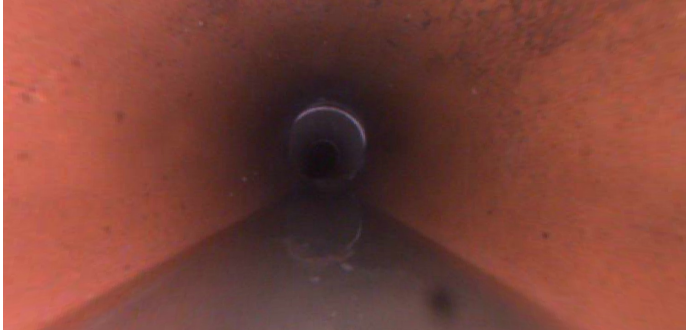
Code: **MWL**
Description: **Water Level**

Distance (ft): **17.3**
Structural Grade: **0**
O&M Grade: **0**
Clock Start/From:
Clock To:
1st Value:
2nd Value:
Value Percent: **5.000**
Continuous Index:
Within 8" of Joint: **NO**
Remarks:

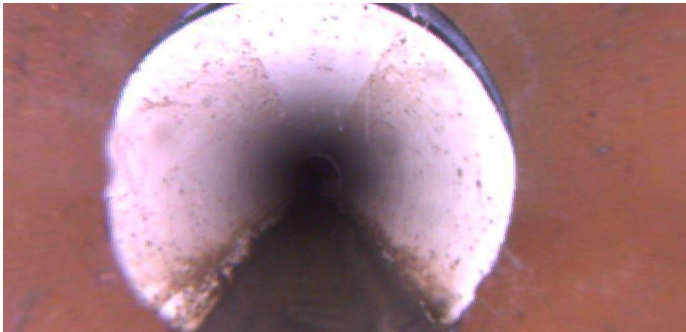
Code: **RPR**
Description: **Repair Point Pipe Replaced**

Distance (ft): **19.7**
Structural Grade: **0**
O&M Grade: **0**
Clock Start/From:
Clock To:
1st Value:
2nd Value:
Value Percent:
Continuous Index:
Within 8" of Joint: **NO**
Remarks: **pvc**

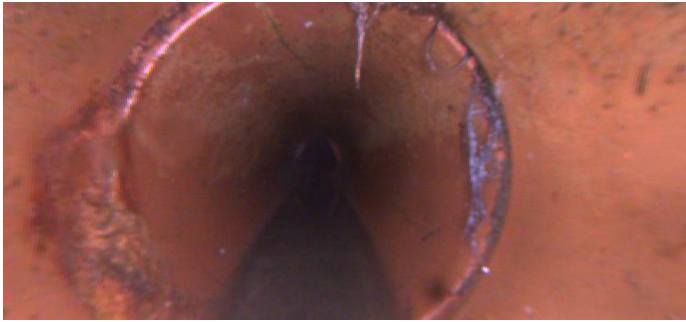
Code: **RFJ**
Description: **Roots Fine Joint**

Distance (ft): **27.9**
Structural Grade: **0**
O&M Grade: **1**
Clock Start/From: **12**
Clock To: **3**
1st Value:
2nd Value:
Value Percent:
Continuous Index:
Within 8" of Joint: **YES**
Remarks:

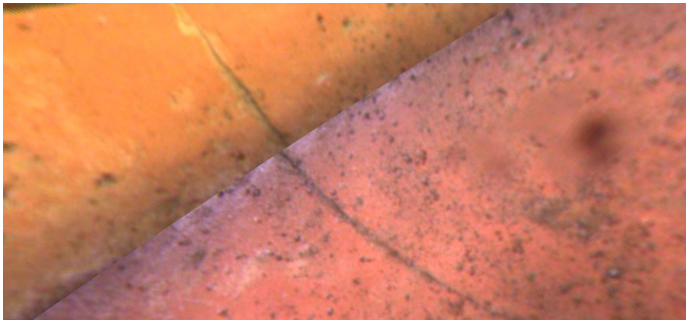
Code: **SZ**
Description: **Surface Other**

Distance (ft): **28.7**
Structural Grade: **0**
O&M Grade: **0**
Clock Start/From: **12**
Clock To:
1st Value:
2nd Value:
Value Percent:
Continuous Index:
Within 8" of Joint: **YES**
Remarks: **scratch**

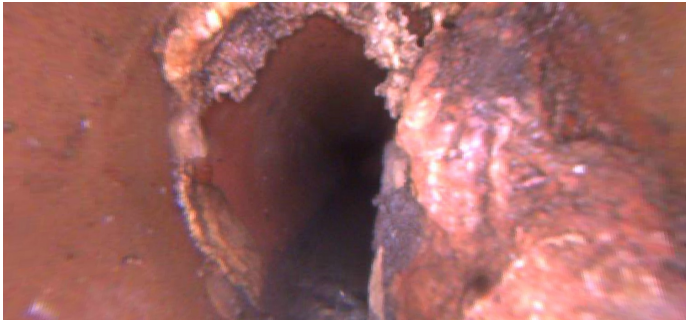
Code: **DAE**
Description: **Deposits Attached Encrustation**

Distance (ft): **40.0**
Structural Grade: **0**
O&M Grade: **5**
Clock Start/From: **11**
Clock To: **6**
1st Value:
2nd Value:
Value Percent: **50.000**
Continuous Index:
Within 8" of Joint: **YES**
Remarks:

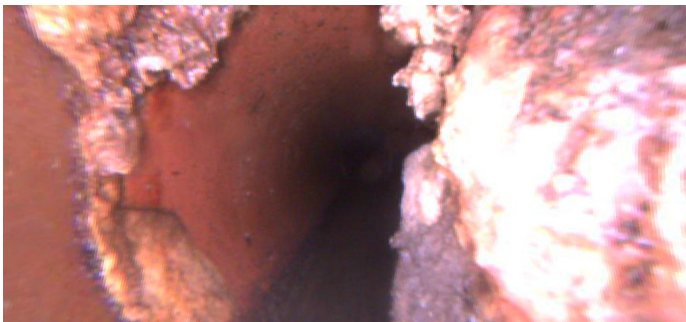
Code: **MSA**
Description: **Abandoned Survey**

Distance (ft): **40.2**
Structural Grade: **0**
O&M Grade: **0**
Clock Start/From:
Clock To:
1st Value:
2nd Value:
Value Percent:
Continuous Index:
Within 8" of Joint: **NO**
Remarks: **dae**

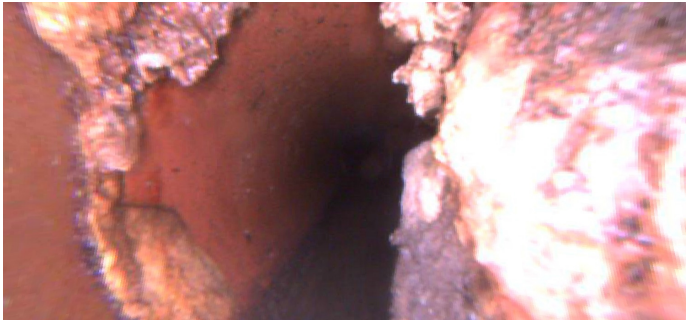
Code: **DAE**
Description: **Deposits Attached Encrustation**

Distance (ft): **40.2**
Structural Grade: **0**
O&M Grade: **2**
Clock Start/From: **9**
Clock To: **3**
1st Value:
2nd Value:
Value Percent: **10.000**
Continuous Index: **F02**
Within 8" of Joint: **YES**
Remarks: **wandering in %**

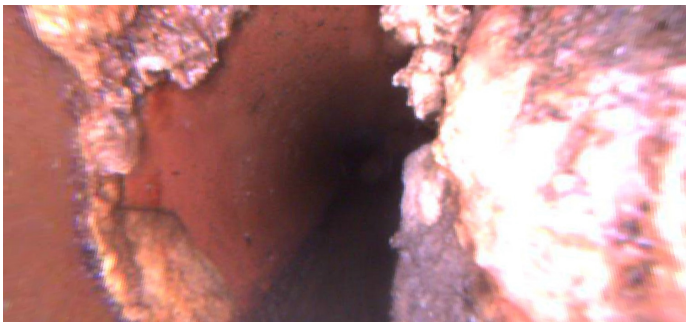
Code: **DSZ**
Description: **Deposits Settled Other**

Distance (ft): **40.2**
Structural Grade: **0**
O&M Grade: **2**
Clock Start/From: **6**
Clock To:
1st Value:
2nd Value:
Value Percent: **5.000**
Continuous Index: **F01**
Within 8" of Joint: **NO**
Remarks: **debris/sediments**
