Profile/Photo Observation Report

Date:	04/08/2018	Weather:		Coding:	PACP 6.0
Pipe Length (ft):	217.7	Owner:	NA	Pre Clean:	No Pre-Cleaning
P.O.#:		Surveyor:	Mark Ruby	PSR:	P-606-079-078
Customer:		Clean Date:	01/01/1900	Shape:	C

Street:	S CONNECTICUT ST	Flow Control:	Not Controlled
City:	Hobart, IN	Year Renewed:	
Location:	Yard	Tape/Media #:	
Purpose:	Routine Assessment	Dia/Height:	10"
Use:	Sanitary	Material:	VCP
Drain Area:	NA	Lining:	
Category:	NA		
Comment:			
Location Details:		Direction of Survey:	Upstream
US MH:	M-606-078	DS MH:	M-606-079
		Total Length Surveyed (ft):	77.3

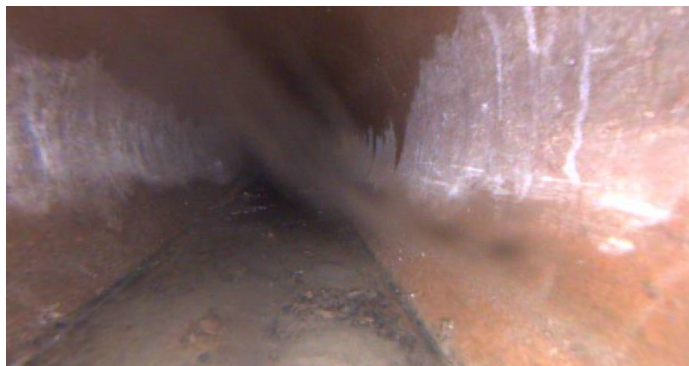
Code: **AMH**
 Description: **Manhole**

Distance (ft): **.0**
 Structural Grade: **0**
 O&M Grade: **0**
 Clock Start/From:
 Clock To:
 1st Value:
 2nd Value:
 Value Percent:
 Continuous Index:
 Within 8" of Joint: **NO**
 Remarks: **M-606-079**

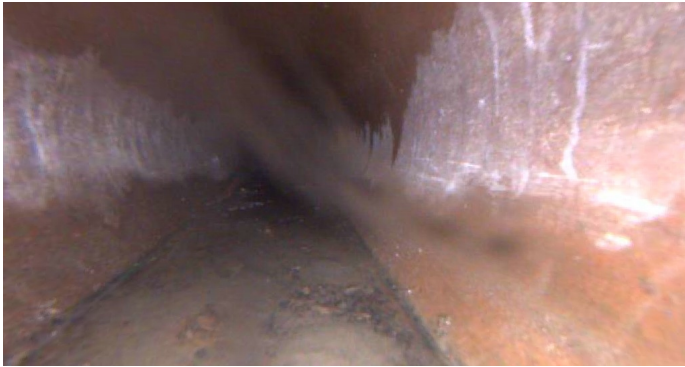
Code:	MWL
Description:	Water Level

Distance (ft):	.0
Structural Grade:	0
O&M Grade:	0
Clock Start/From:	
Clock To:	
1st Value:	
2nd Value:	
Value Percent:	10.000
Continuous Index:	
Within 8" of Joint:	NO
Remarks:

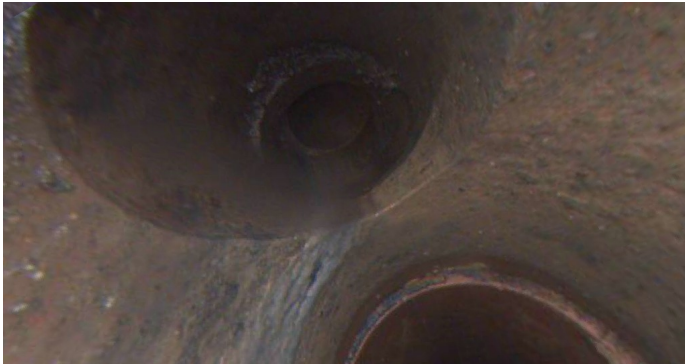
Code:	TF
Description:	Tap Factory

Distance (ft):	5.6
Structural Grade:	0
O&M Grade:	0
Clock Start/From:	2
Clock To:	
1st Value:	4.000
2nd Value:	
Value Percent:	
Continuous Index:	
Within 8" of Joint:	
Remarks:

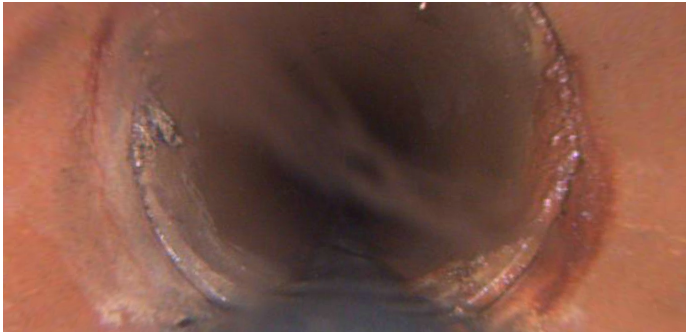
Code: **IW**
Description: **Infil Weeper**

Distance (ft): **13.8**
Structural Grade: **0**
O&M Grade: **2**
Clock Start/From: **8**
Clock To: **4**
1st Value:
2nd Value:
Value Percent:
Continuous Index:
Within 8" of Joint: **YES**
Remarks:

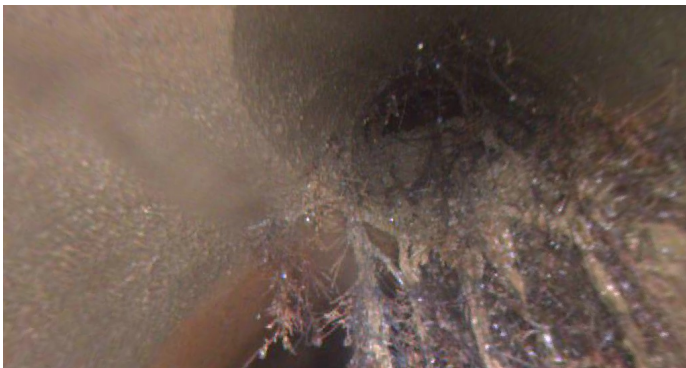
Code: **TFD**
Description: **Tap Factory Defective**

Distance (ft): **19.2**
Structural Grade: **0**
O&M Grade: **2**
Clock Start/From: **11**
Clock To:
1st Value: **4.000**
2nd Value:
Value Percent:
Continuous Index:
Within 8" of Joint:
Remarks: **RFL**

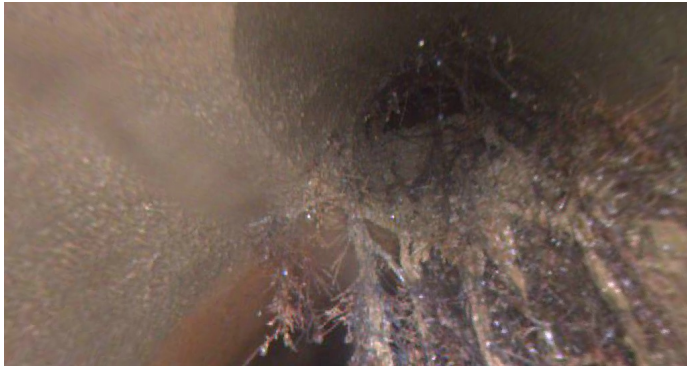
Code: **RFL**
Description: **Roots Fine Lateral**

Distance (ft): **19.2**
Structural Grade: **0**
O&M Grade: **1**
Clock Start/From: **11**
Clock To:
1st Value:
2nd Value:
Value Percent:
Continuous Index:
Within 8" of Joint: **NO**
Remarks:

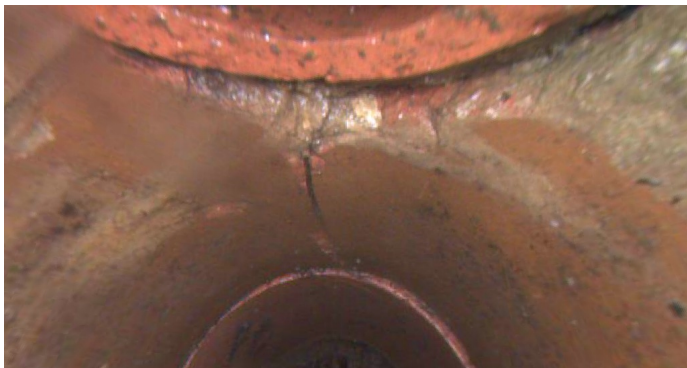
Code: **FM**
Description: **Fracture Multiple**

Distance (ft): **21.2**
Structural Grade: **4**
O&M Grade: **0**
Clock Start/From: **5**
Clock To: **7**
1st Value:
2nd Value:
Value Percent:
Continuous Index:
Within 8" of Joint:
Remarks:

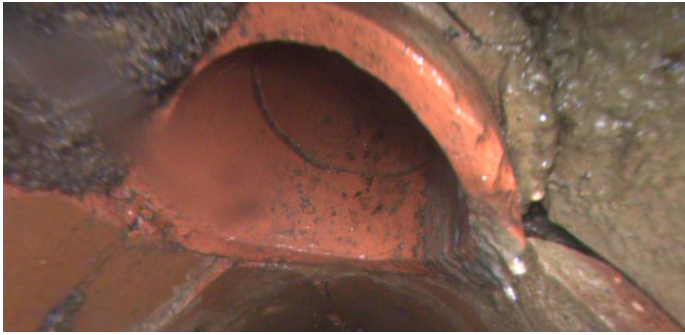
Code: **TBI**
Description: **Tap Break-in Intruding**

Distance (ft): **21.6**
Structural Grade: **0**
O&M Grade: **2**
Clock Start/From: **12**
Clock To:
1st Value: **4.000**
2nd Value: **1.000**
Value Percent:
Continuous Index:
Within 8" of Joint:
Remarks:

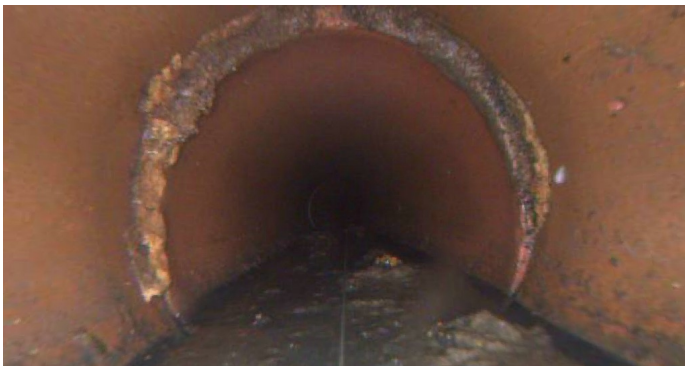
Code: **DAE**
Description: **Deposits Attached Encrustation**

Distance (ft): **36.6**
Structural Grade: **0**
O&M Grade: **2**
Clock Start/From: **5**
Clock To: **7**
1st Value:
2nd Value:
Value Percent: **5.000**
Continuous Index:
Within 8" of Joint: **YES**
Remarks:

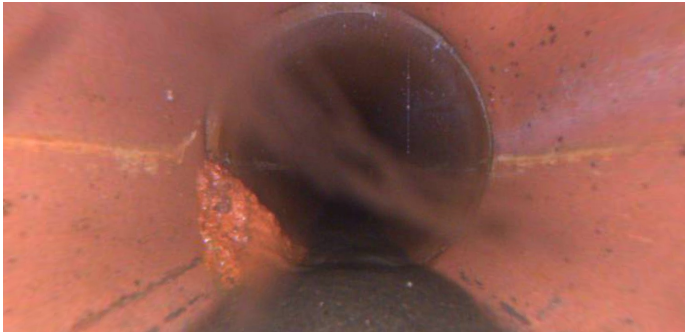
Code: **DAE**
Description: **Deposits Attached Encrustation**

Distance (ft): **43.0**
Structural Grade: **0**
O&M Grade: **2**
Clock Start/From: **7**
Clock To: **9**
1st Value:
2nd Value:
Value Percent: **10.000**
Continuous Index:
Within 8" of Joint: **YES**
Remarks:

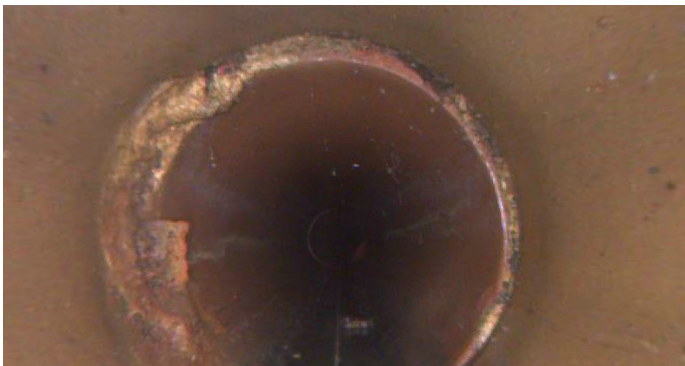
Code: **DAE**
Description: **Deposits Attached Encrustation**

Distance (ft): **48.4**
Structural Grade: **0**
O&M Grade: **2**
Clock Start/From: **5**
Clock To: **12**
1st Value:
2nd Value:
Value Percent: **10.000**
Continuous Index:
Within 8" of Joint: **NO**
Remarks:

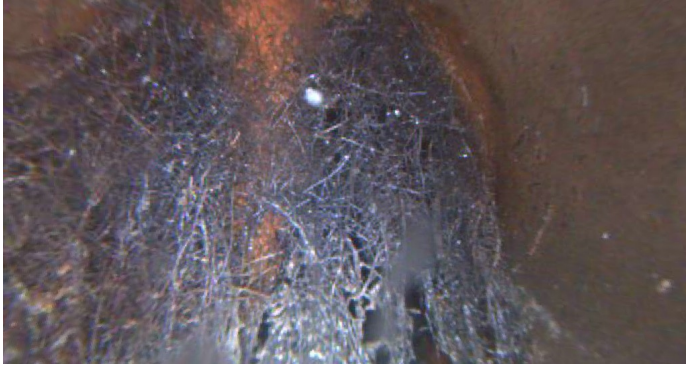
Code: **RBJ**
Description: **Roots Ball Joint**

Distance (ft): **60.3**
Structural Grade: **0**
O&M Grade: **4**
Clock Start/From: **12**
Clock To: **12**
1st Value:
2nd Value:
Value Percent: **95.000**
Continuous Index:
Within 8" of Joint: **YES**
Remarks:

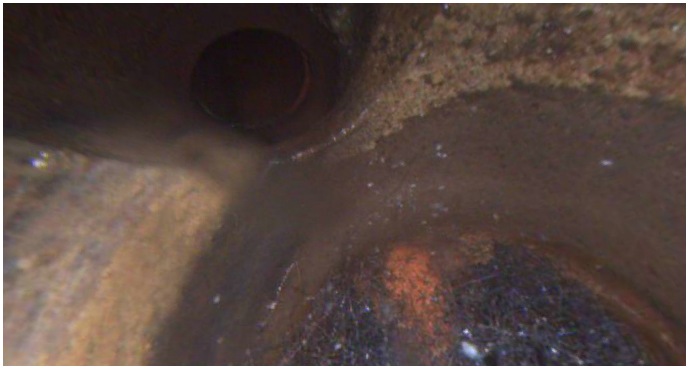
Code: **TF**
Description: **Tap Factory**

Distance (ft): **60.5**
Structural Grade: **0**
O&M Grade: **0**
Clock Start/From: **1**
Clock To:
1st Value: **4.000**
2nd Value:
Value Percent:
Continuous Index:
Within 8" of Joint:
Remarks:

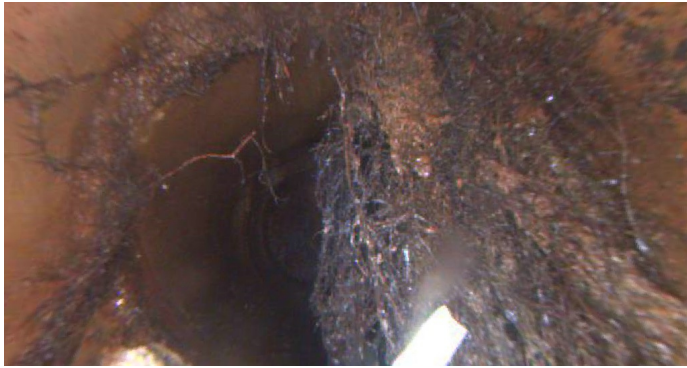
Code:	RBJ
Description:	Roots Ball Joint
Distance (ft):	62.2
Structural Grade:	0
O&M Grade:	4
Clock Start/From:	5
Clock To:	7
1st Value:	
2nd Value:	
Value Percent:	60.000
Continuous Index:	
Within 8" of Joint:	YES
Remarks:

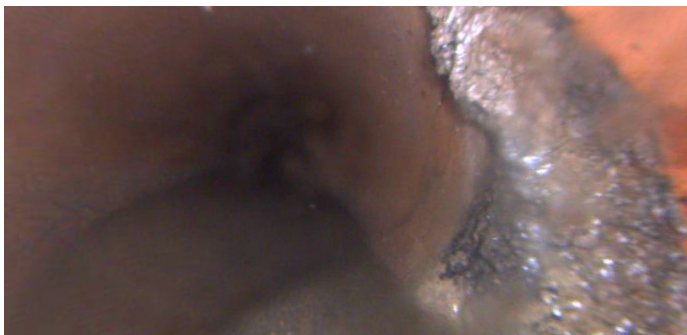
Code:	DAE
Description:	Deposits Attached Encrustation
Distance (ft):	73.3
Structural Grade:	0
O&M Grade:	2
Clock Start/From:	1
Clock To:	4
1st Value:	
2nd Value:	
Value Percent:	10.000
Continuous Index:	
Within 8" of Joint:	YES
Remarks:

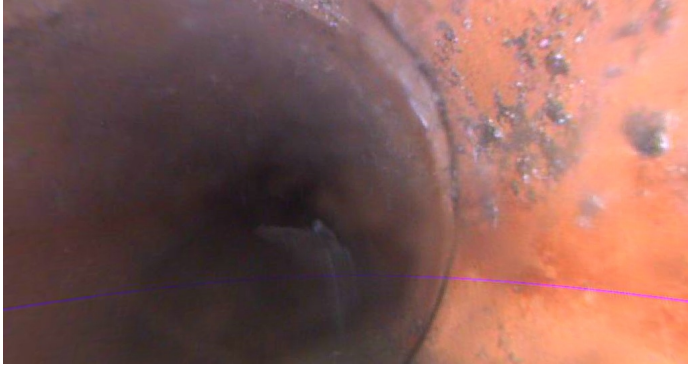
Code:	MSA
Description:	Abandoned Survey
Distance (ft):	77.3
Structural Grade:	0
O&M Grade:	0
Clock Start/From:	
Clock To:	
1st Value:	
2nd Value:	
Value Percent:	
Continuous Index:	
Within 8" of Joint:	NO
Remarks:	No blockage
